## INSPECTION REPORT

**Site Number:** V-00334-9/915525 Date: August 26, 2009

**Site Name:** Grief Bros. Corporation

**Location:** 2122 Colvin Blvd, Tonawanda

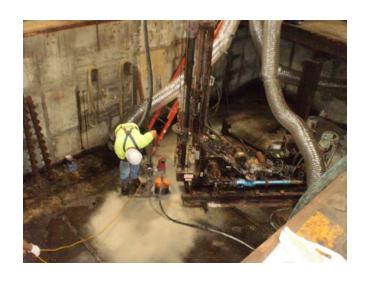
Nothnagel coring and augering VP-2 well. Struggle to get skid mounted rig into pit. Some evidence of DNAPL flowed to surface when core was removed. Core completed at 1135 hrs

082609-01 VP-2 Coring.JPG

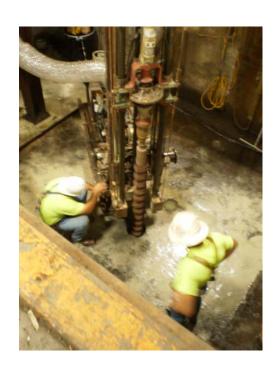
VP-2 - PID at bottom of slab ~112, PID reading just above pit floor ~0. Soil sample from upper cuttings PID - ~1160. Soil sample from ~3' below pit floor PID ~1729. Soil sample from ~6' below pit floor PID ~2045 ppm. Visual evidence of DNAPL. Free product collects in bottom of bag. Evidence of DNAPL on floor from augers. VP-2 augers advanced to 6' below pit floor. 7' slotted PVC screen installed in VP-2 boring.

082609-03 VP-2 Augers.JPG Greif Bros

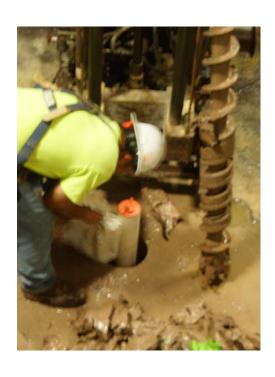
082609-07 VP-2 Sand pack.JPG Greif Bros
