*REPORT ON THE
IMPLEMENTATION OF
THE INTERIM REMEDIAL MEASURES*

*AT 3241 WALDEN AVENUE
DEPEW, N.Y.*

JULY 12, 1999 TO JULY 26, 1999

NORAMPAC INC.

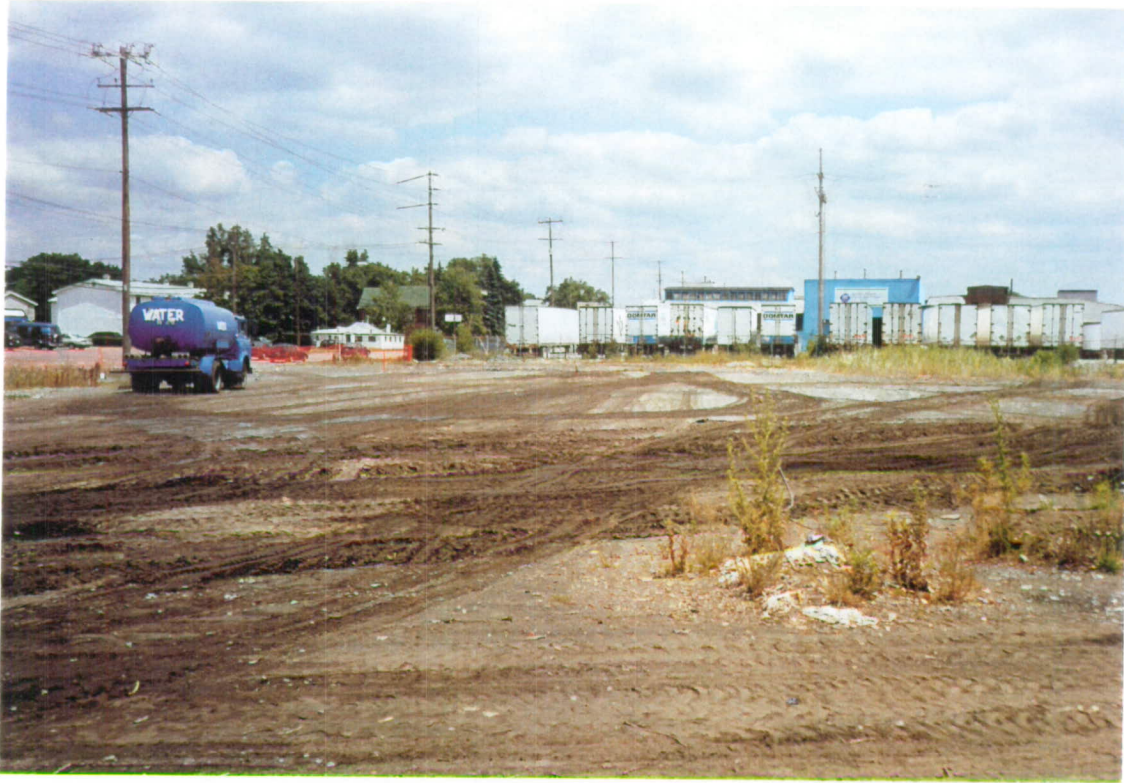
Spraying the site before activity on site, July 13, 1999

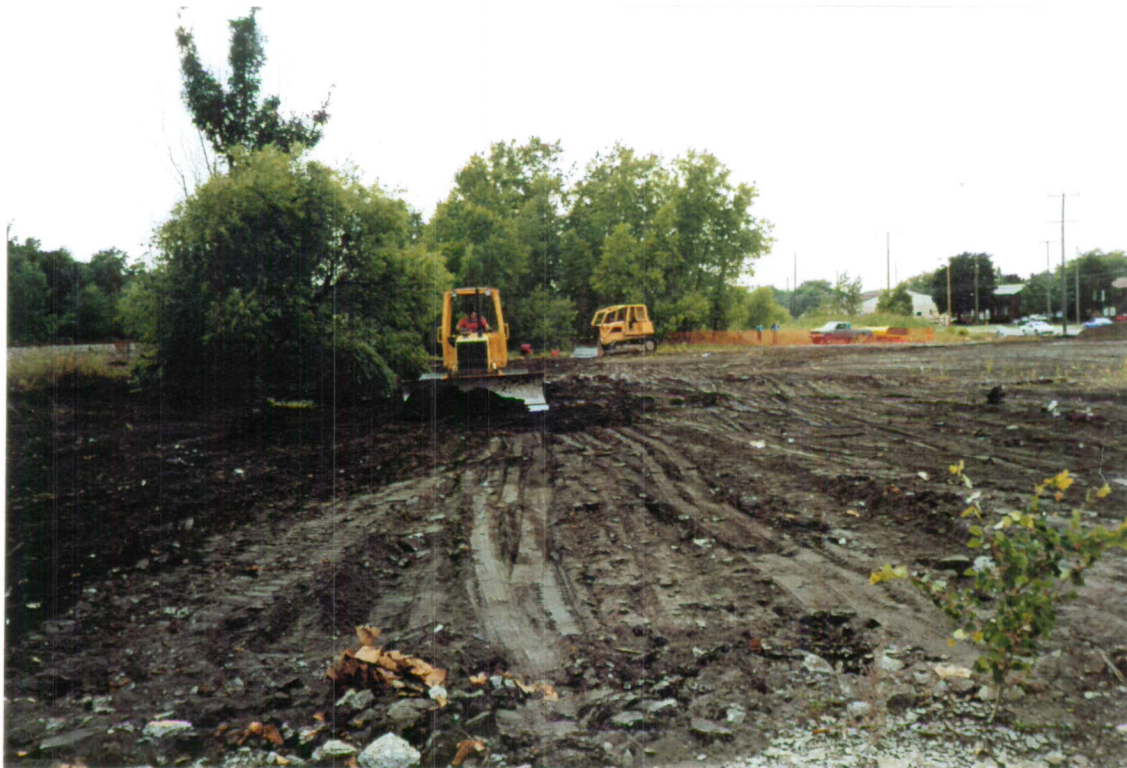
Initial grading of contaminated soil, July 13, 1999

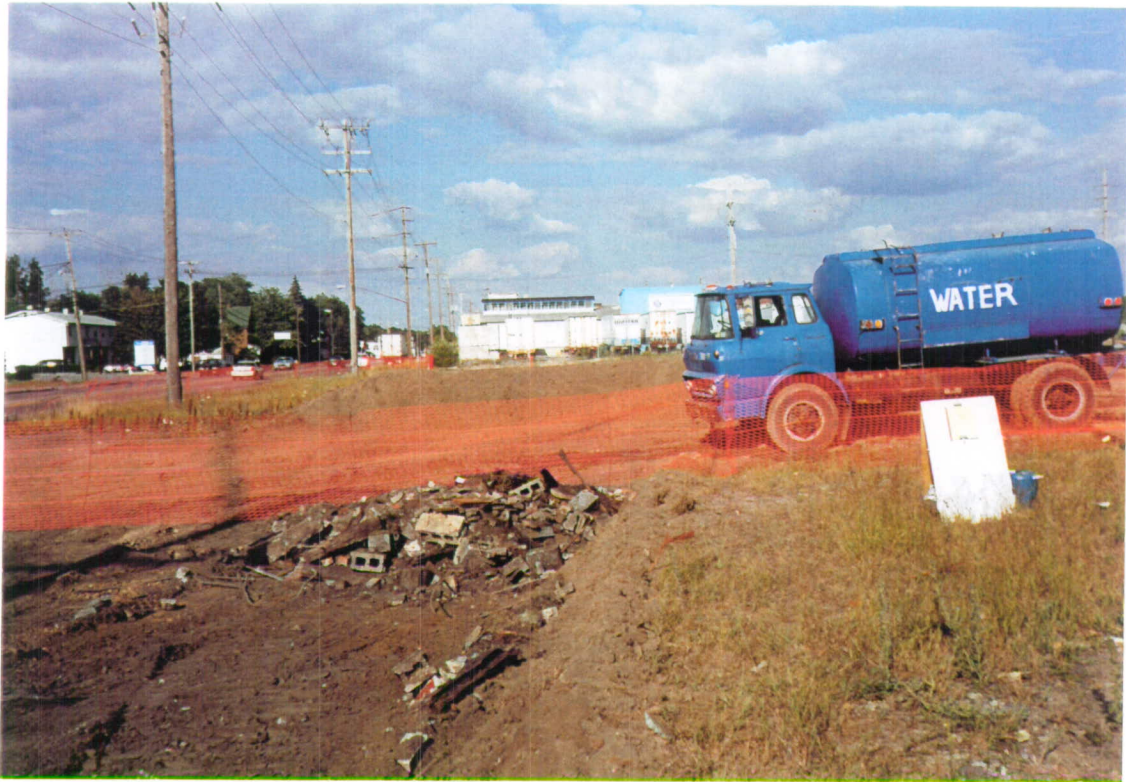
Debris deposit in the entrance excavation, July 13, 1999

The concrete blocks and rubble were broken up and buried beneath the new entrance way for future disposal. As mentioned before, the rubble was covered with crusher run gravel.

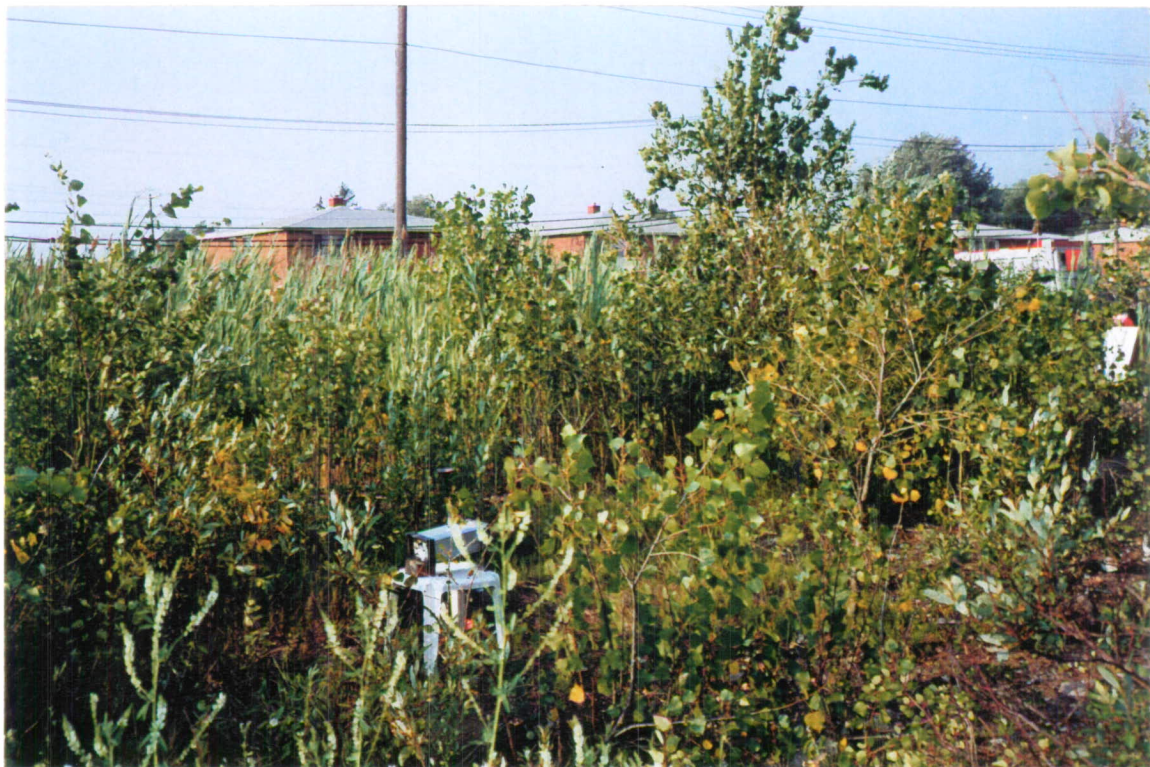
Air monitoring unit upwind of activities, July 14, 1999

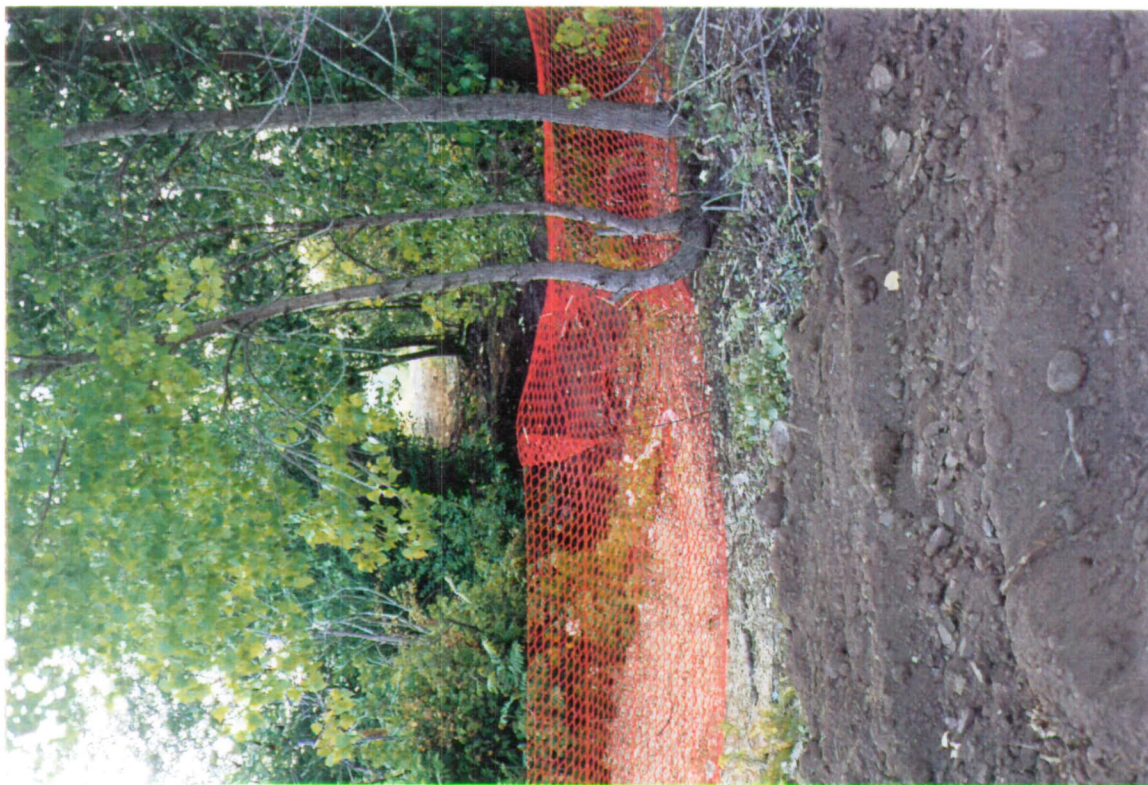
Clearance in forest for fence, July 15, 1999

During the first three days, brush and dead trees were removed thus creating a clearing between the trees and the south property line where the fence was installed.

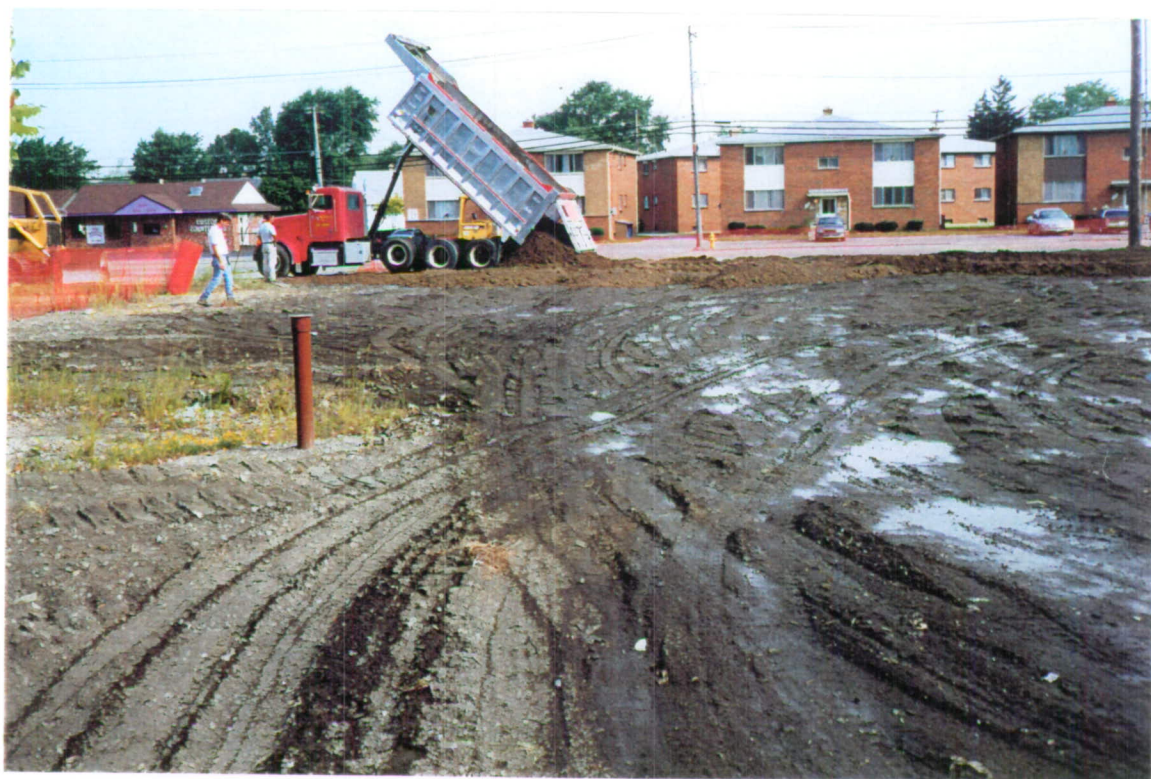
Receiving topsoil and water sprayed on the contaminated soil

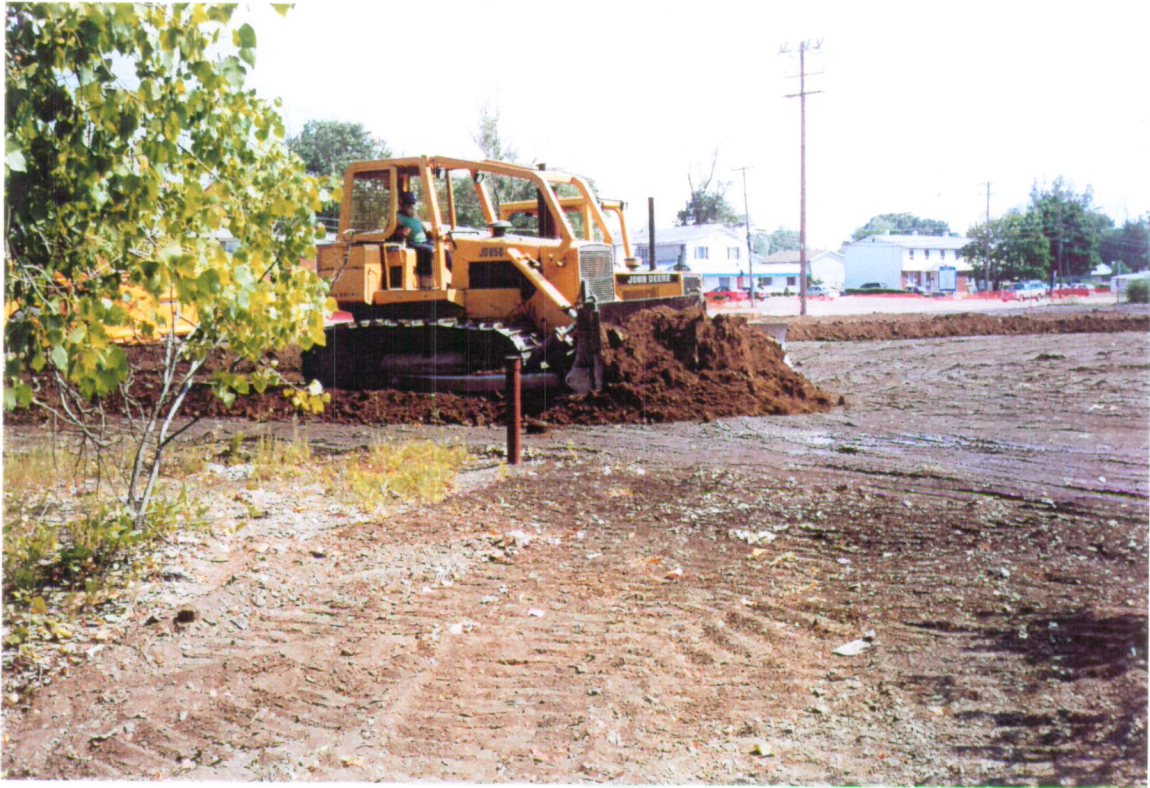
Grading topsoil over contaminated soil, July 15, 1999

The central portion surrounded by the new fence and the section situated between the north property line and the curb on Walden Avenue was graded off with 0.10 – 0.15 meters (4 – 5 inches) of topsoil. Bulldozers were able to push the topsoil very successfully.

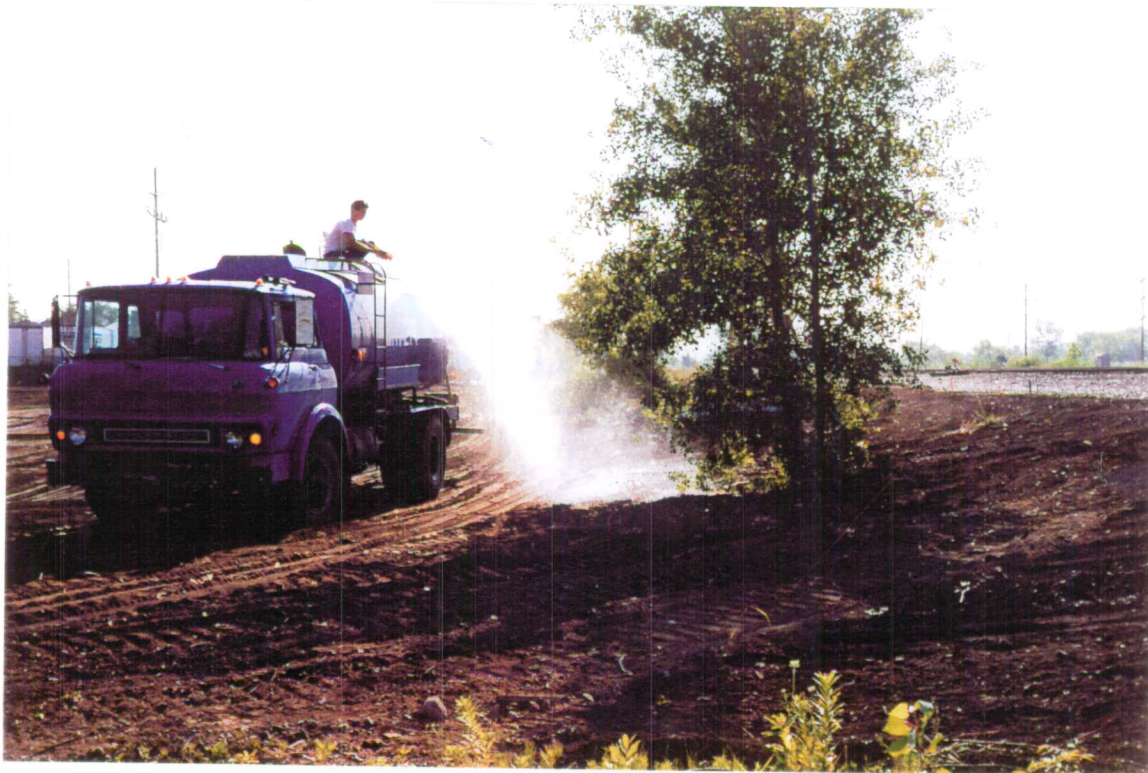
Water being applied to new topsoil, July 15, 1999

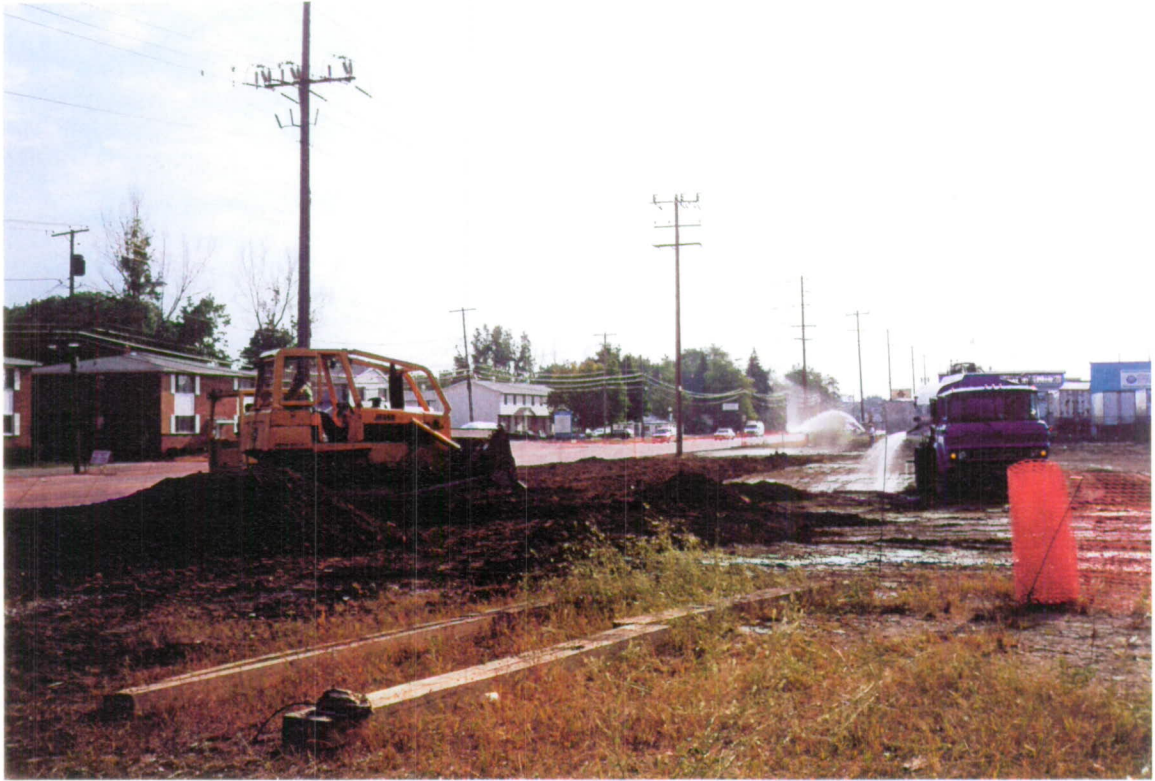
*Topsoil receiving area at new entrance
Water truck in operation, July 15, 1999*

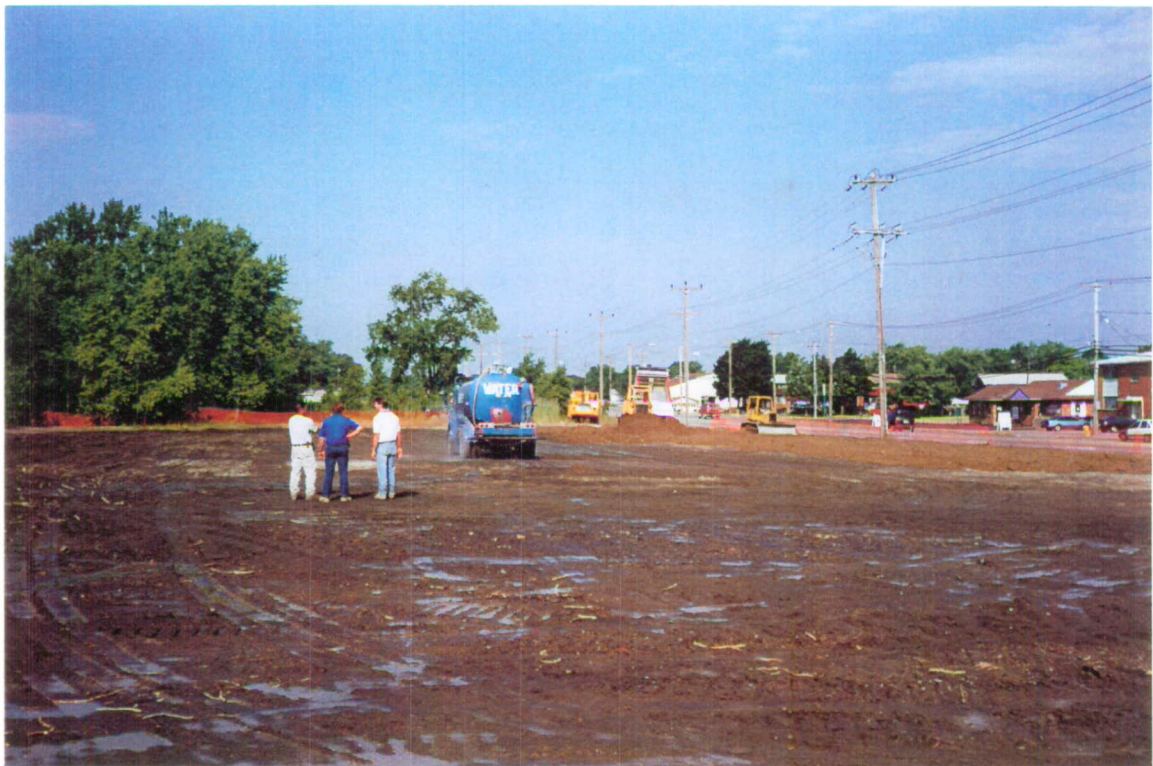
*Topsoil receiving, July 15, 1999
Note how the lot is kept moist by the water truck*

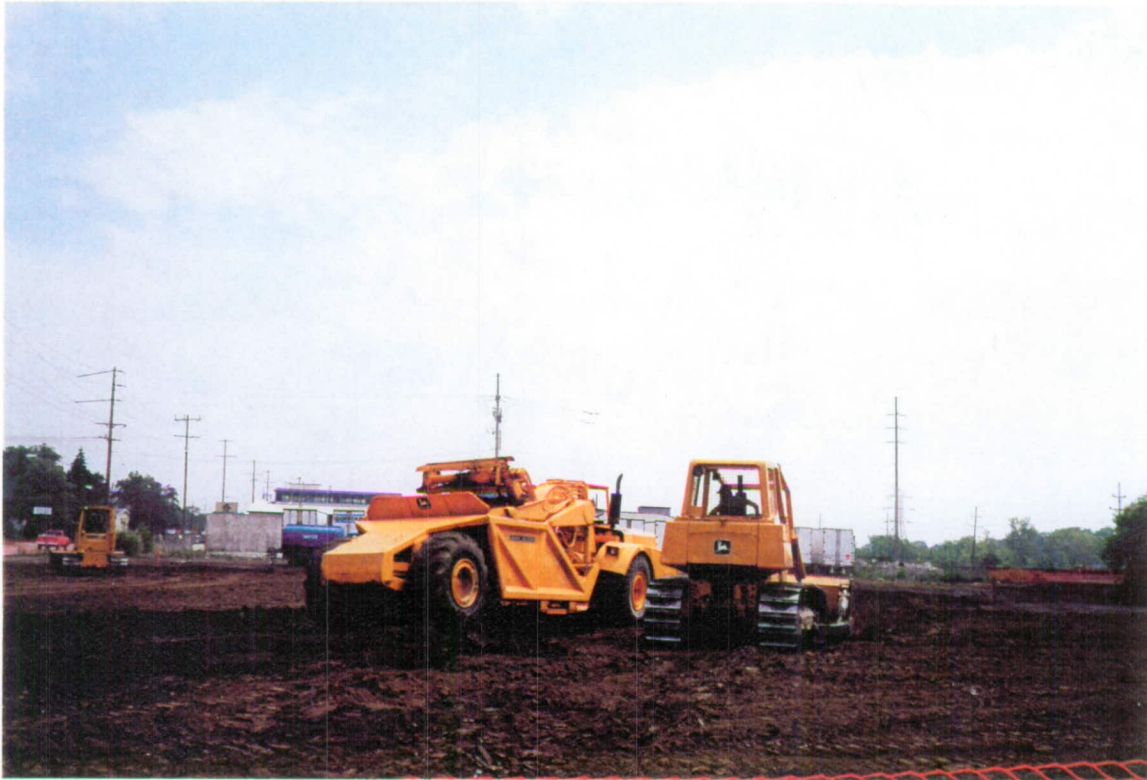
Two bulldozers and a Pan moving the topsoil from the new entrance at north west going toward the south-east corner, July 15, 1999

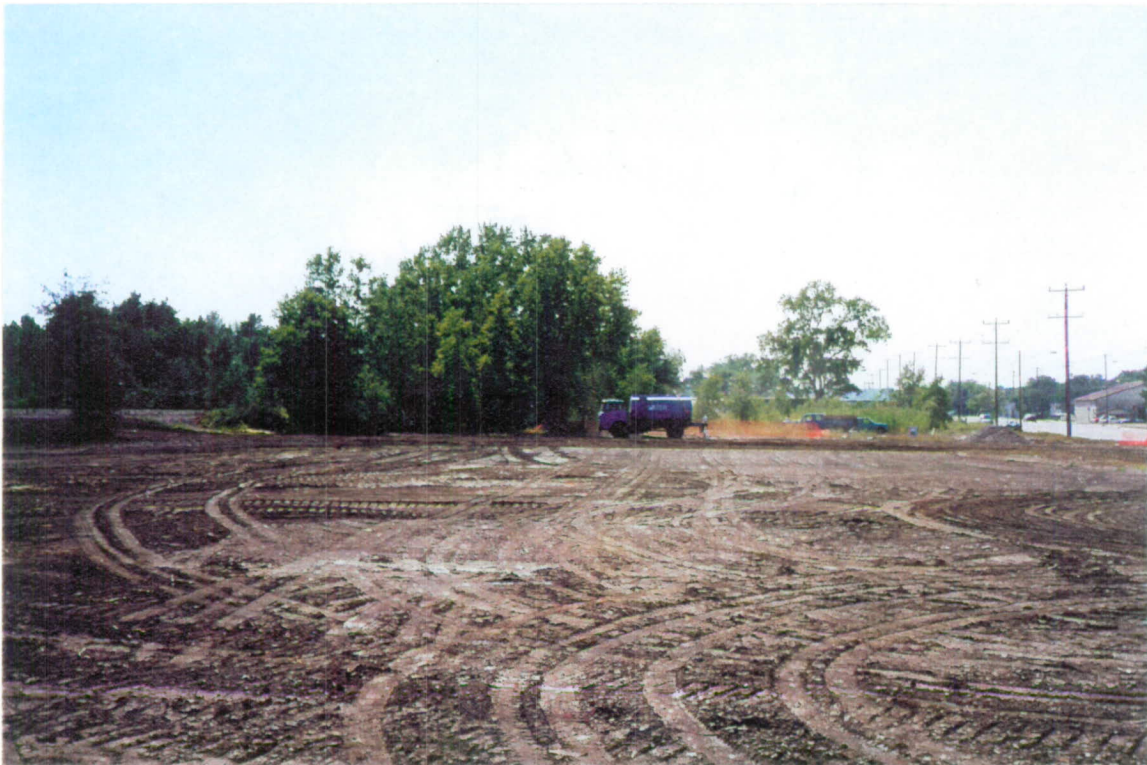
*Rough graded topsoil end of July 15, 1999
Water truck still in operation*

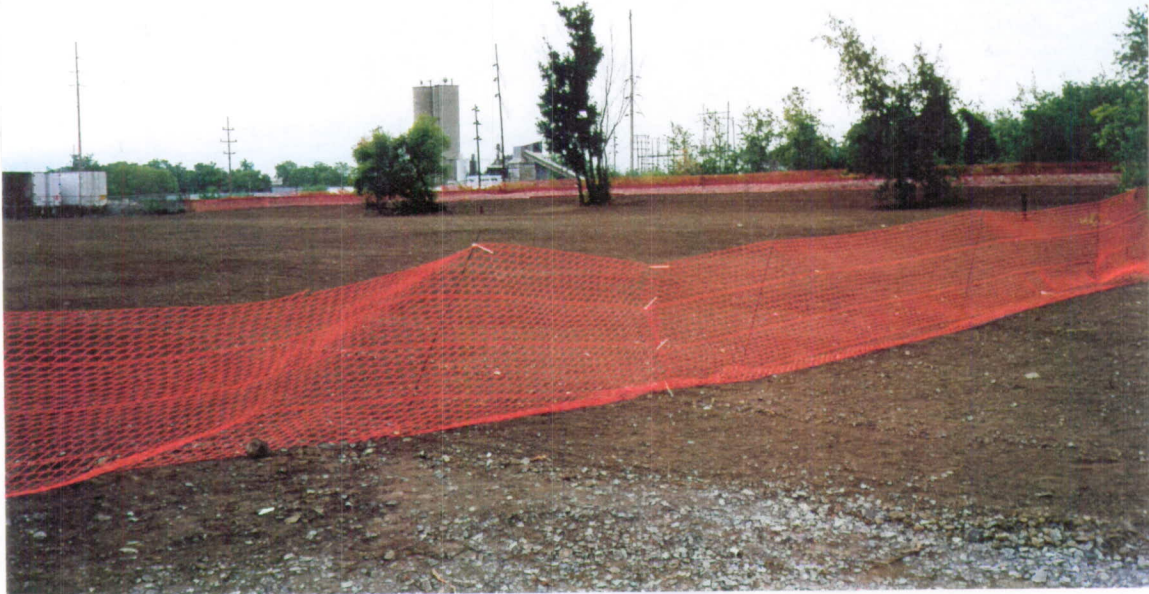
*After rake out of new topsoil
Safety fence in place, July 16, 1999*

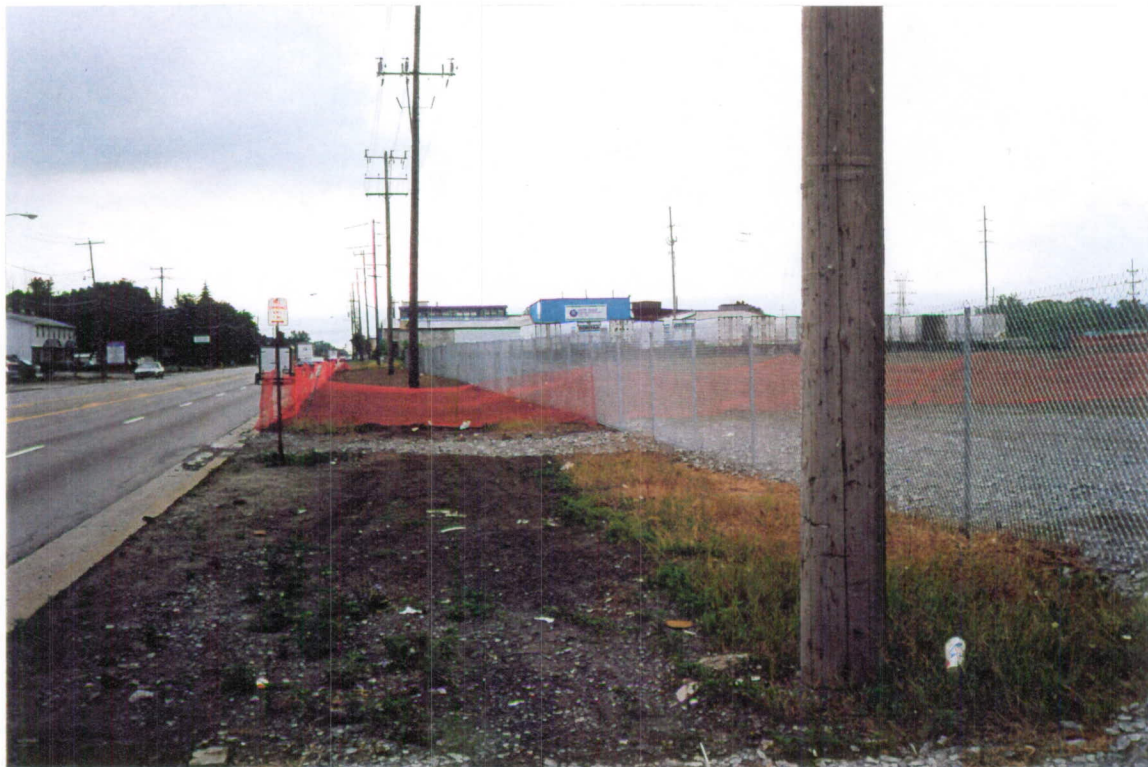
*After rake out of new topsoil
Safety fence reinstalled because new fence is not complete, July 16, 1999*

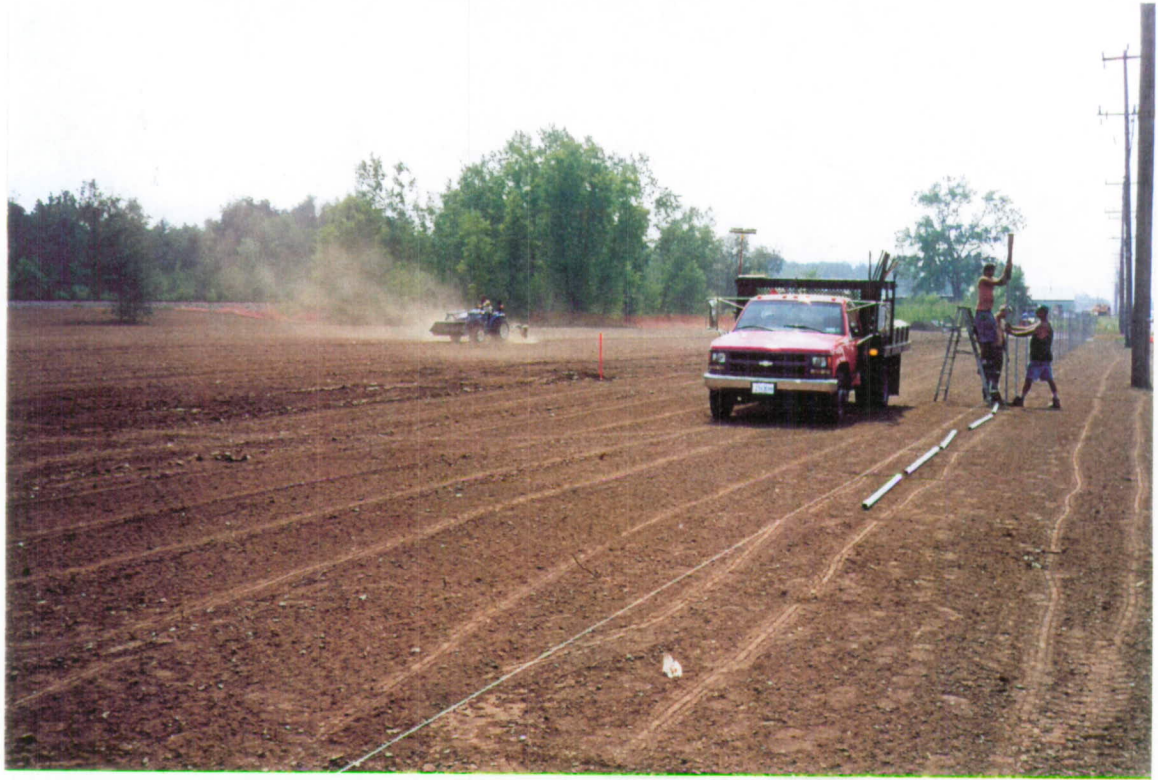
Rake out of topsoil and installation of fence, July 16, 1999

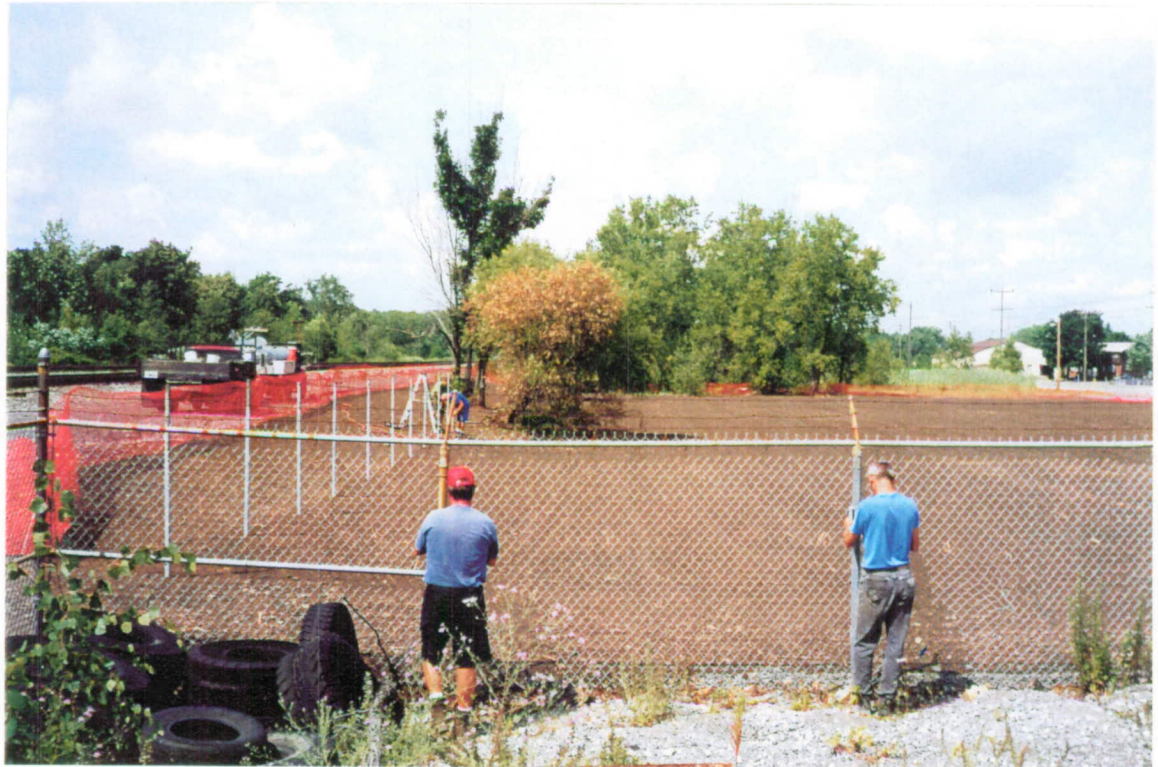
*Repair to old end fence
Installation of new fence, July 20, 1999*

Seneca Fence installed the posts by driving them into the ground. Therefore no auger was utilized. The corner posts were made stronger by Z bracing, thus joining the posts in either direction from the corner. Some soil excavated by hand tools for the main gate posts was all carried to the decontamination area and later covered with topsoil.

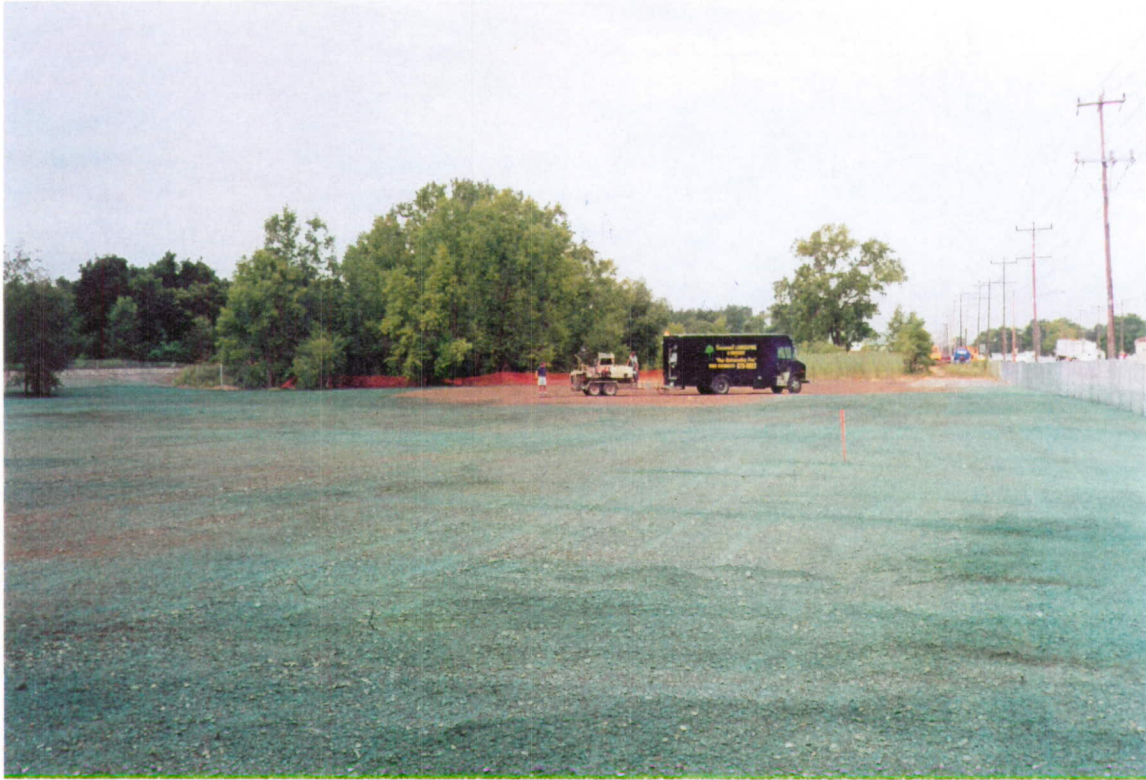
Hydroseeding equipment in operation, July 22, 1999

The hydro-seeding of top soil was completed within six hours on July 21, 1999, using 8000 gallons of hydro-seeding solution on 7435 m² (80 000 square feet). The surface hydro-seeded included some wooden area and the driveway approach. The conditions for driving on the site were ideal and the hydro-seeding did not damage the prepared surface of topsoil at the site.

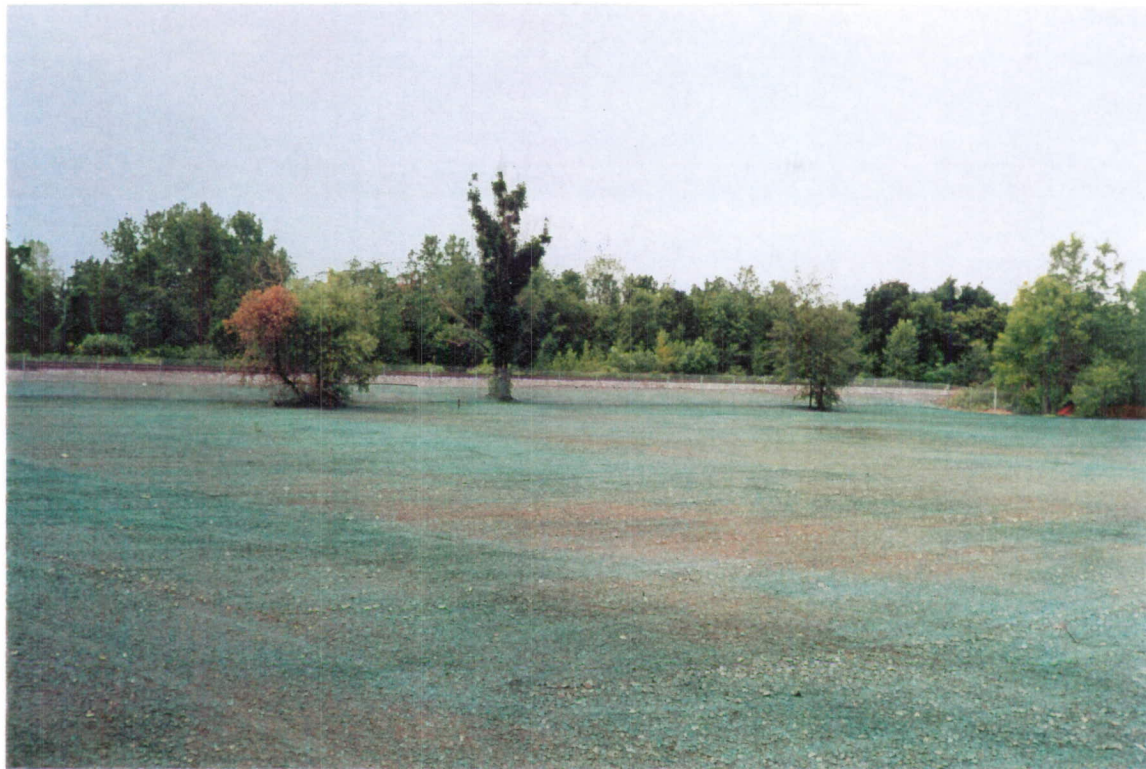
Topsoil surface hydroseeded, July 22, 1999

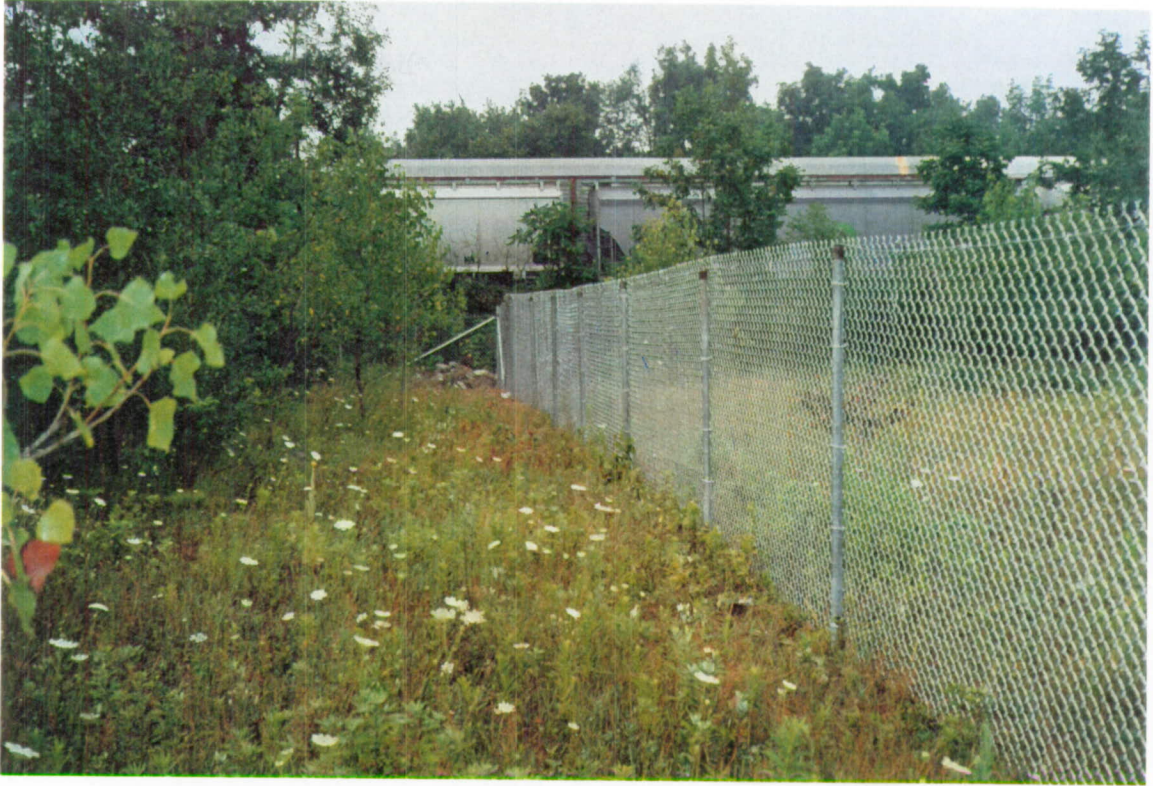
New fence across west end of work area, July 23, 1999

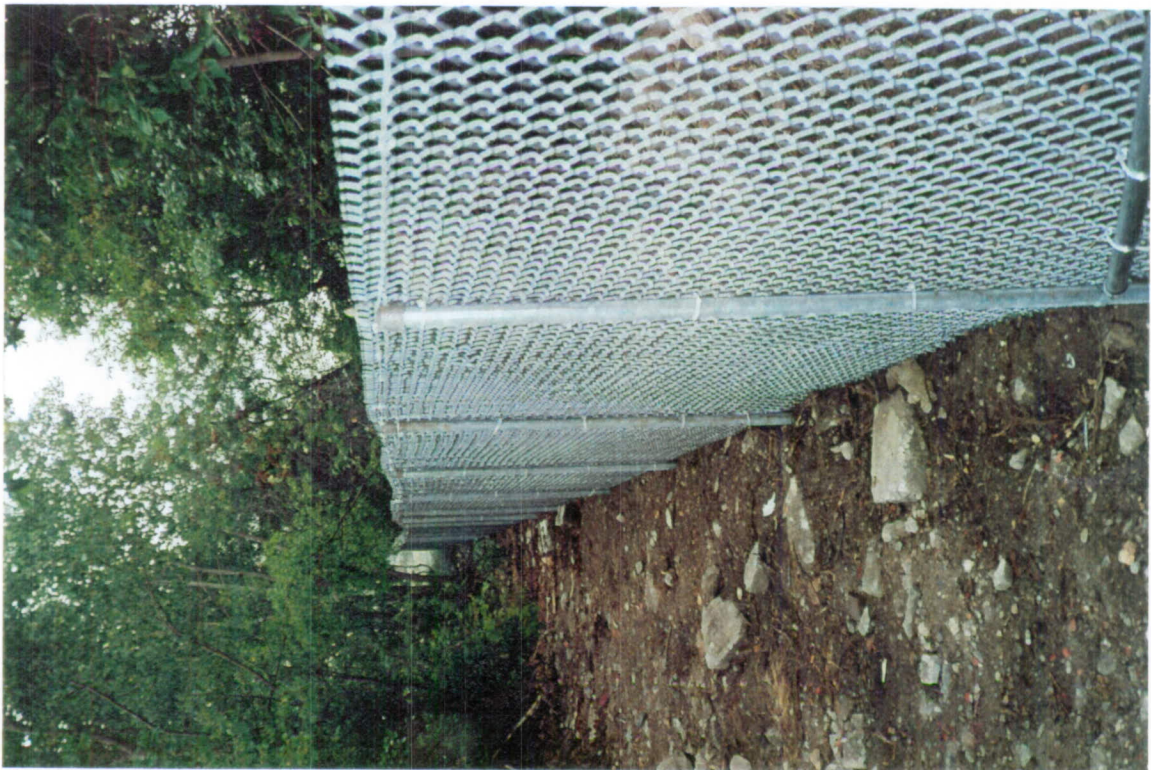
New fence through woods running parallel to the south side of property, July 23, 1999
