Periodic Review Report

PER NYSDEC DER-10 6.3

Congers Colonial Plaza
285 Route 303
Congers, Town of Clarkstown, Rockland County, New York
Section 35.19 Block 2 Lot 11
March 2020
DEC Case #V00456
BEI Job #060141

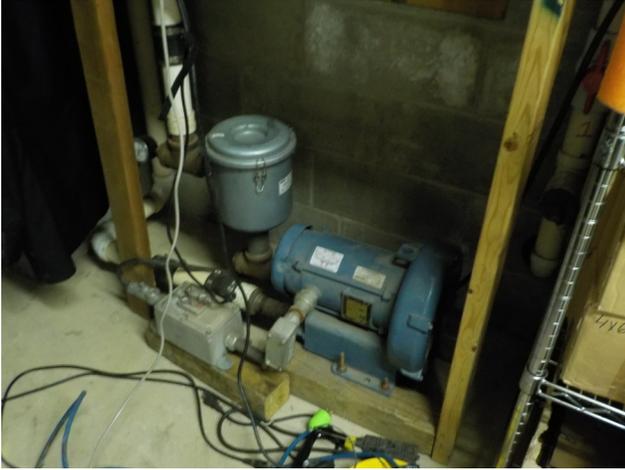
During the December site inspections, both SVE systems were inspected. VES-2 was functioning properly. The vacuum blower for VES-1 was damaged disabling the SVE system. A CMWP will be submitted to NYSDEC outlining the plan to return the site to compliance with the SMP. The Institutional and Engineering Controls Certification Form and the General Site-Wide Inspection Checklist are included as Appendices 1 and 2, respectively.

Photo 1: View of VES-2 during December 3, 2019 site inspection.

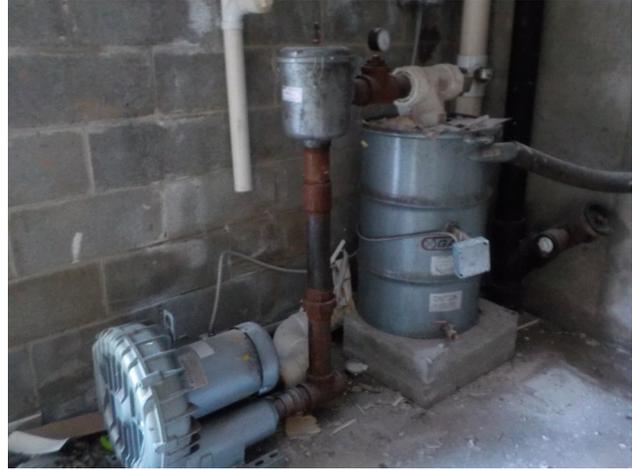
The former Tutor Time tenant space remains vacant. VES-1 was inoperable upon inspection. VES-2 is running.

Photo 2: View of VES-1 during December 3, 2019 site inspection.

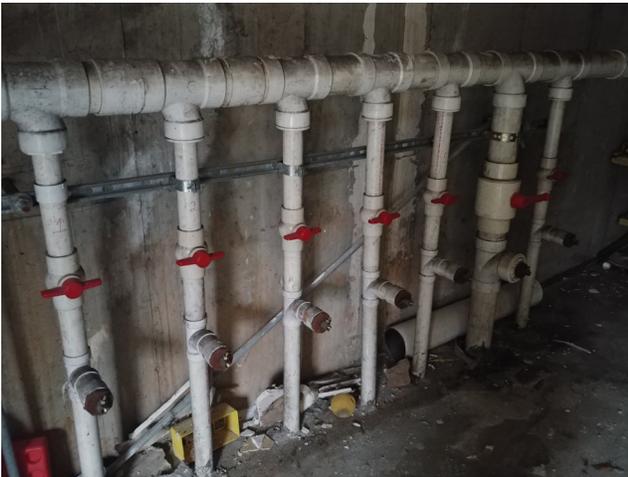
Photo 3: View of VES-1 during December 9, 2019 site inspection by AWT.

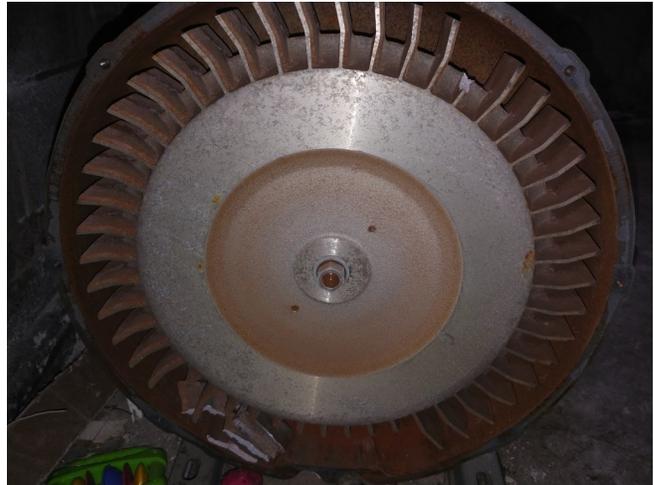
BEI conducted a site visit on December 3, 2019 and determined that VES-1 systems was not functioning. AWT conducted a supplemental inspection on December 9, 2019 to determine the cause of the system breakdown. AWT determined that several blades on the vacuum blower were broken, disabling the SVE system. The blower on VES-1 is required to be replaced. The site use at the Controlled Property was in compliance with the ICs detailed in the SMP. However, since VES-1 is disabled, the requirements set forth in the SMP are not being met. A CMWP will be submitted documenting the proposed repairs and system monitoring. The Institutional and Engineering Controls Certification Form is included as Appendix 1 and the General Site-Wide Inspection Checklist is included as Appendix 2.

Photo 4: View of broken blades on blower of VES-1 during December 9, 2019 AWT site inspection.
