RE: Interim Remedial Measure Summary Report
Dalewood I Shopping Plaza
357 North Central Avenue, Hartsdale, NY
VCP Site V00457-3

INDOOR AREA INVESTIGATION AND INTERIM REMEDIAL MEASURE SUMMARY REPORT

**Dalewood I Shopping Plaza
357 North Central Avenue
Hartsdale, NY**

September 2003

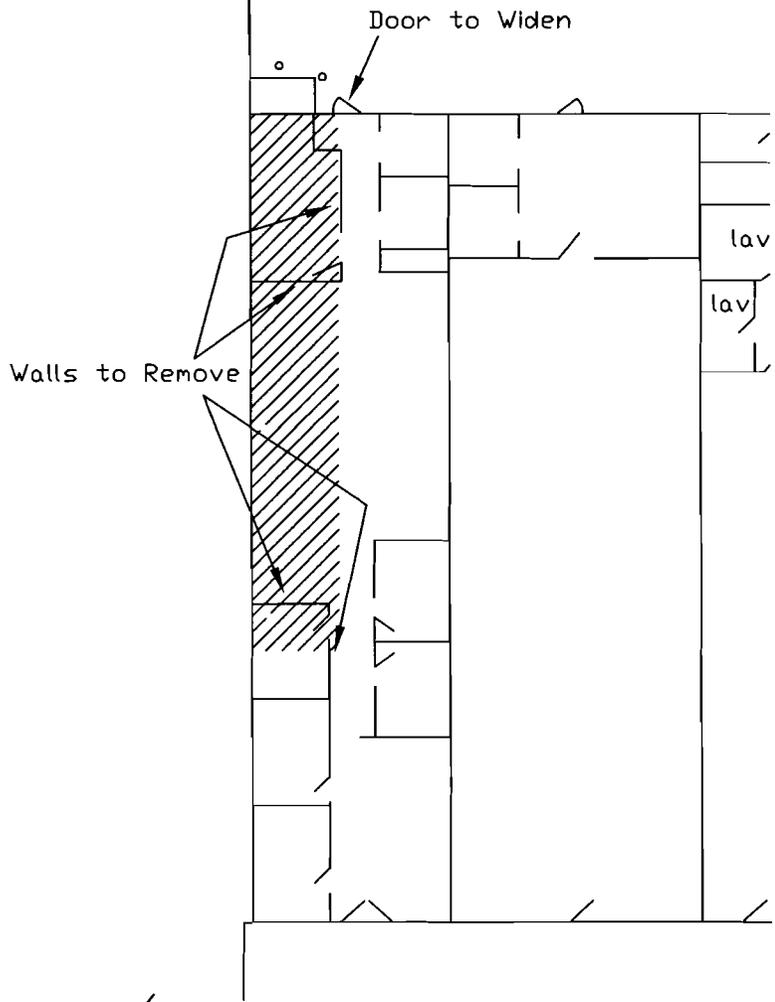
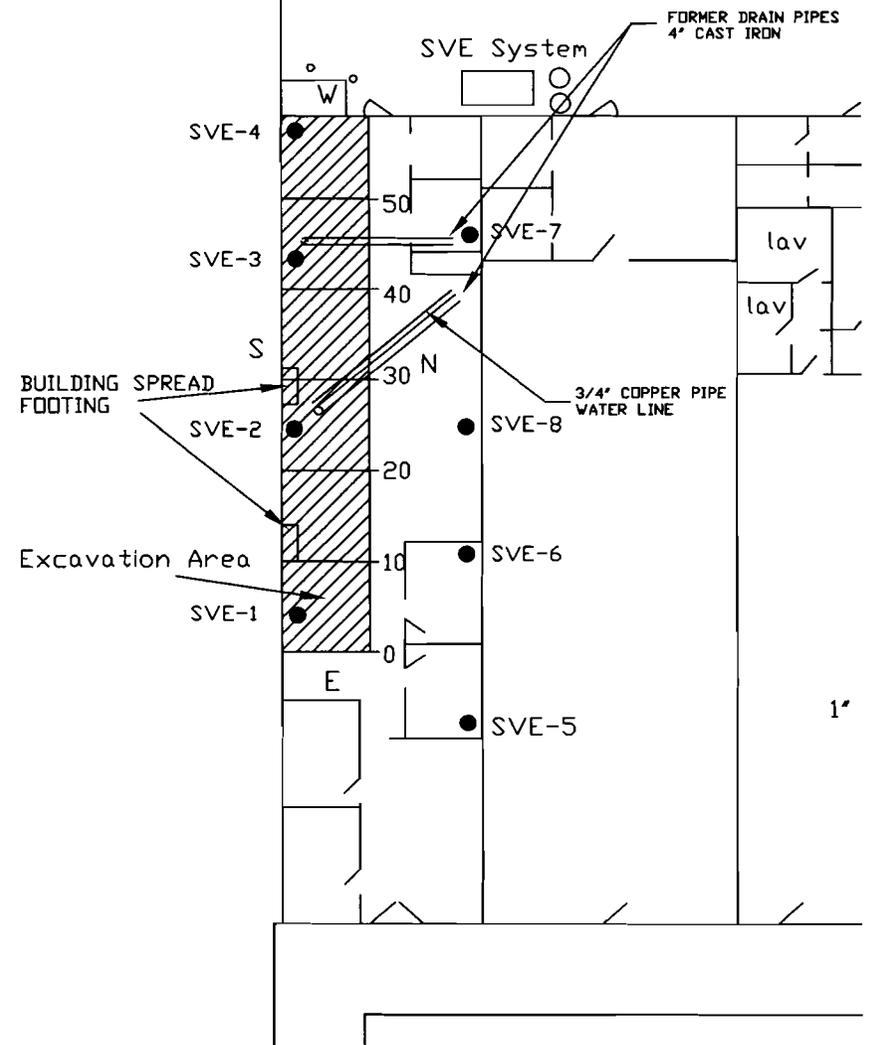
FIGURE 5 - DALEWOOD PLAZA
INDOOR EXCAVATION - UNIT 357

The concrete floor within unit 357 was removed throughout the area shown on Figure 5. The concrete was broken and removed from the building utilizing a skid steer ram and loader. The concrete was removed from the Site as construction derived materials and delivered to a standard debris recycling facility where it was crushed and re-used in construction materials. The floor drain located in the area of SVE-2 was fully exposed during the concrete removal process. An additional sewer drain pipe was identified in the area of SVE-3, towards the bathroom location. Poly sheeting was placed over the exposed soil during the daytime hours and the SVE system remained operational.

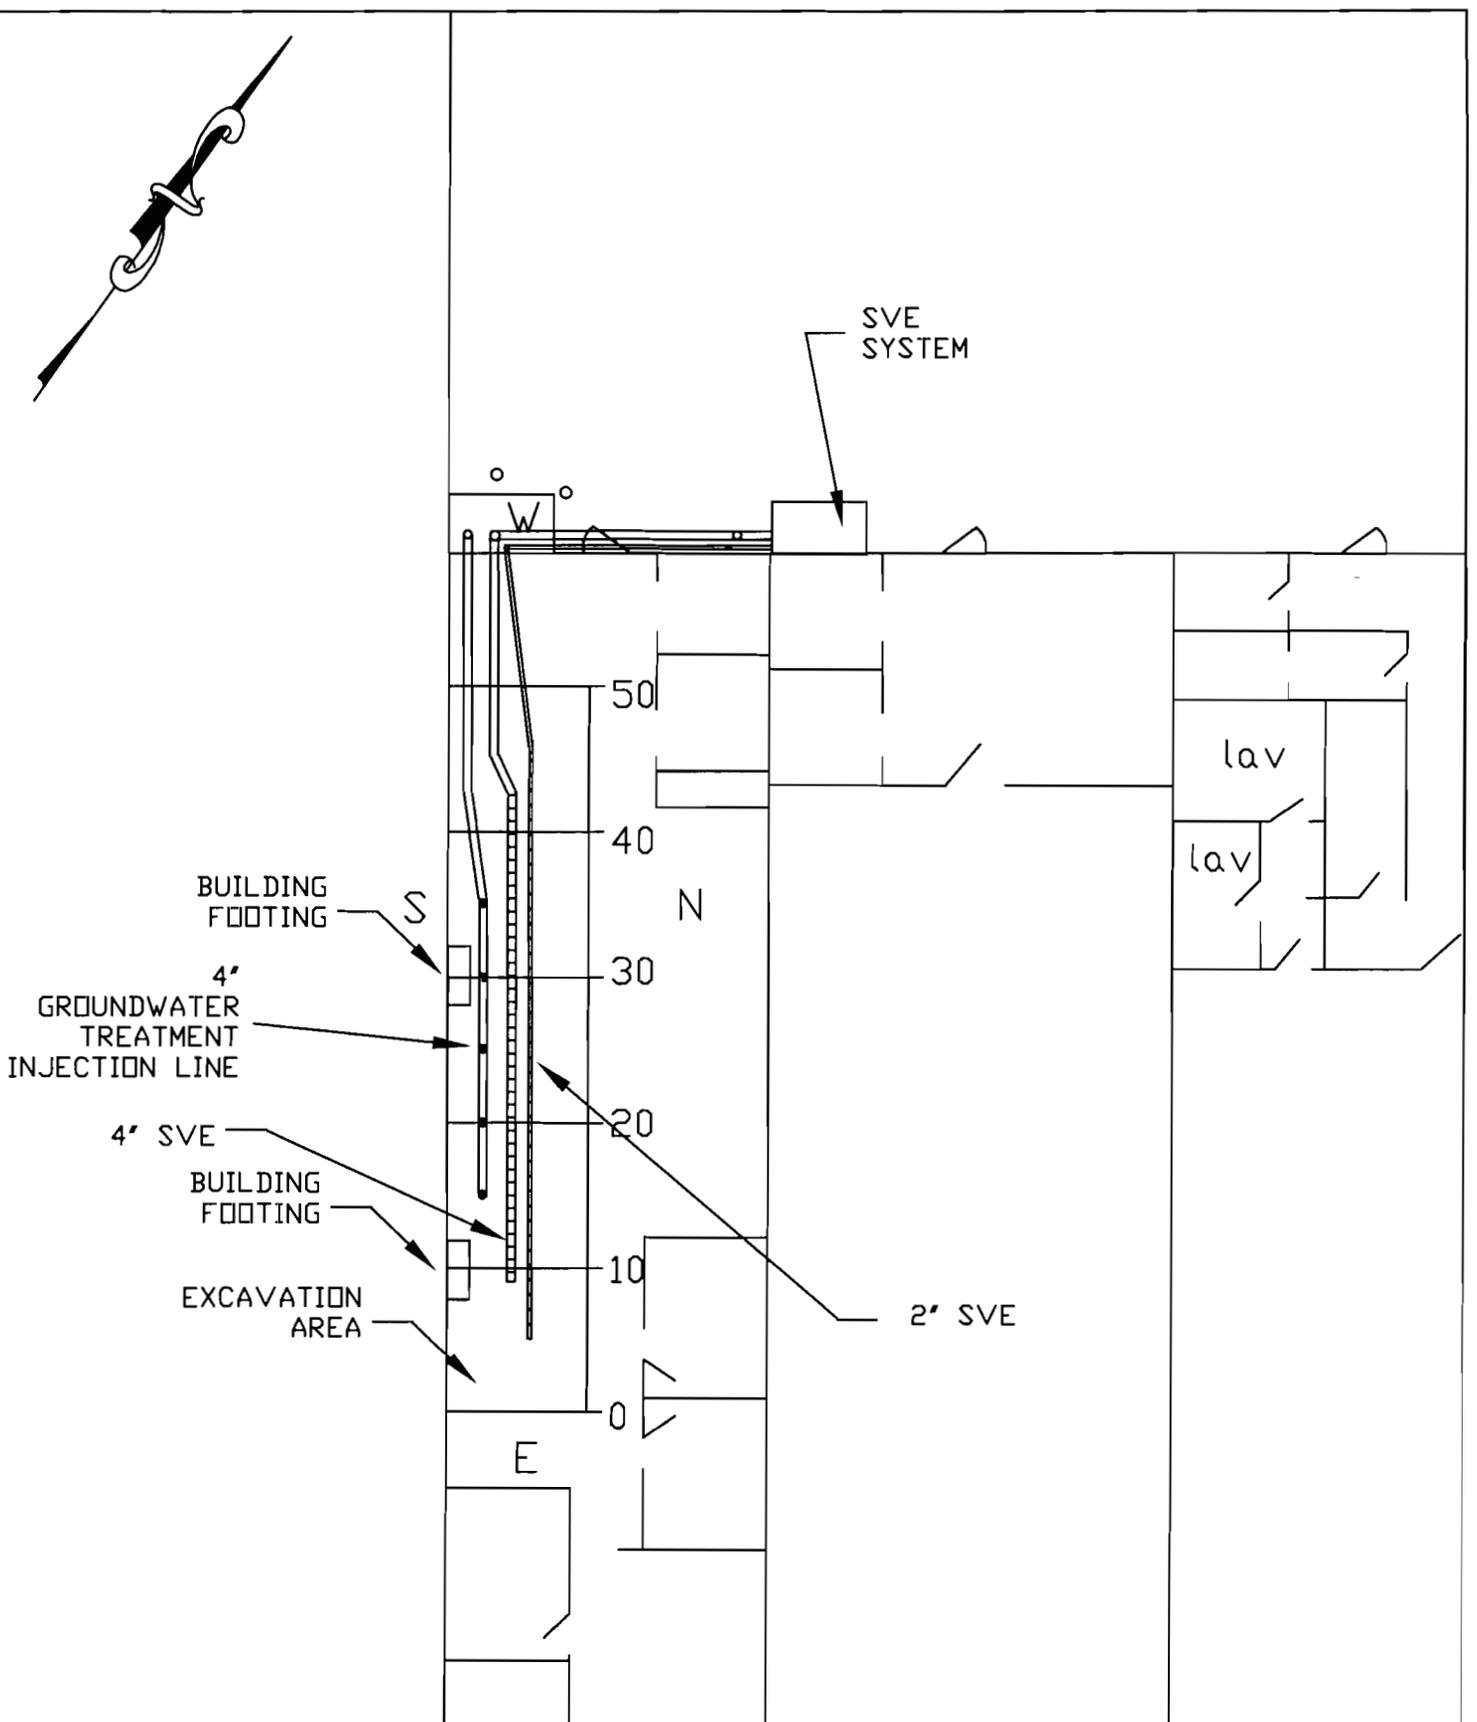
FIGURE 7 DALEWOOD PLAZA
HORIZONTAL SVE AND
GROUNDWATER INJECTION LINES

The design of groundwater treatment piping consisted of a two foot length of 4 inch diameter screened PVC installed vertically into the groundwater table utilizing handheld post hole digging equipment. The screen section was backfilled with a mix of silica sand and the SRC™ product. Vertical screen sections were installed approximately three to four feet out from the south (Coconuts) wall at Grids #15, #20, #25, #30, and #35. The vertical screen section installed at Grid #35 was one and a half feet long. Each of the screen sections were connected to a single four inch diameter solid PVC pipe that was extended to the rear of the building. Plan and profile views of the piping are illustrated in Figures 7 and 8, respectively.

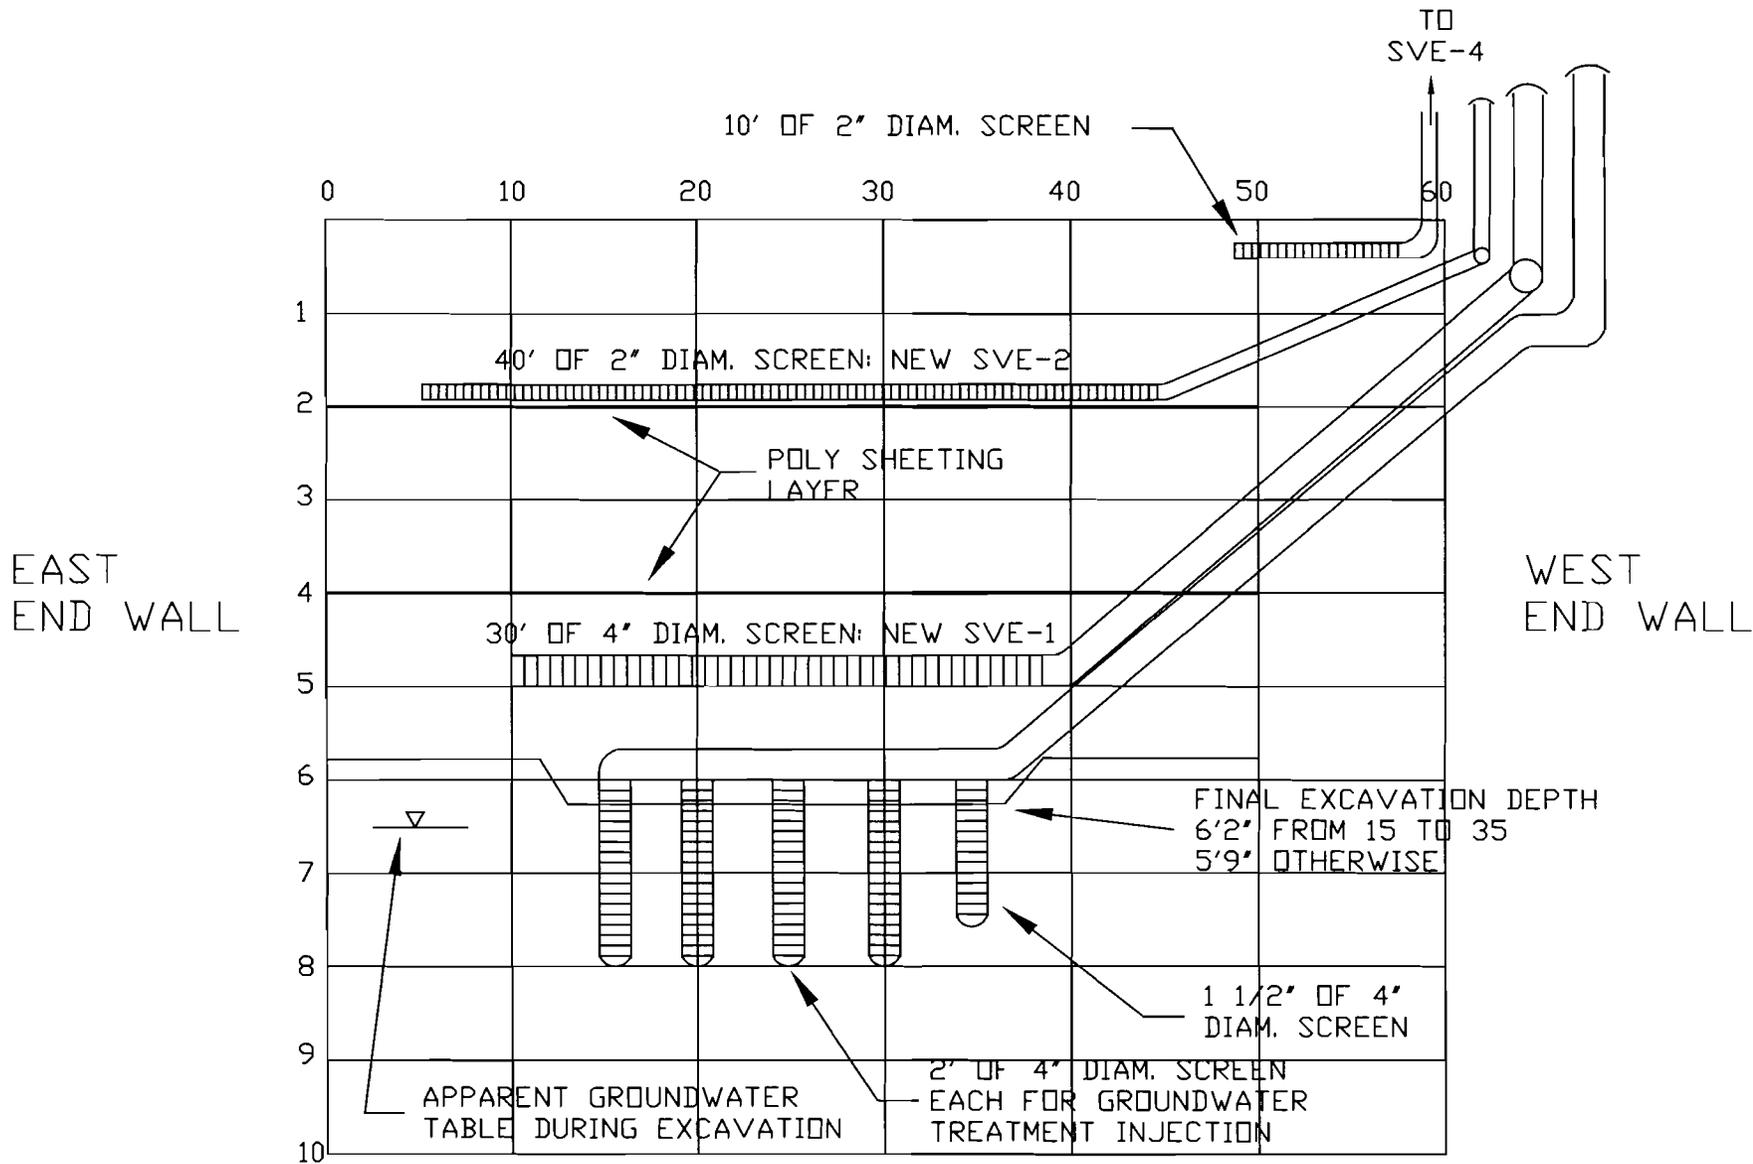
FIGURE 8 DALEWOOD PLAZA
 PROFILE VIEW - HORIZONTAL
 SVE AND GROUNDWATER
 TREATMENT INJECTION SYSTEM

an elevation above the groundwater table and able to influence the residual contamination area. Figure 8 illustrates the depth and location of the screen sections.
