**ANNUAL SITE MANAGEMENT REPORT
METROPOLITAN AVENUE CAMPUS (Q167)
9130 METROPOLITAN AVENUE
FORST HILLS, NY
VCP AGREEMENT # V-00500**

Date of Issue: March 22, 2011

ATC Associates Inc. Project No. 015.19125.1108

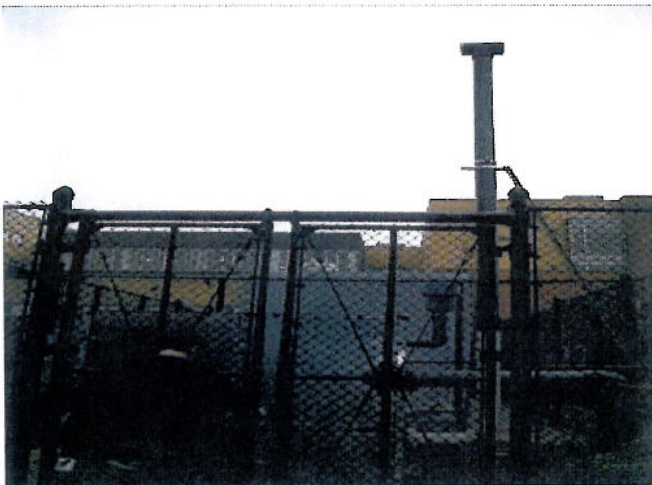
1. The SSDS includes a network of perforated PVC piping beneath the building which is connected to the blower unit in the southern portion of the property located on ground level.
2. The blower's components are enclosed in a metal box with a stack for exhaust. No visible gages or light indicators proving that the system is working, except for the motor noise. The BMS was not operating at the time of the inspection.

Photo 3: View of blower unit in the southern portion of the property.

1. ATC advised the custodian to complete the monthly inspection forms moving forward. Also, ATC provided the custodian with required training.
2. Cracks on the concrete floor of Rooms 0005 and 0021, as well as on the side walks of the school will need to be repaired;
3. The blower gage and indicators lights need to be visible for periodic inspections for general operation and pressure readings;
4. The Site should remain accessible for evaluation by the NYSDEC and NYSDOH.

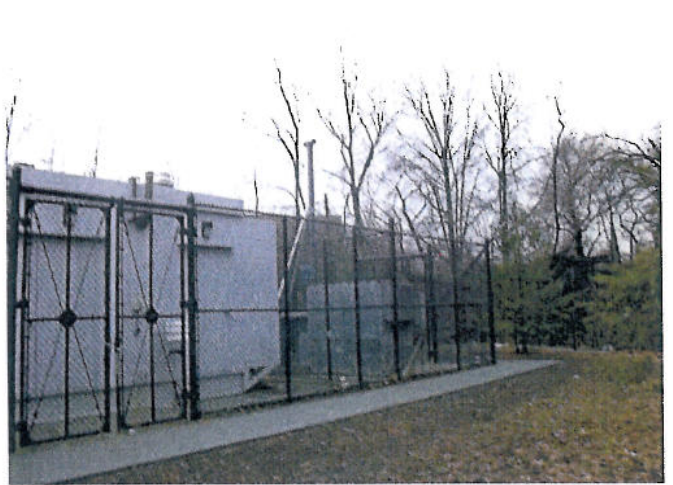
Photo 4: View of blower unit in the southern portion of the property.

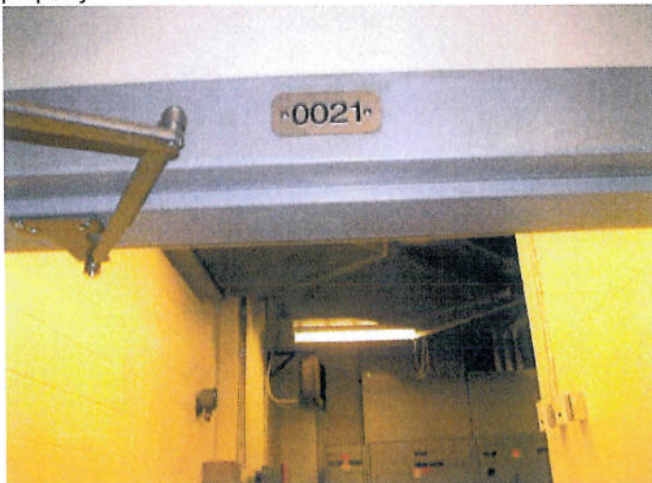
1. ATC observed several hairline cracks on the basement floor of Rooms 0005 and 0021. In addition, ATC observed approximately 6 linear feet of ¼" crack on the floor of Room 0021.
2. If engineering controls are in effect and the SSDS is operational, the hairline surficial cracks are not a concern. However ¼" or more cracks may require engineering evaluation and repair.

Photo 5: View of entrance to Room # 0021 which has floor cracks.

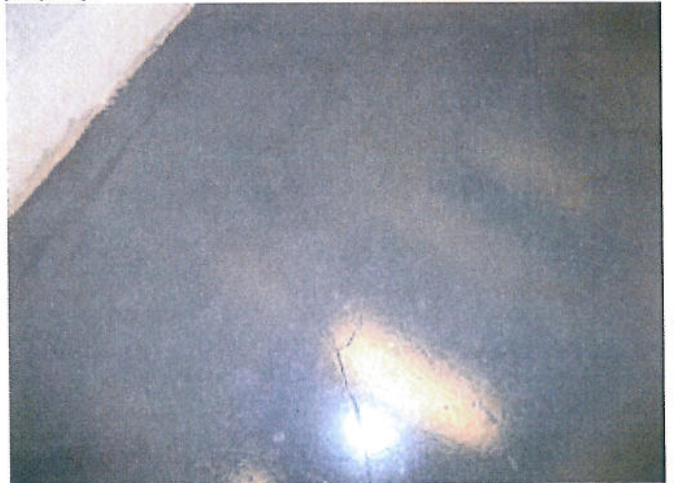
Photo 6: View of hairline cracks in Room # 0021 floor hair.

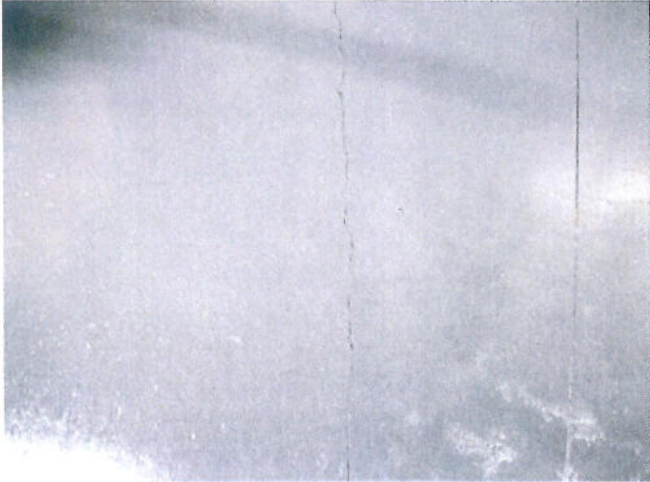
Photo 7: View of hairline cracks in room # 0021 floor.

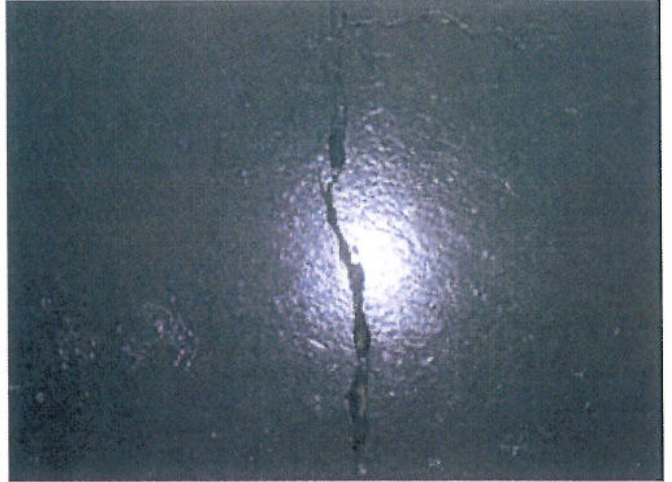
Photo 8: View of a minimum of 1/4" crack in Room 0021.

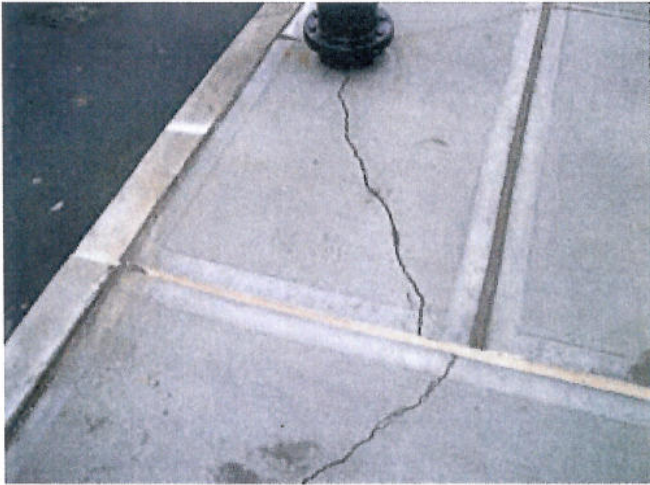
1. Exit District 75/Q233;

Photo 9: View of sidewalk cracks by district 75/Q233 exit.

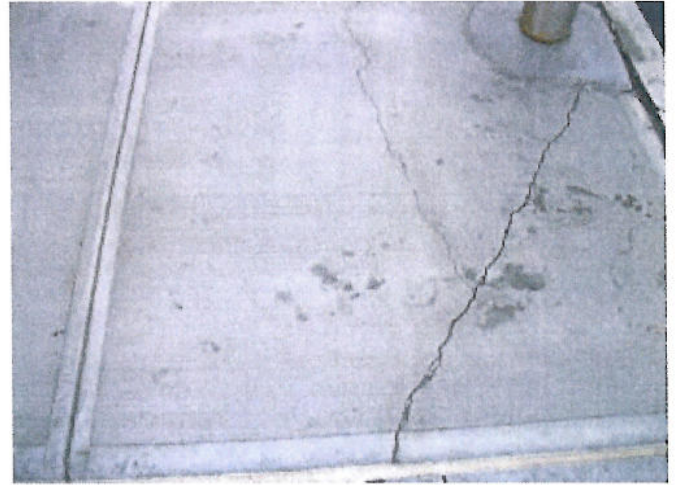
Photo 10: View of sidewalk cracks by district 75/Q233.

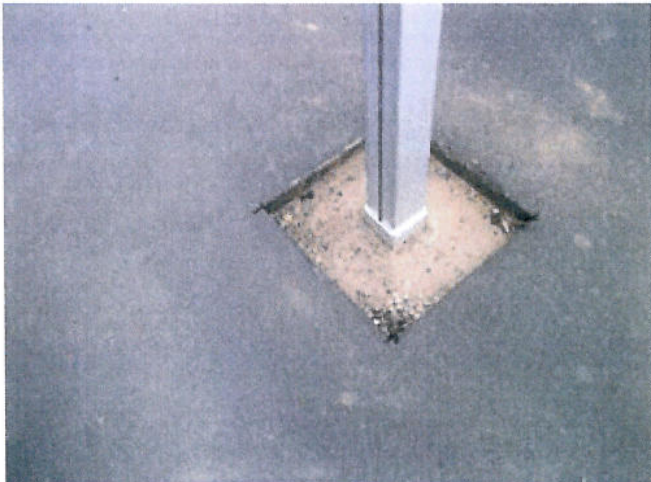
Photo 11: View of volleyball court (spot cutting of the paved area to erect the net pole).

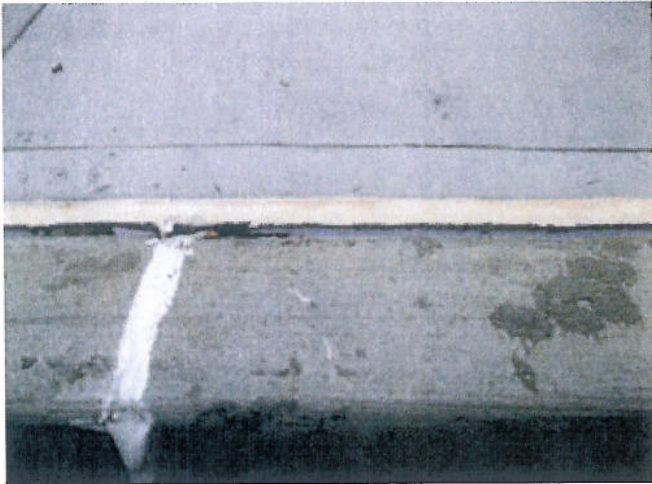
Photo 13: View of noticeable separation between a sidewalk and its edge by the artificial turf on North side.

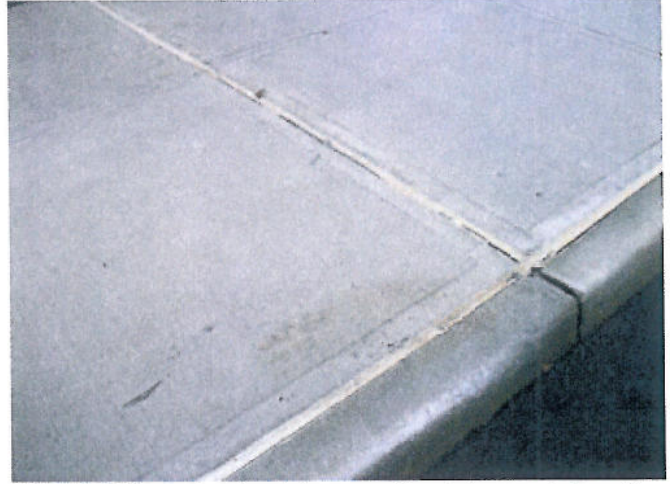
Photo 14: View of noticeable separation between side walk and its edge by the artificial turf on North side.

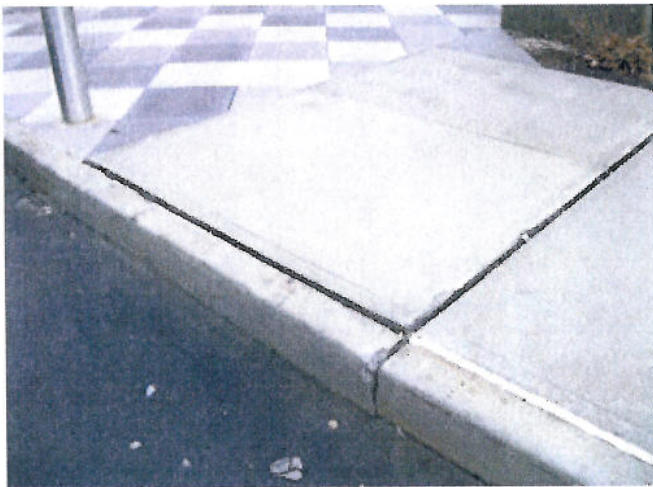
Photo 15: View of raised side walk and separation by Queens Metropolitan HS entrance.

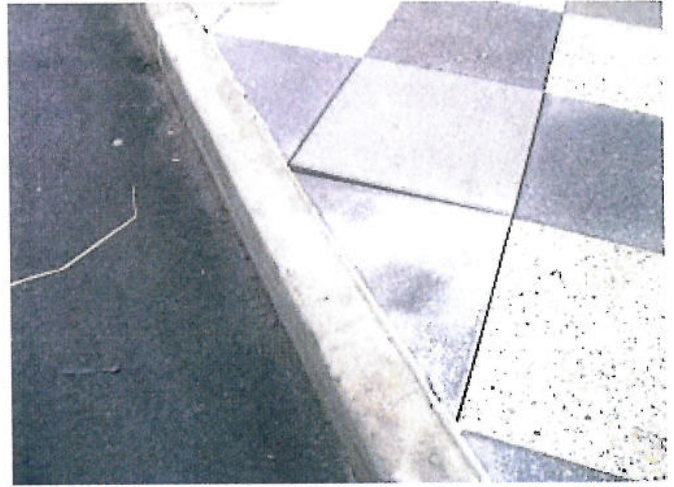
Photo 16: View of uneven side walk floor tiles by Queens Metropolitan HS entrance.

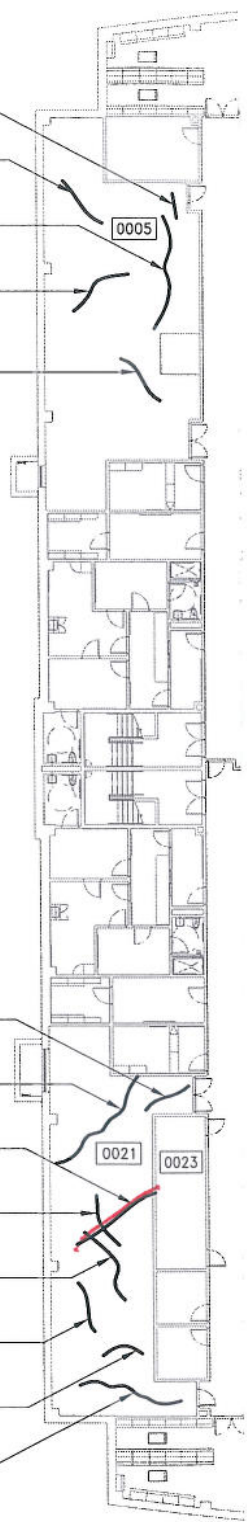
CELLAR PLAN

1/4" CRACK LINE

6' CRACK LENGTH

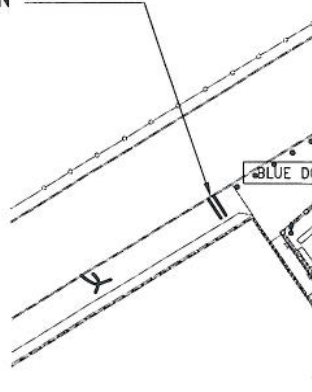
SITE PLAN

1/2" CRACK LINE IN
EXPANSION JOINT
4' CRACK LENGTH

1/2" CRACK ON
PAVEMENT SIDE BY DRAIN
4' CRACK LENGTH

1/4" CRACK LINE
4' CRACK LENGTH
