PCB CONTAMINATION OF THE HUDSON RIVER ECOSYSTEM

COMPILATION OF CONTAMINATION DATA THROUGH 2008

HUDSON RIVER NATURAL RESOURCE DAMAGE ASSESSMENT

HUDSON RIVER NATURAL RESOURCE TRUSTEES

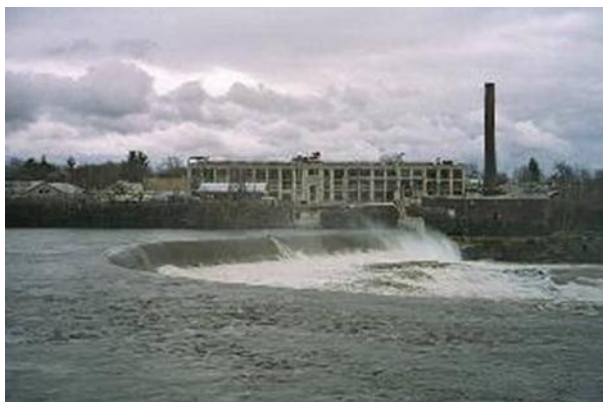
EXHIBIT 2: THE GENERAL ELECTRIC HUDSON FALLS PLANT ON THE HUDSON RIVER

The General Electric Hudson Falls plant used PCBs for manufacturing operations beginning in 1947. The abandoned Allen Mill structure situated just below the Hudson Falls Plant failed in 1991, leading to a temporary spike in outflow of PCBs to the Hudson River.

Two General Electric facilities (Exhibit 2) have been identified as the predominant historical sources of PCBs to the Hudson River. EPA has estimated that these plants released up to 1,300,000 pounds of PCBs to the Hudson River between the 1940s and 1977 (EPA 2002). After 1977, seepage of PCBs from the bedrock beneath these General Electric facilities, combined with erosion of remnant deposits and contaminated banks, continued to release PCBs to the river for some time (EPA 2000a). In more recent years, the amount of PCBs released from seepage has been markedly reduced due to the continuing performance of remedial measures at these facilities (NYSDEC 2004).
