Hydrilla (*Hydrilla verticillata*) in the Croton River System: 2014 and 2015

By Chris Doyle
Sr. Aquatic Biologist

July 1, 2016

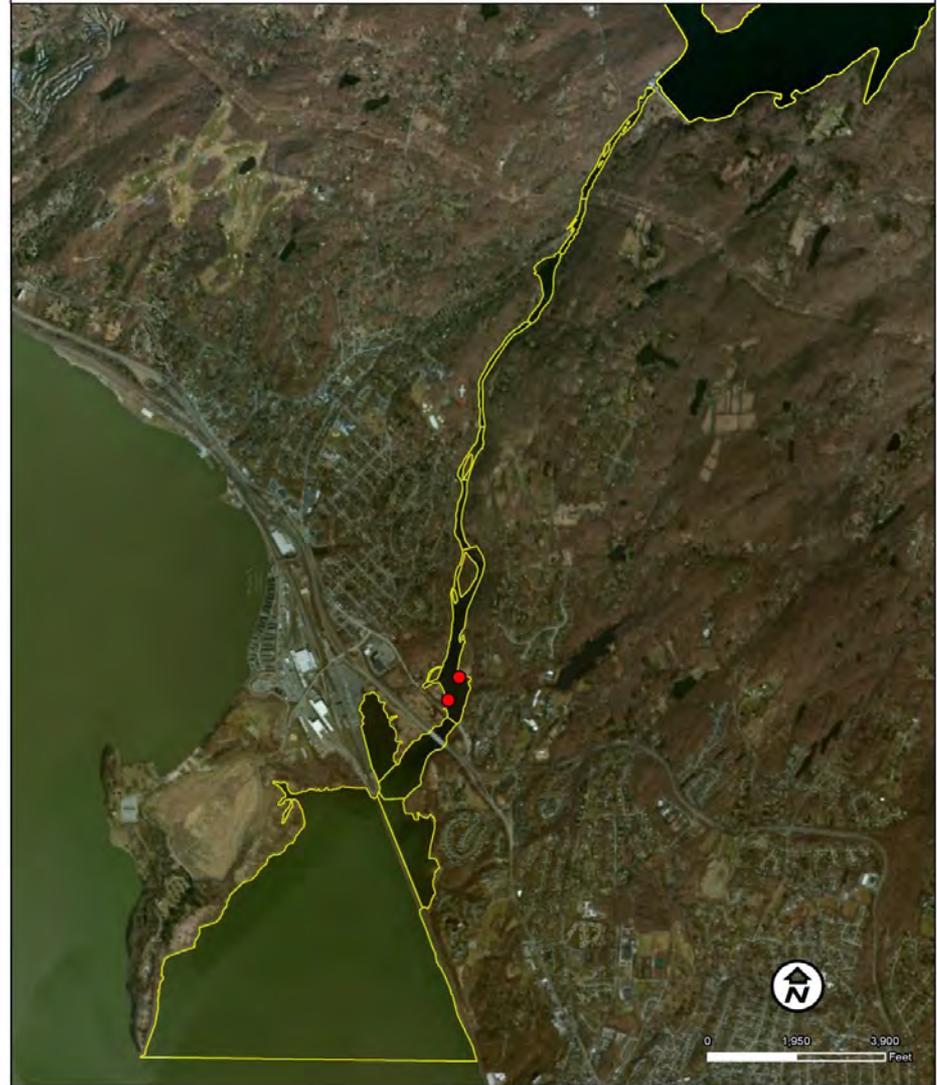
CROTON RIVER INITIAL HYDRILLA DISCOVERY OCTOBER 2013

- NY Botanical Garden Survey
- Confirmed by S. Kishbaugh
 - NYSDEC
- Rooted Plants and Non-rooted fragments observed
- 2014 Point Intercept SAV Survey conducted by Allied Biological, Inc.

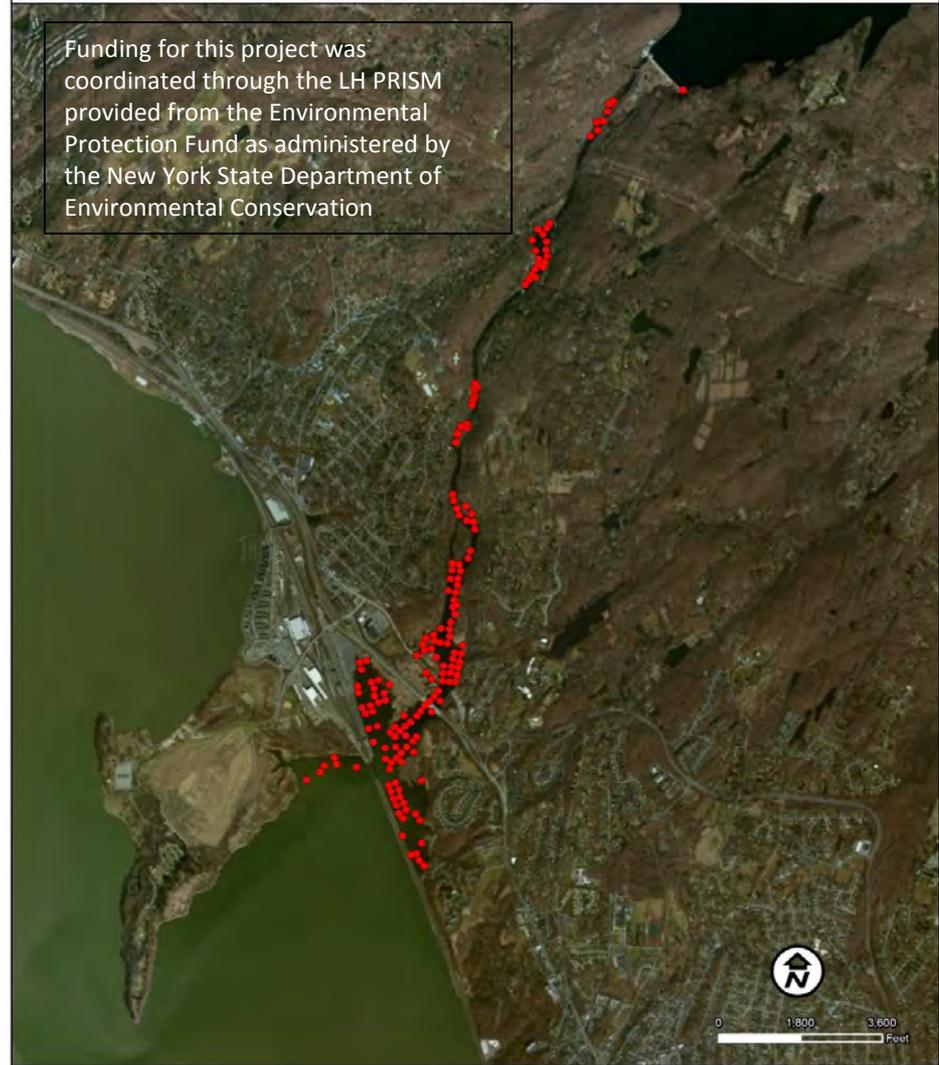
2014 HYDRILLA OCCURRENCE IN THE CROTON RIVER

- Similar to methods employed at Cayuga Inlet
 - 50 m grid
 - 2 rake tosses per site
- 354 Sites in Nine Locations
- **Hydrilla was collected/observed at 42.3% of the sites surveyed**

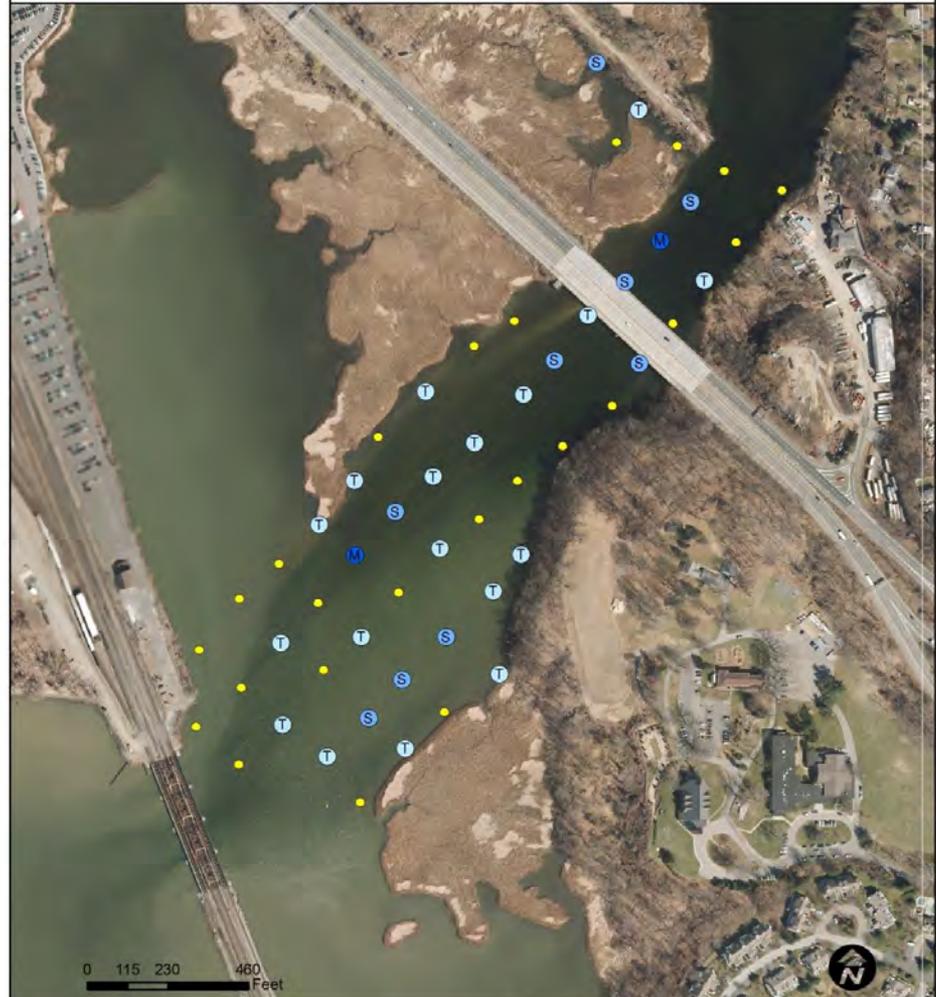
**Croton River - Section B2
Aquatic Vegetation Survey
August 26, 2014**

53 Sites

Percent Distribution	Abundance	Sites	Percent
	Total	29	55%
	Trace	18	62%
	Sparse	9	31%
	Medium	2	7%
	Dense	0	0%

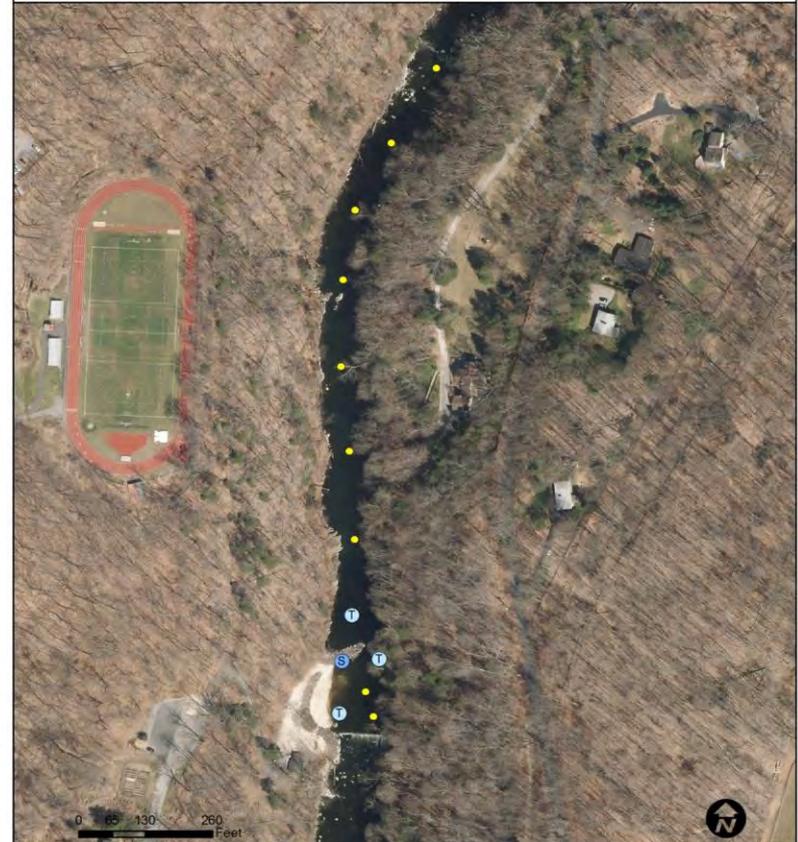
Croton River - Section C
Aquatic Vegetation Survey
August 20, 2014

13 Sites

Percent Distribution	Abundance	Sites	Percent
	Total	4	31%
	Trace	3	75%
	Sparse	1	25%
	Medium	0	0%
	Dense	0	0%

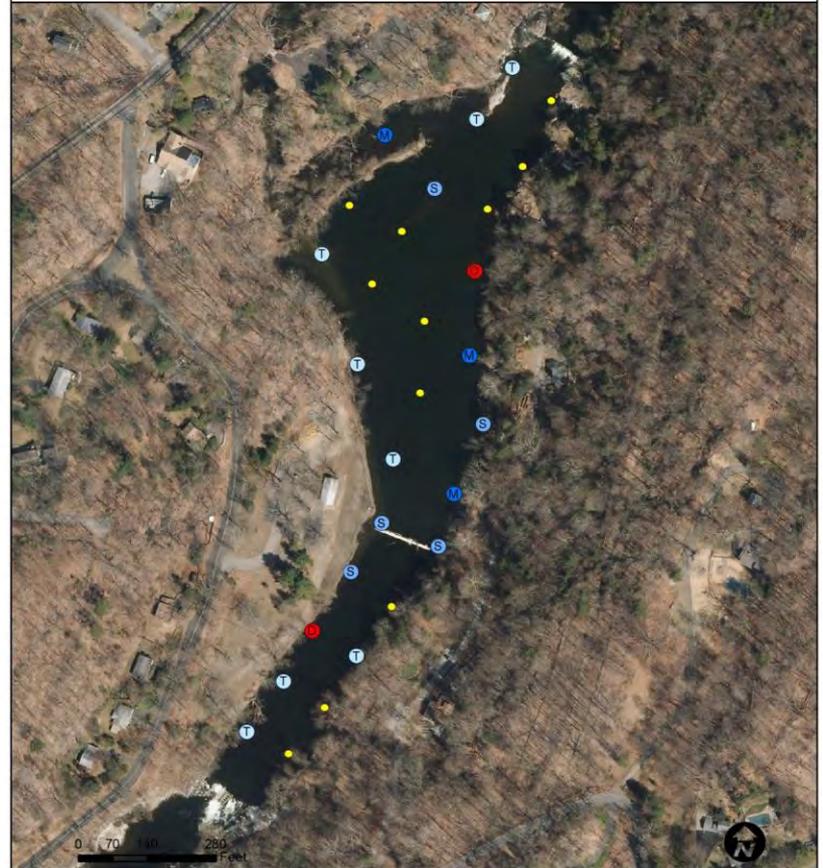
Croton River - Section D
Aquatic Vegetation Survey
August 20, 2014

29 Sites

Abundance	Sites	Percent
Total	18	62%
Trace	8	44%
Sparse	5	28%
Medium	3	17%
Dense	2	11%

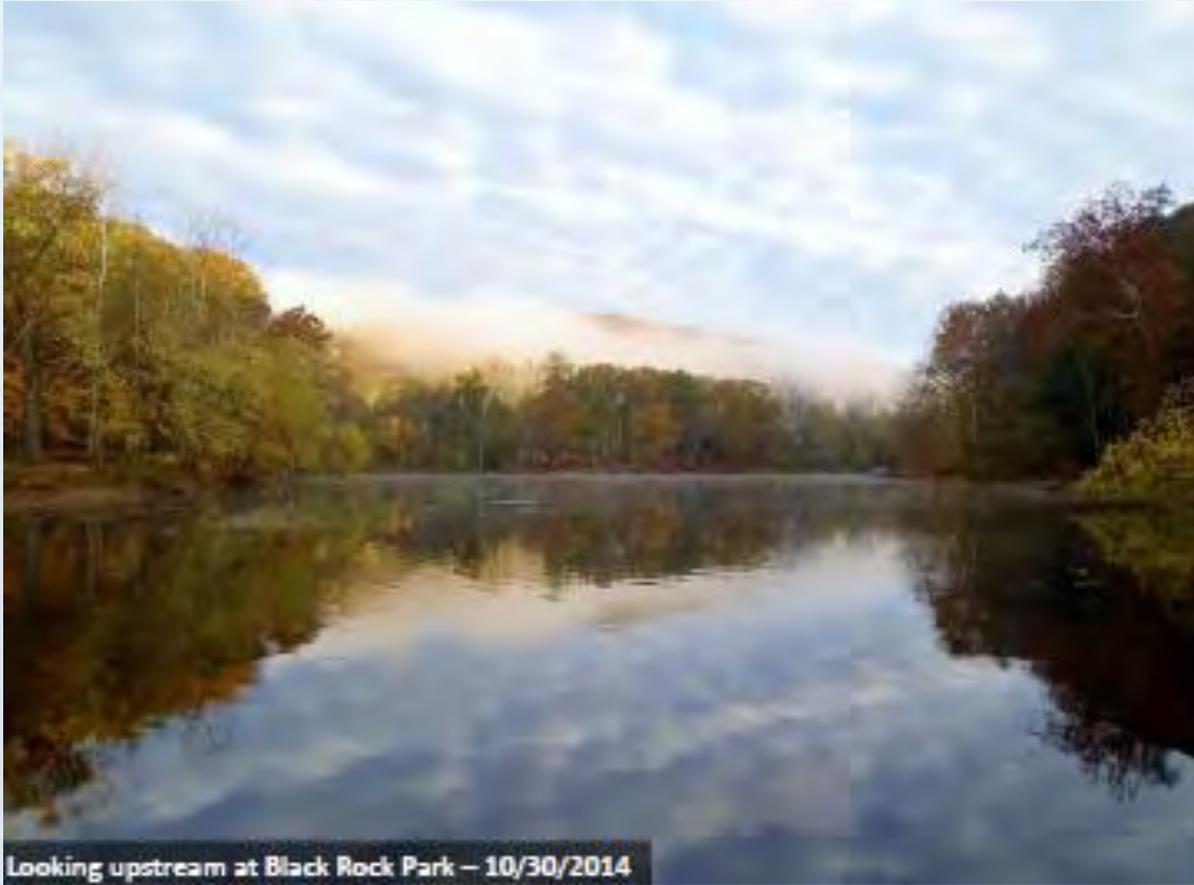
Looking upstream at Black Rock Park – 10/30/2014

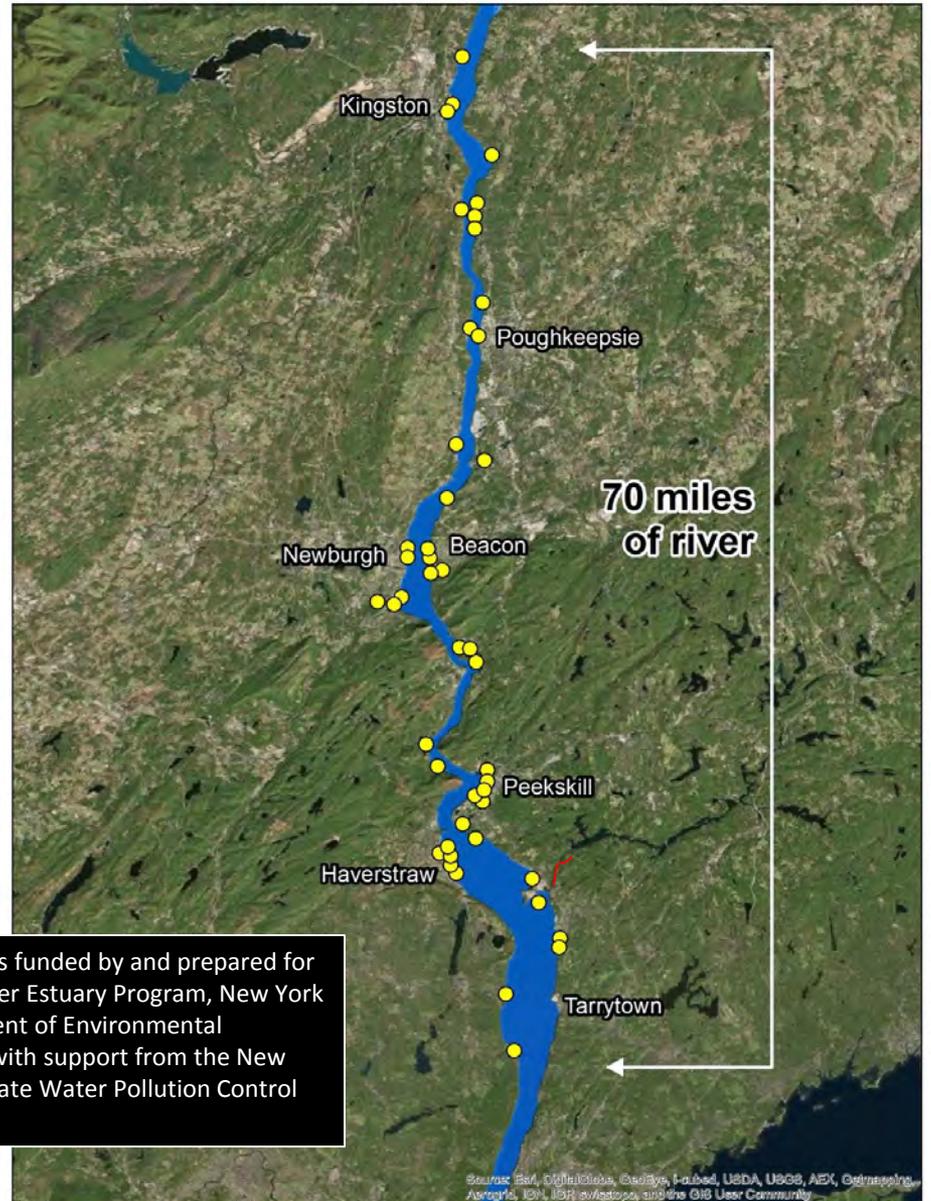
46 Survey Locations

- 0.7 acres to 639 acres
- Open water, tributaries, backwater bays, marinas
- Locations Selected by NYSDEC
- 70 mile stretch of the Hudson River

**No Hydrilla Documented
at Any Locations 😊**

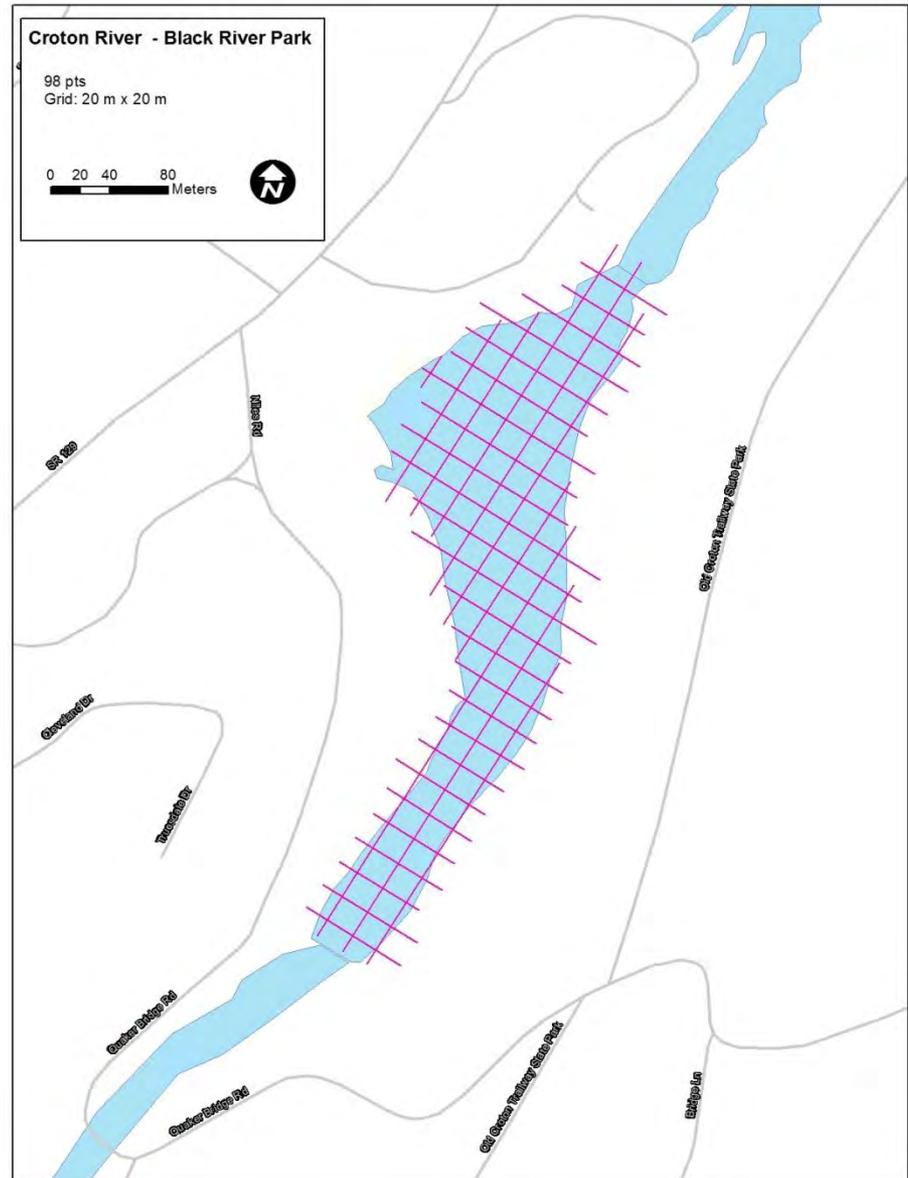
2016 Croton River River Monitoring

- July and September
- Five Locations
- ~450 GPS-referenced sites
- 2 Rake Tosses/site
- Tuber Sampling in Fall
