**Department of
Environmental
Conservation**

2016 Croton River Hydrilla Control Project

**Croton Hydrilla Public Information Meeting
June 28, 2016**

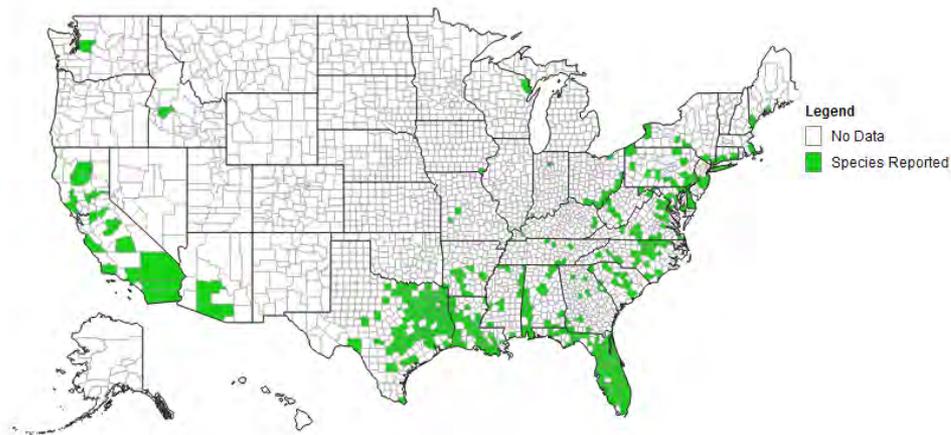
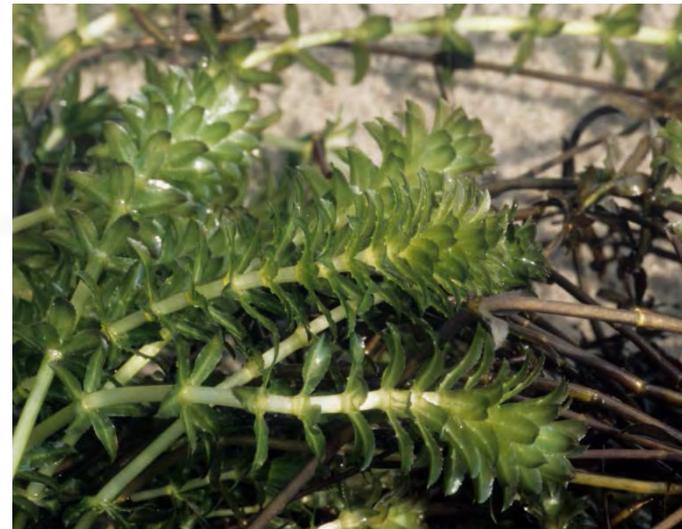
Hydrilla in the U.S.

hydrilla (*Hydrilla verticillata*)

Map generated on Jun 22, 2016

EDD MapS
Early Detection & Distribution Mapping System

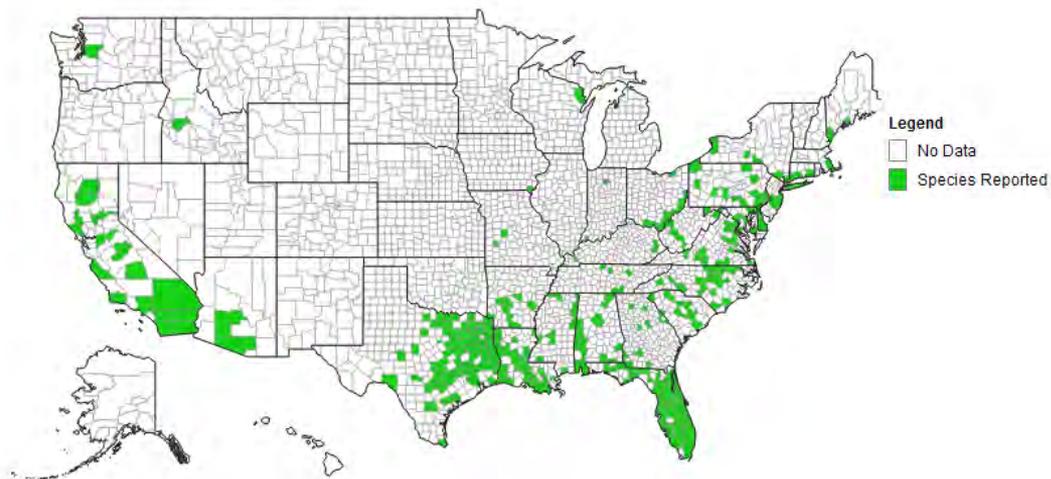
Negative Impacts and Costs in Other States

hydrilla (*Hydrilla verticillata*)

Map generated on Jun 22, 2016

EDDMapS
Early Detection & Distribution Mapping System

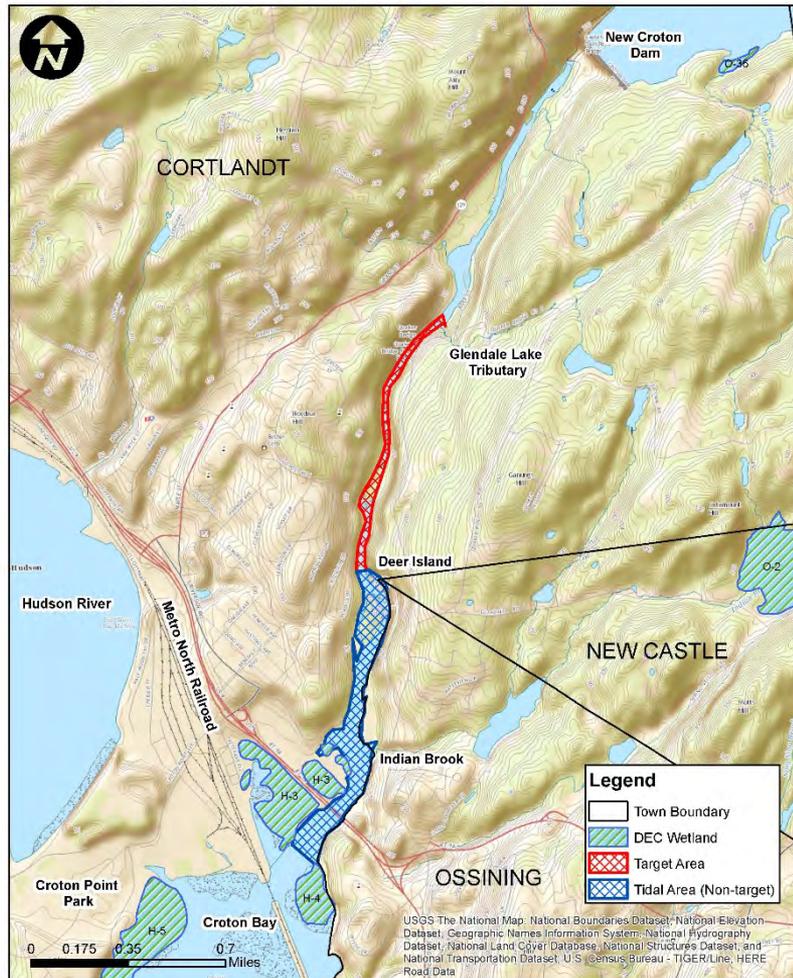
FIGURE 1 LOCATION MAP

- 2016 effort important for developing a long term control project
- Herbicide treatment summer 2016 by injection method, no more than 100 gal of herbicide will be used
- Timing is critical to disrupt turion and tuber development
- 1.5-2.0ppm for 24-36 hours, dosage based on water flow
- Target area: Black Rock Dam to Deer Island (15.5 acres, 1.2 mi)
- Effective treatment area may extend beyond target area but will be diluted as the river widens

Croton River Hydrilla Control Project 2016
Article 24 Freshwater Wetlands Permit
Towns of Cortlandt and Ossining
Westchester County, New York
