Cayuga Lake Watershed Hydrilla Project

*Croton Hydrilla
Public/Stakeholder Meeting
December 1, 2015*

*James A. Balyszak
Program Manager
Hydrilla Task Force of the
Cayuga Lake Watershed*

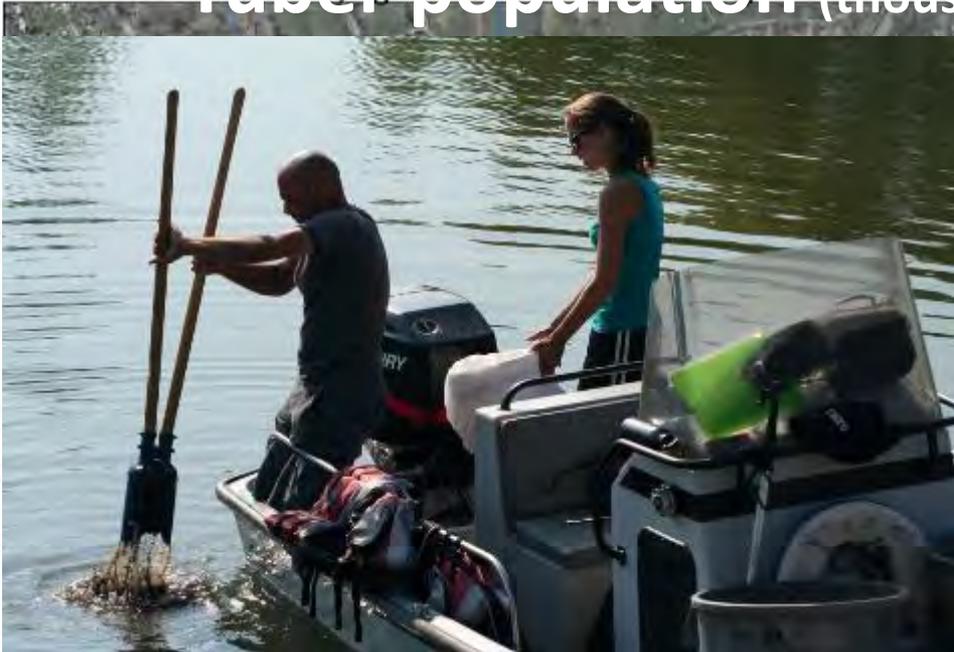
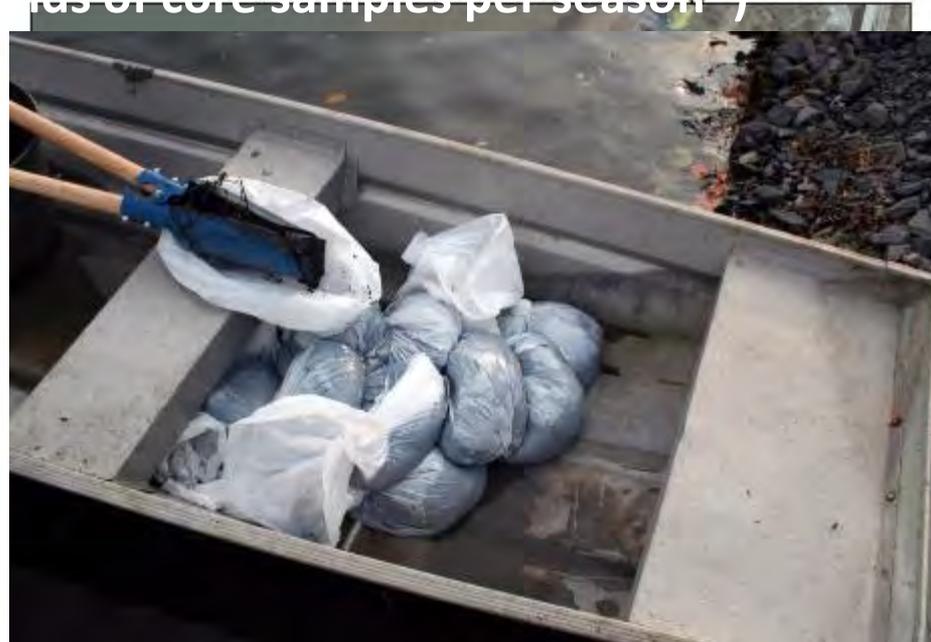
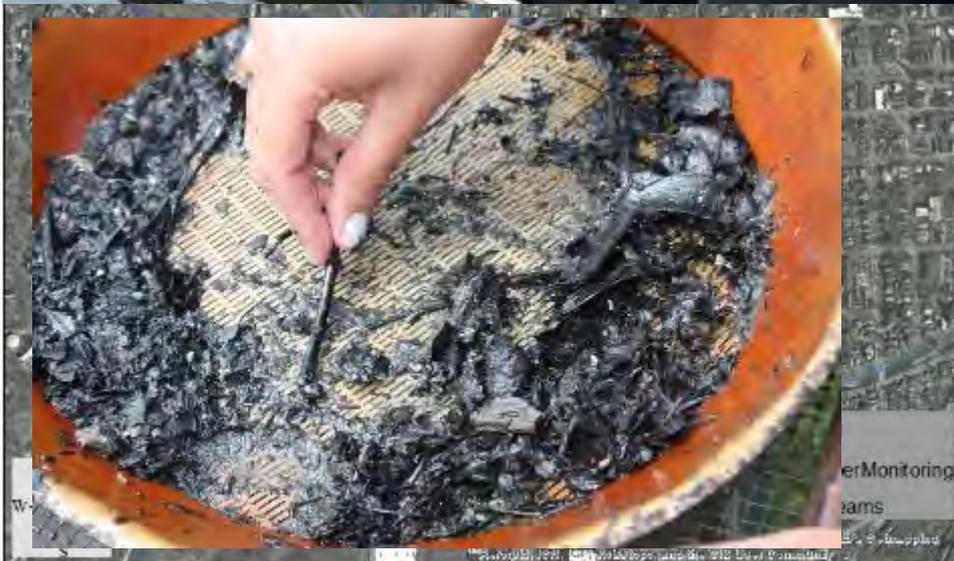
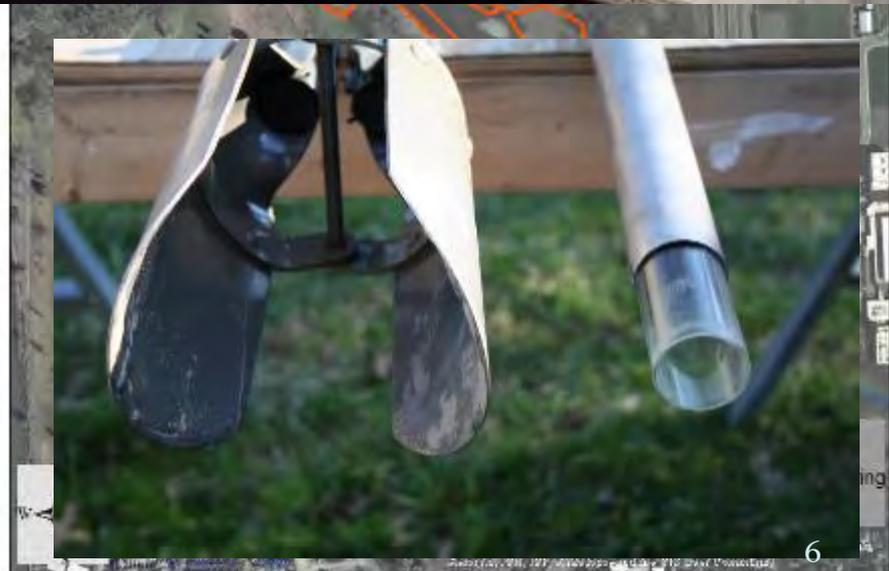
Monitoring & Sampling Sites

2015 Oregon Inland Tule Monitoring
Ruler population (thousands)

2015 Fall Creek Tule Monitoring
mas of core samples per season

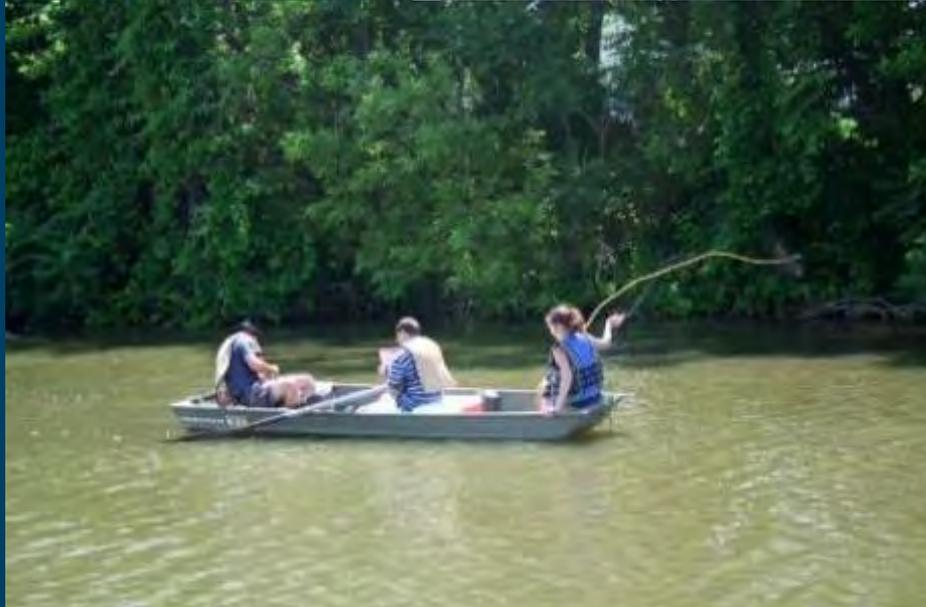
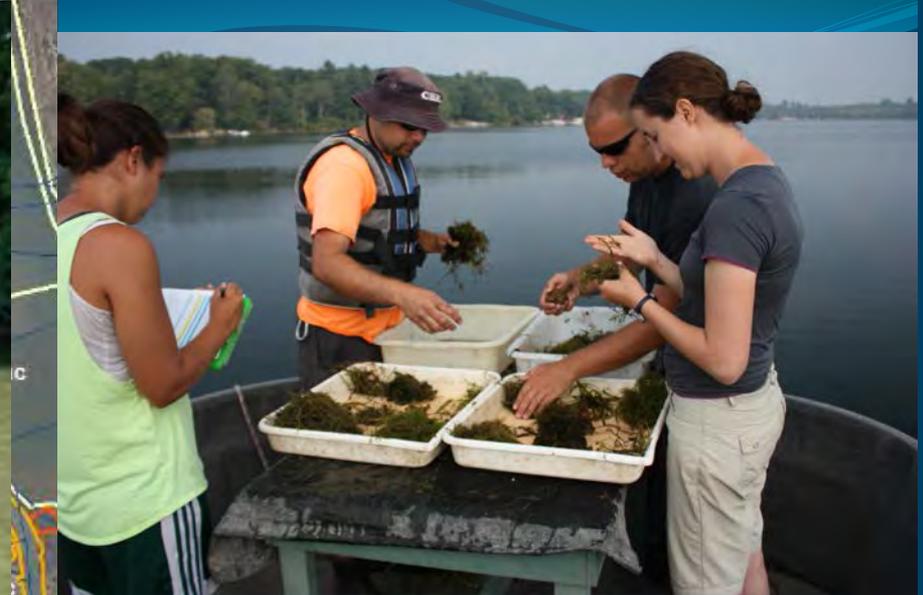
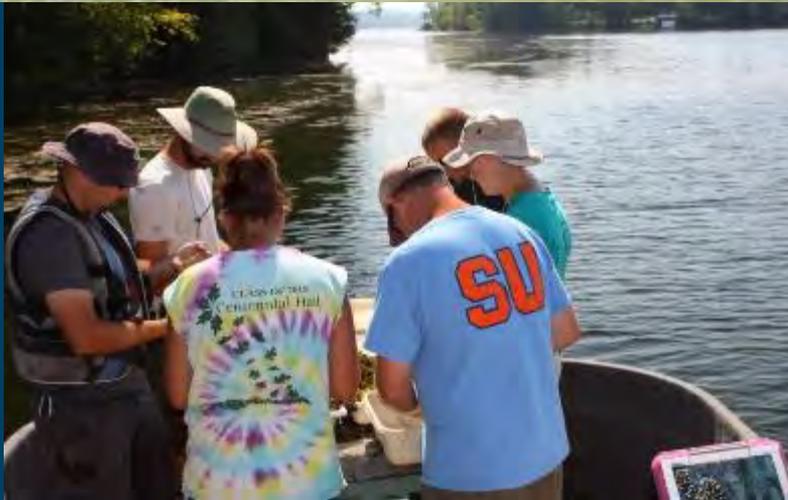
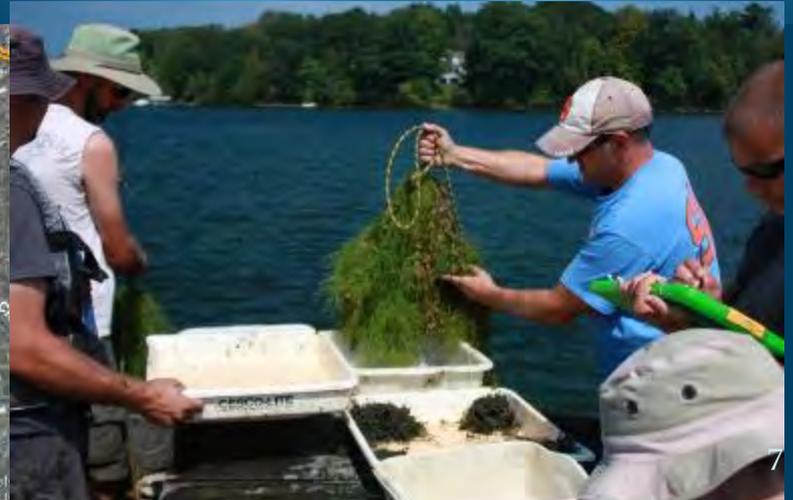
Monitoring & Sampling

Plant Community Monitoring in Cayuga Inlet, Fall Creek, and Southern Cayuga Lake (2,440 locations sampled in 2015)

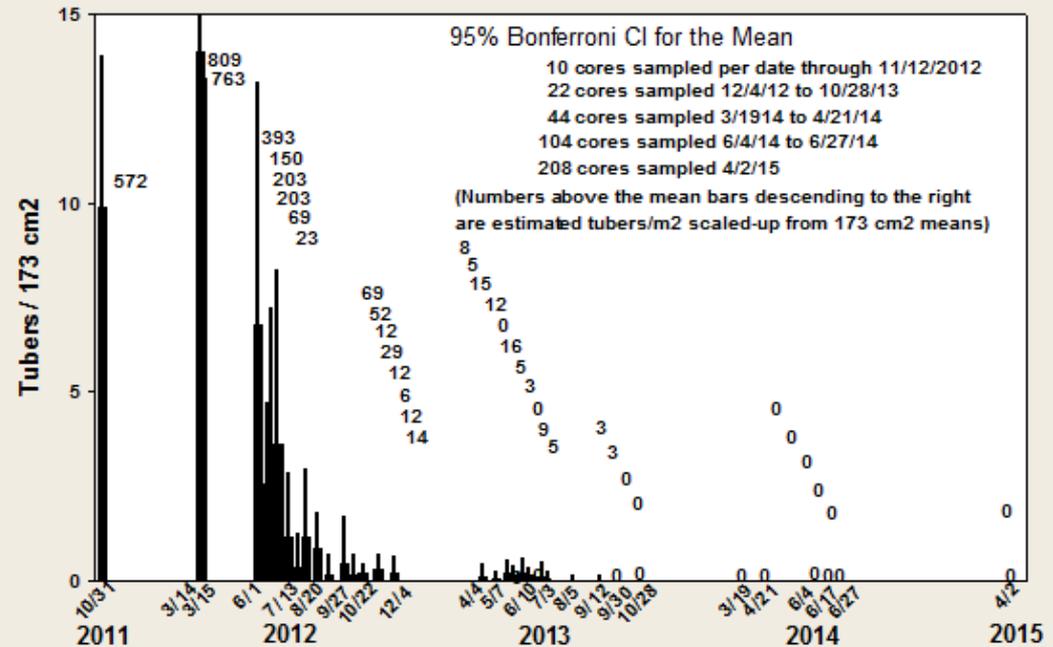
Sprouted + Unsprouted Tubers at Cayuga Inlet S of Rt 79 Bridge

- Results of Hydrilla Tuber Density Measurements from 2011 – early 2015

- Eradication progress continues in Cayuga Inlet with great results!

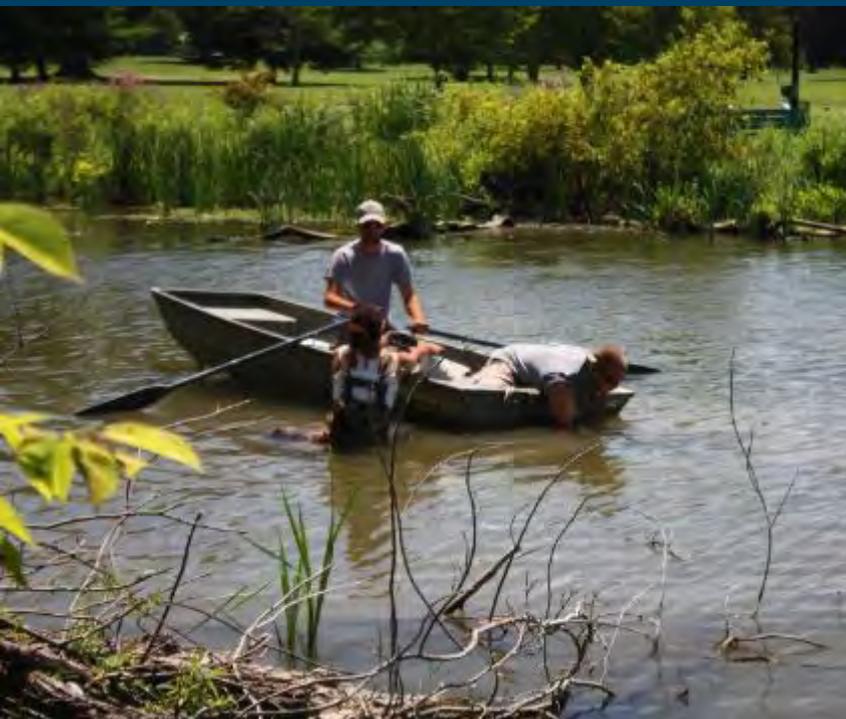
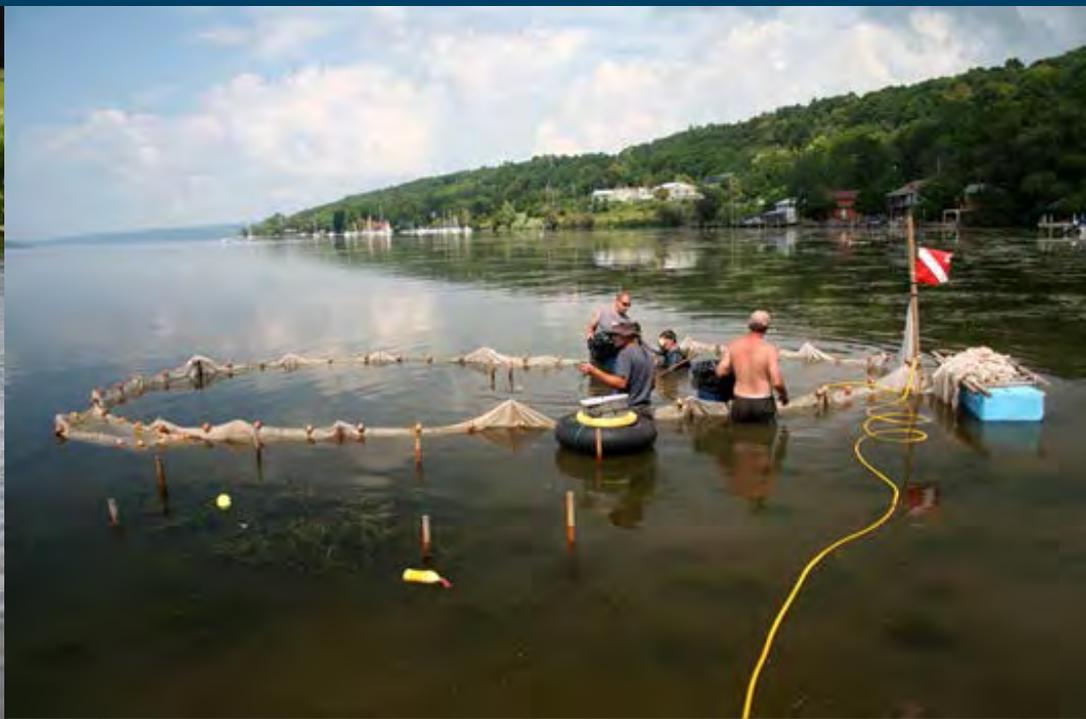
Other Methods of Treatment

- Suction Harvesting by divers in fall of 2011 [*Do not Use*]
- Excavation of Linderman Creek [*Worked well, Followed up with herbicides*]
- Hand removal to prevent vegetation movement [*Worked well*]
- Hand removal with Benthic barriers in Lake in 2013 [*Worked very well*]
- Benthic barriers on hydrilla patches in the Lake late summer 2014 [*Worked very well*]
