Re: *DEC Facility No. 8-4432-00085
Finger Lakes, LLC Underground LPG Storage Facility
Reading (T), Schuyler County*

PRE-CONSTRUCTION
NOTIFICATION
(Revised)

FINGER LAKES STORAGE, LLC -
LIQUID PROPANE GAS STORAGE SYSTEM
PROJECT

Town of Reading
Schuyler County, New York

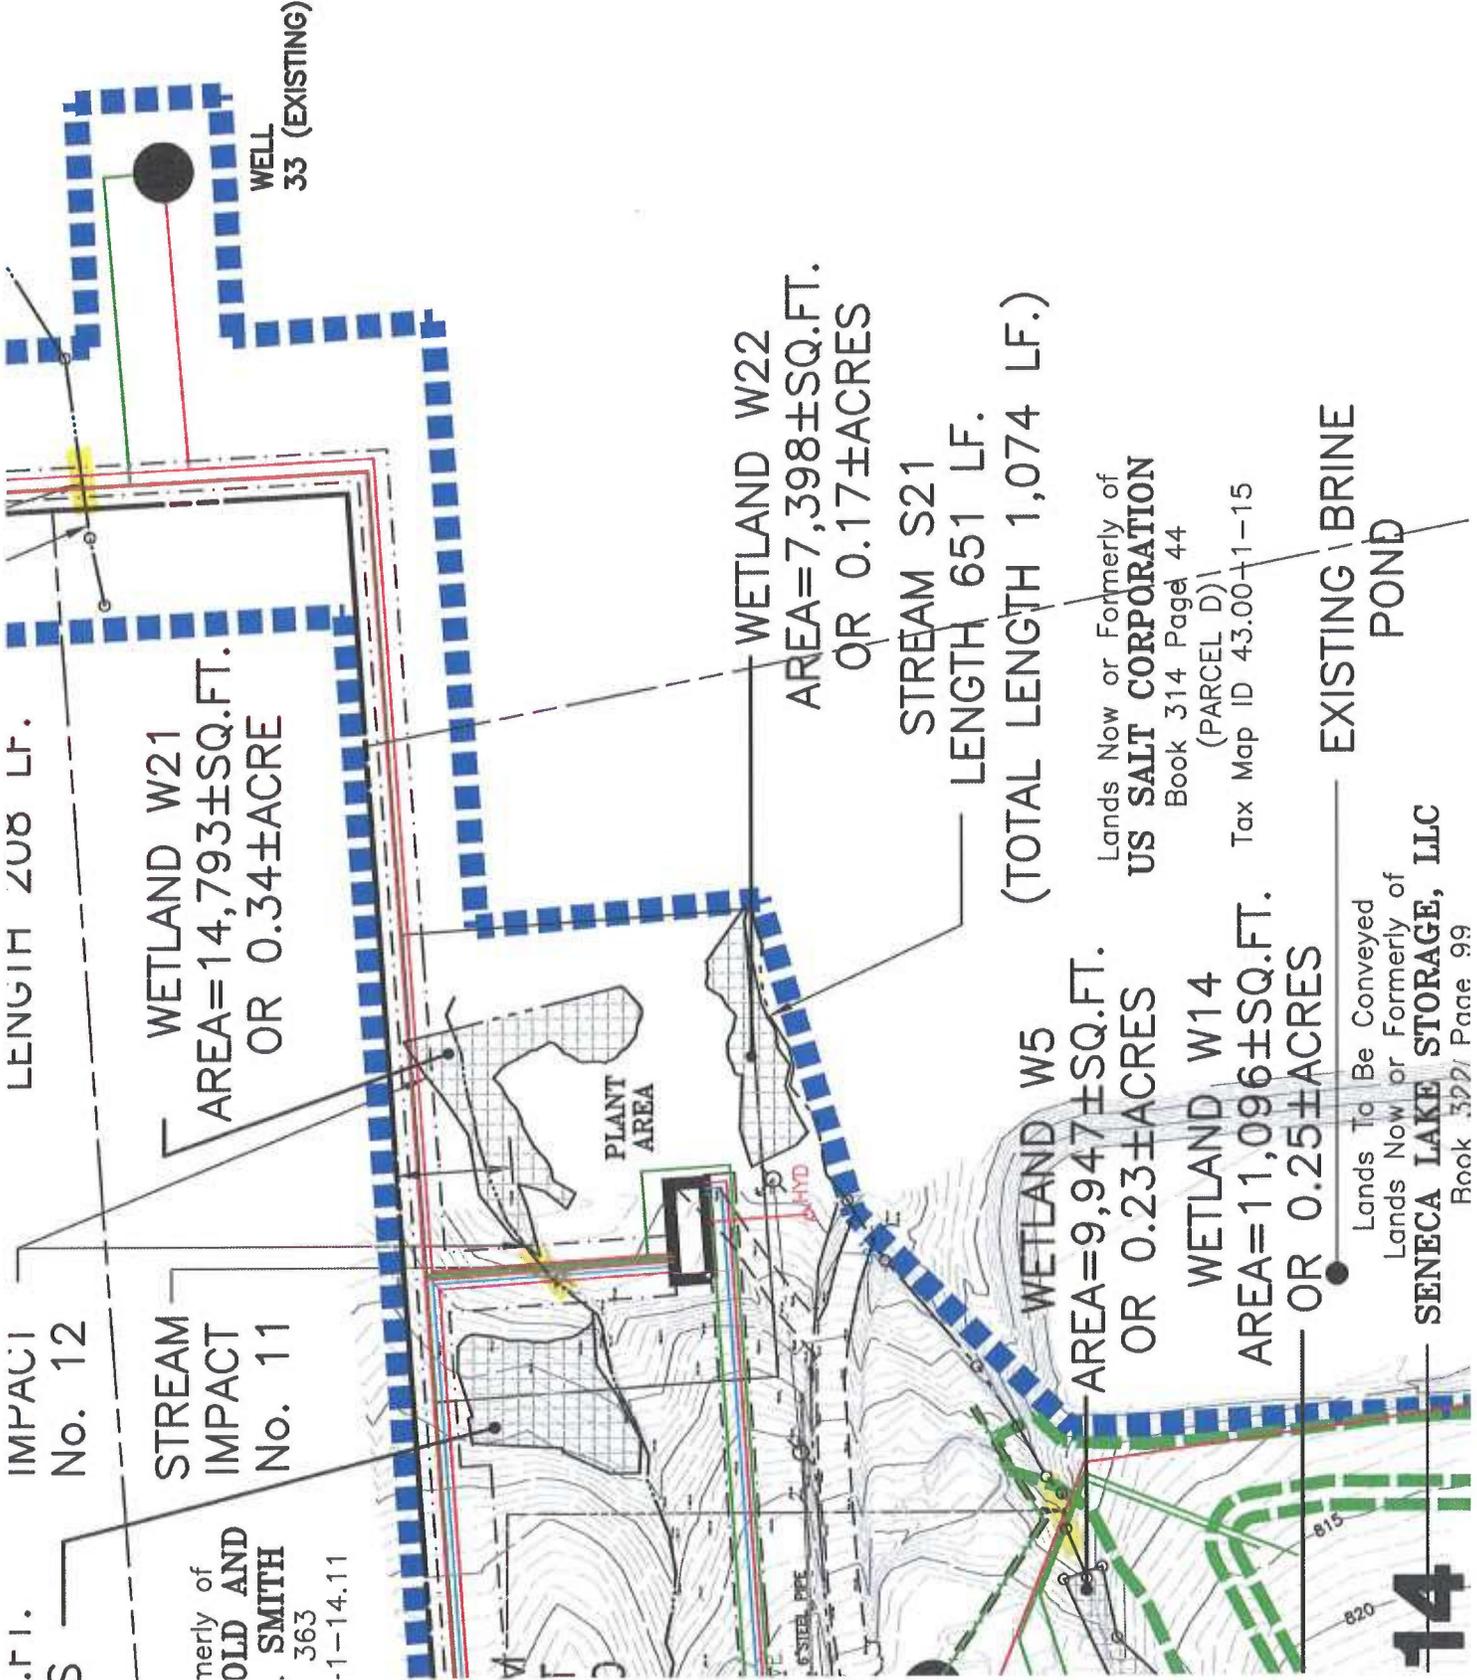
Wetland Impact Chart

Impact No.	Area Affected	Wetland Impact Type		Stream Impact Type	Remarks	
		Permanent	Temporary			
1	Stream S2			211 LF.	Culvert under R.R. siding	
2	Stream S2			25 LF.	Proposed pipelines across stream	
3	Stream S2			89 LF.	Culvert under roadway	
4	Wetland W1	0.02 Acre			Area within West Brine Pond	
5	Wetland W3	0.08 Acre			Area within West Brine Pond	
6	Stream S1				Proposed aerial pipeline crossing over stream	
7	Stream S4			50 LF.	Proposed pipelines across stream	
8	Stream S6			25 LF.	Single pipeline crossing stream	
9	Stream S5				Proposed aerial pipeline crossing over stream	
10	Stream S21				Proposed aerial pipeline crossing over stream	
11	Stream S15			66 LF.	Proposed pipelines across stream	
12	Wetland 21		0.01		Proposed pipelines across wetland	
13	Stream S7			25 LF.	Proposed pipelines across stream	
14	Stream S8				Proposed aerial pipeline crossing over stream	
Total		0.10 Acre	0.01 Acre	300 LF.	191 LF.	Total Wetlands/Streams Impacted

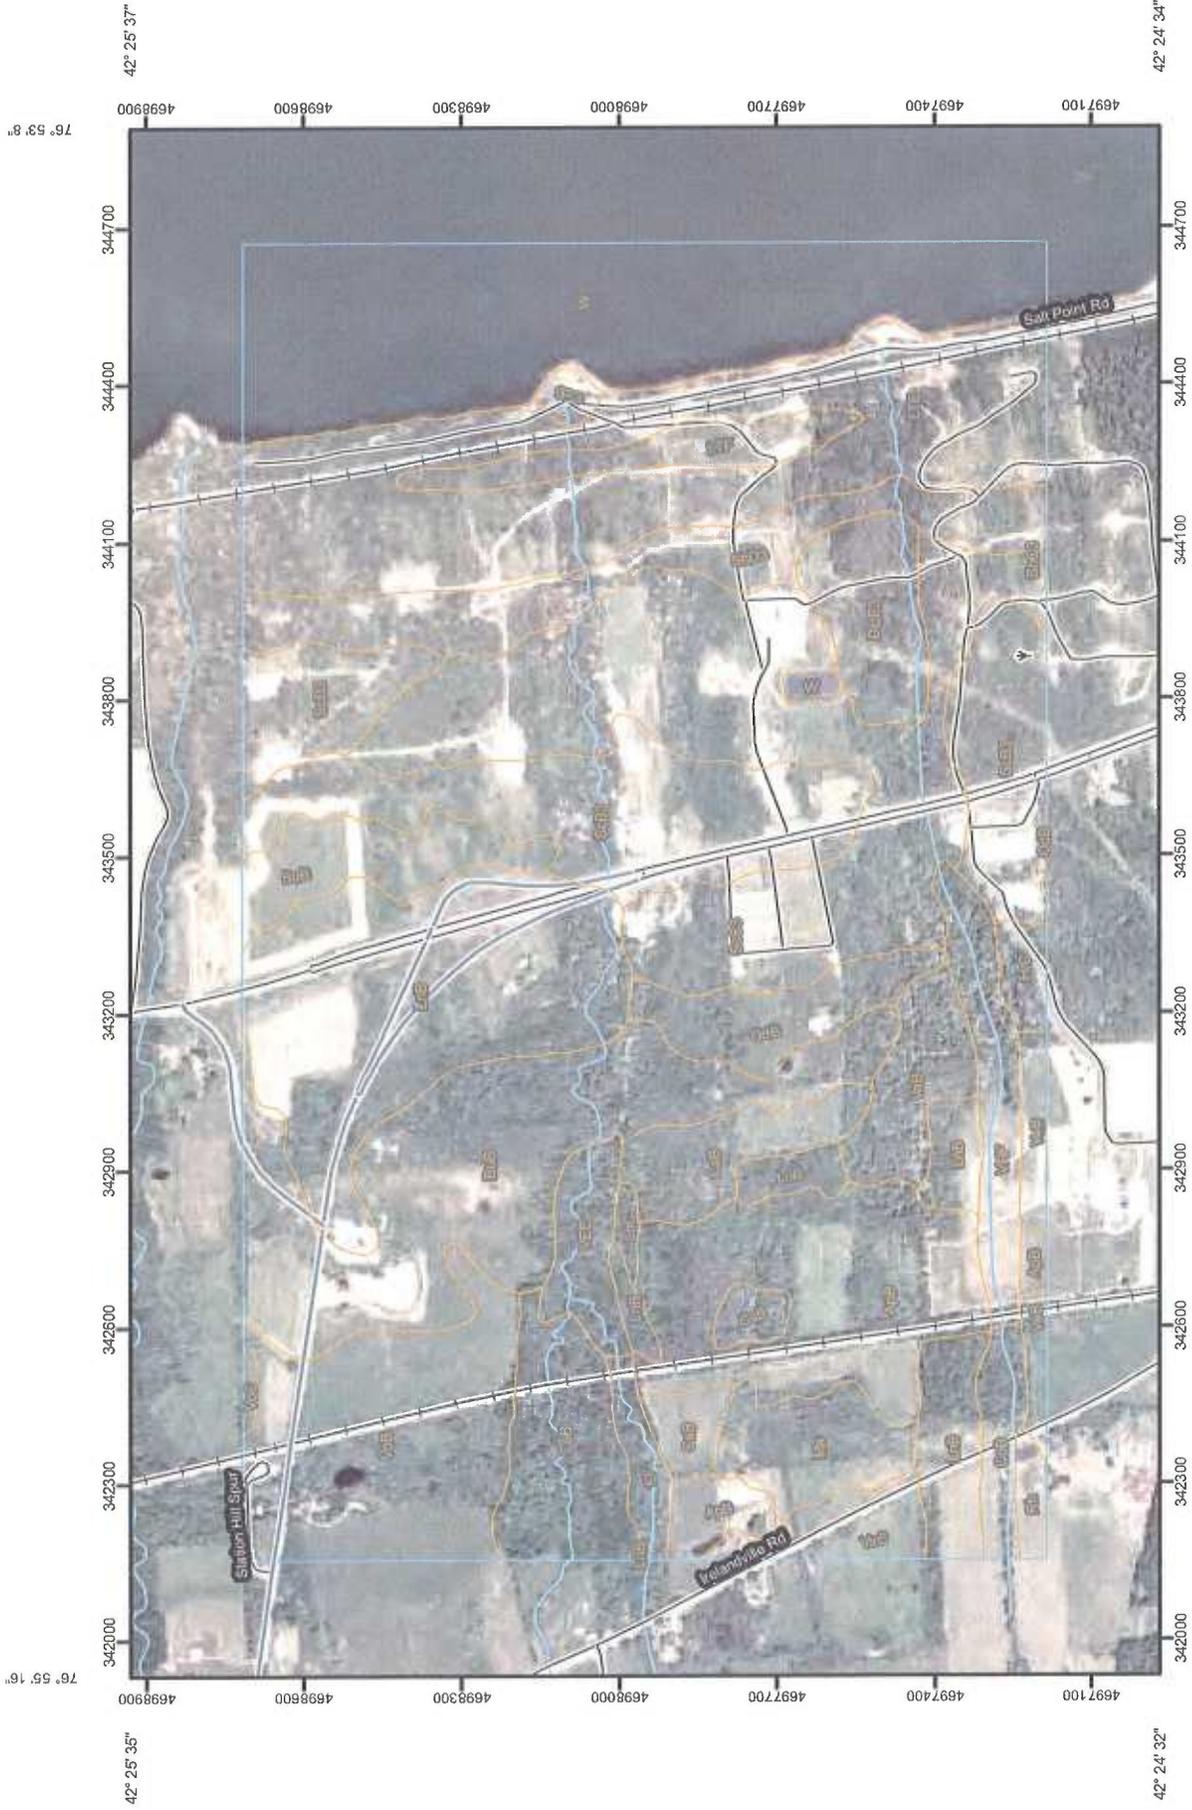
Soil Map—Sch. County, New York

According to the United States Department of Agriculture (USDA), Natural Resources Conservation Service Web Soil Survey, there are seven soil series (containing nine soil units) identified in the Project area. Table 1 includes the nine soils units and their physical characteristics/limitations. The soil units include the Burdett silt loam (BuB), 3 to 8 percent slopes, Conesus silt loam (CsB), 3 to 8 percent slopes, Lansing gravelly silt loam (LnB), 3 to 8 percent slopes, Odessa silt loam, 3 to 8 percent slopes, Schoharie silty clay loam (ScB3) 3 to 8 percent slopes, 8 to 15 percent slopes (ScC3) and 15 to 25 percent slopes (ScD3), Valois soils (VEE), steep, and the Volusia channery silt loam (VoB), 3 to 8 percent slopes. The Soil Survey mapping of the Project Area is shown in Figure 4.

The BuB and OdB units are listed as Prime Farmland, if drained, while CsB and LnB are listed as Prime Farmland. ScB3 and VoB are listed as Farmland of Statewide Importance, while ScC3, ScD3, and VEE are not listed as being Prime Farmland. The BuB, OdB, and VoB units have a water table at approximately 12 inches below ground surface (bgs), while the CSB unit and Schoharie series have water table depths of approximately 21 and 27 inches bgs, respectively. The LnB and VEE units have water tables of greater than (>) 78 inches bgs. There were no soils identified on the hydric soils list. Depth to bedrock for all soils is greater than (>) 78 inches. Soil descriptions are included in Appendix D.

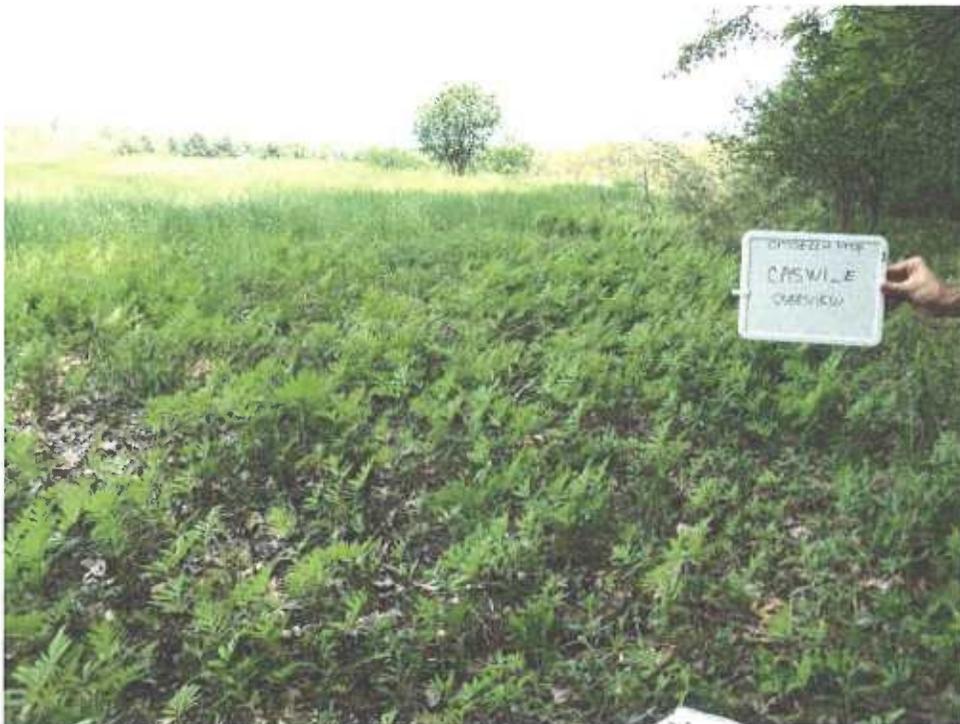
2. Wetland W1, PEM isolated, facing east.

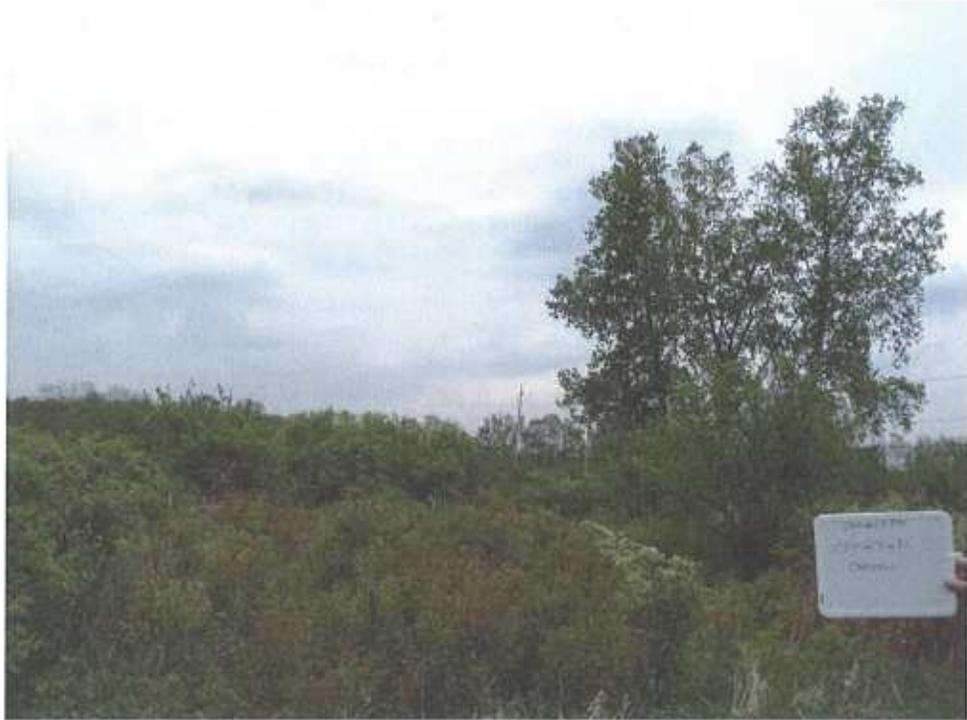
3. Wetland W2, PSS/PEM, facing north.

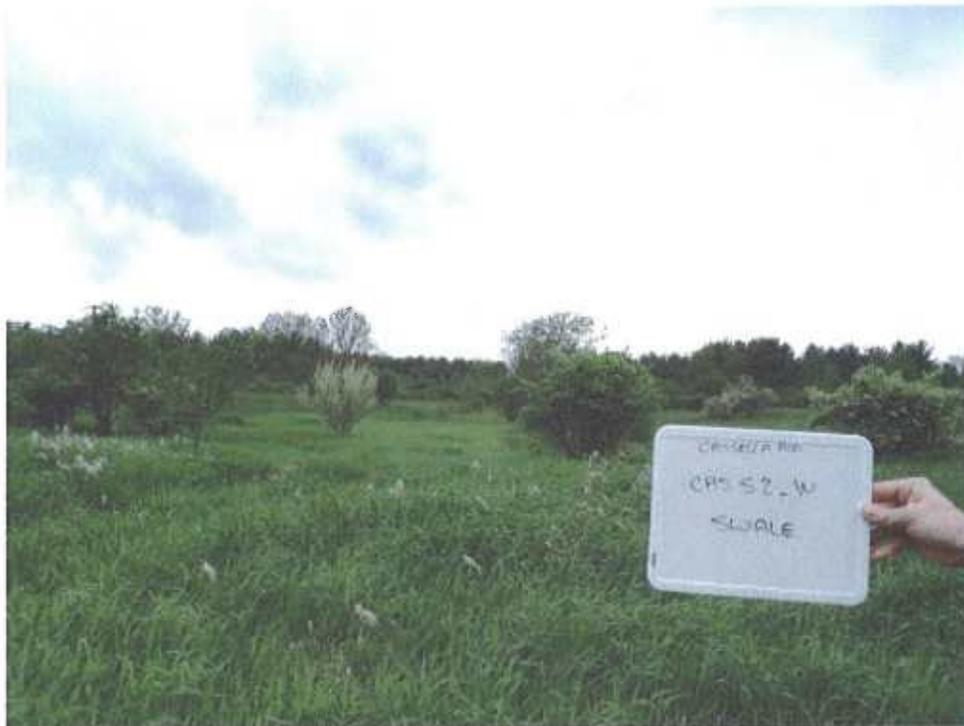
5. S2 and the edge of PEM portion of W2 on the former Casella Property.

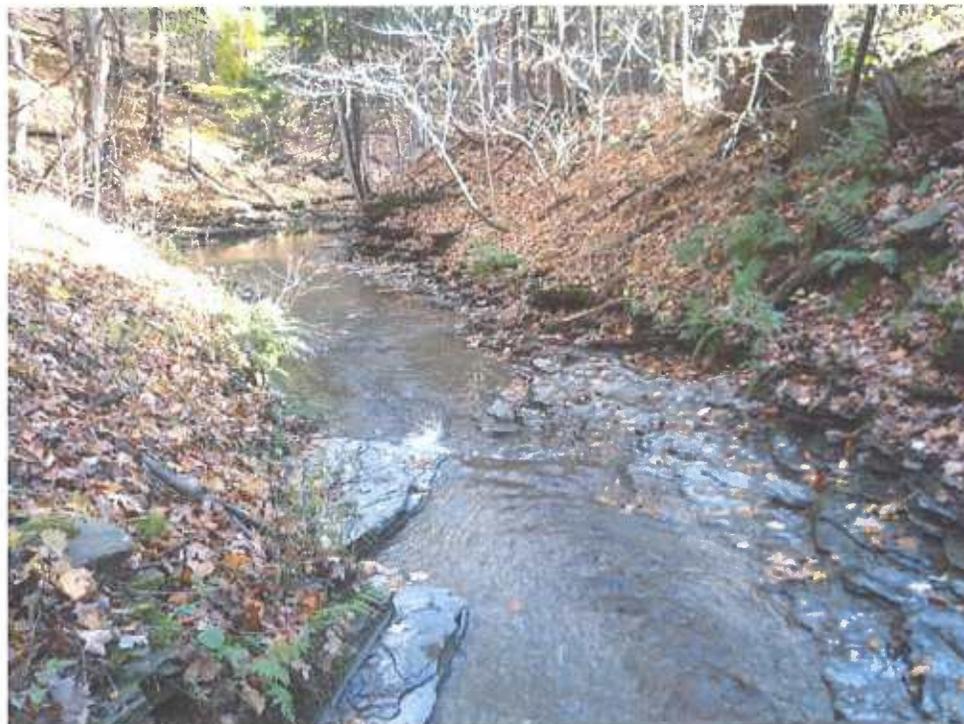
6. View of S1, facing northeast and downstream.

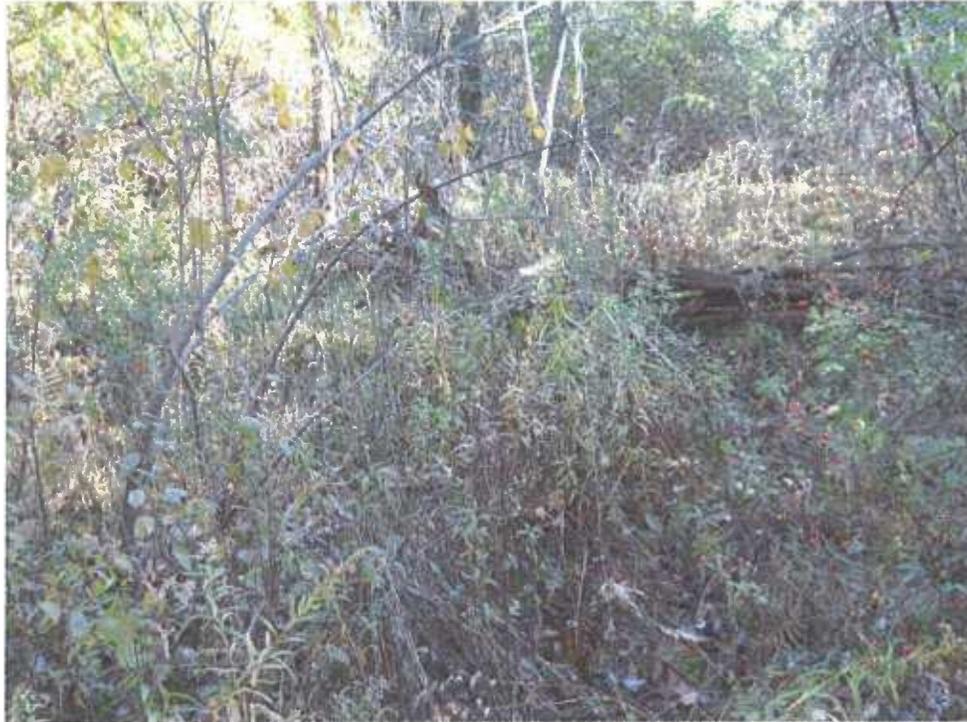
7. View of W4, facing northeast.

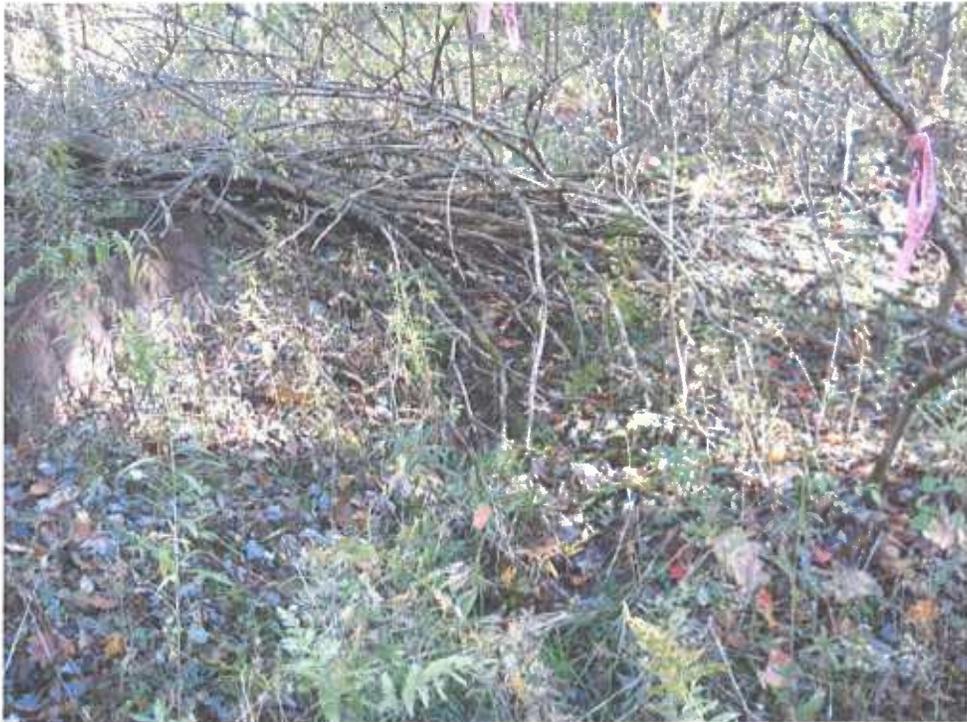
8. View looking north at S3, with W4 in the background.

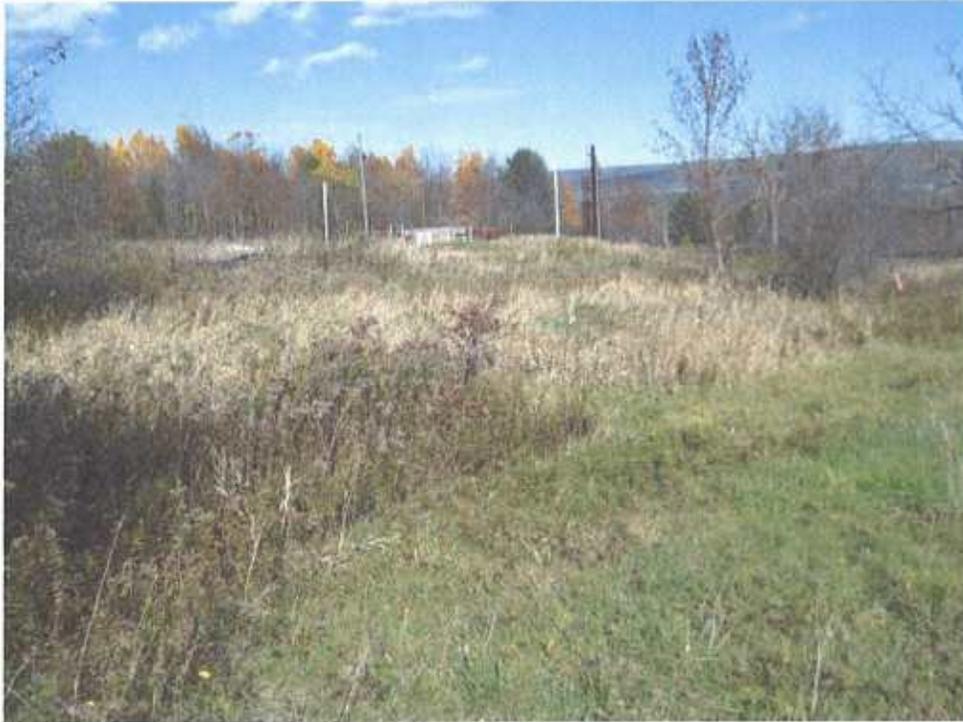
11. View looking east at W5.

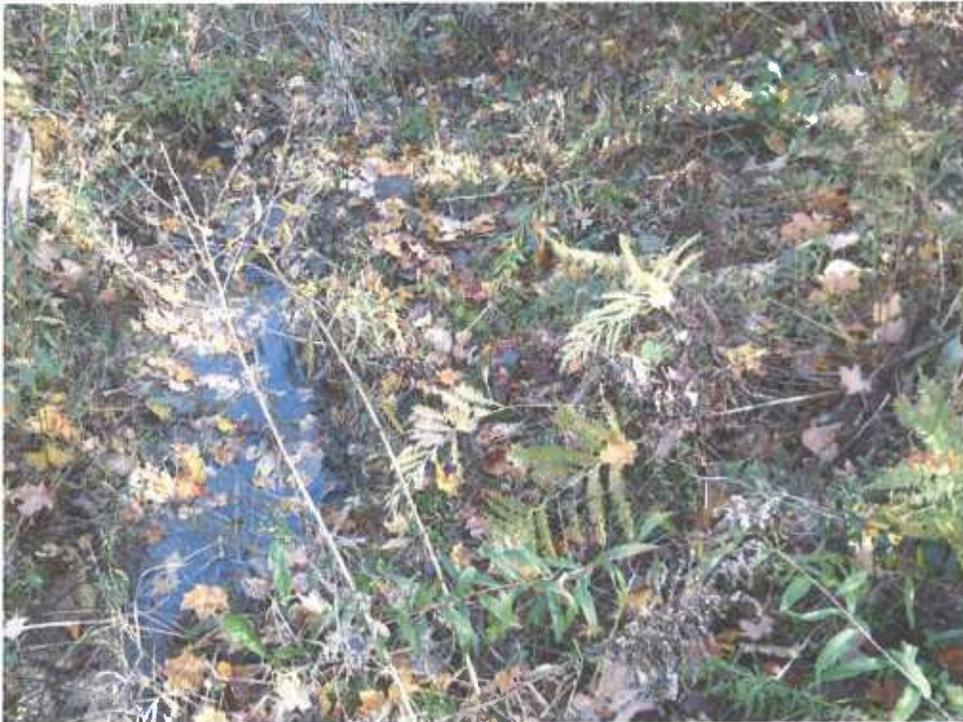
12. View of S5, facing east.

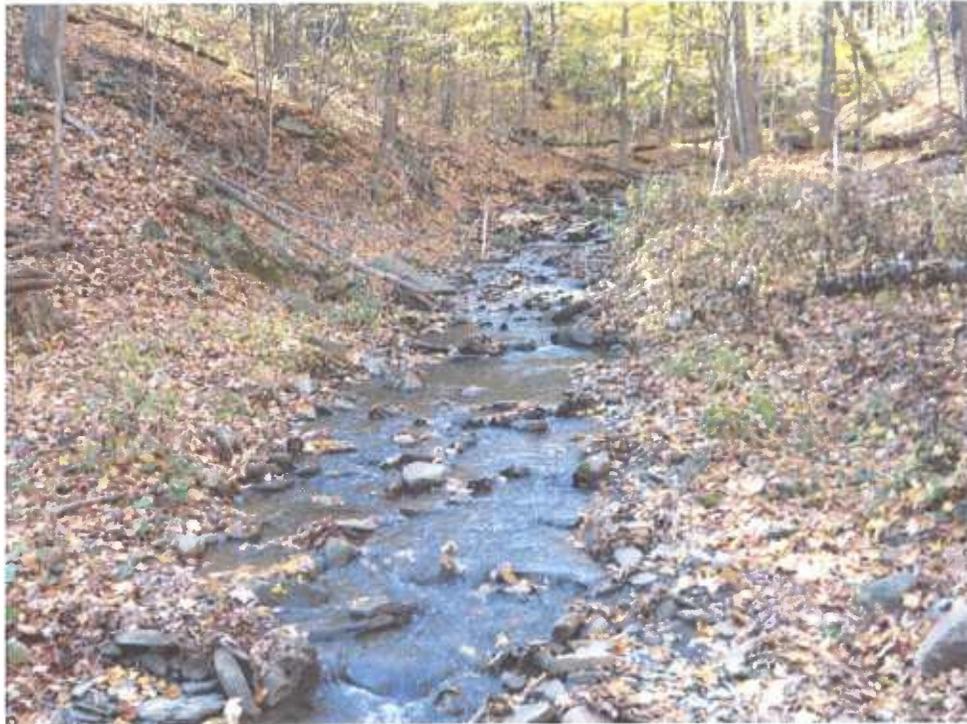
13. View of S6, facing west.

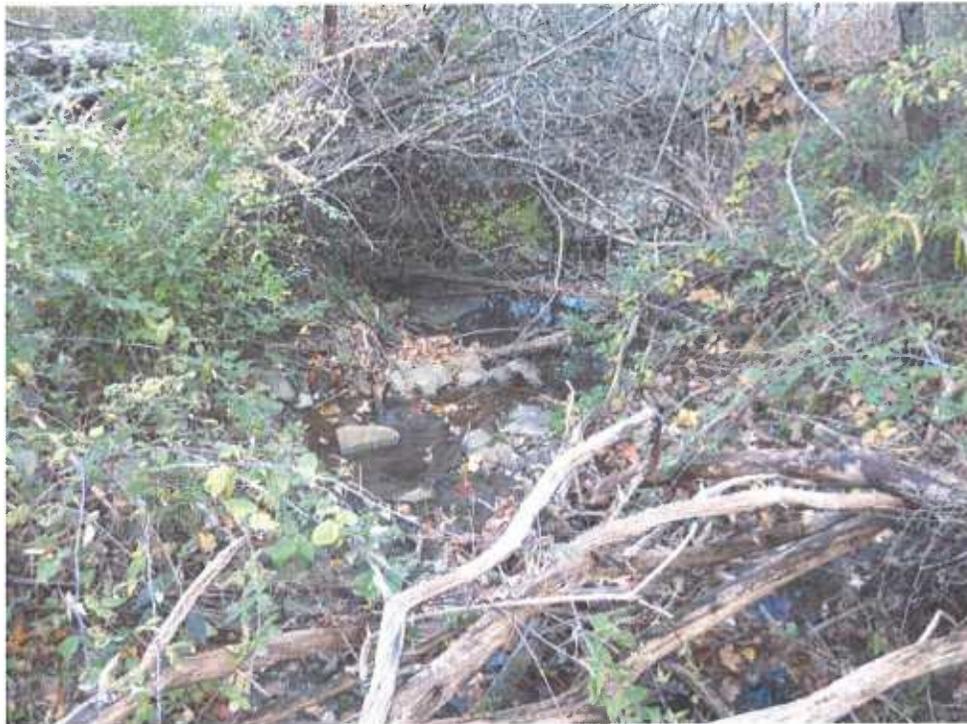
14. View of S7 (same feature as S4), facing east.

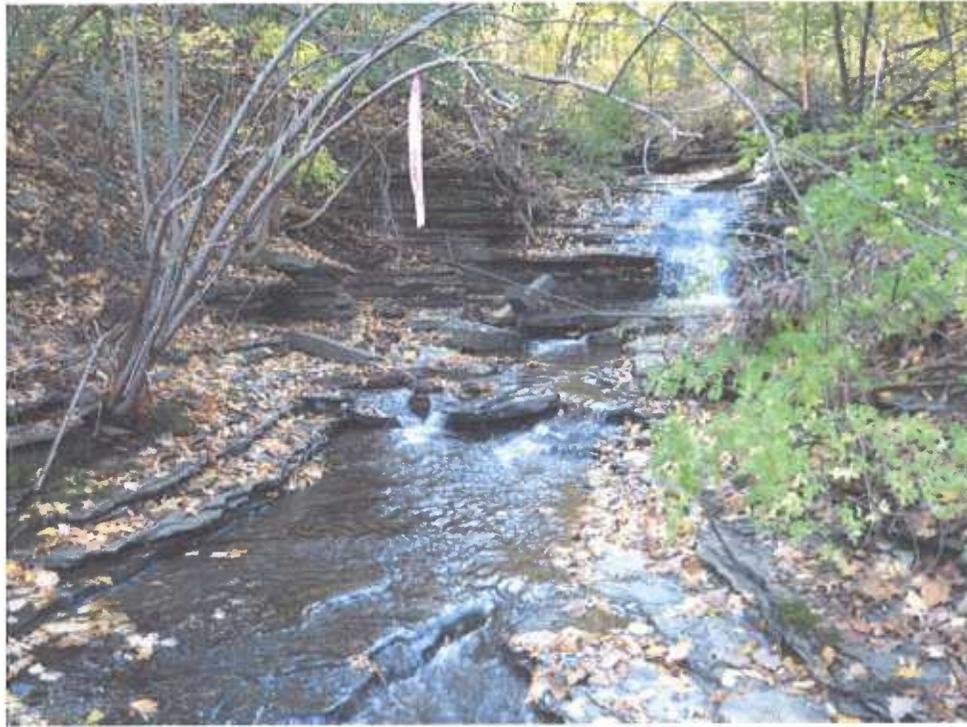
15. View of S8 (same feature as S1), facing west.

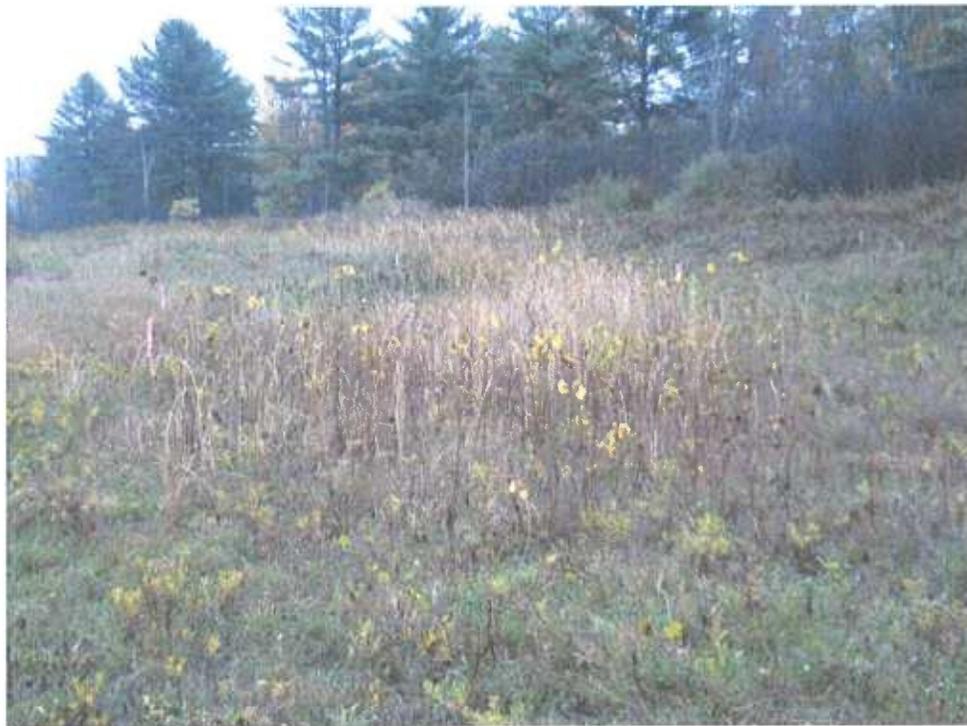
16. View facing east at W6, located on an old well pad.

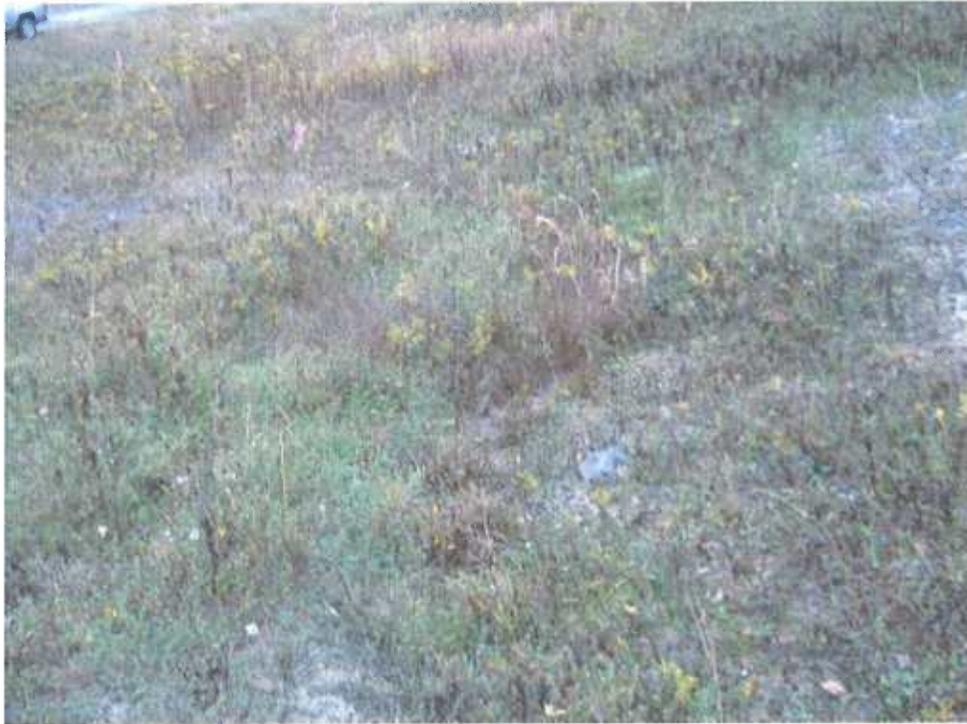
17. View looking east at S9 feeding and its convergence with W6.

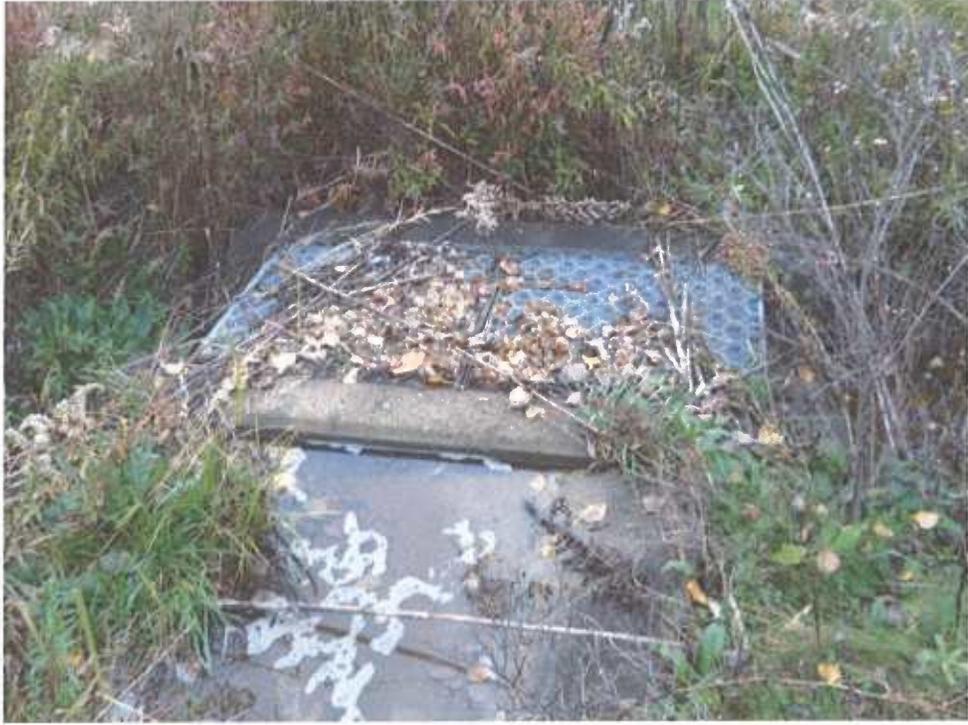
34. Receiving storm drain for feature in Photo 30, adjacent to NY State Route 14.

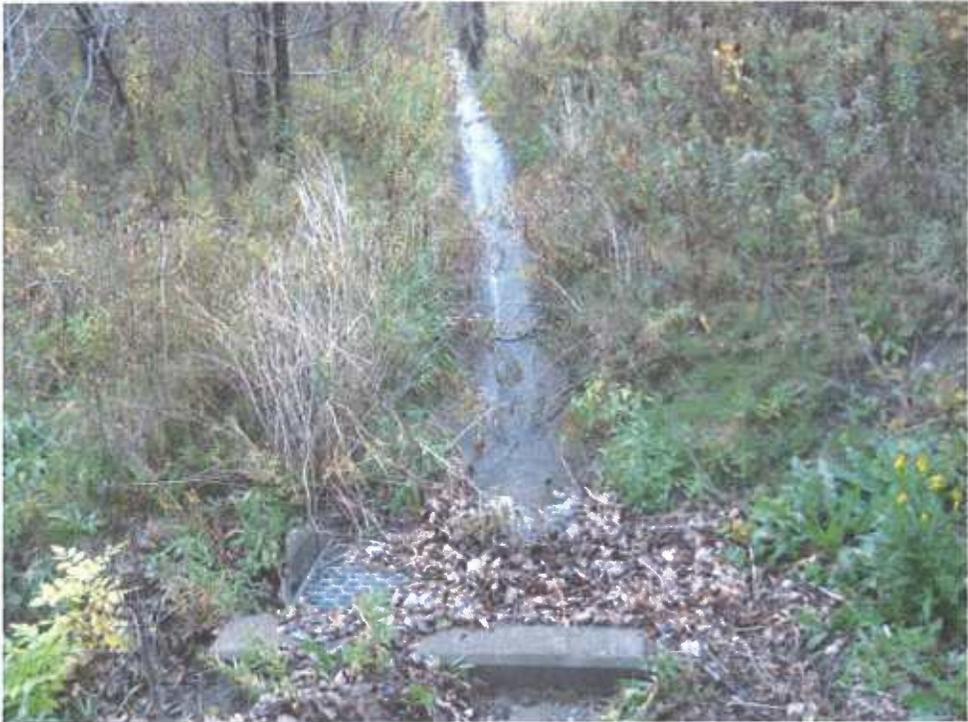
35. View of cement flume and the upgradient source of S13, west of and adjacent to S.R. 14.

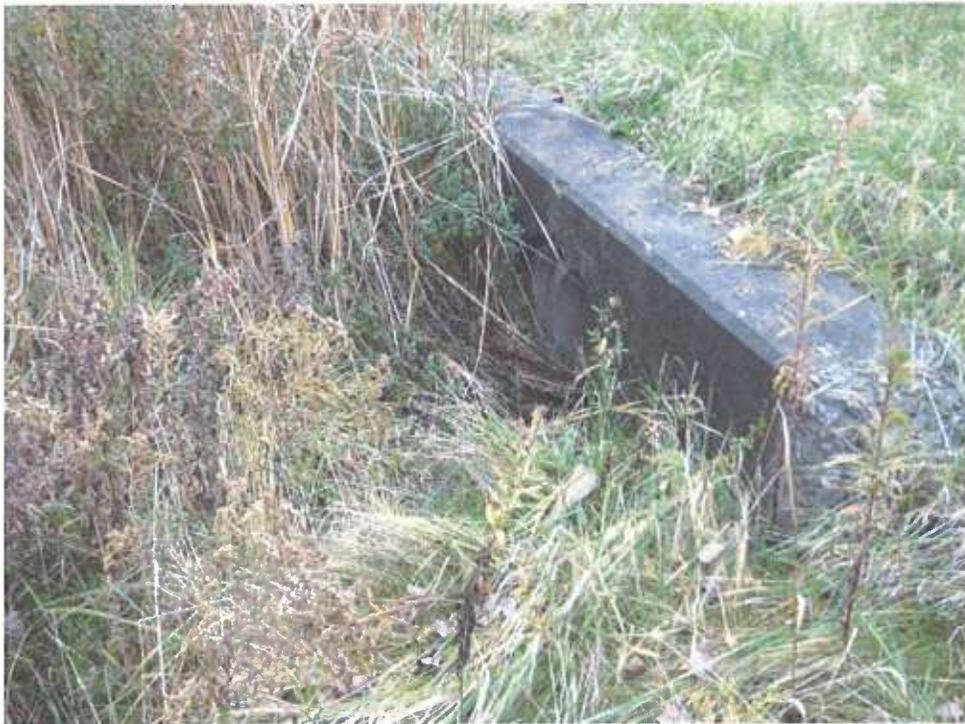
37. View of culvert pipe west of NY State Route 14 that feeds the on-site S14.

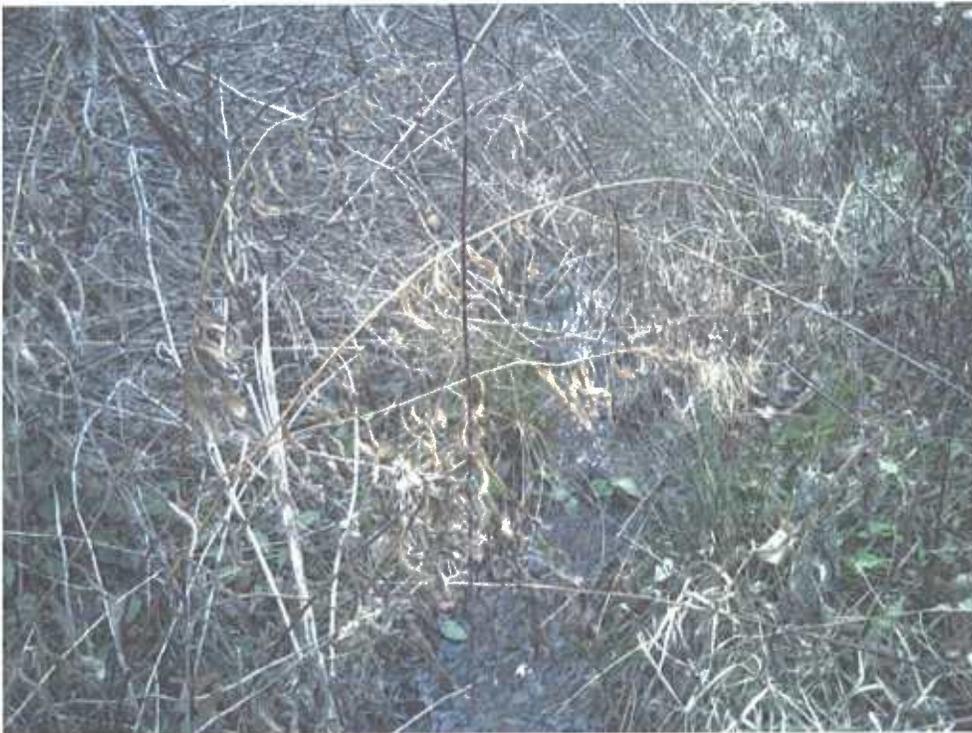
39. View of ephemeral Stream S17, facing north.

Stream S17 is a short drainage channel along the edge of an existing access road that carries ephemeral flow towards S16. The width of S17, from bank to bank, is approximately 6 feet.

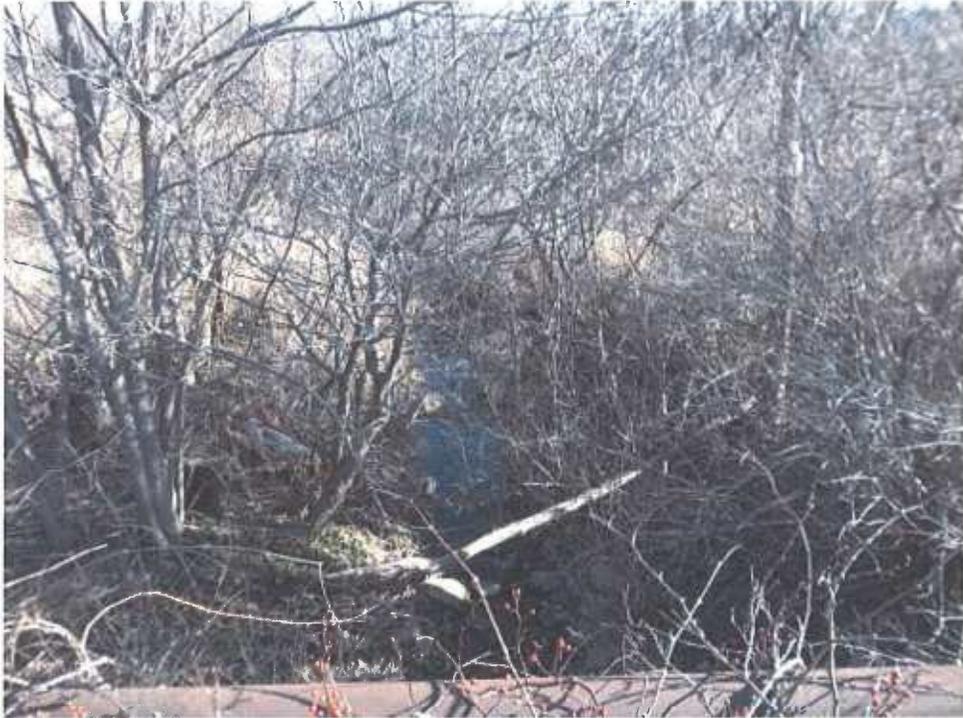
41. View of S21.

Stream S21 is an intermittent stream that flows east and under the main access road to the Seneca Compressor Station. It flows approximately 1,000 linear feet through the study corridor. It has a bank to bank width of approximately 2 feet.

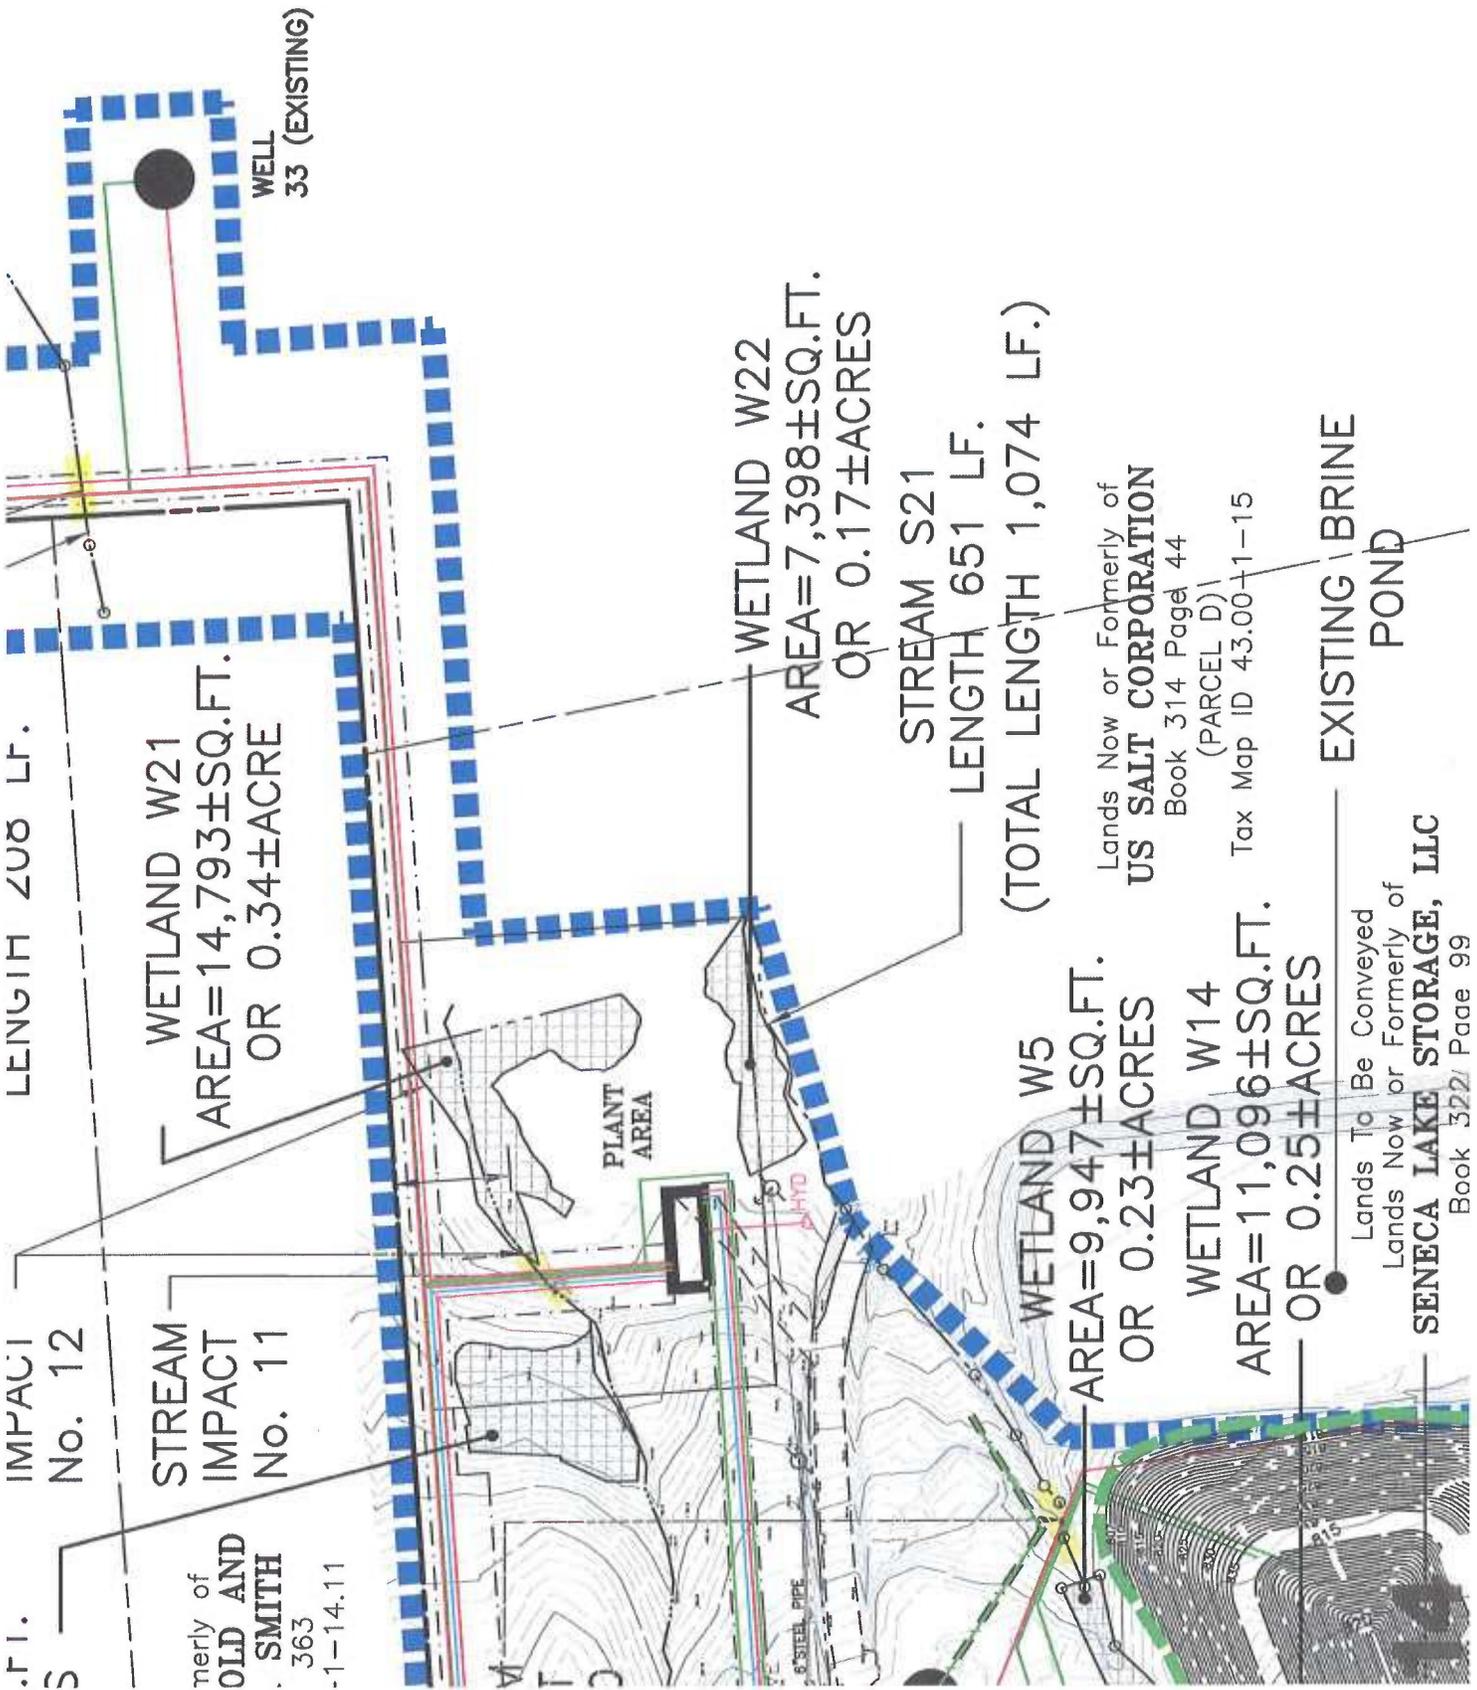
Wetland Impact Chart

Impact No.	Area Affected	Wetland Impact Type		Stream Impact Type	Remarks	
		Permanent	Temporary			
1	Stream S2			211 LF.	Culvert under R.R. siding	
2	Stream S2			25 LF.	Proposed pipeline across stream	
3	Stream S2			89 LF.	Culvert under roadway	
4	Wetland W1	0.02 Acre			Area within West Brine Pond	
5	Wetland W3	0.08 Acre			Area within West Brine Pond	
6	Stream S1				Proposed aerial pipeline crossing over stream	
7	Stream S4			50 LF.	Proposed pipelines across stream	
8	Stream S6			25 LF.	Single pipeline crossing stream	
9	Stream S5				Proposed aerial pipeline crossing over stream	
10	Stream S21				Proposed aerial pipeline crossing over stream	
11	Stream S15			66 LF.	Proposed pipeline across stream	
12	Wetland 21		0.01		Proposed pipelines across wetland	
13	Stream S7			25 LF.	Proposed pipelines across stream	
14	Stream S8				Proposed aerial pipeline crossing over stream	
Total		0.10 Acre	0.01 Acre	300 LF.	191 LF.	Total Wetlands/Streams impacted
