Belleayre Mountain Ski Center
Catskill State Park
Highmount Ski Resort, Aerial Imagery

Figure 4.3-3 Belleayre Mountain Ski Center Utility Locations

On-site Conditions and Wetland Characteristics

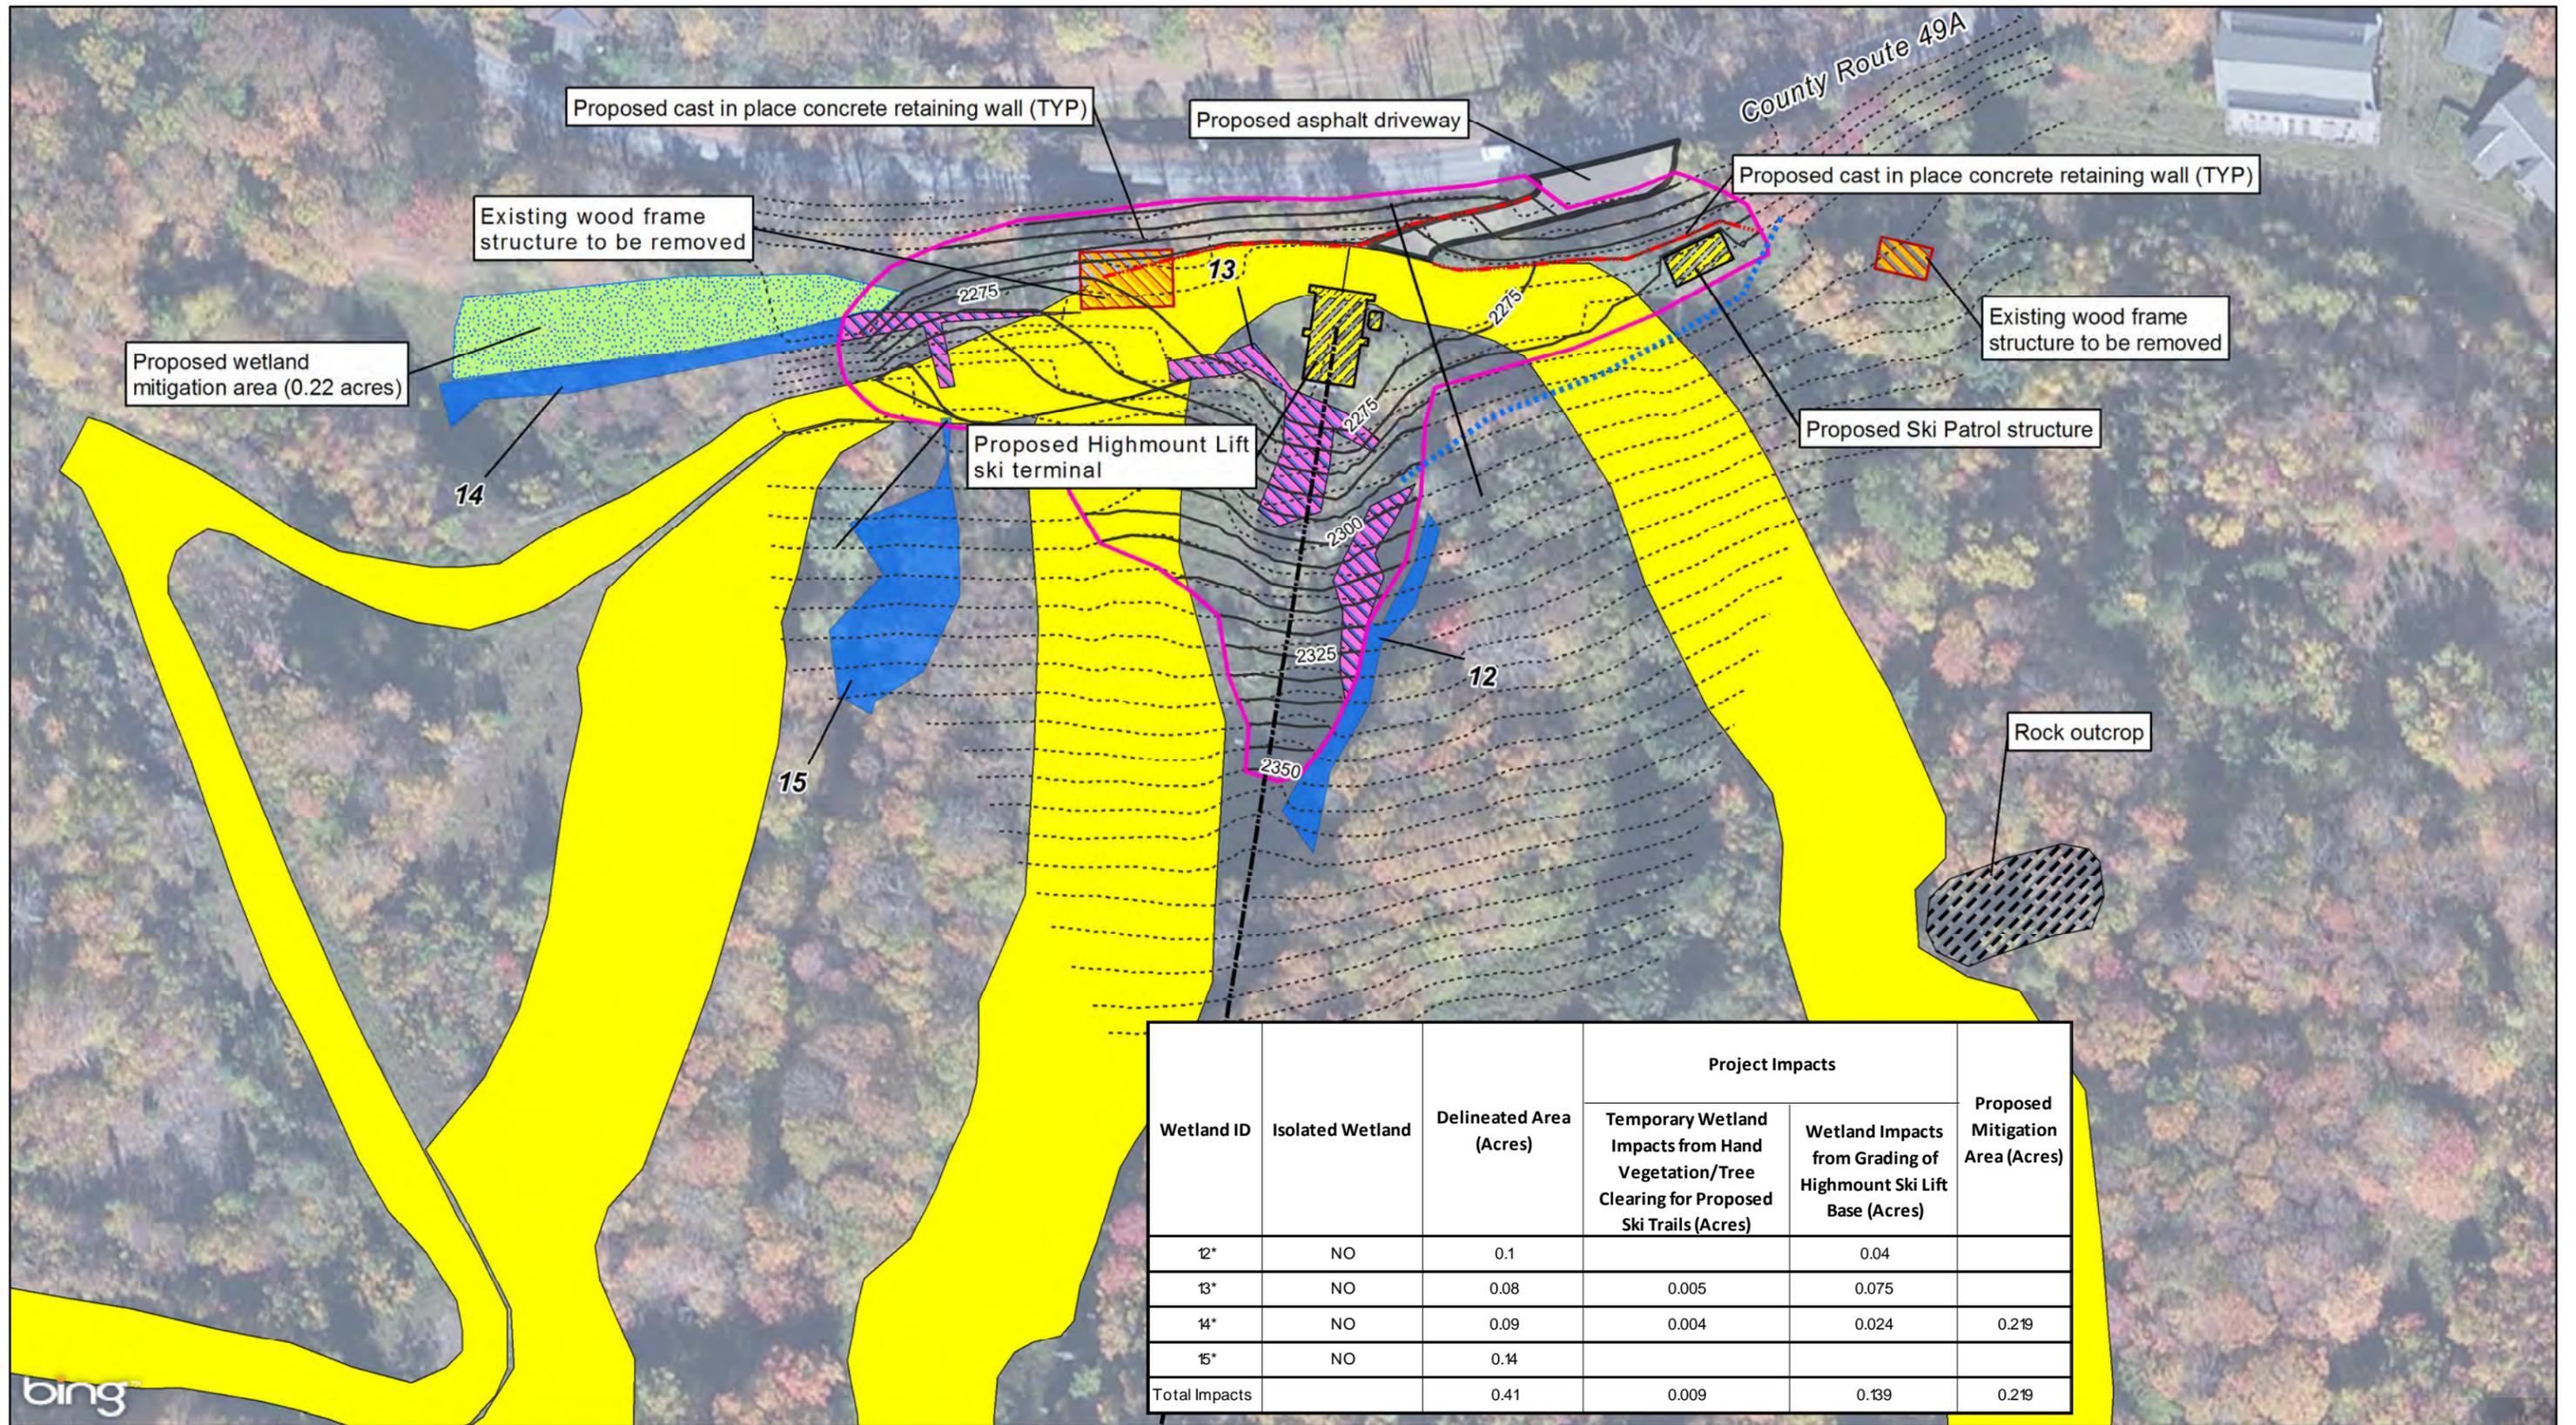
- Proposed Ski Lift Line
- Existing Contour
- Proposed Contour
- Flow Diversion
- Existing Structure
- Proposed Structure
- Proposed Driveway
- Rock Outcrop
- Area of Proposed Grading
- Proposed Retaining Wall
- Delineated Wetland Area
- Proposed Trail Clearing
- Wetland Mitigation Area
- Impacts to Wetlands due to Grading
- Temporary Impacts to Wetlands due to Trail Clearing

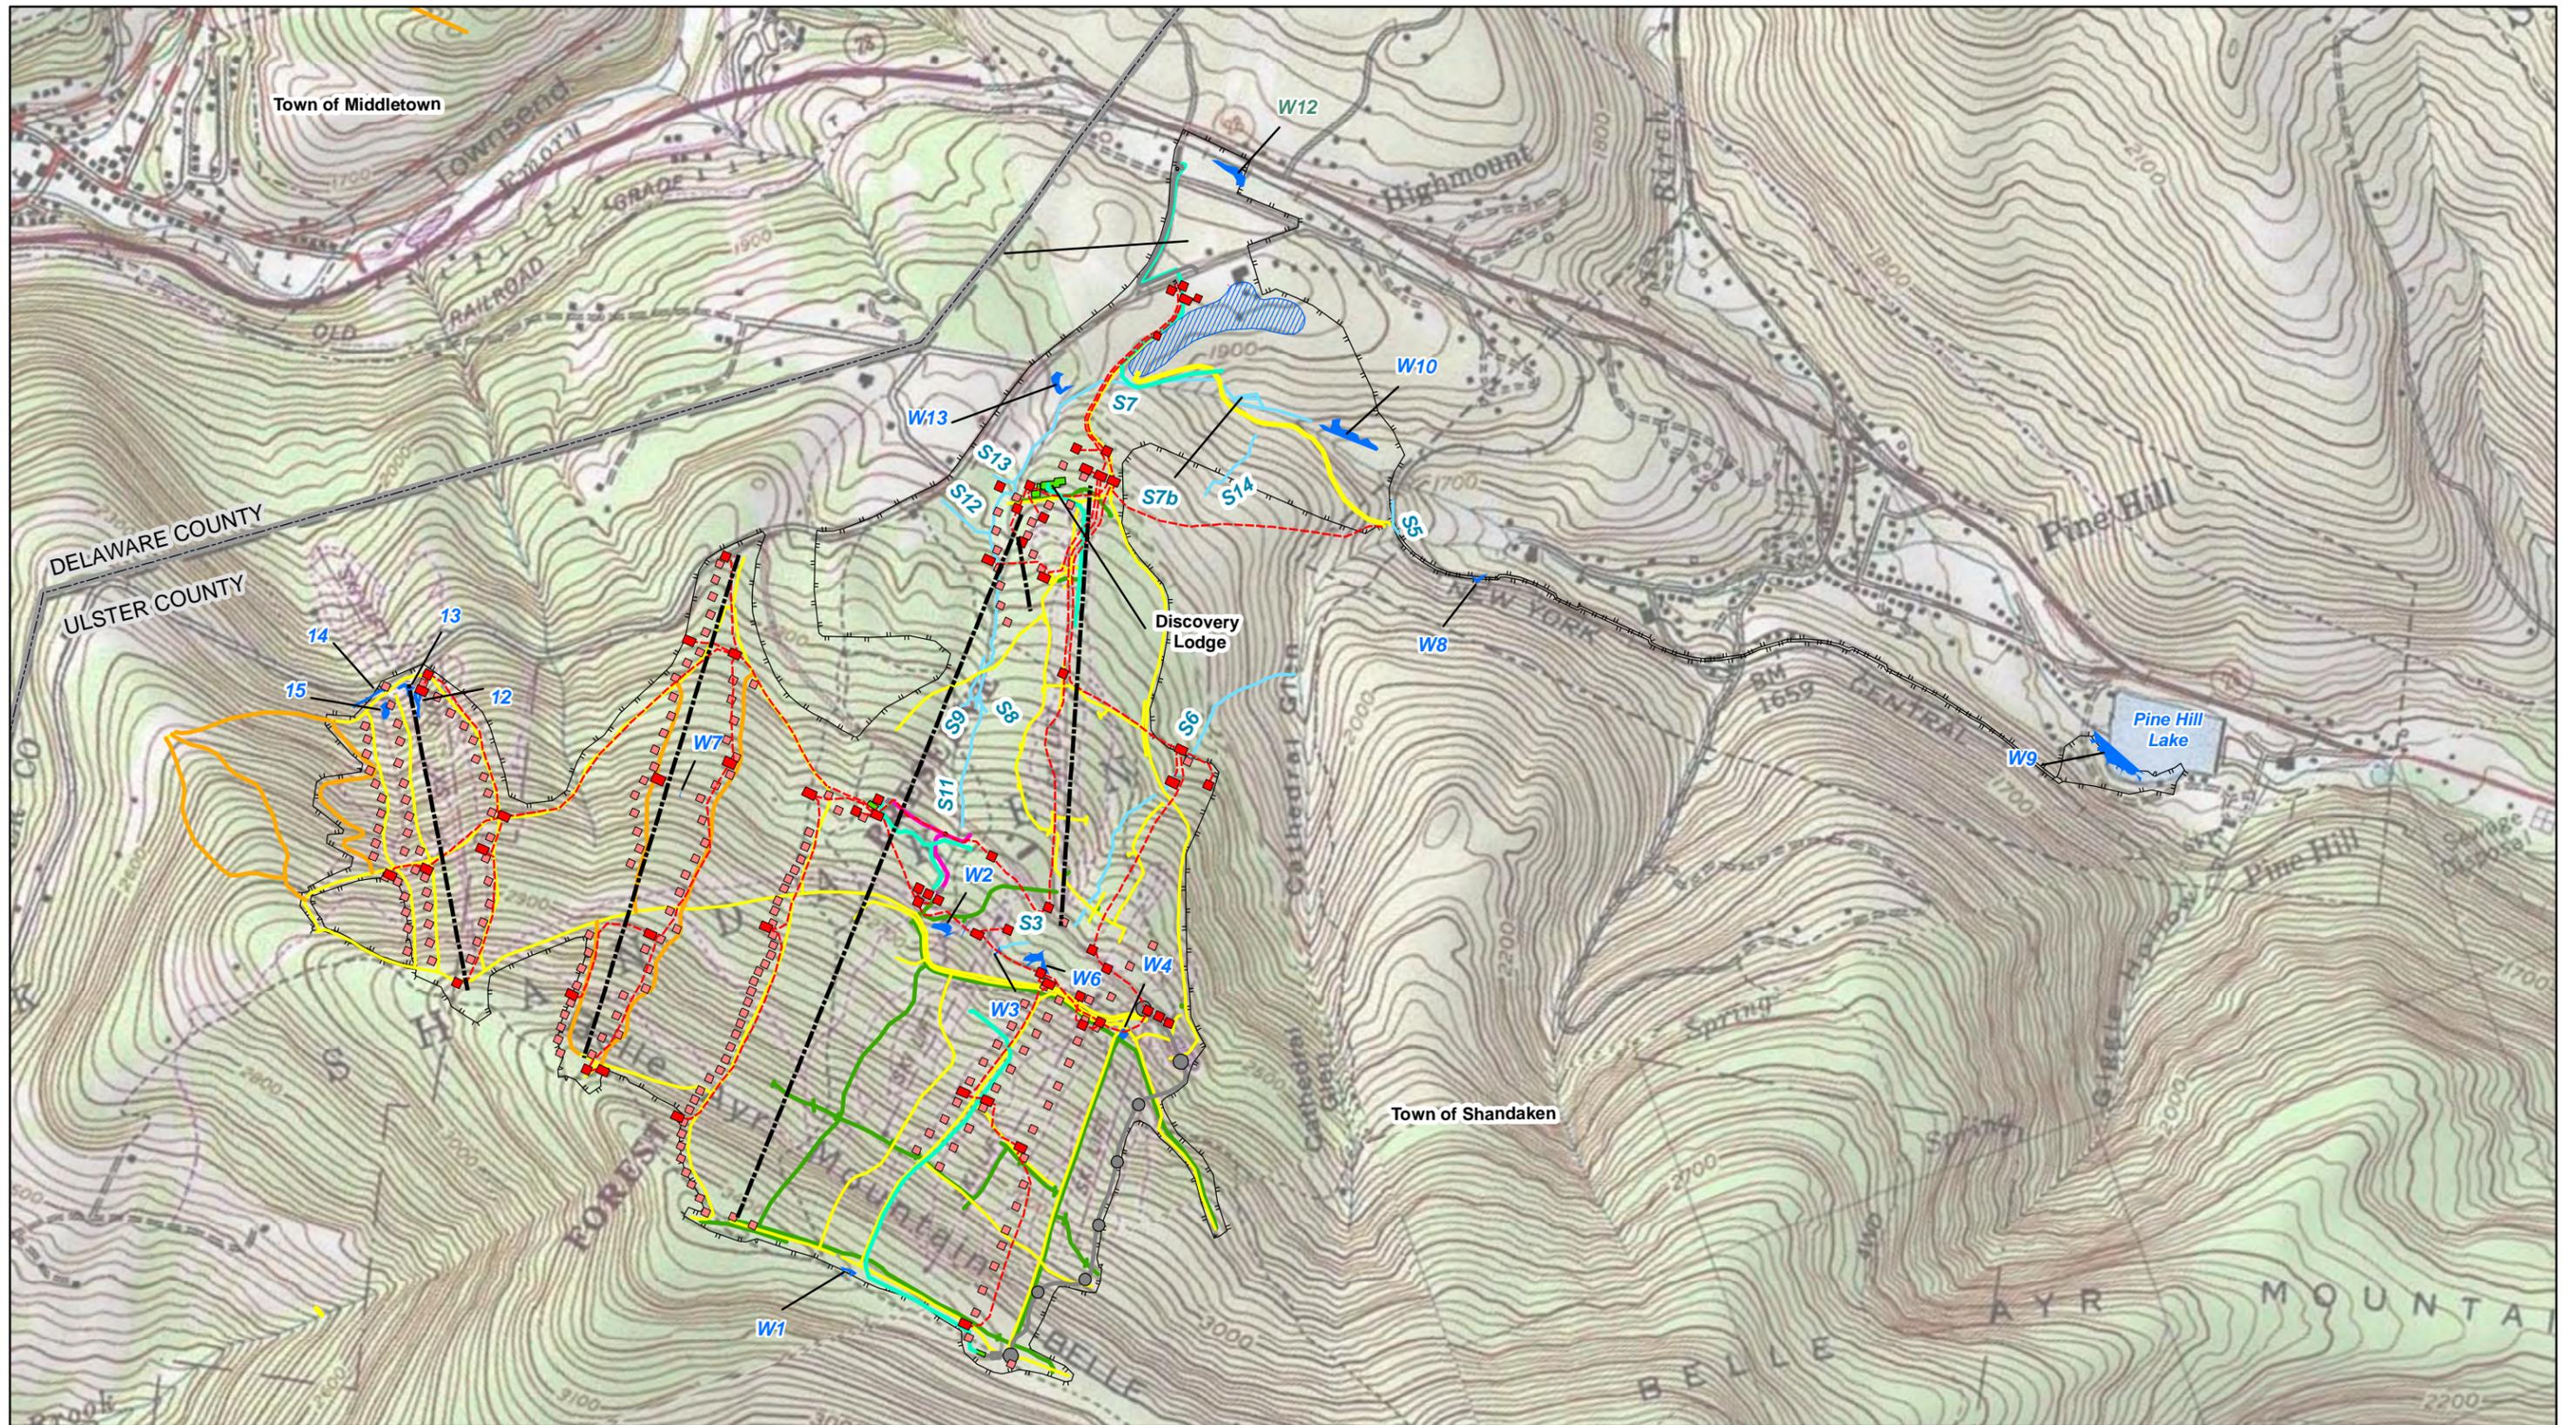
Belleayre Mountain Ski Center
Catskill State Park
Project Area, USGS Topographic Imagery

| --- Proposed Ski Lift | --- Proposed Underground Electric Line | ■ Proposed Electric Device | ■ Proposed Electric Fan Gun Receptacle |
| — Unclassified Delineated Stream Line | — Proposed Sewer Line | ● Proposed Sewer | ■ Discovery Lodge |
| ■ Delineated Wetland | — Proposed Potable Water Line | — Proposed Snow Air Line | ▭ Township Boundary |
| ■ Proposed Snow Making Pond | — Proposed Sanitary Sewer | — Proposed Snow Water Line | ▭ Study Boundary (October, 2009) |

This mapped stream will be crossed by a ski trail and utility lines (see Figure 4,3-3). During the wetland delineation conducted in 2008, this stream channel was not observed. Subsequent review of the stream mapping, which is based on topographic surveys on a large scale, depicted the headwaters of this stream extending up to the proposed utility line. Prior to any construction, the Department will conduct another wetland survey during the growing season to confirm the boundary of the headwaters. Stream crossings by utility lines will be either overhead or underground and will not impact wetlands.

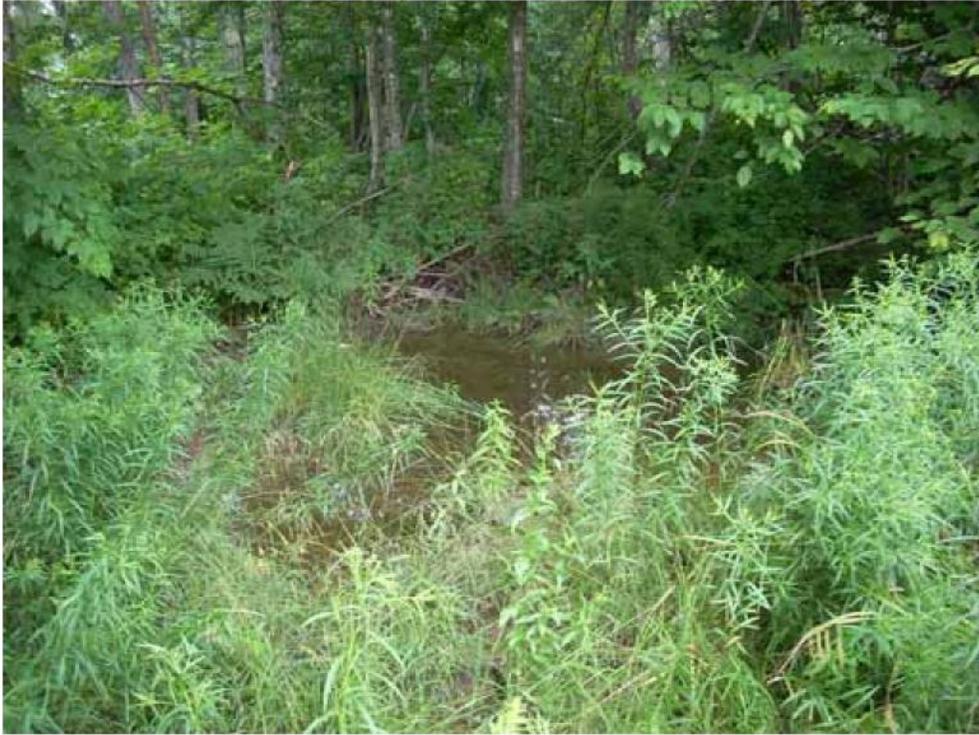
Photo 1: Looking southwest at Wetland 1 (W1).

W1 is a small emergent wetland located at the top of the Area 51 slope, just above the proposed trail expansion. The wetland flows into a small drainage swale that flows downslope to the southwest. Many tadpoles were observed in the ponded portion of the wetland. The dominant vegetation is rough-stemmed goldenrod (*Solidago rugosa*), flat-top goldenrod (*Euthamia graminifolia*), fringed sedge (*Carex crinita*), fringed willowherb (*Epilobium glandulosum*), melic mannagrass (*Glyceria melicaria*), and fowl mannagrass (*Glyceria striata*).

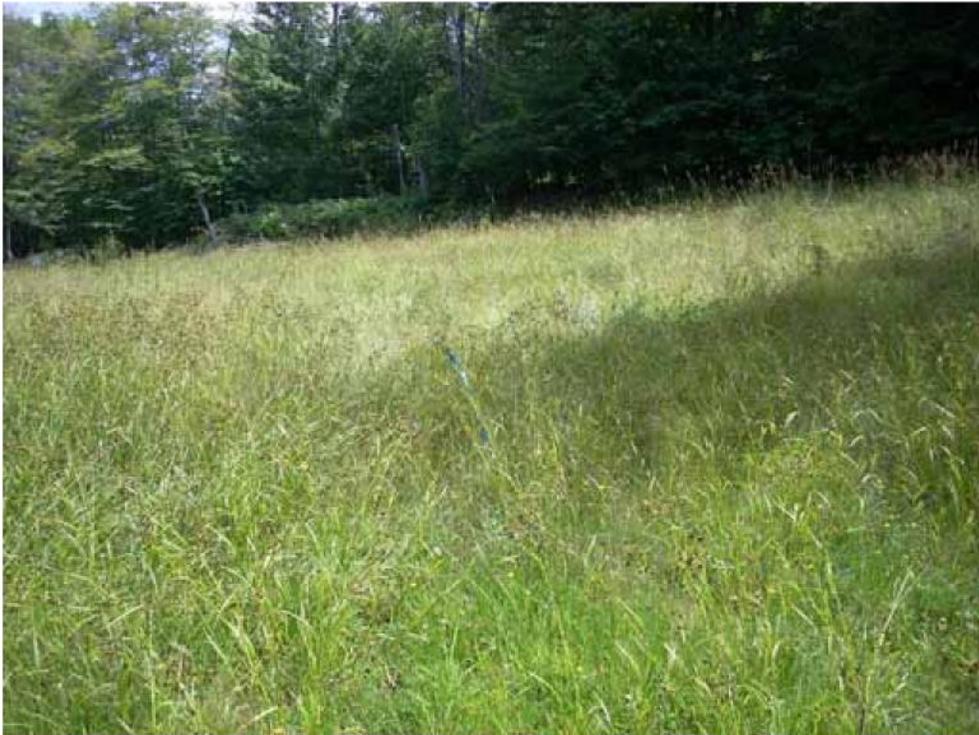
Photo 2: Looking southeast at Wetland 2 (W2).

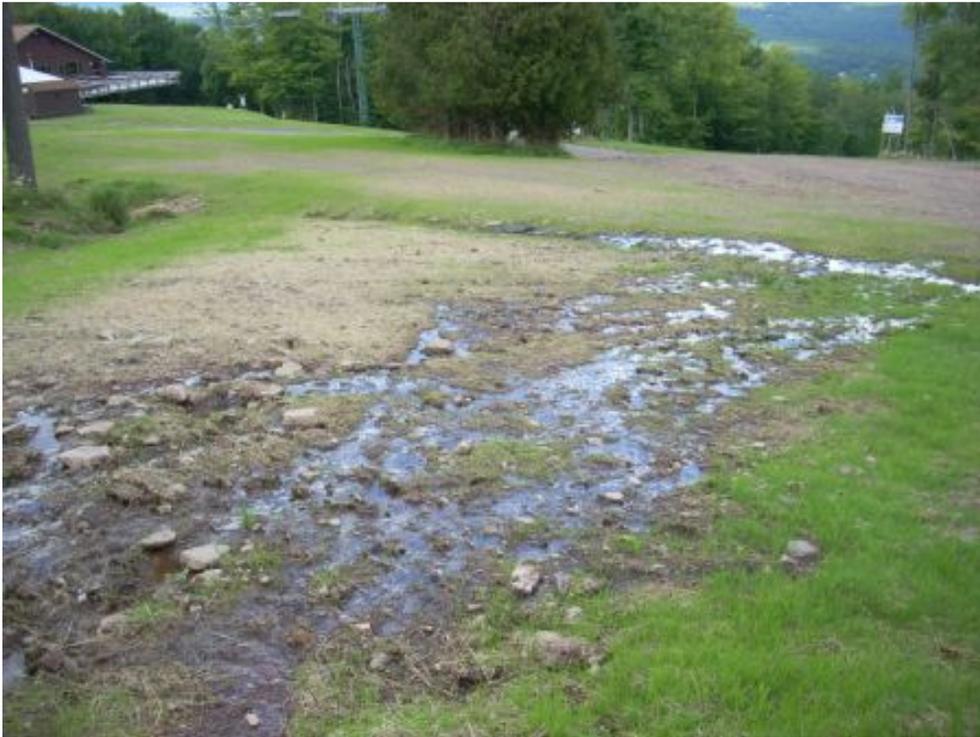
Photo 3: Looking northeast at Wetland 4 (W4).

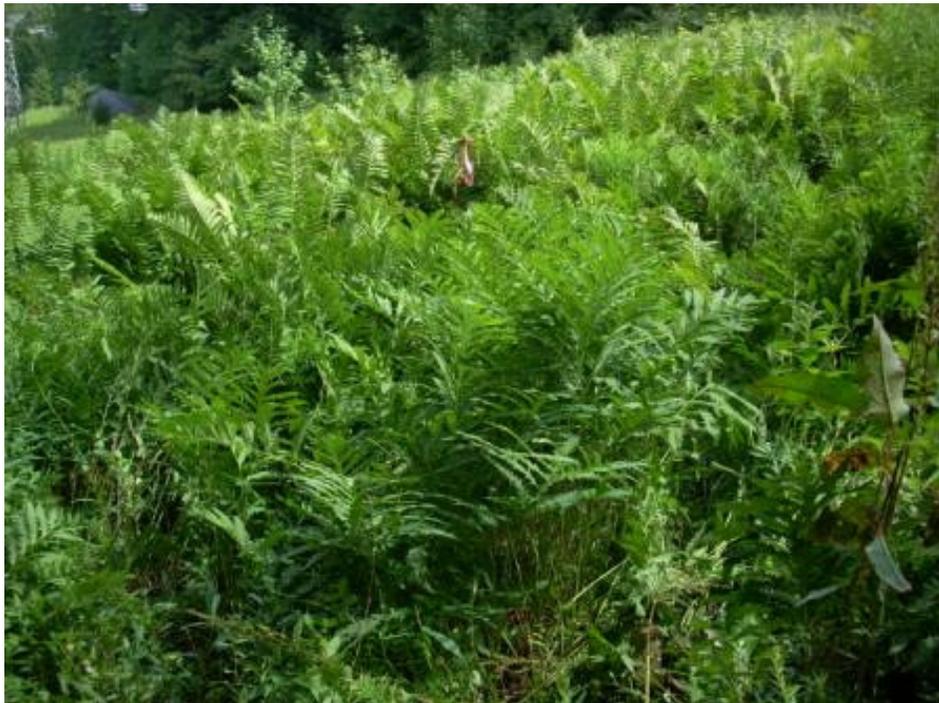
Photo 4: Looking east at Wetland 6 (W6).

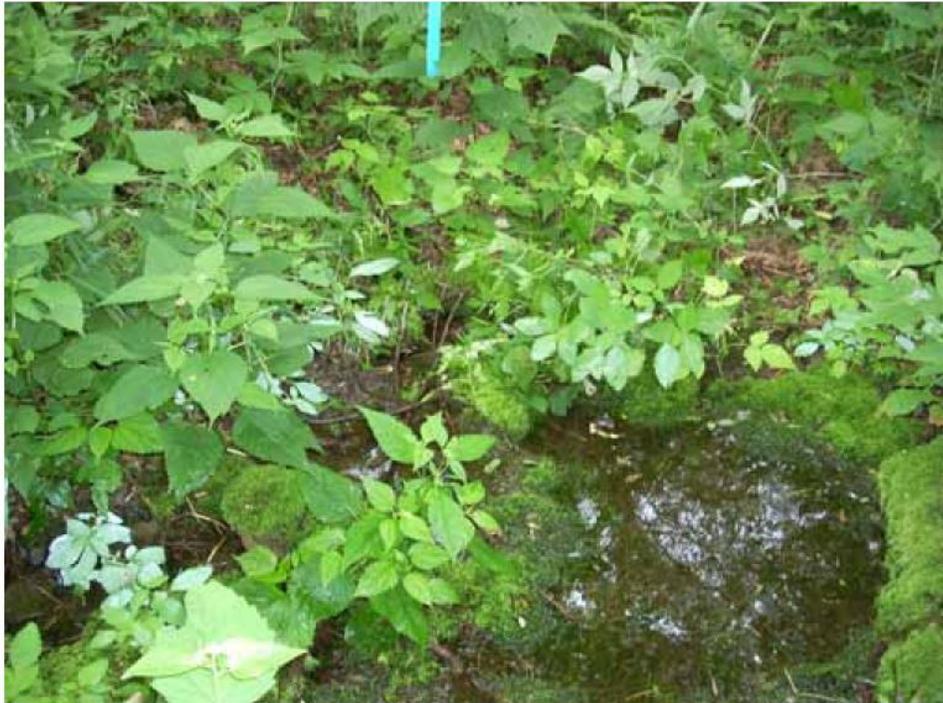
Photo 5: Looking south southwest at Wetland 7 (W7).

One of the 16 wetlands (Wetland W7) does not have any hydrological surface connection to any other jurisdictional waters of the United States and is isolated pursuant to *Solid Waste Agency of Northern Cook County (SWANCC) v. United States Army Corps of Engineers*¹. The wetlands identified were typical of wetlands found in northeastern New York. Many exhibited evidence of direct and indirect disturbance from both previous and present land uses. The following describes the specific attributes of the wetlands found throughout the study area corridor. A wetland delineation map (see Figure 4.3-1 [back pocket]) depicts the natural resources study area, the wetland boundaries, and the locations of all streams noted during the survey.

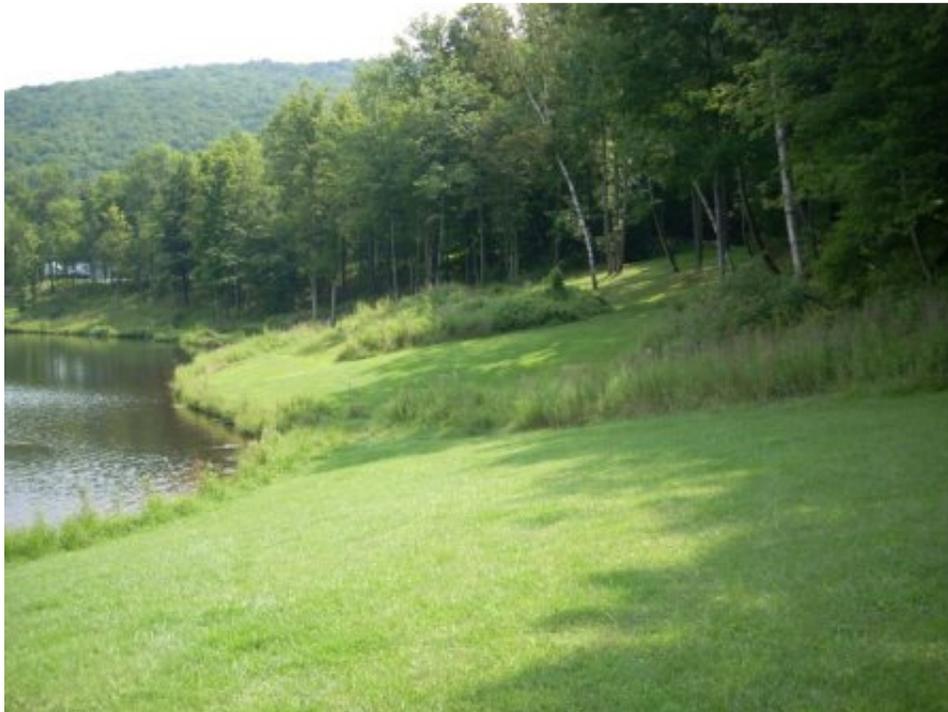
Photo 6: Looking east at an overview of Wetland 9 (W9) which is adjacent to Pine Hill Lake.

W9 is composed of an emergent wetland fringe and an aquatic vegetation bed abutting Pine Hill Lake to the southwest with both surface water and groundwater hydrology. It provides wildlife habitat as well as aesthetic and recreational functions. Drainage from the wetland flows into Pine Hill Lake. The dominant vegetation is fox sedge (*Carex vulpinoidea*), bottlebrush sedge (*Carex hystericina*), purple loosestrife (*Lythrum salicaria*), flat-top goldenrod (*Euthamia graminifolia*), sensitive fern (*Onoclea sensibilis*), soft rush (*Juncus effusus*), spotted joe-pye-weed (*Eupatorium maculatum*), common cinquefoil (*Potentilla simplex*), and purpleleaf willowherb (*Epilobium coloratum*).

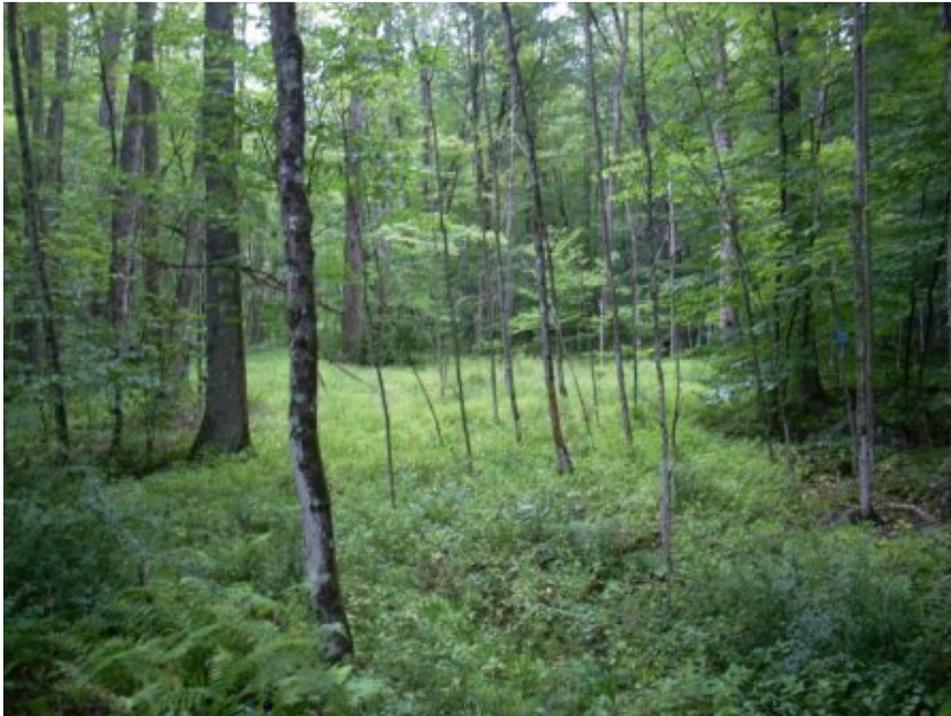
Photo 7: Looking northwest at Wetland 10 (W10).

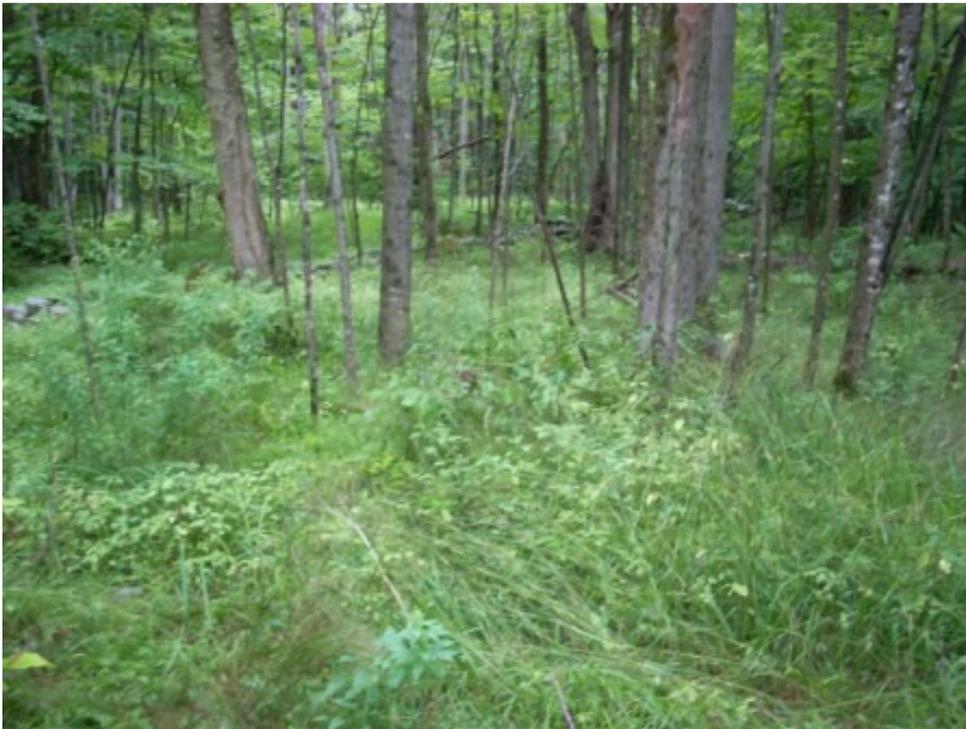
Photo 8: Looking southwest at Wetland 12 (W12).

Red maple hardwood swamp is a community consisting of a variant hardwood swamp occurring in poorly drained depressions on inorganic soils. This type of swamp was generally found at the base of ski and hillside slopes in the natural resources study area. Many of these swamps were closely associated with groundwater recharge/discharge functions, runoff retention, or adjacent to watercourses. The canopy is usually dominated by red maple or can be mixed with other hardwoods such as American elm, trembling aspen, and green ash (*Fraxinus pennsylvanica*). The shrub layer, which can be dense at times, includes winterberry, arrowwood (*Viburnum recognitum*), dogwoods (*Cornus* spp.), willows (*Salix* spp.), spice bush (*Lindera benzoin*), and canopy tree saplings. The groundcover, in some instances, is highly productive and consists of ferns, sedges, mosses, bugleweed, and spotted touch-me-not. An example of a typical red maple hardwood swamp in the natural resources study area is W12, located in a depression along State Highway 28.

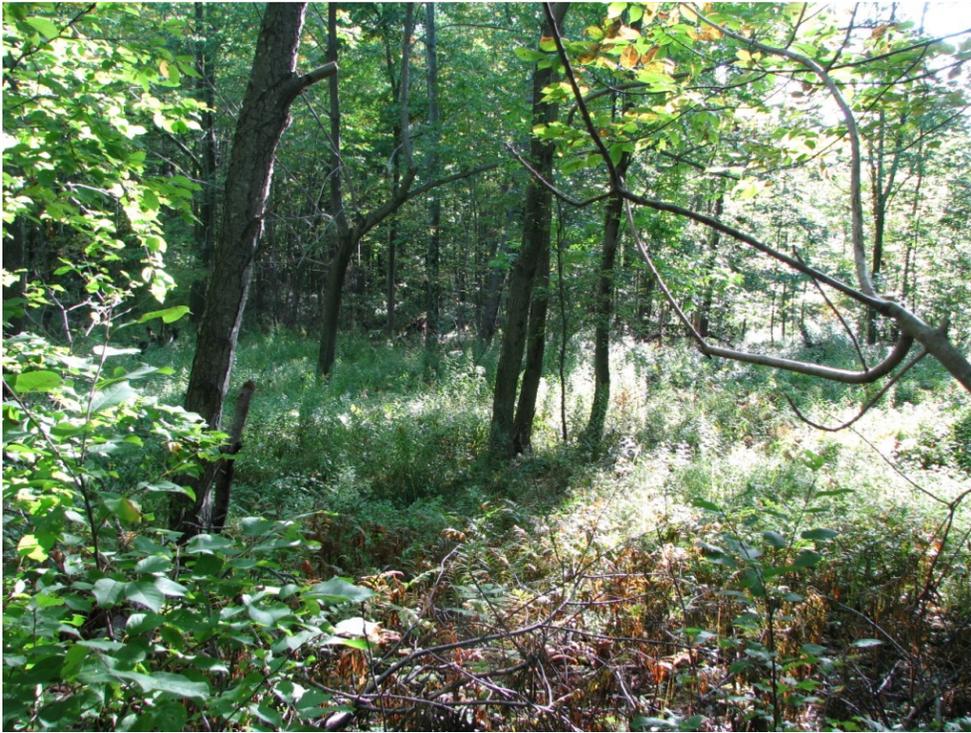
Photo 9: Looking northeast at Wetland 13 (W13)
