Hillcrest Industries Update: 9/19/12

What is Hillcrest Industries? The Hillcrest Industries facility located on Favor Street in Attica processes glass fragments (cullet) into reflective road striping beads and abrasive blast media. The facility also collects boiler slag material (hardened residue collected from off-site coal boilers) and processes it into abrasive blast media (sandblasting materials).

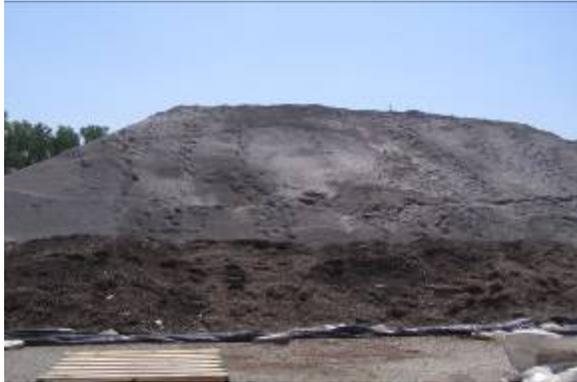
North side of glass pile with two applications of Posi-Shell (shot-crete like material)

What is Hillcrest doing to address community concerns? To reduce particulate emissions (dust) Hillcrest has repaired leaking process equipment, sealed off broken bag filters, ordered replacement filters, applied a dust suppressant to the facility's roadways, washes truck tires before they exit the facility, and covered some of the piles comprised of fine material with Posi-shell. Hillcrest continues to remove the piles of plastic and paper that have been separated from the glass fragments from the property. Hillcrest implemented several measures in an attempt to reduce odors and to decrease the temperature in the interior of the pile. These measures included an air withdrawal and treatment system (not currently in use), a nitrogen/carbon dioxide injection system, and application of an impermeable Posi-shell cover system. Nine injection wells were installed in the pile and nitrogen/carbon dioxide was injected in an attempt to remove oxygen from the pile and reduce the temperatures in the pile. The temperature of the pile at each injection point is being monitored. Following installation of the Posi-shell cover system on

August 31, 2012, injections of nitrogen and later carbon dioxide resumed. Despite these efforts, the temperatures have remained high in two locations and the pile continues to smolder. In one location, the temperature was as high as 750 degrees F but has been as low as 650 degrees F. A second location is in the 500 – 550 degree range. The remaining 6 locations are in the 150 – 225 degree range. Based on the temperatures recorded in the glass, paper and plastic pile and the visual evidence of smoke leaving the pile, we believe that the pile is smoldering as the paper and plastic in the pile are consumed. Hillcrest representatives are currently checking with companies that deal with fire suppression/elimination and are reviewing proposals for implementation in the near future.

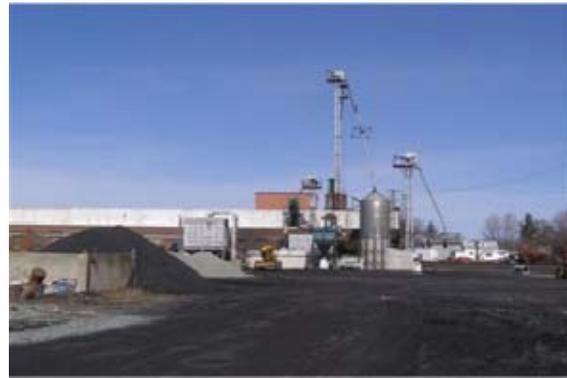
Air pollution control equipment, material conveying and storage equipment for the crushing and screening of slag and colored glass.

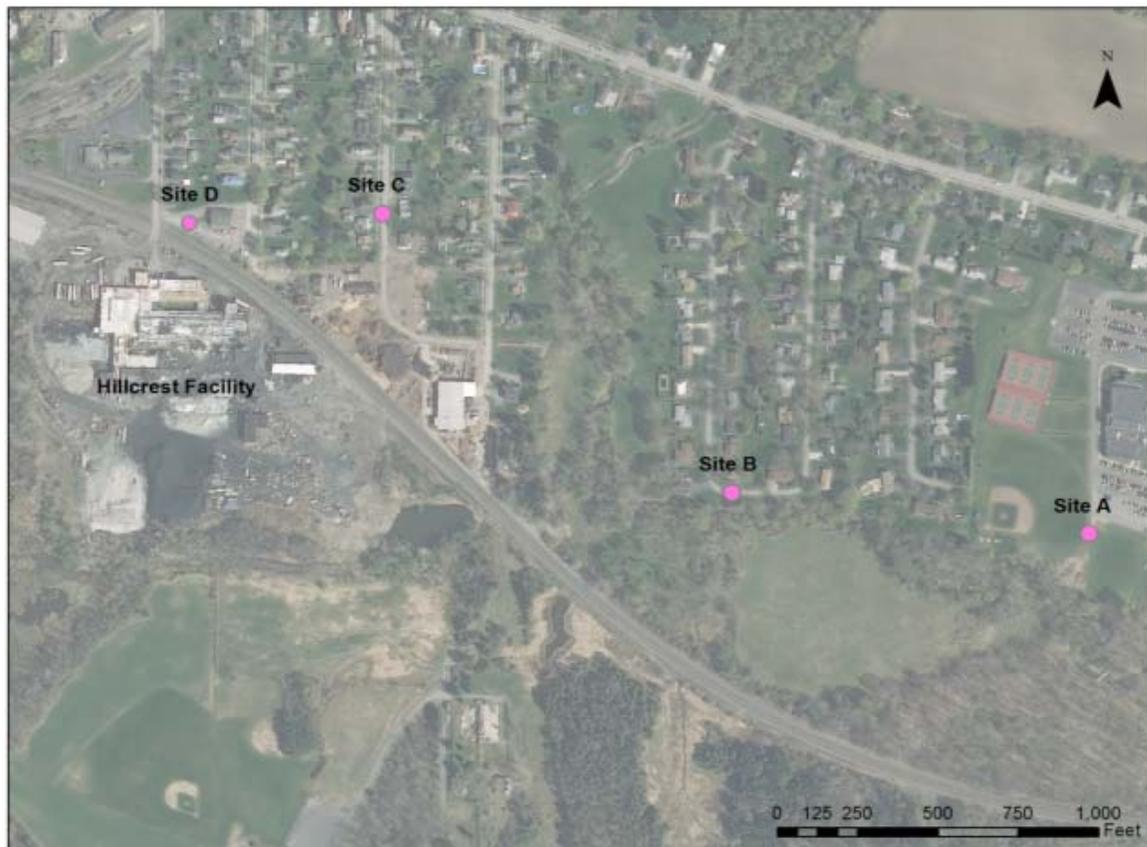
Air Sampling Locations

DEC collected four one-hour ambient air samples on August 8, 2012 between 12:00 p.m. and 3:00 p.m. in response to community concerns about odors and exposure to volatile air contaminants from the Hillcrest facility. See **Air Sampling Locations** on page 5 for an aerial map of the sampling locations.

Three samples were collected in the odor plume in the neighborhood downwind from the Hillcrest facility, one of which was at the facility property line. A fourth sample was collected at the Attica High School between the gas well and baseball diamond, approximately 20 yards south of the parking lot. DEC's laboratory analyzed all air samples and provided the results for 41 volatile organic compounds (VOCs). These results were compared to DEC's Short-term Guideline Concentrations (SGCs) since the sample collection was a short period of time. SGC's are used by DEC to ensure that short-term exposures do not cause any significant health effects.

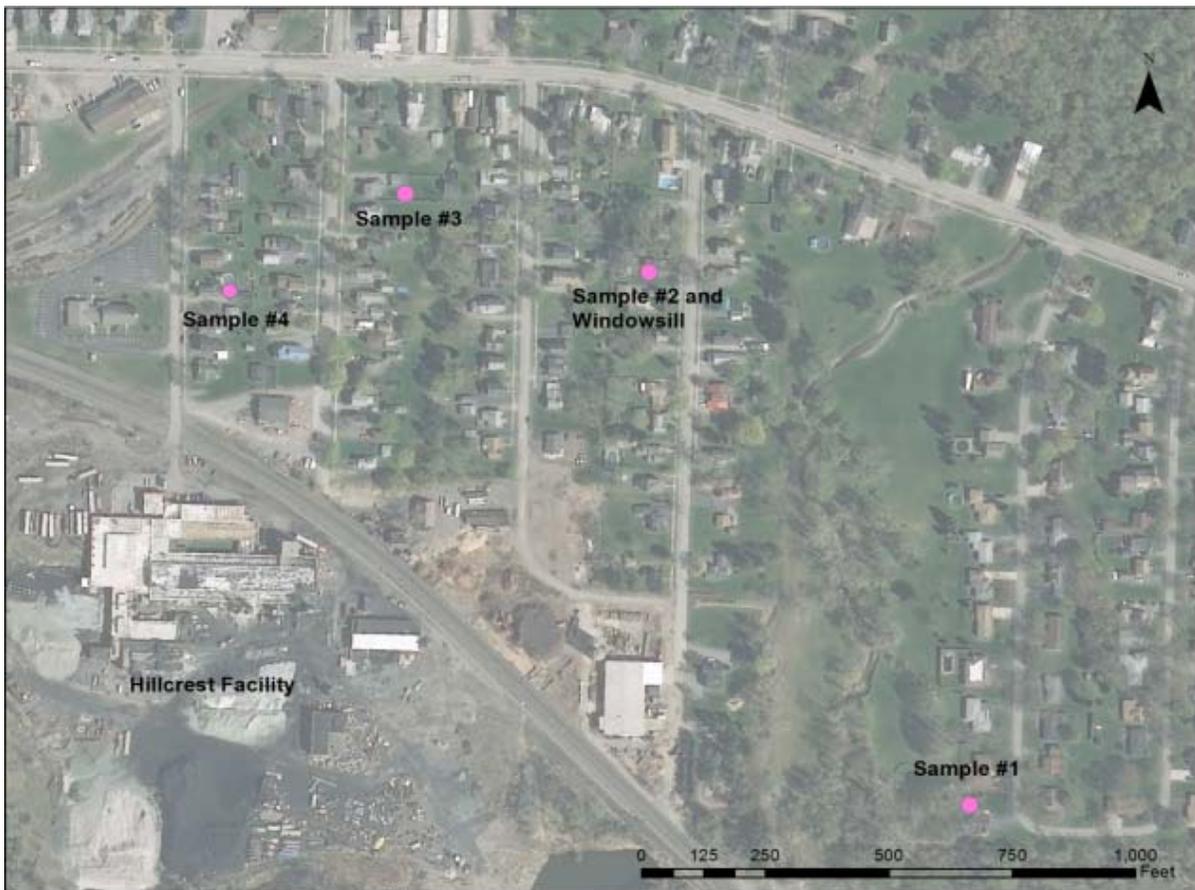
Dust Sampling Locations

DEC collected five dust samples from four residential properties in response to resident's concerns about health risks from exposure to dust releases from the facility. Dust samples were collected July 10-17, 2012. See **Dust Sampling Locations** on page 6 for an aerial map of the sampling locations. Eleven samples were collected on site of the facility at specific release points and from raw material and finished product. Matching the types of particles found on the residential properties with the types found onsite of the facility could provide DEC staff with an understanding of which release points need to be better controlled. The samples were submitted to DEC's Microscopy Lab for analysis. The lab determined the composition of the residential dust samples and the size of the particles to evaluate whether the dust could be from operations at the Hillcrest facility.
