Hillcrest Industries Update: 11/1/12

Summary of Work

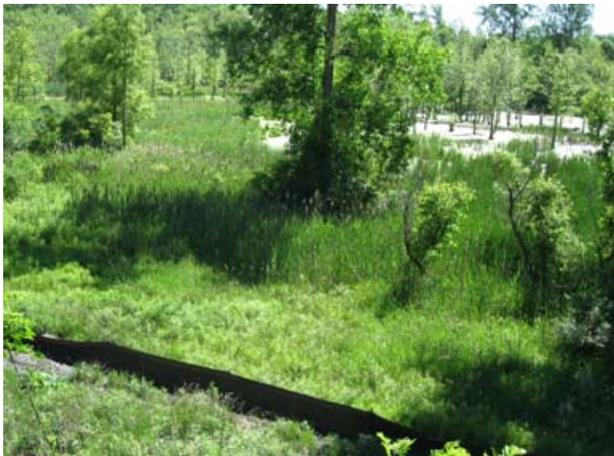
Freshwater Wetland AT-6 as viewed from west edge of recyclable pile, facing south.

- Hillcrest subsequently installed silt fence along the west and south edges of the recyclable pile which kept material from entering the wetland.
- Hillcrest will remove the material from the adjacent area and will undertake other measures to revegetate the adjacent area and mark the boundary of the adjacent area to prevent future encroachment.

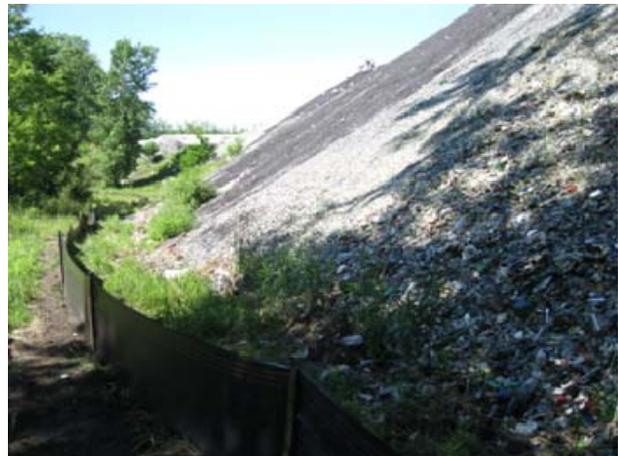
Silt fence installed between recyclable pile and Freshwater Wetland AT-6, facing north.
