**2012 ANNUAL OPERATION, MAINTENANCE AND
MONITORING REPORT**

**LCP BRIDGE STREET SITE (OU-1)
Solvay, New York**

NOVEMBER 2013

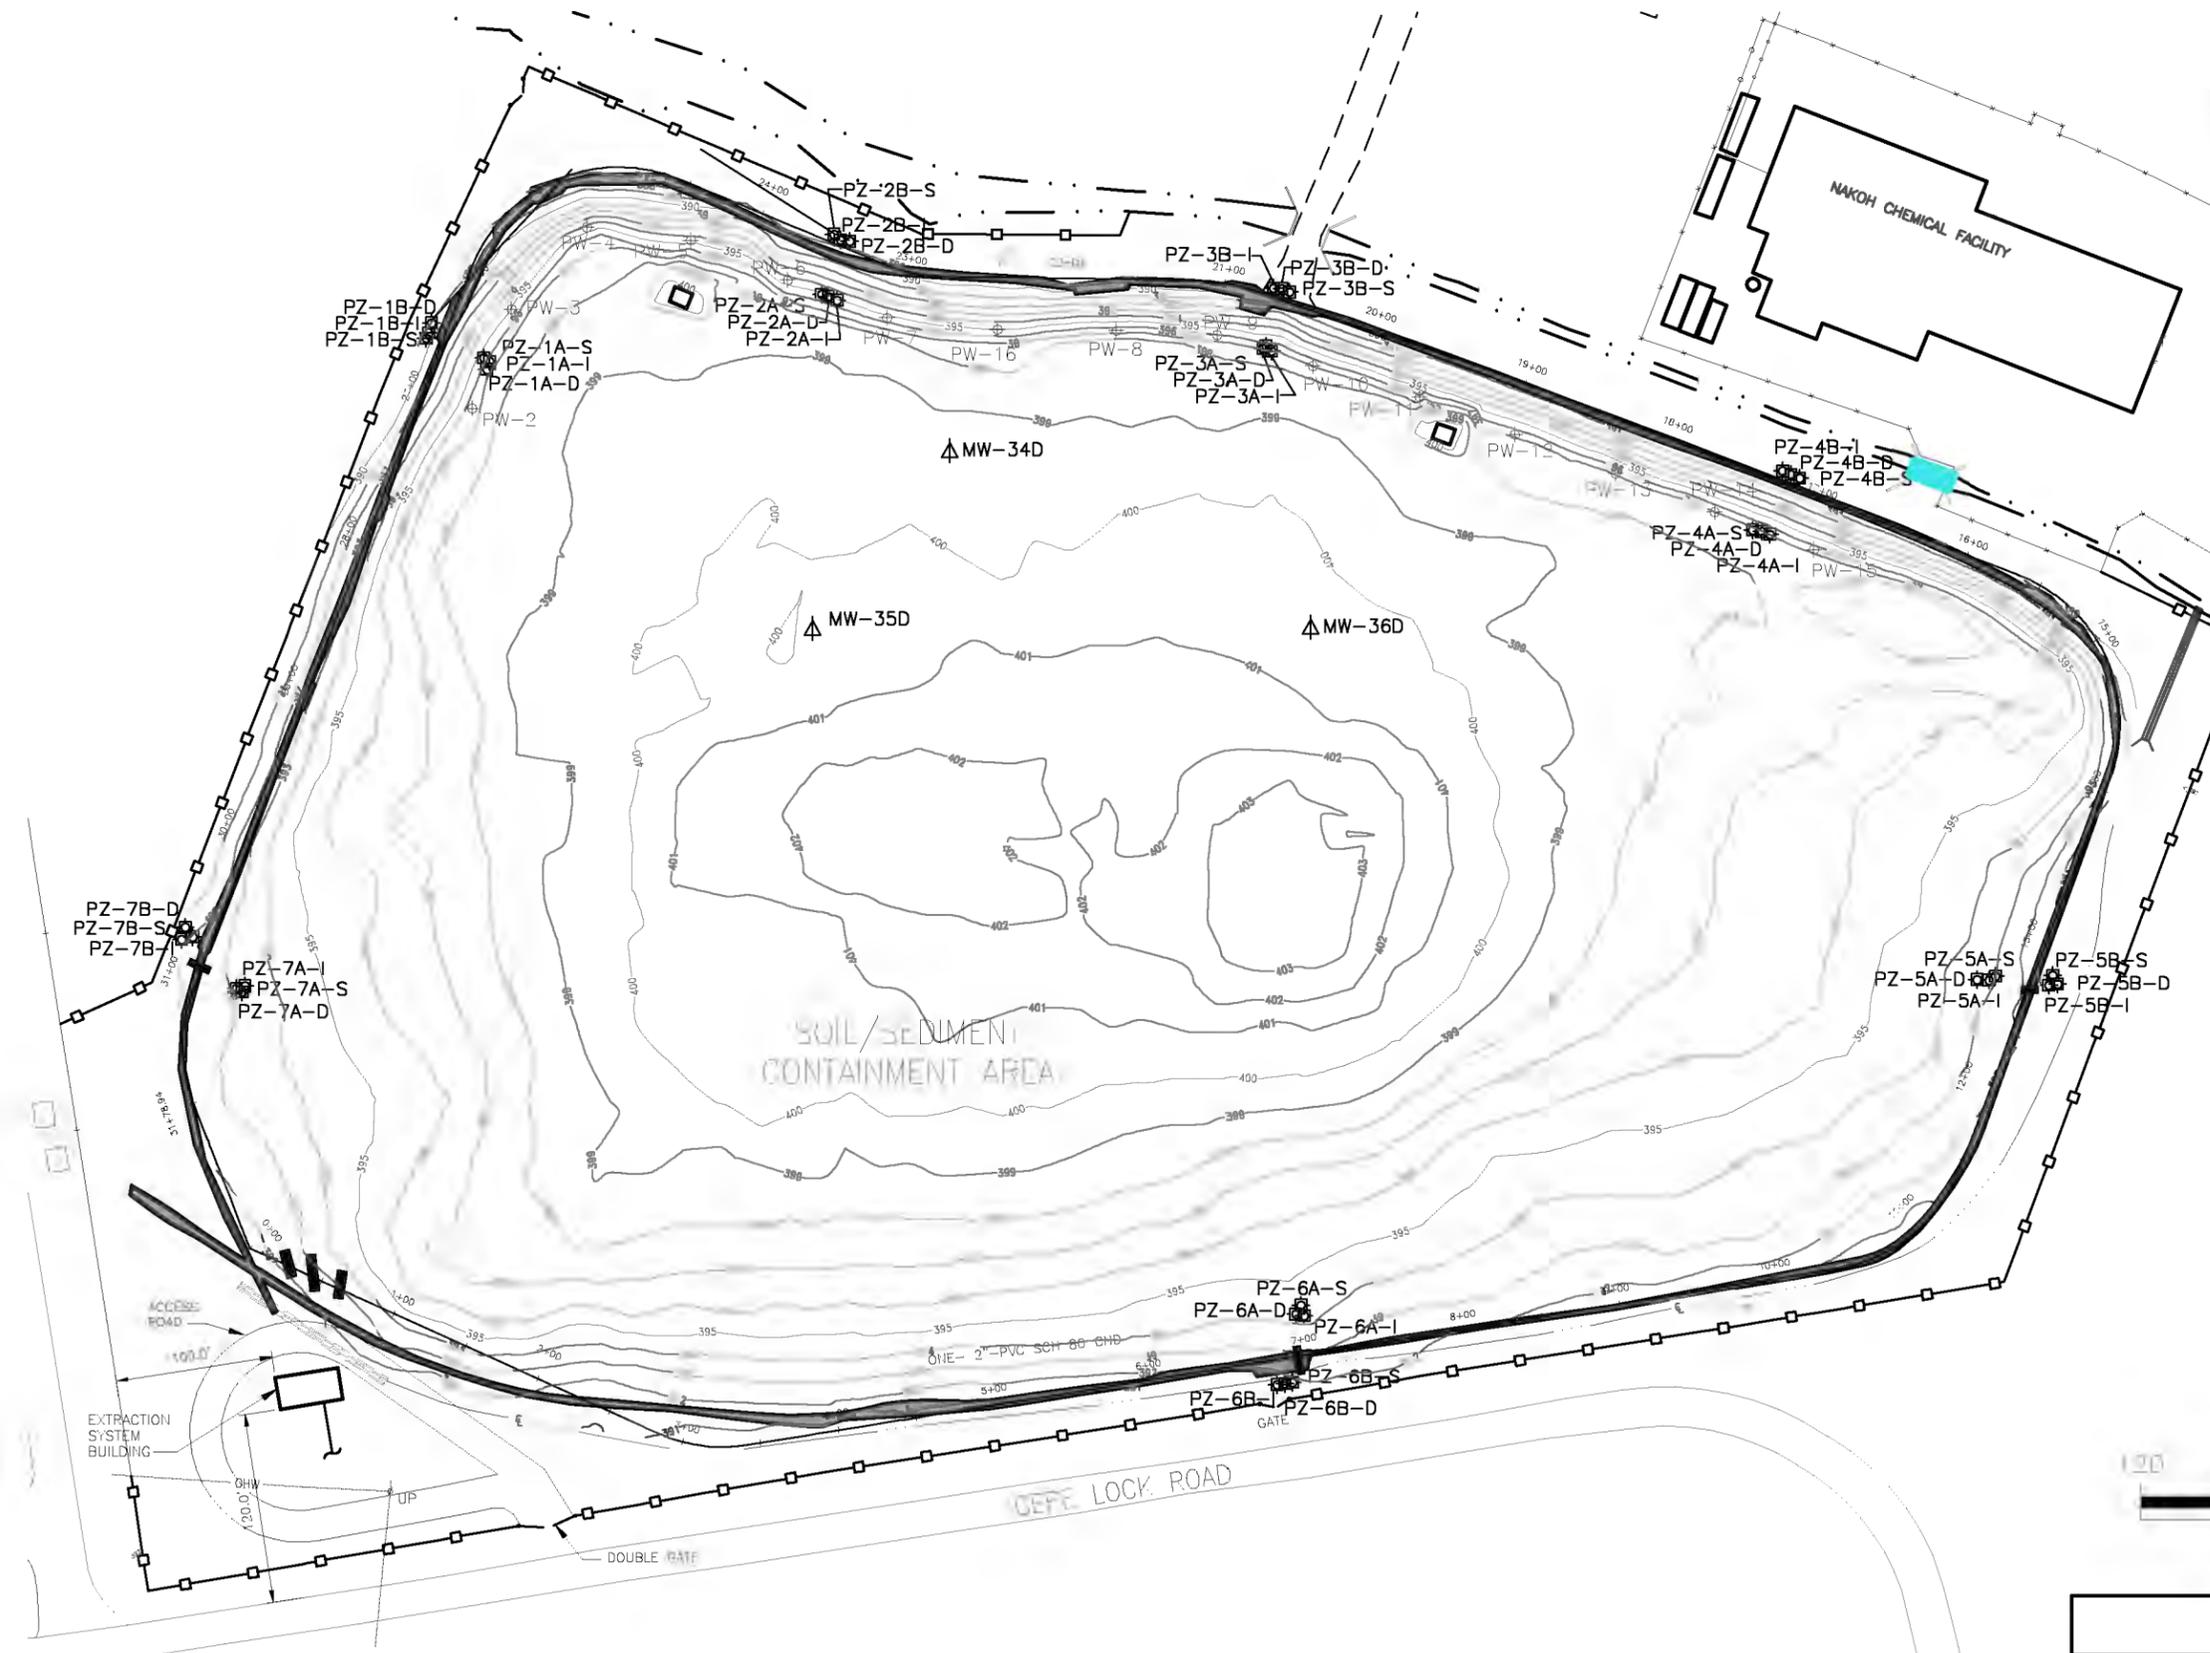
FIGURE 1

GROUNDWATER MONITORING WELL LOCATIONS

PIEZOMETER/MONITORING
WELL LOCATIONS

Groundwater extracted by the 15 pumping wells within the soil/sediment containment area was pumped to two 10,000-gallon tanks in the on-site extraction building (Figure 1). On January 21, 2010, the LCP pre-treatment system began operation. The pre-treatment system consists of a filter feed pump, two 5-micron bag filters, two fiberglass-reinforced plastic granular activated carbon vessels and a flow meter. The design pumping rate is approximately 5 to 25 gpm. Pre-treated groundwater is discharged to the Onondaga County West Side Trunk Sewer from which it flows to the Onondaga County Metropolitan Wastewater Treatment Facility (METRO). In 2012, approximately 1,190,381 gallons were pre-treated on-site and sent to METRO.

Containment of impacted sediments in the soil/sediment containment area is monitored both hydraulically and analytically using the piezometer and monitoring well network shown in Figure 1. The piezometer monitoring system will be updated during final closure of the landfill.

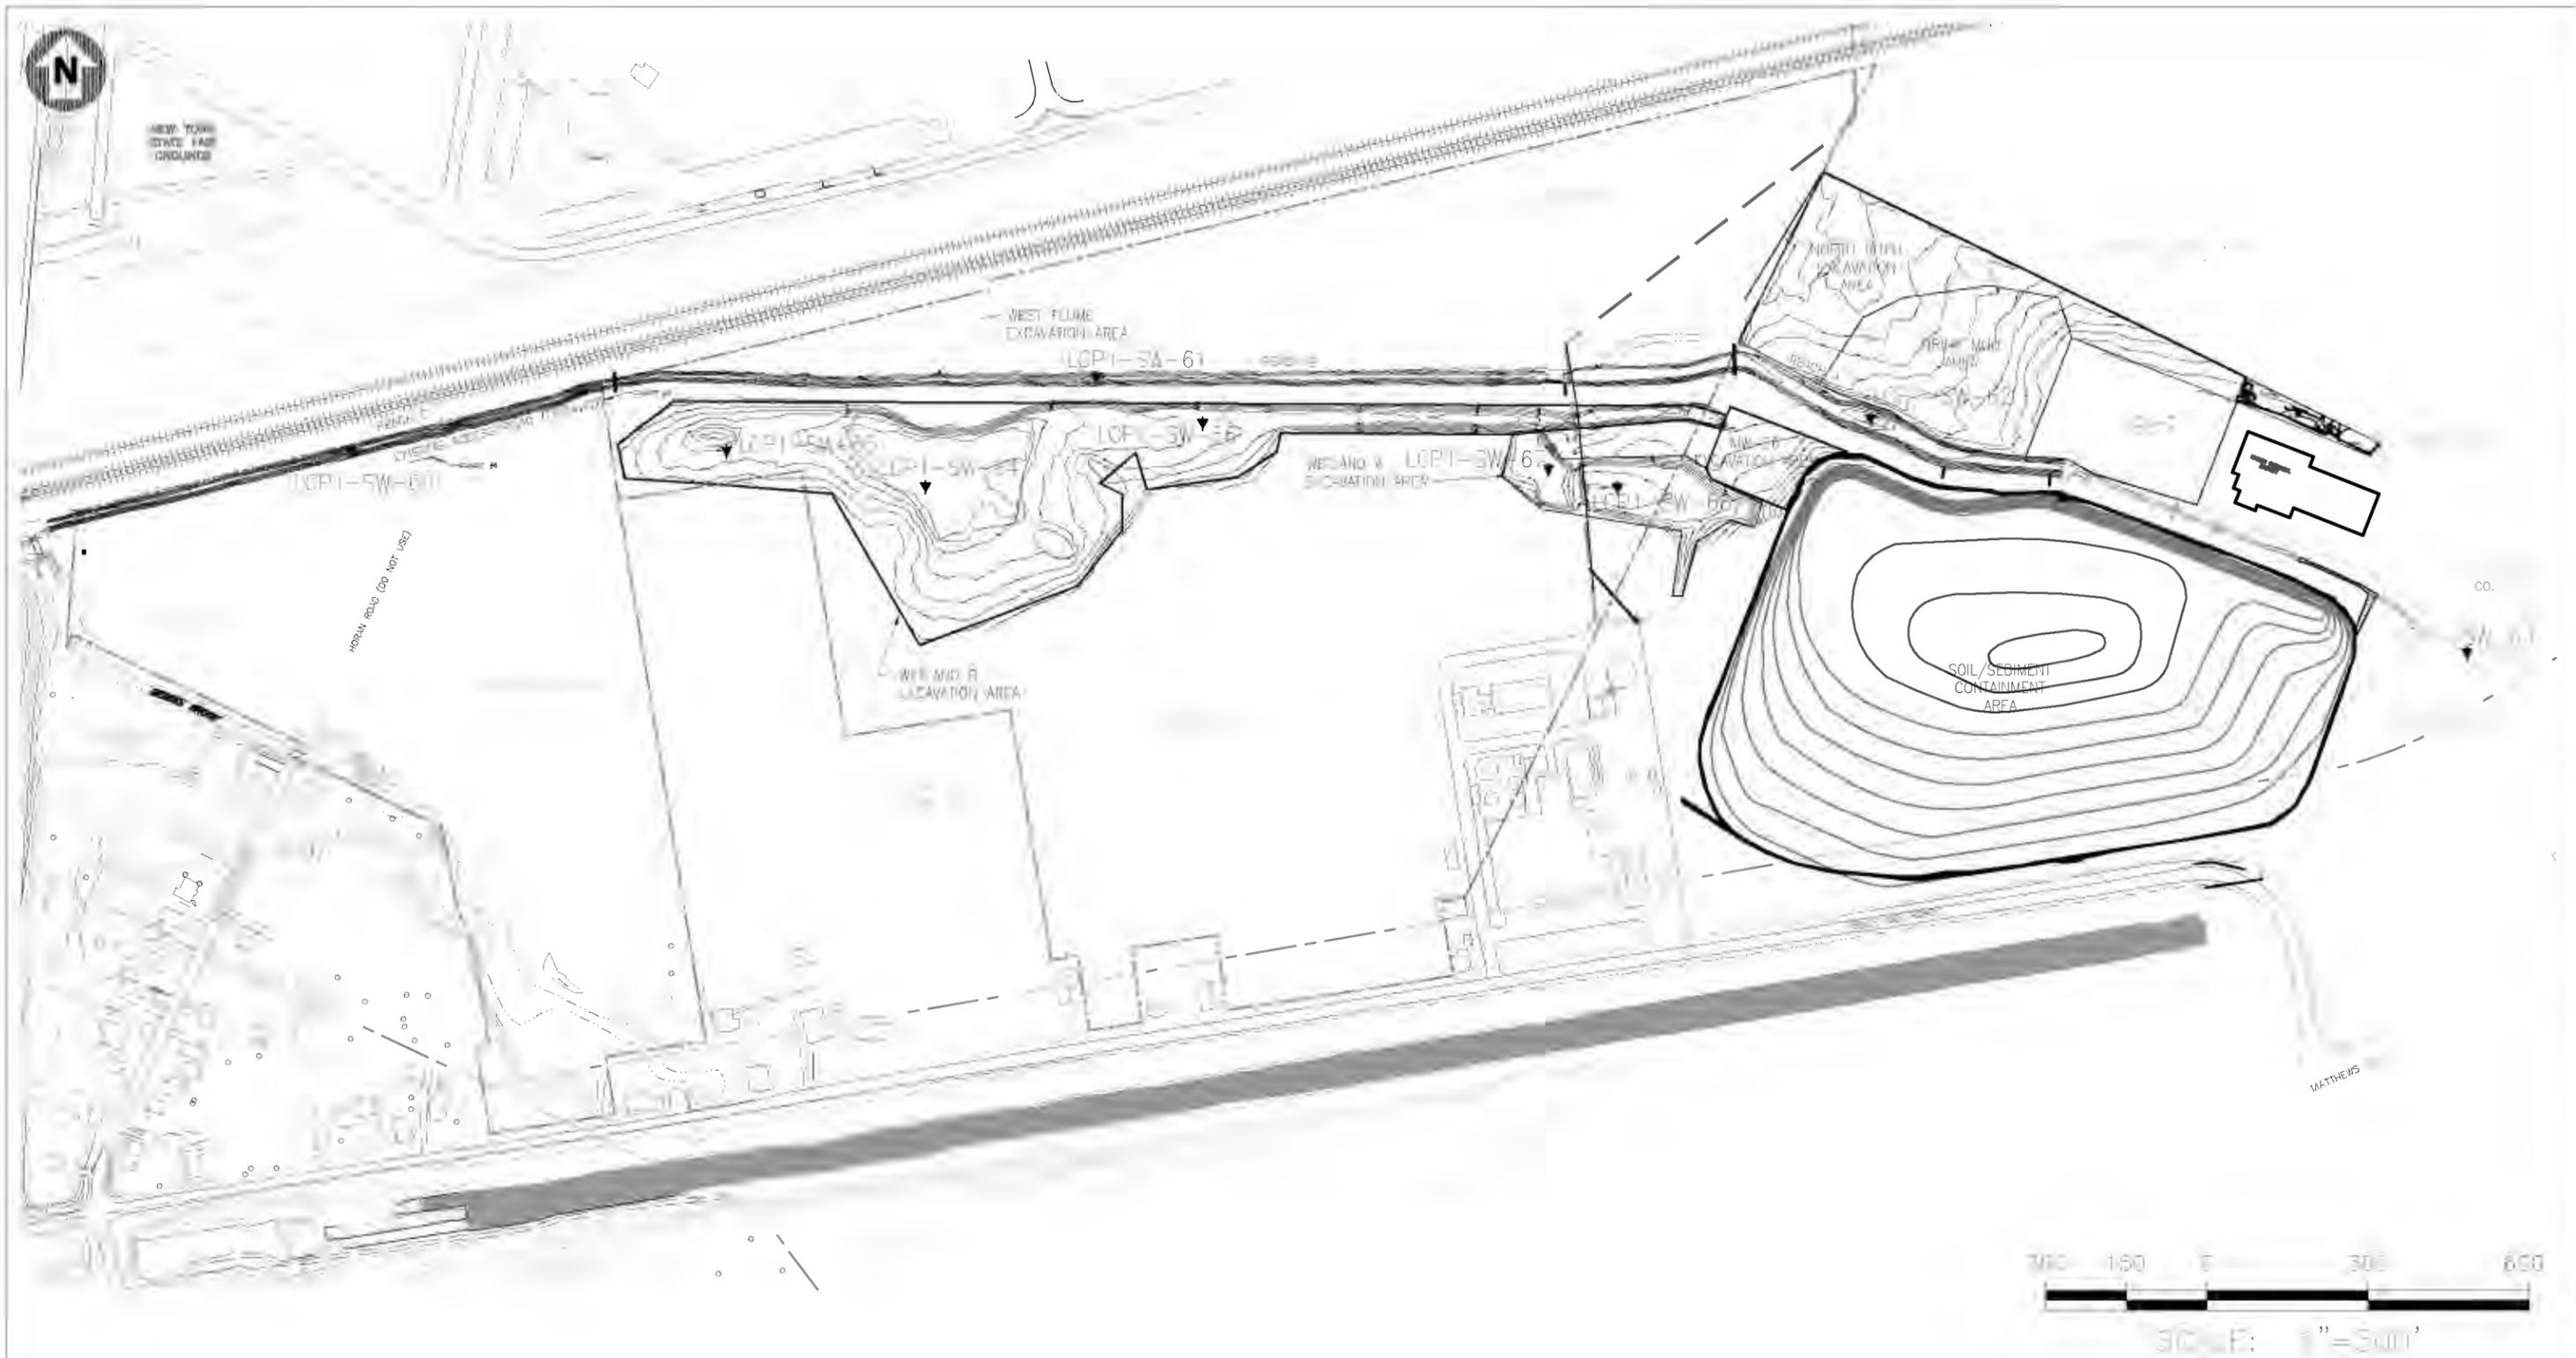
FIGURE 2

ANNUAL SURFACE WATER/SEDIMENT
SAMPLING LOCATION

The OM&M Plan established nine monitoring locations (Figure 2) in the West Flume and Wetland A/B complex that are sampled for total mercury, methylmercury, and dissolved mercury annually (Parsons 2009a). In 2012, the data range for total mercury was 3.1 nanograms per liter

The OM&M Plan also established nine sediment monitoring locations at the same points as surface water that are sampled for total and methyl mercury annually. The total mercury data ranges were 0.36 mg/kg to 0.45 mg/kg for the West Flume (excluding the upstream sample location (LCP1-SW-63)), 0.29 to 1.0 mg/kg for Wetland A and 0.04 mg/kg to 0.13 mg/kg for Wetland B. Individual sample results are provided in Table 6 of this report.

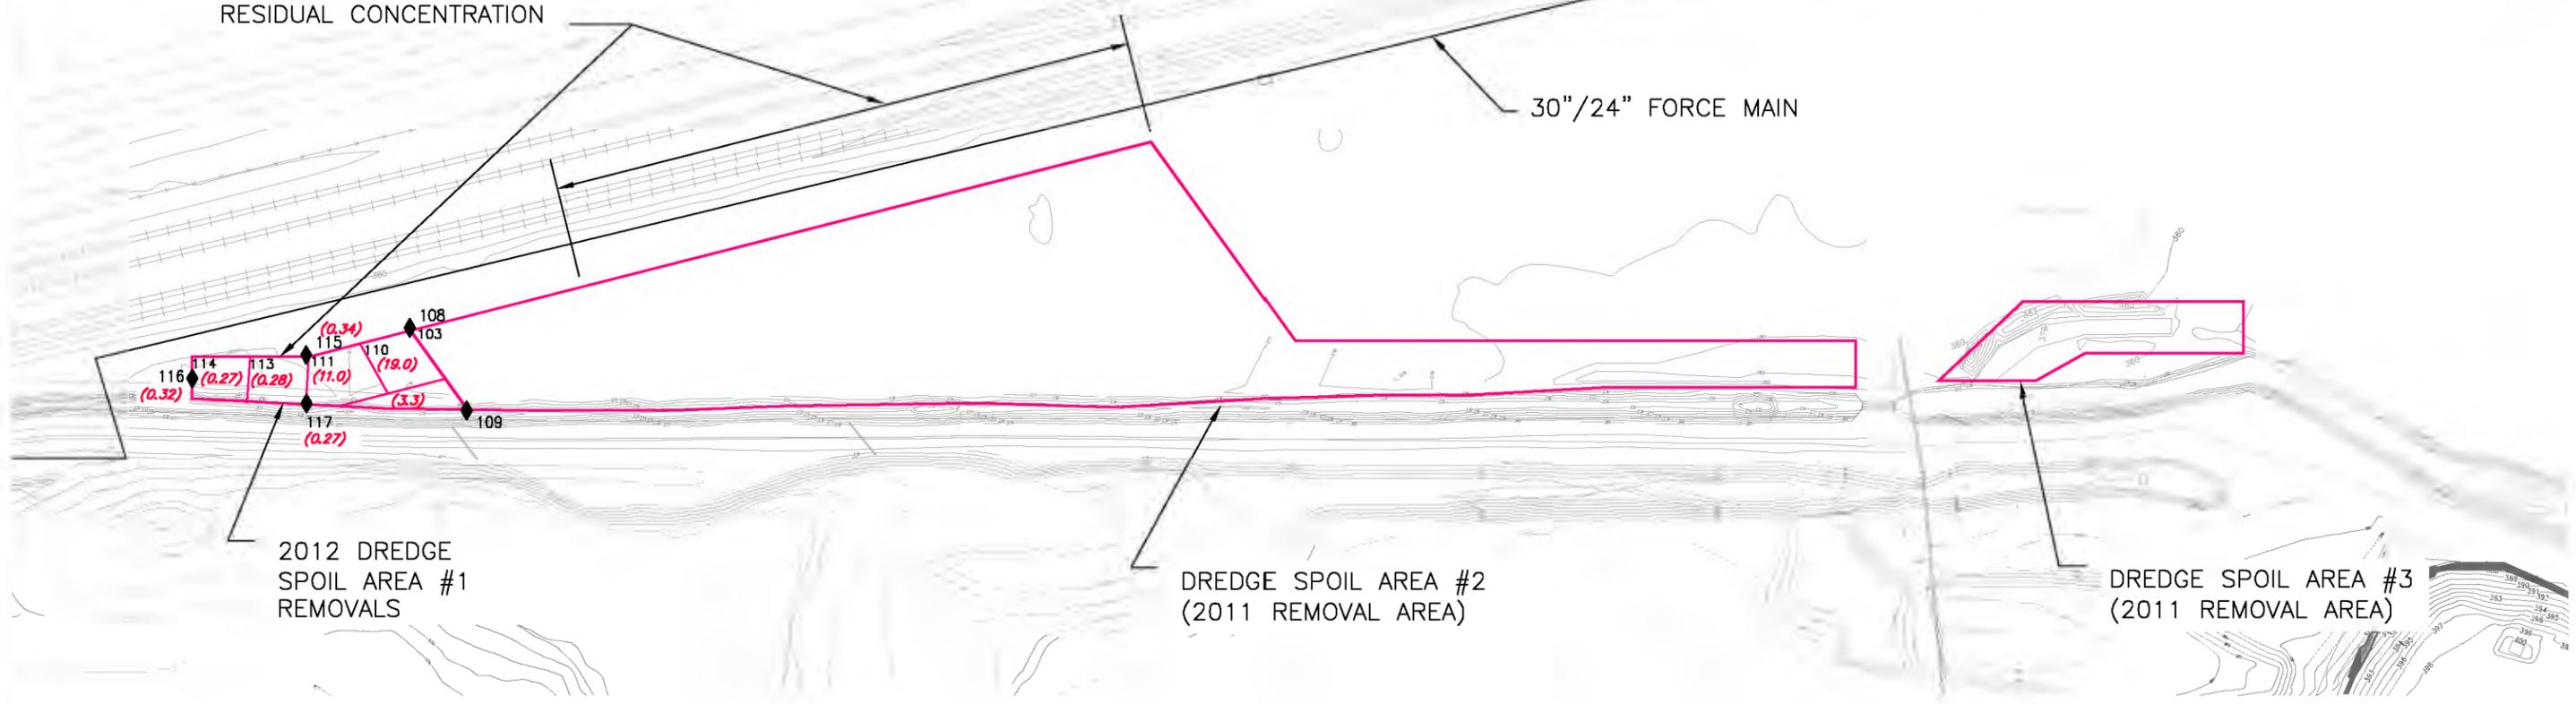
LOW PERMEABILITY MATERIAL WAS
INSTALLED IN EXCAVATION BOTTOM
AND SIDEWALLS TO ISOLATE
RESIDUAL CONCENTRATION

2012 DREDGE
SPOIL AREA #1
REMOVALS

DREDGE SPOIL AREA #2
(2011 REMOVAL AREA)

2012 DREDGE SPOILS AREA
SAMPLE RESULTS AND
EXCAVATION PLAN

As noted in the 2011 Annual Operations, Maintenance, and Monitoring Report (Parsons, 2012), several issues during excavation of the Dredge Spoil Area north of the West Flume resulted in expansion of the remedial activities. The original scope of work called for the removal of approximately 12,000 to 12,500 cubic yards (cy) of material from this area. Previous sampling in the area that was used to delineate remedial areas indicated a clay layer at approximately 2 ft. in depth. During remedial construction, it became evident, based upon confirmatory sampling that this was a reworked layer intermingled with mercury-impacted material. Excavation depths increased to remove this impacted material and prevent recontamination of the remediated areas. Excavation depths continued through the reworked material into a native silty clay layer. In addition, areal limits of excavation were expanded in some areas based upon confirmatory sampling results.

The removal of the additional volume resulted in a corresponding increase in the 2011 schedule causing operations to continue into winter weather conditions. Removal efforts were stopped in early January 2012 due to the inability to continue to treat construction water at the Geddes Brook construction water treatment plant and to continue to receive stabilizing cement from our vendor. As a result, approximately 2,000 cy of material from the western portion of the Dredge Spoils Area (Dredge Spoils Area#1) was left in place for removal in the 2012 construction season. Overall, approximately 33,400 cy were removed during 2011 and 2012 (5,900 cy from the East Ditch; 2,800 cy from the West Ditch; 700 cy from Wetland A; and 24,000 cy from the Dredge Spoils Area (Wetland C)). In addition, restoration activities in Dredge Spoils Area #1 and # 2 were also delayed until 2012.

During excavations completed in the area at the end of 2011, it was also observed that in areas along the western limits of the excavation, the silty clay layer dropped significantly in elevation as it was excavated. Based upon the presence of abandoned utilities, it was believed that this is the result of historic excavation in this area for the installation of these utilities. Excavation to the native silty clay layer in this area would have potentially undermined and damaged the existing sewer force main and railroad tracks located to the north of the excavation area. Impacted material in this area was removed to a depth of 4 ft. and remaining concentrations were mitigated by installing a low-permeability material along the excavation bottom and sidewalls as shown on Figure 4. The installation of the low permeability material over impacted materials will isolate the impacted materials and mitigate any potential for recontamination into the restored wetland.

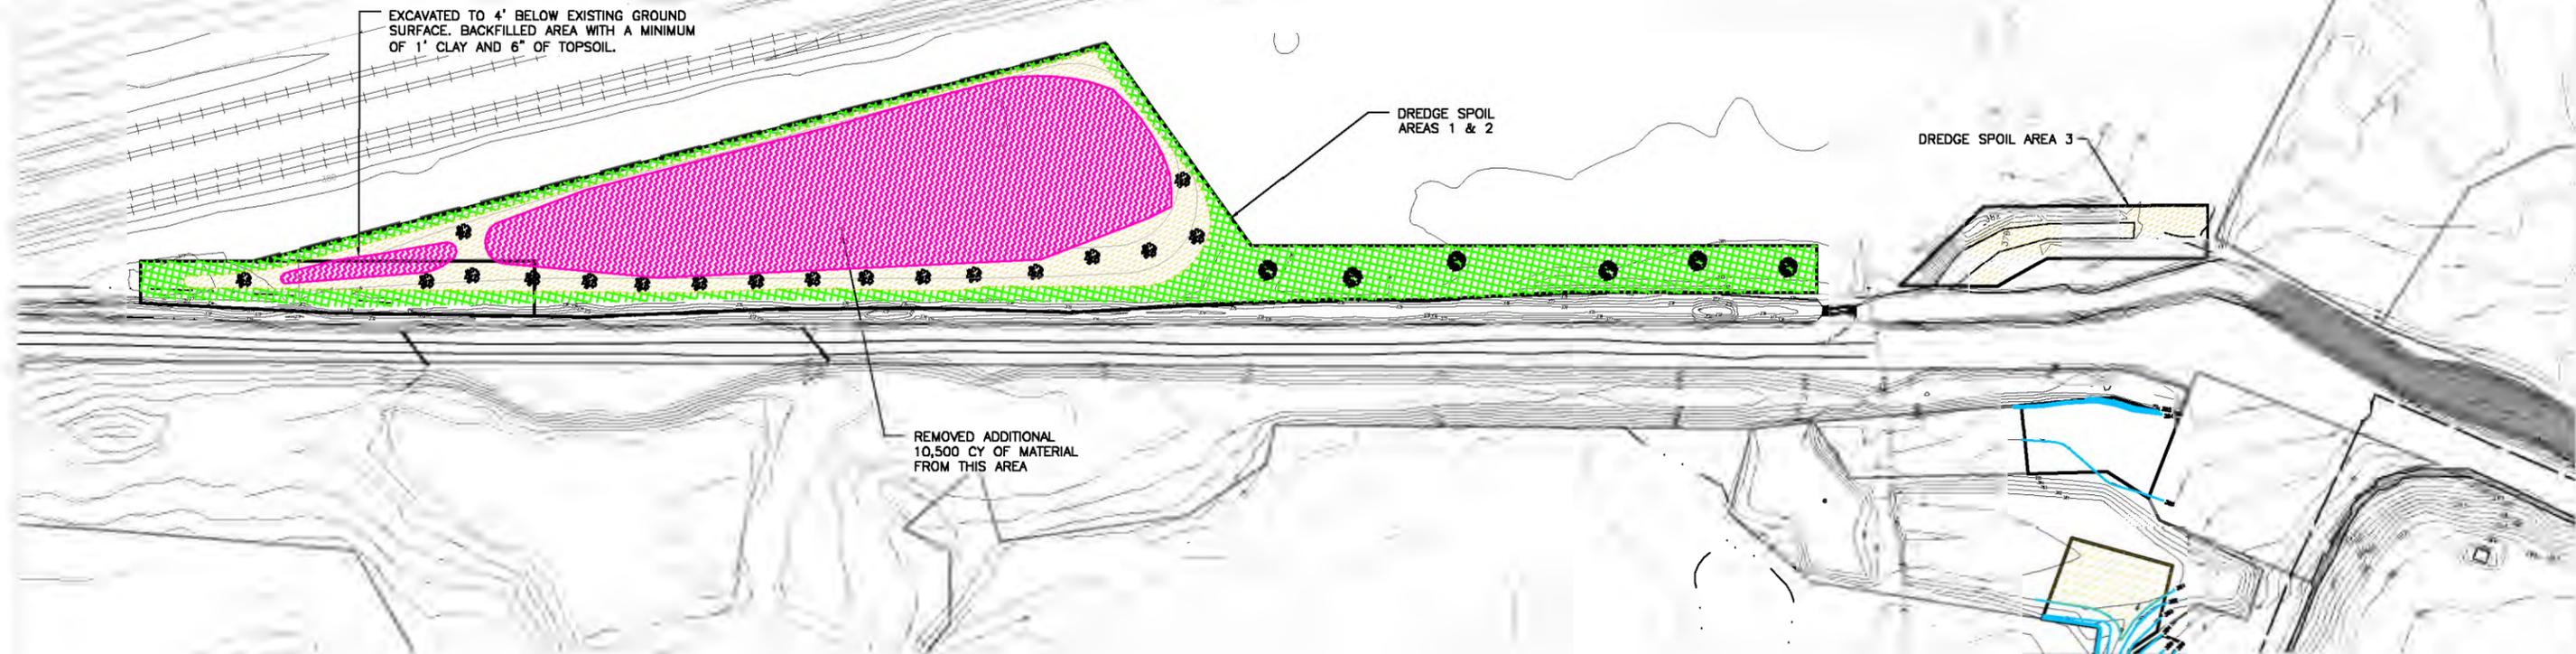
1. PROJECTED WATER ELEVATIONS IN DREDGE SPOILS AREA IS 376.
2. CONSTRUCTED LOW BERM ACROSS THE MOUTH OF DREDGE SPOILS AREA 3, USING UNCLASSIFIED FILL AND TOPSOIL. INSTALLED PERMANENT EROSION CONTROL FABRIC (SI LANDLOK C2 OR EQUAL) OVER BERM TO A MINIMUM OF 10' PASS THE TOE OF SLOPE ON EITHER SIDE OF BERM.
3. GRADES SHOWN ARE FINAL GRADES AFTER APPLICATION OF 6 INCHES OF TOPSOIL.
4. DREDGE SPOILS AREAS WERE BE RESTORED TO A MAXIMUM SLOPE OF 3 HORIZONTAL TO 1 VERTICAL (3:1).
5. VEGETATION PLANTINGS ARE SPECIFIED IN THE RESTORATION SECTION OF THE WORK PLAN.
6. TOPSOIL DETAILS ARE SPECIFIED IN THE RESTORATION SECTION OF THE WORK PLAN.

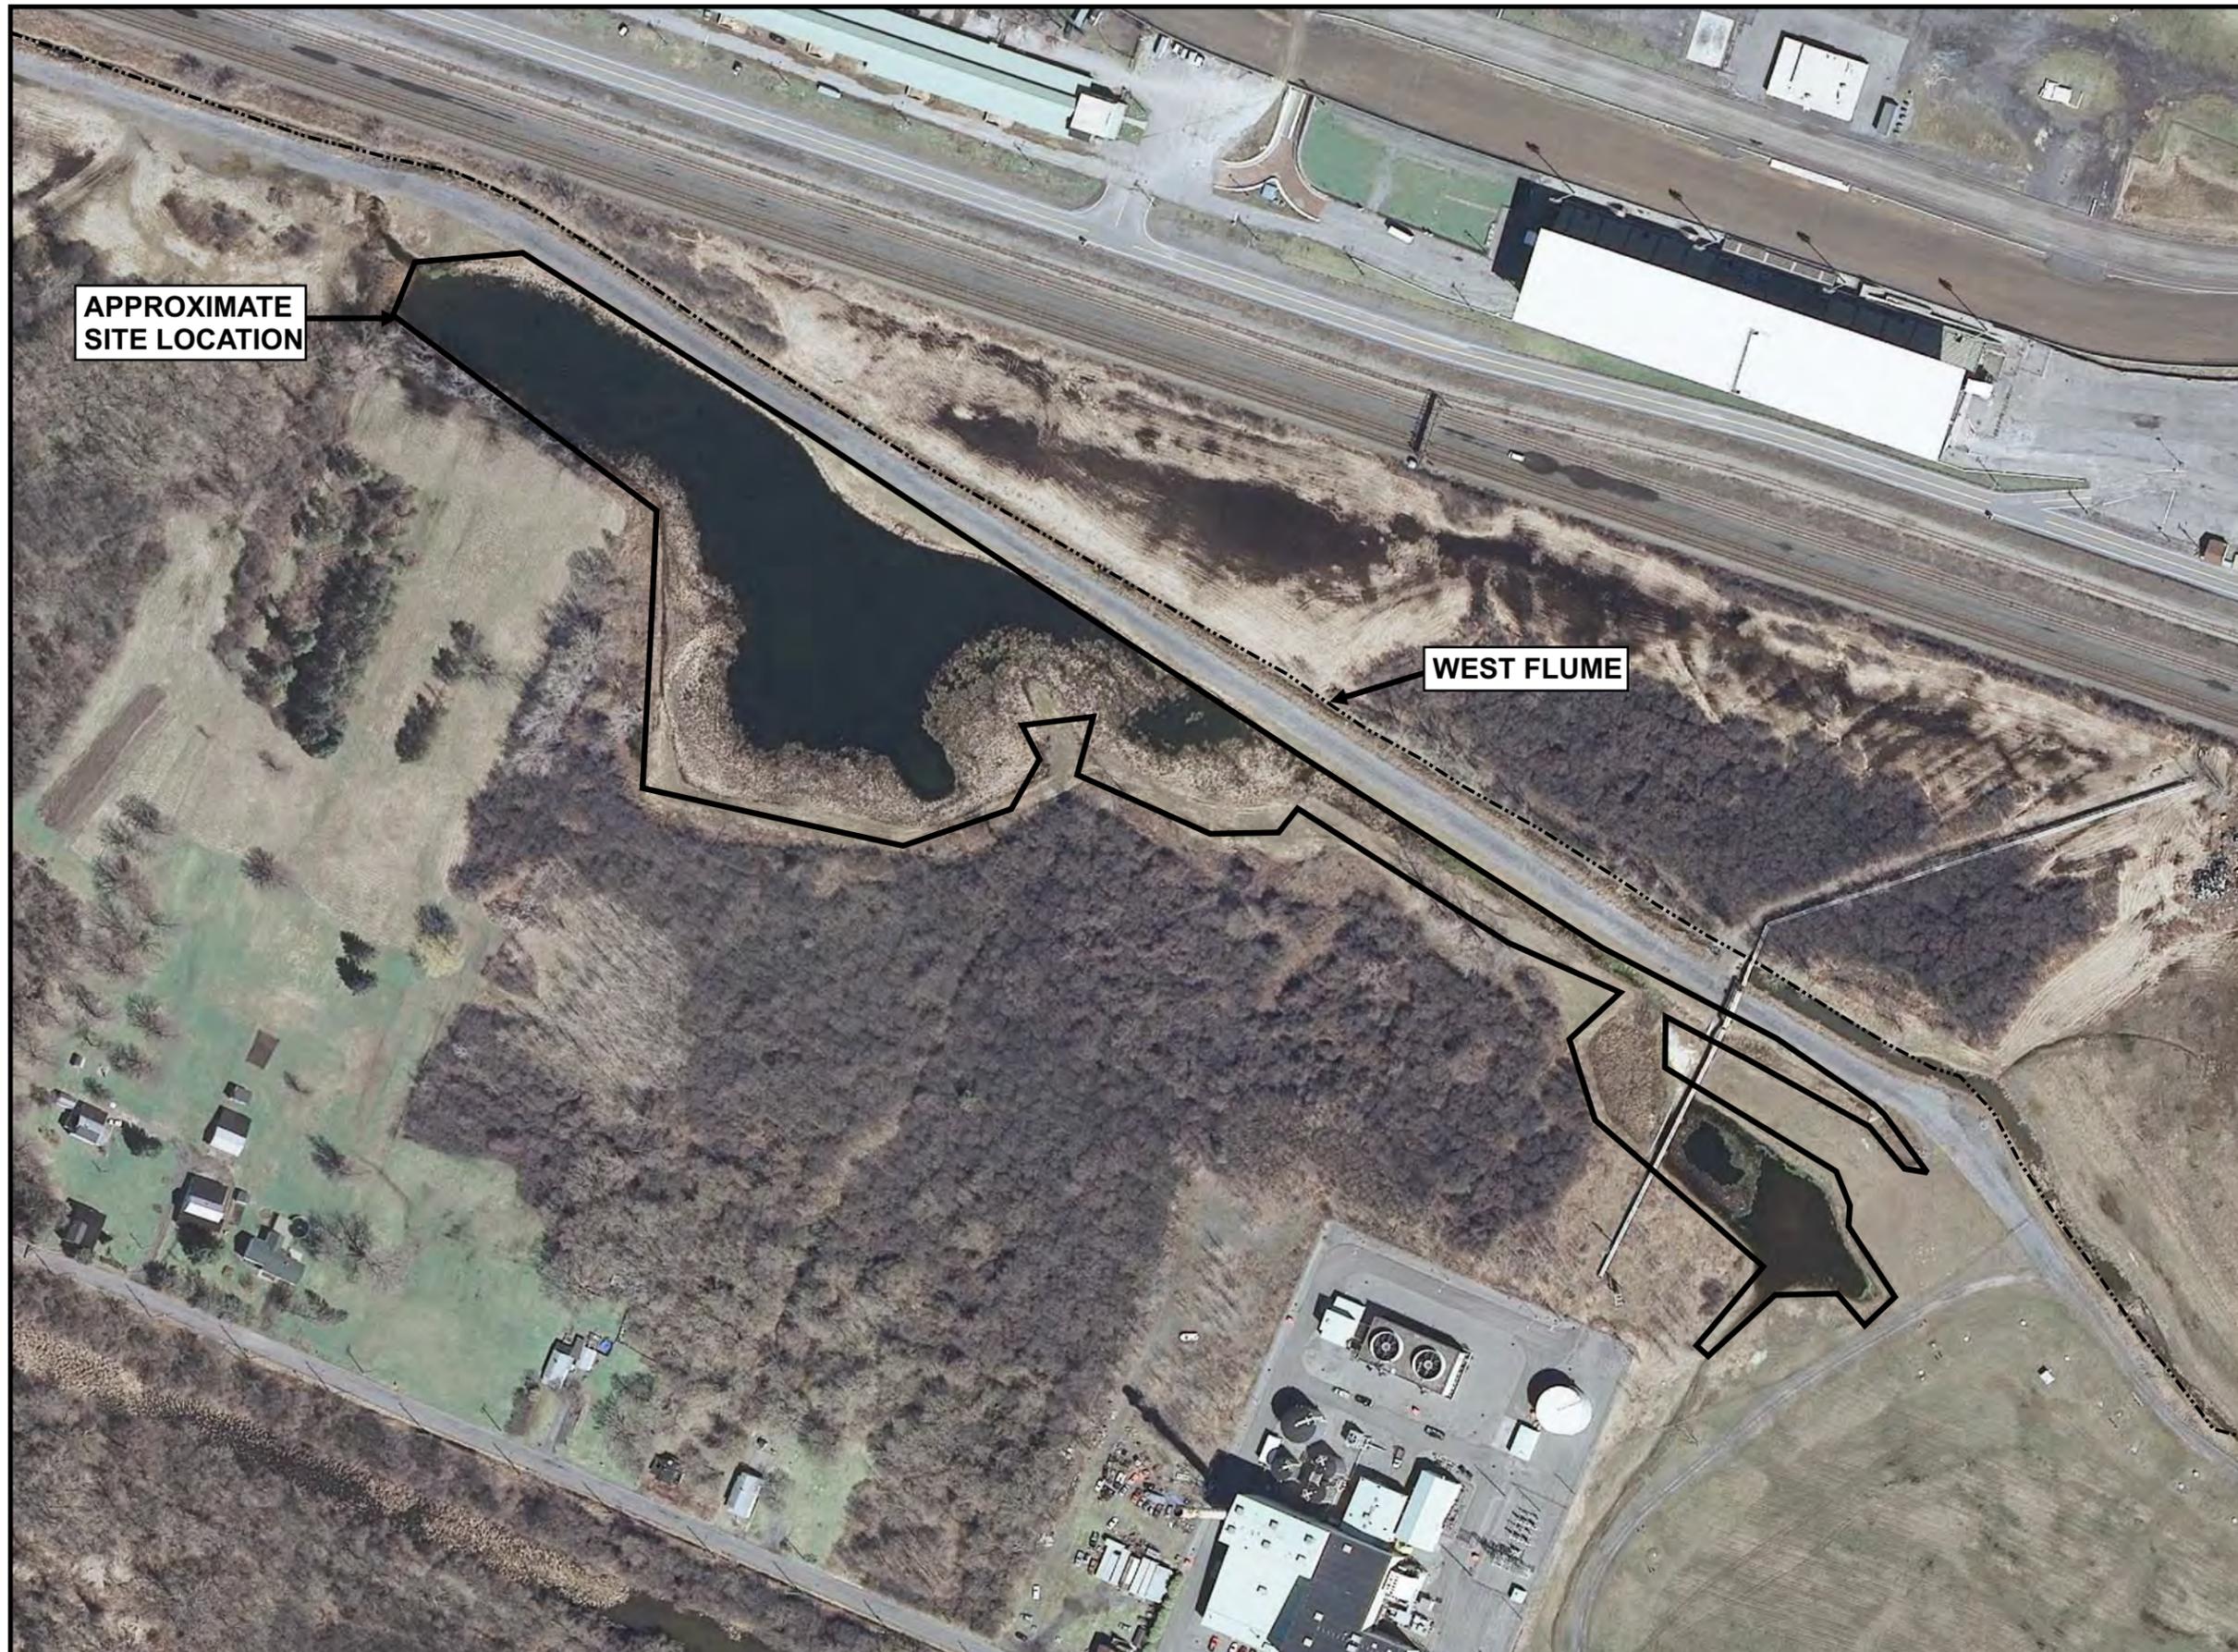
**April 2009
Aerial Photograph
Showing
Remediation Work
(completed)**

**LCP Bridge Street
Restoration Area**

The restoration area is composed of three areas: Wetland A, Wetland B, and the West Flume. An April 2009 aerial photograph (Figure 3a) and a November 2008 oblique aerial photograph (Figure 3b) show the three areas after restoration. The post-remediation grading plan for these three areas is provided as Figure 4. Figure 6 shows the location and extent of the vegetation cover types found in the restoration areas during the 2012 monitoring effort. Plant species observed in the areas are listed in Table 4. The vegetation, hydrology, and wildlife usage of the restored areas is described in the following sections.

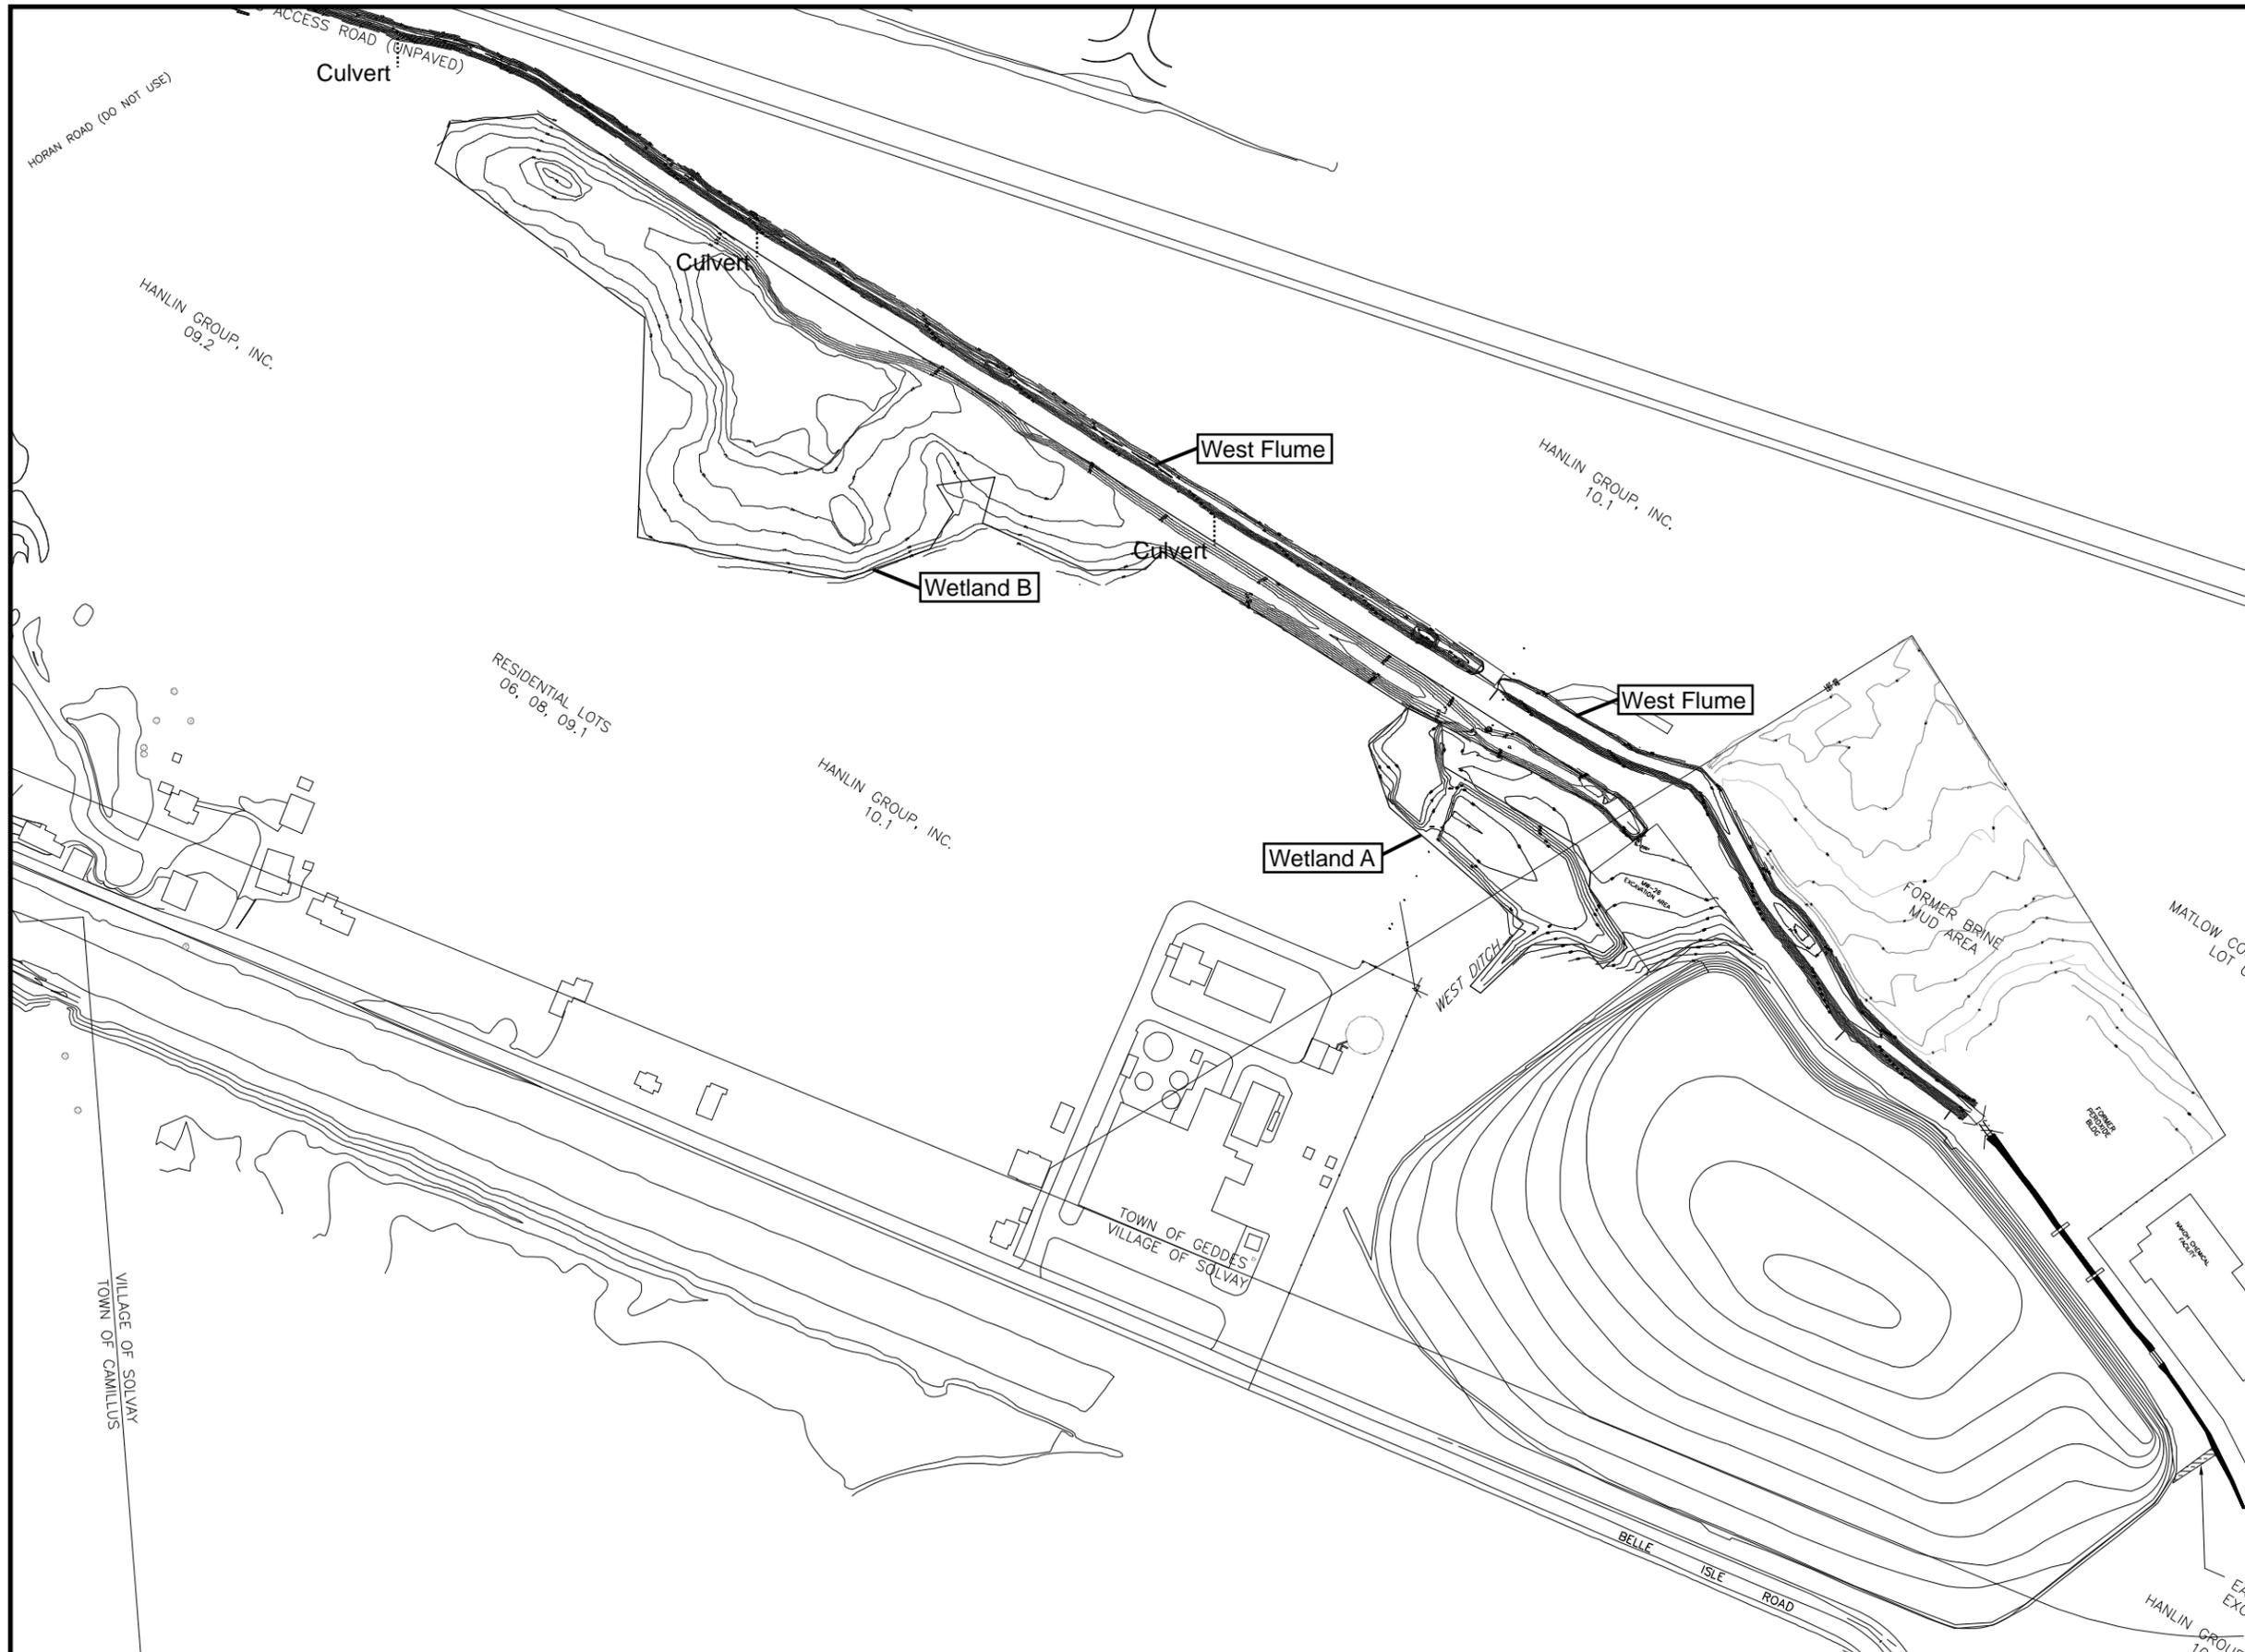
Figure 4.
**Post Remediation
Grading Plan**
**LCP Bridge Street
Restoration Area**
