**2012 ANNUAL OPERATION, MAINTENANCE AND
MONITORING REPORT**

**LCP BRIDGE STREET SITE (OU-1)
Solvay, New York**

NOVEMBER 2013

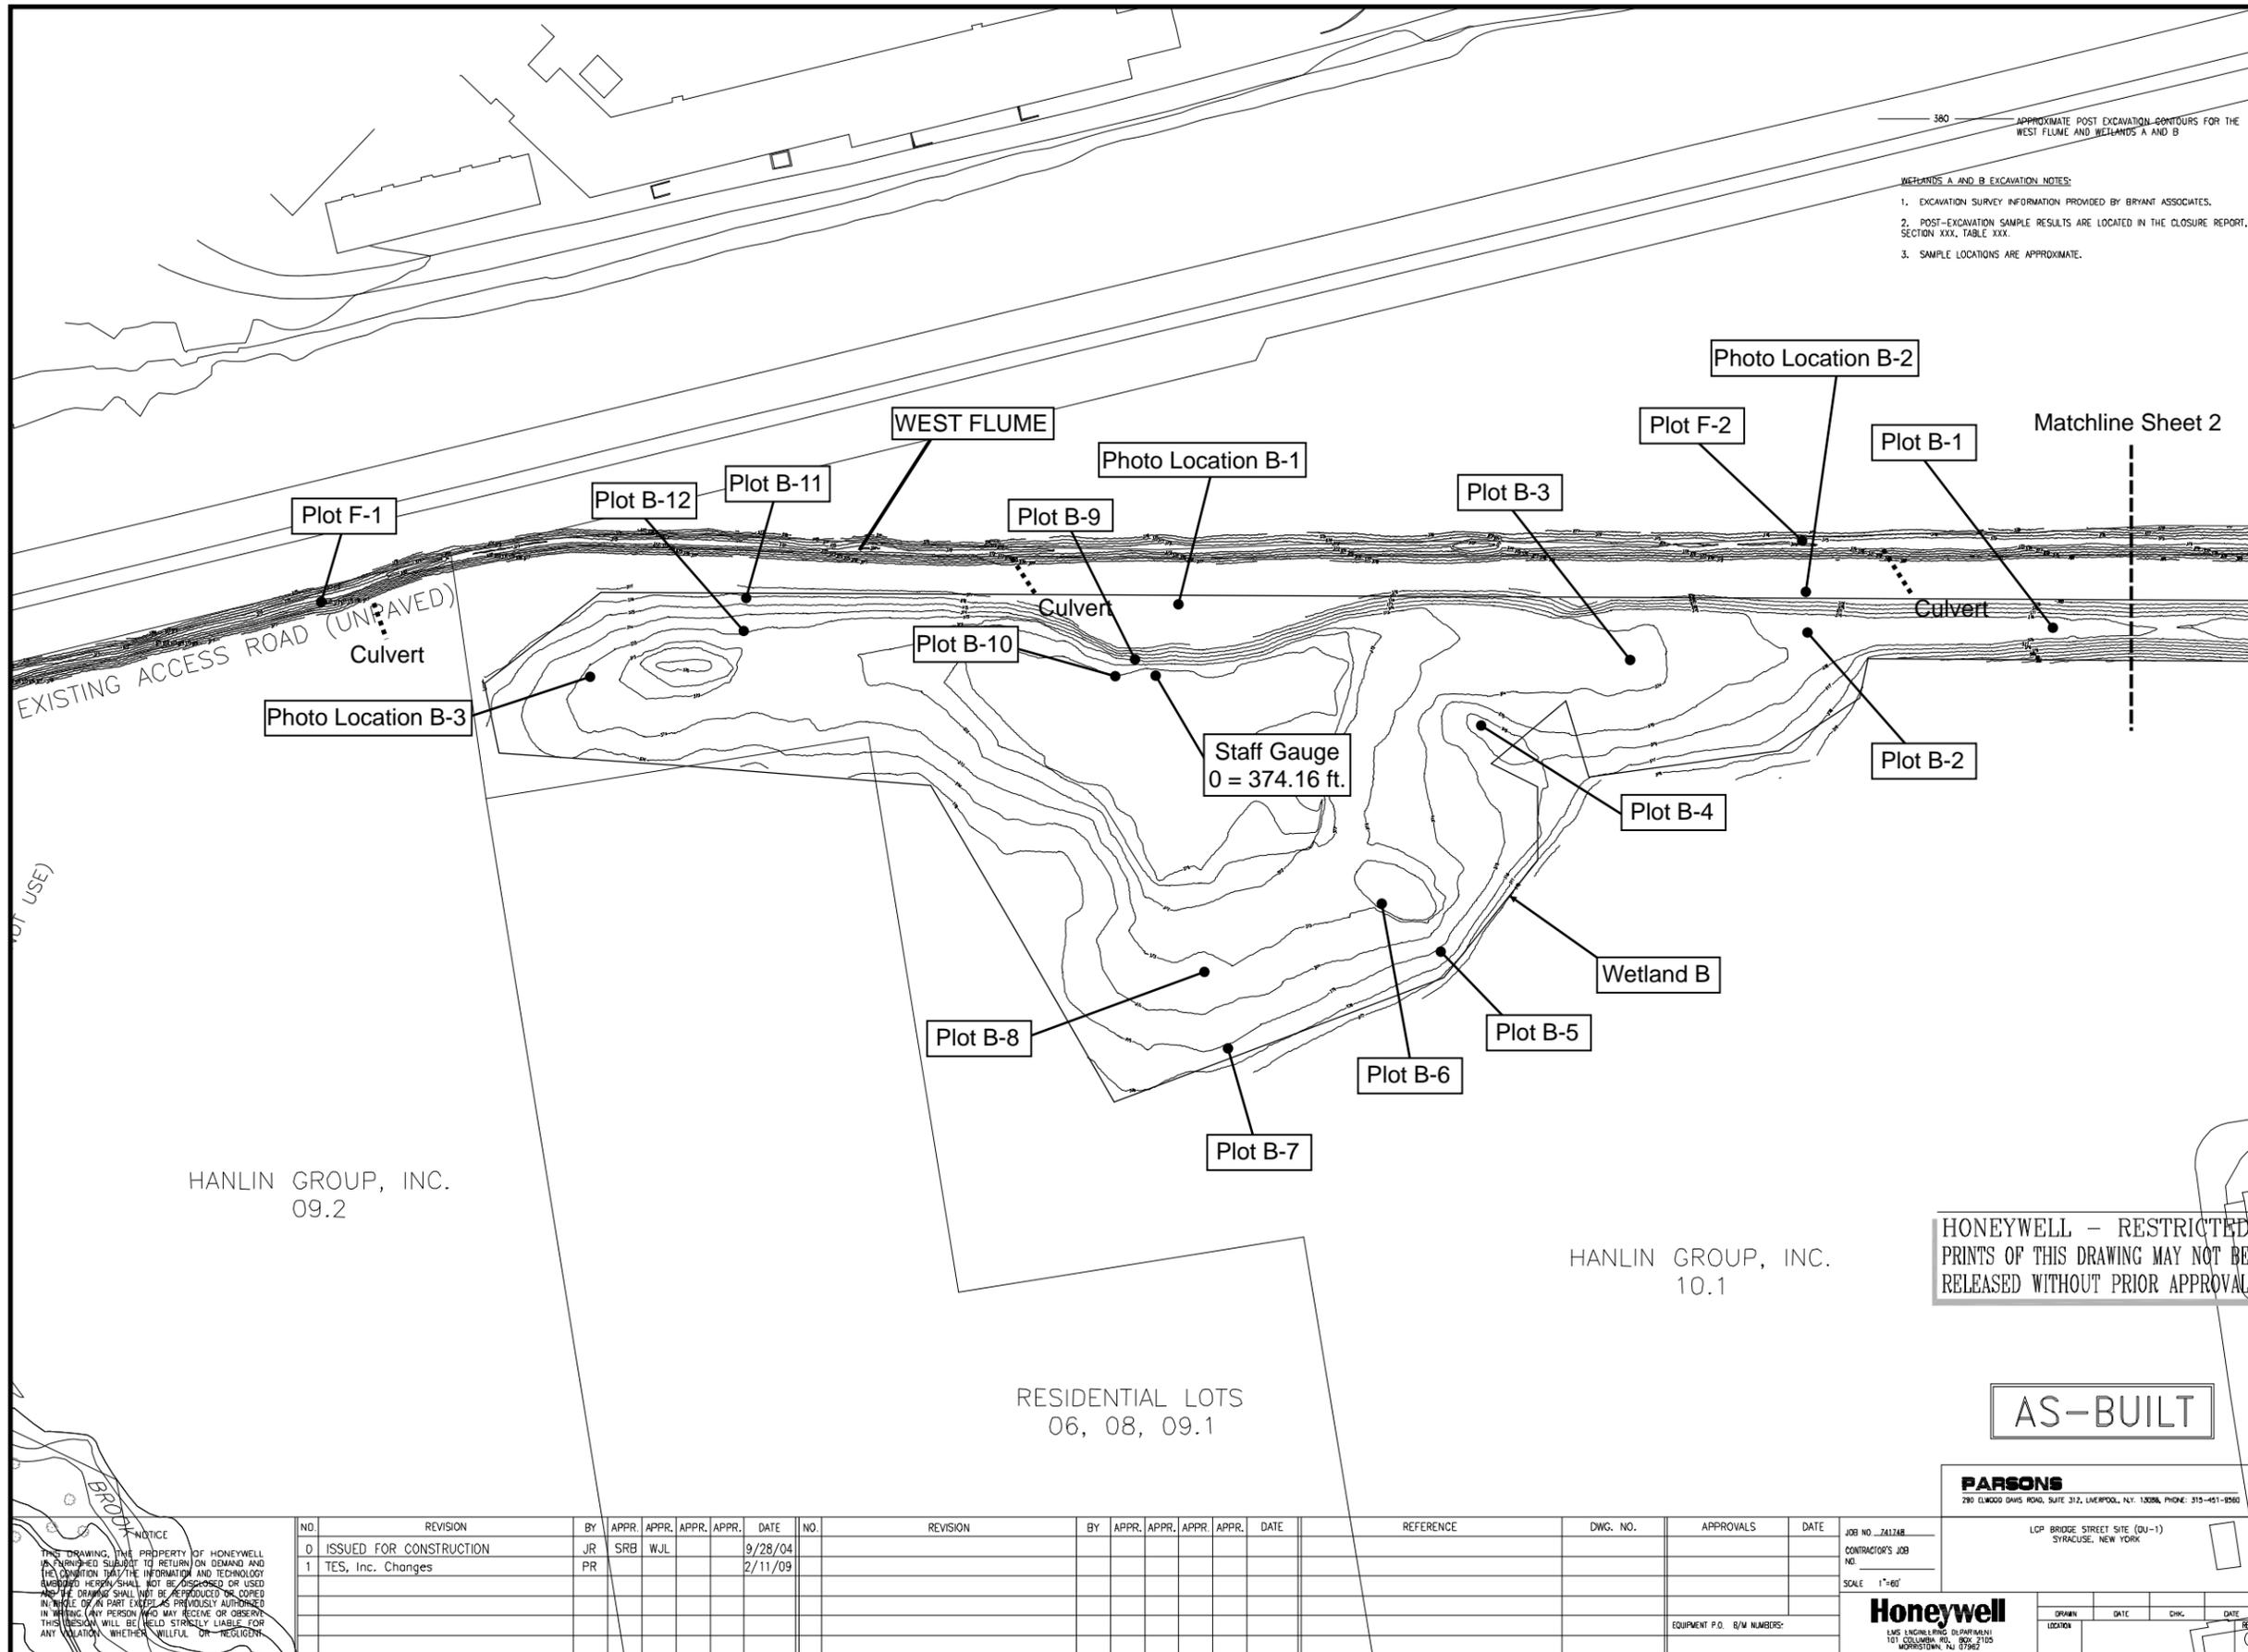
APPROXIMATE POST EXCAVATION CONTOURS FOR THE WEST FLUME AND WETLANDS A AND B
