**2011 ANNUAL OPERATION, MAINTENANCE AND
MONITORING REPORT**

**LCP BRIDGE STREET SITE (OU-1)
Solvay, New York**

PARSONS

JULY 2012

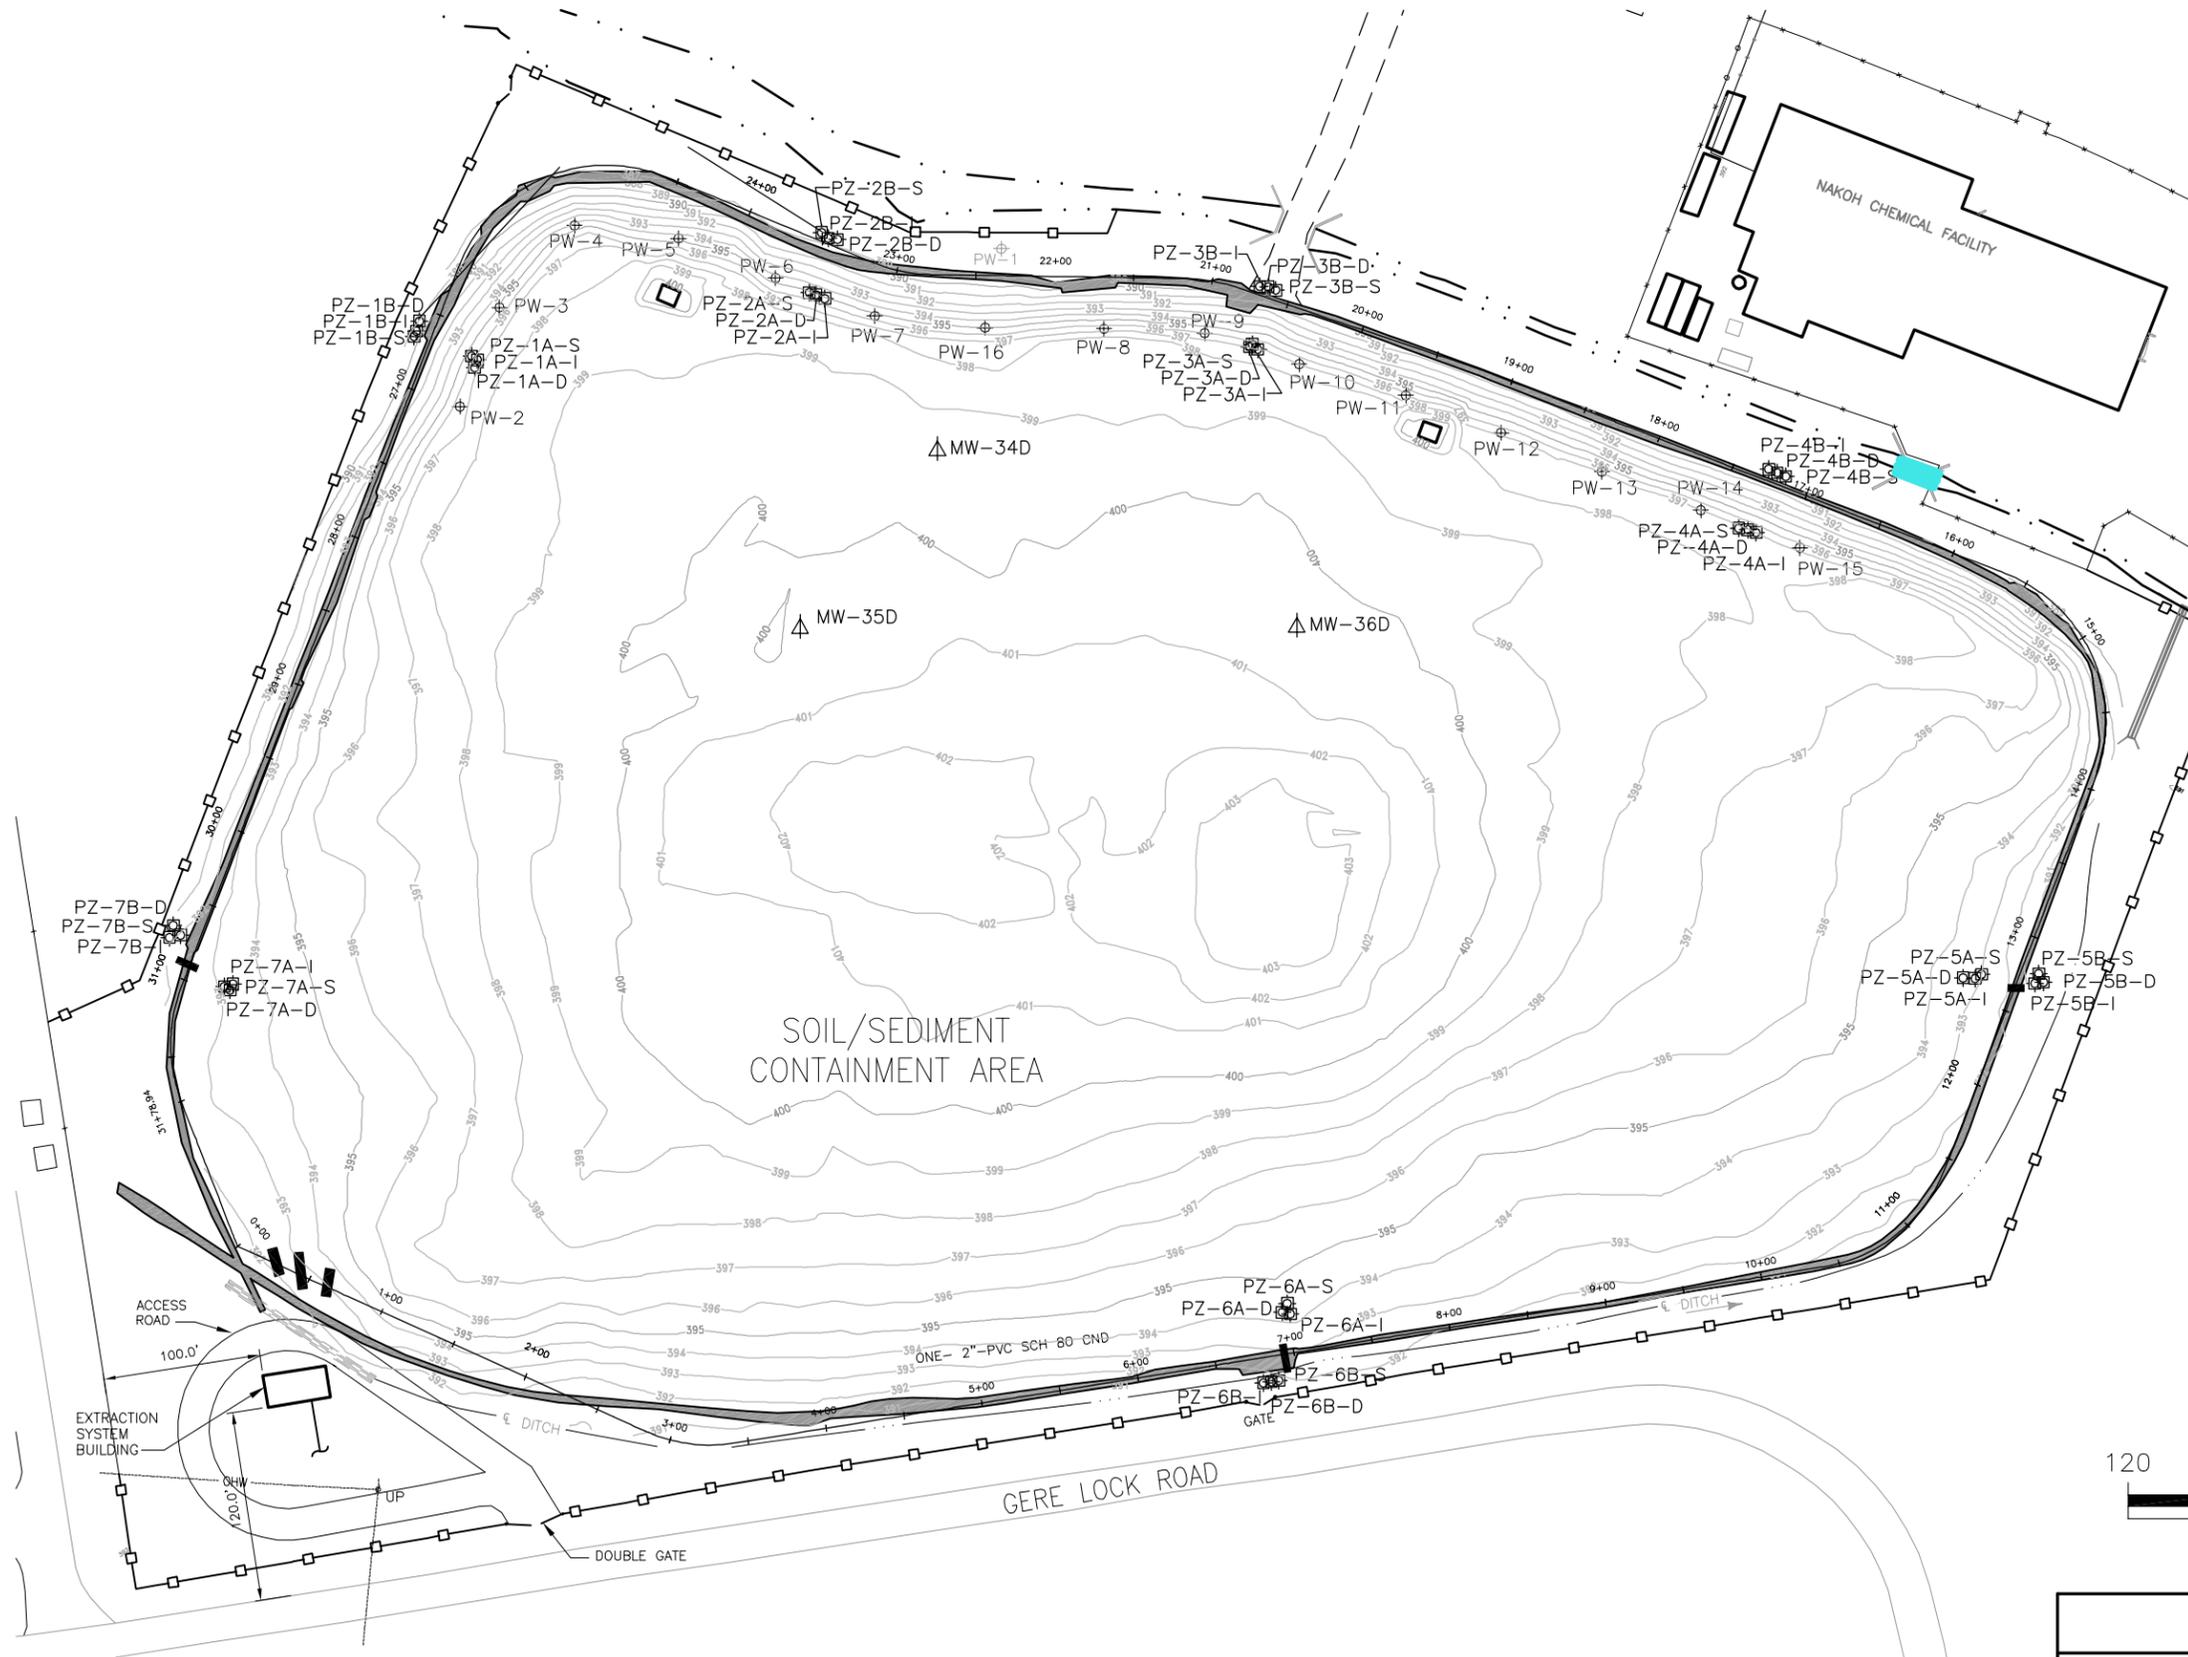
FIGURE 1

PIEZOMETER/MONITORING
WELL LOCATIONS

Groundwater extracted by the 15 pumping wells within the soil/sediment containment area was pumped to two 10,000-gallon tanks in the onsite extraction building (Figure 1). On January 21, 2010, the LCP pre-treatment system began operation. The pre-treatment system consists of a filter feed pump, two 5-micron bag filters, two fiberglass-reinforced plastic granular activated carbon vessels and a flow meter. The design pumping rate is approximately 5 to 25 gpm. Pre-treated groundwater is discharged to the Onondaga County West Side Trunk Sewer from which it flows to the Onondaga County Metropolitan Wastewater Treatment Facility (METRO). In 2011, approximately 2,474,896 gallons were pre-treated onsite and sent to METRO.

Containment of impacted sediments in the soil/sediment containment area is monitored both hydraulically and analytically using the piezometer and monitoring well network shown in Figure 1.

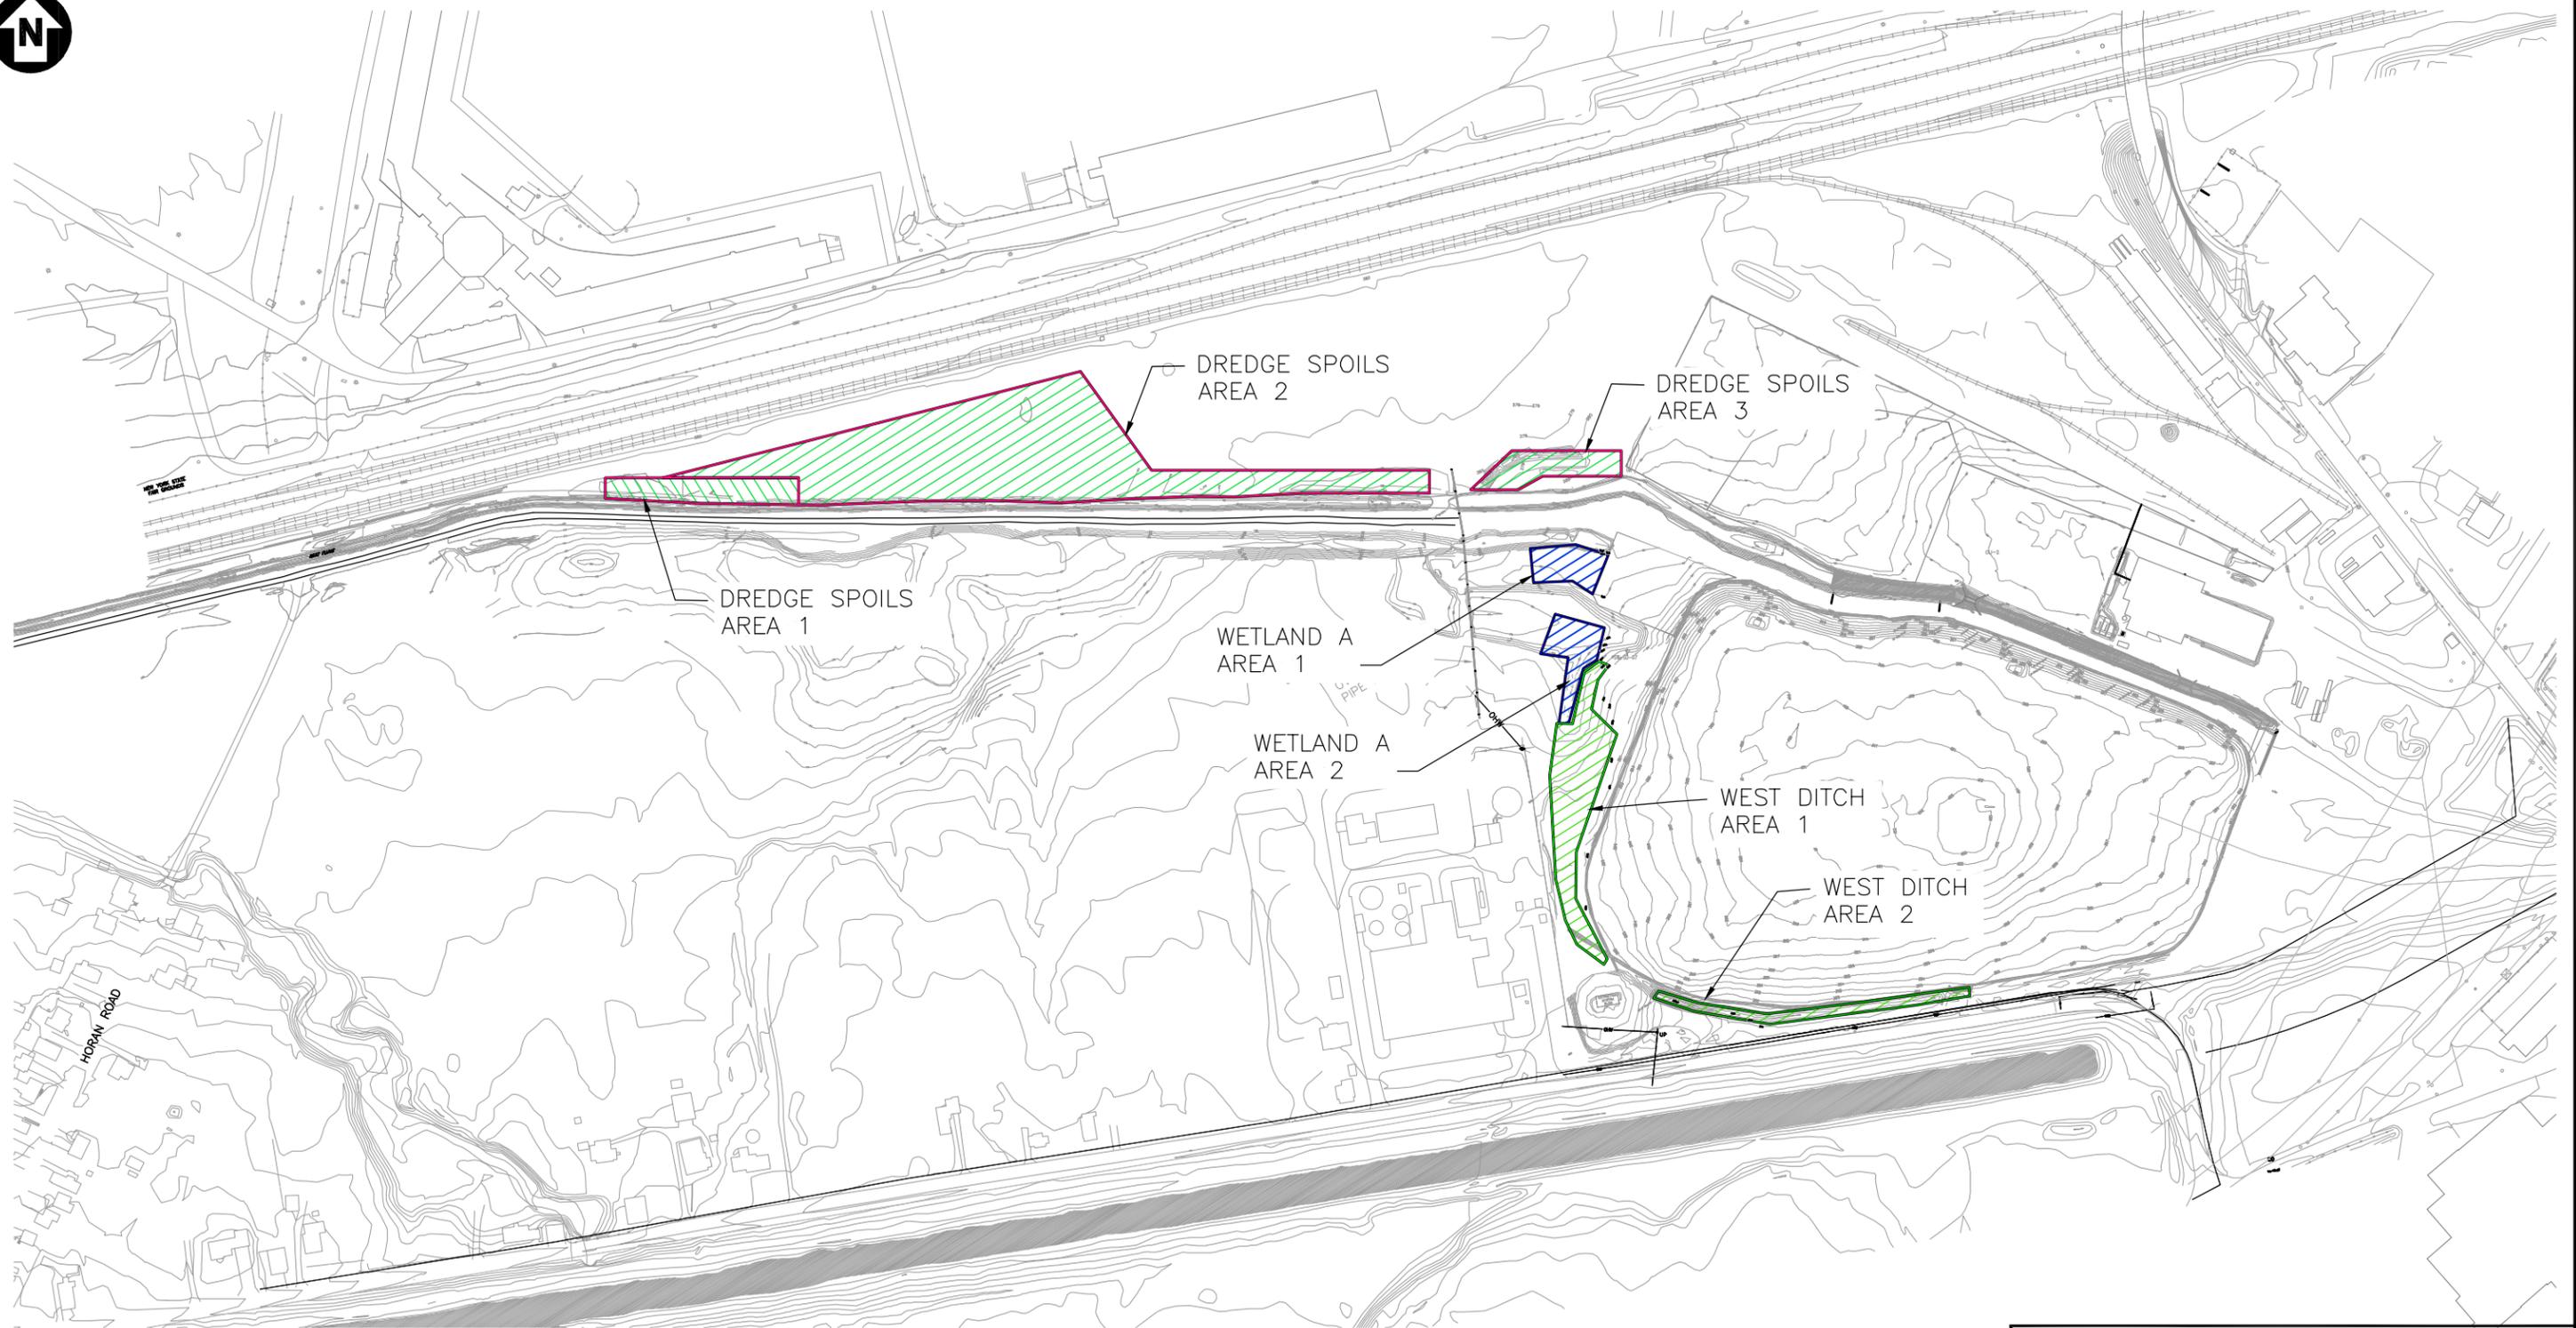
FIGURE 2

LCP 2011 OM&M
REMOVAL AREAS

In 2011, additional soil/sediment removals were conducted in the West Ditch, Wetland A, and the Dredge Spoils Area to address impacted material identified during previous OM&M sampling events (Figure 2). Removals were completed in accordance with the *LCP OU-1 Proposed Soil Removal – West Ditch, Wetland A and Dredge Spoils Areas* (Parsons, 2011).

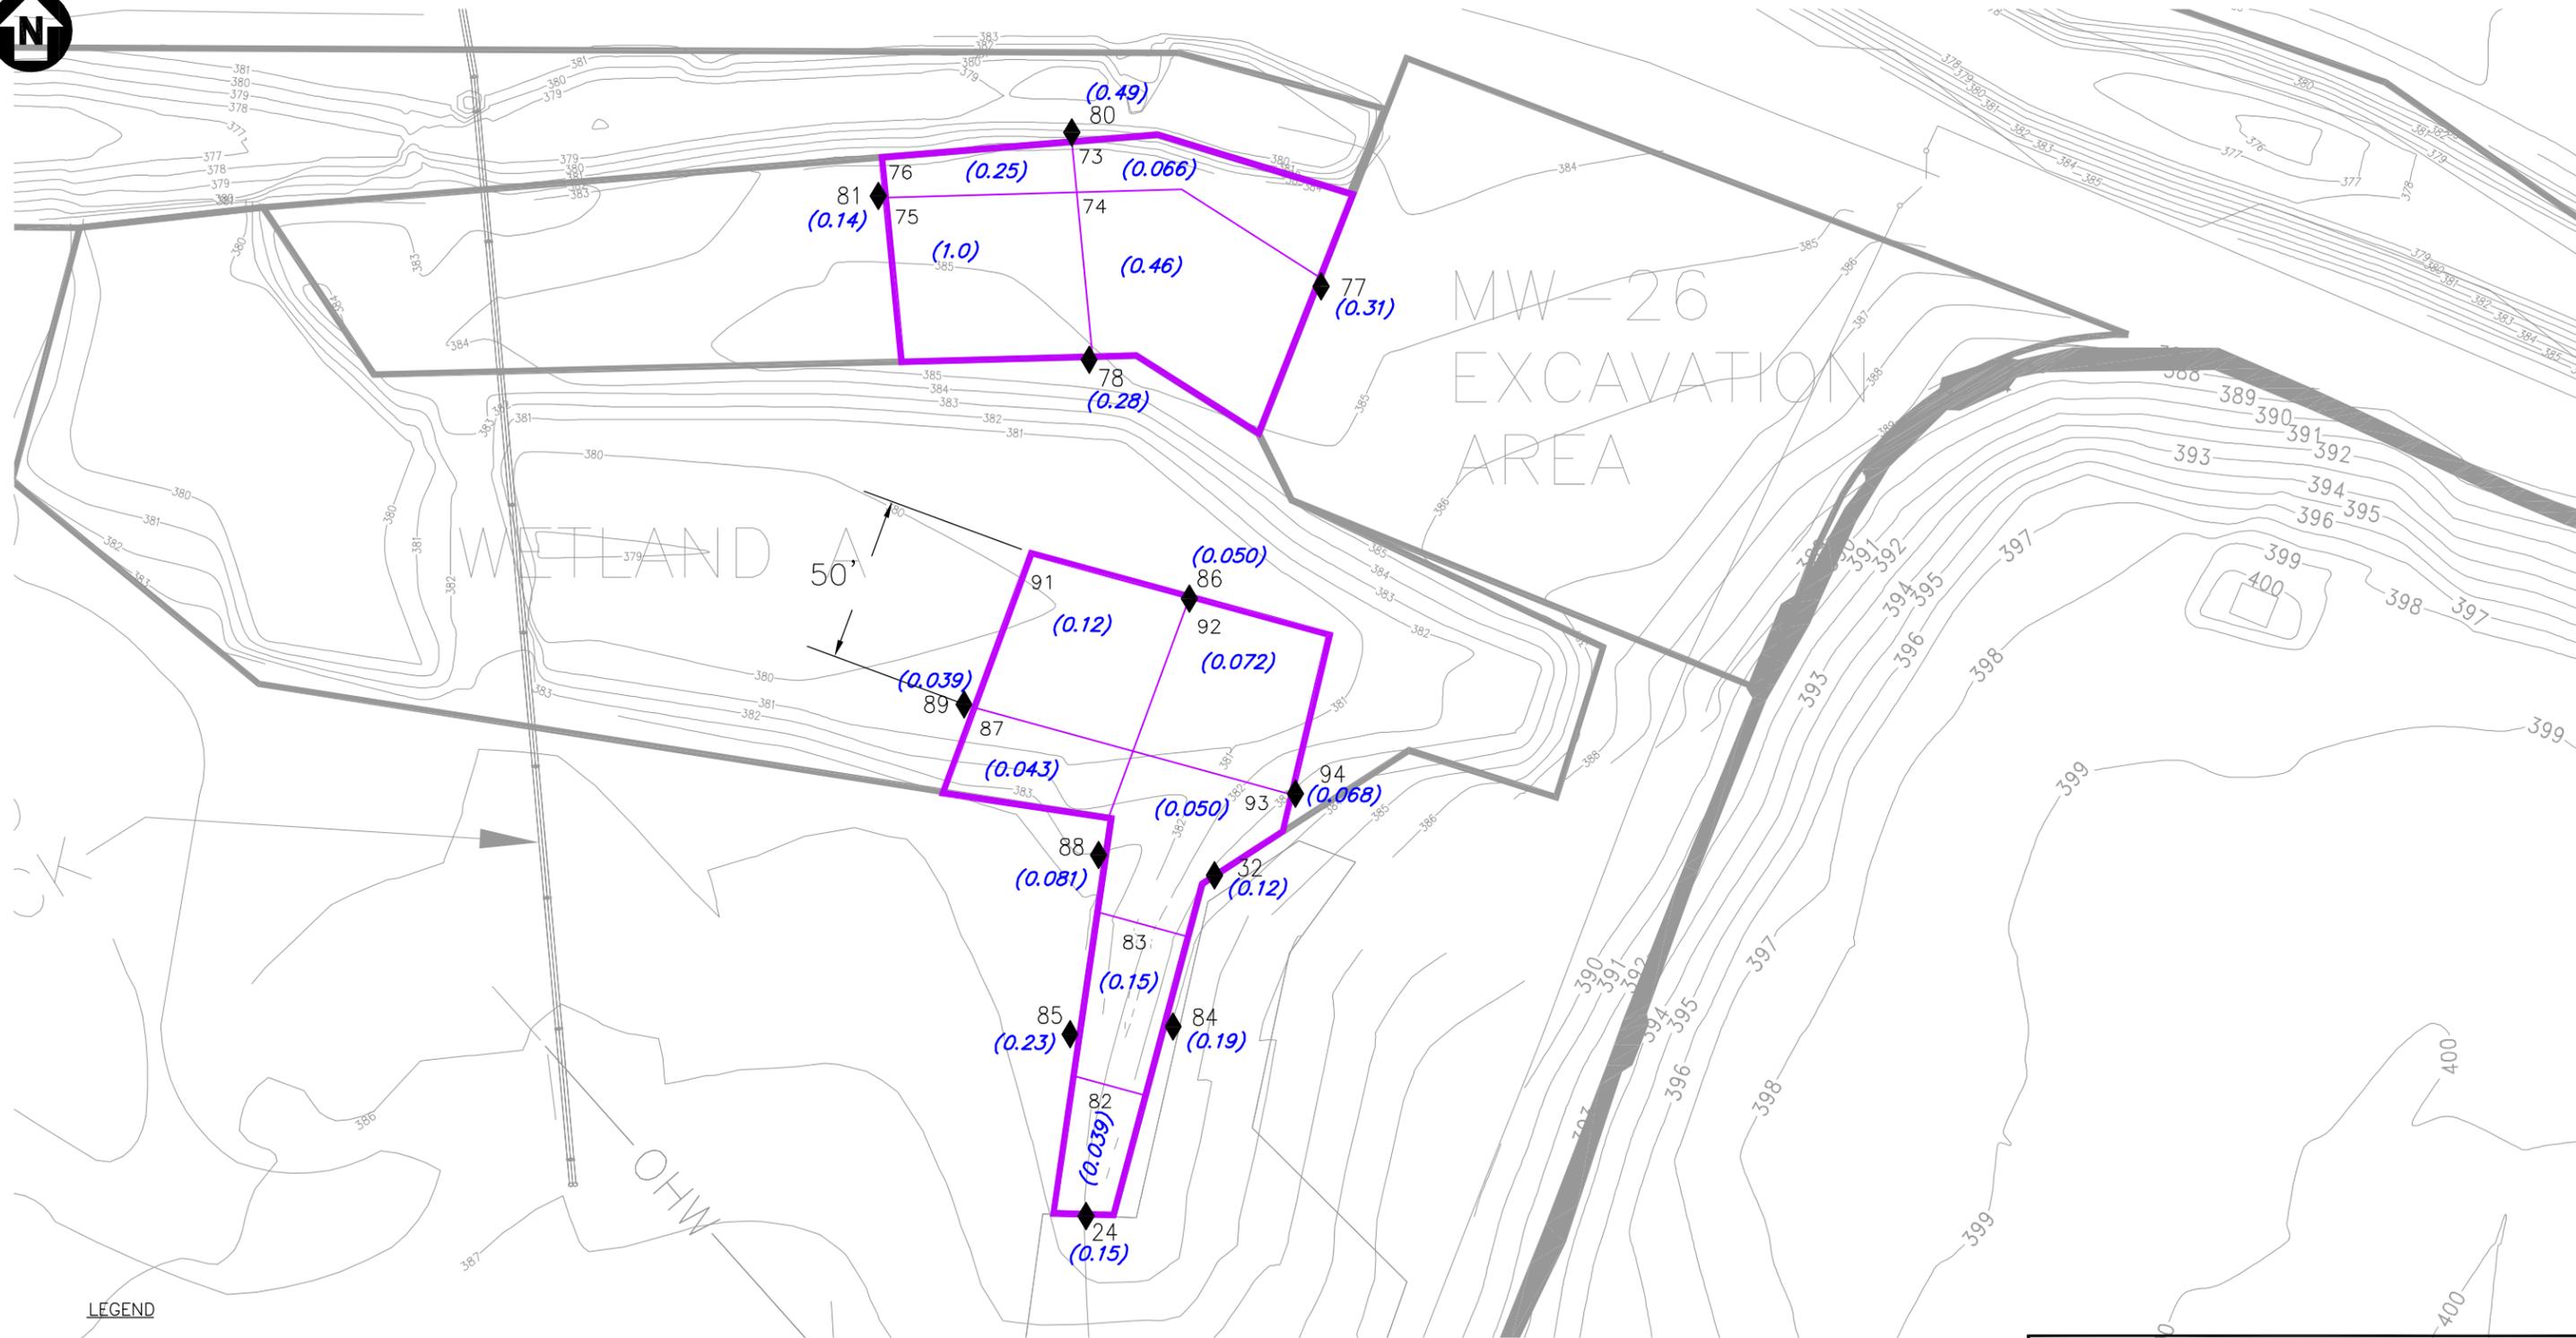
FIGURE 5

WETLAND A & MW-26 SAMPLE RESULTS AND EXCAVATION PLAN

Soils/sediment removed during remedial excavation were relocated to the LCP landfill and managed with the Geddes Brook IRM sediment. For the West Ditch, Wetland A and Dredge Spoils Area 3, removals were completed in 2011 and the areas were restored in accordance with the above referenced work plan. Removals were also completed within Dredge Spoils Area #2 in 2011, excavation in Dredge Spoils Area 1 will be completed in 2012 and both areas #1 and #2 will be restored during the 2012 construction season. Following excavation, post-excavation samples were collected in accordance with the remedial work plan indicated above. As agreed upon by Honeywell and NYSDEC, confirmatory sample results are summarized in Table 2 and tag maps are provided as Figures 3 through 6.

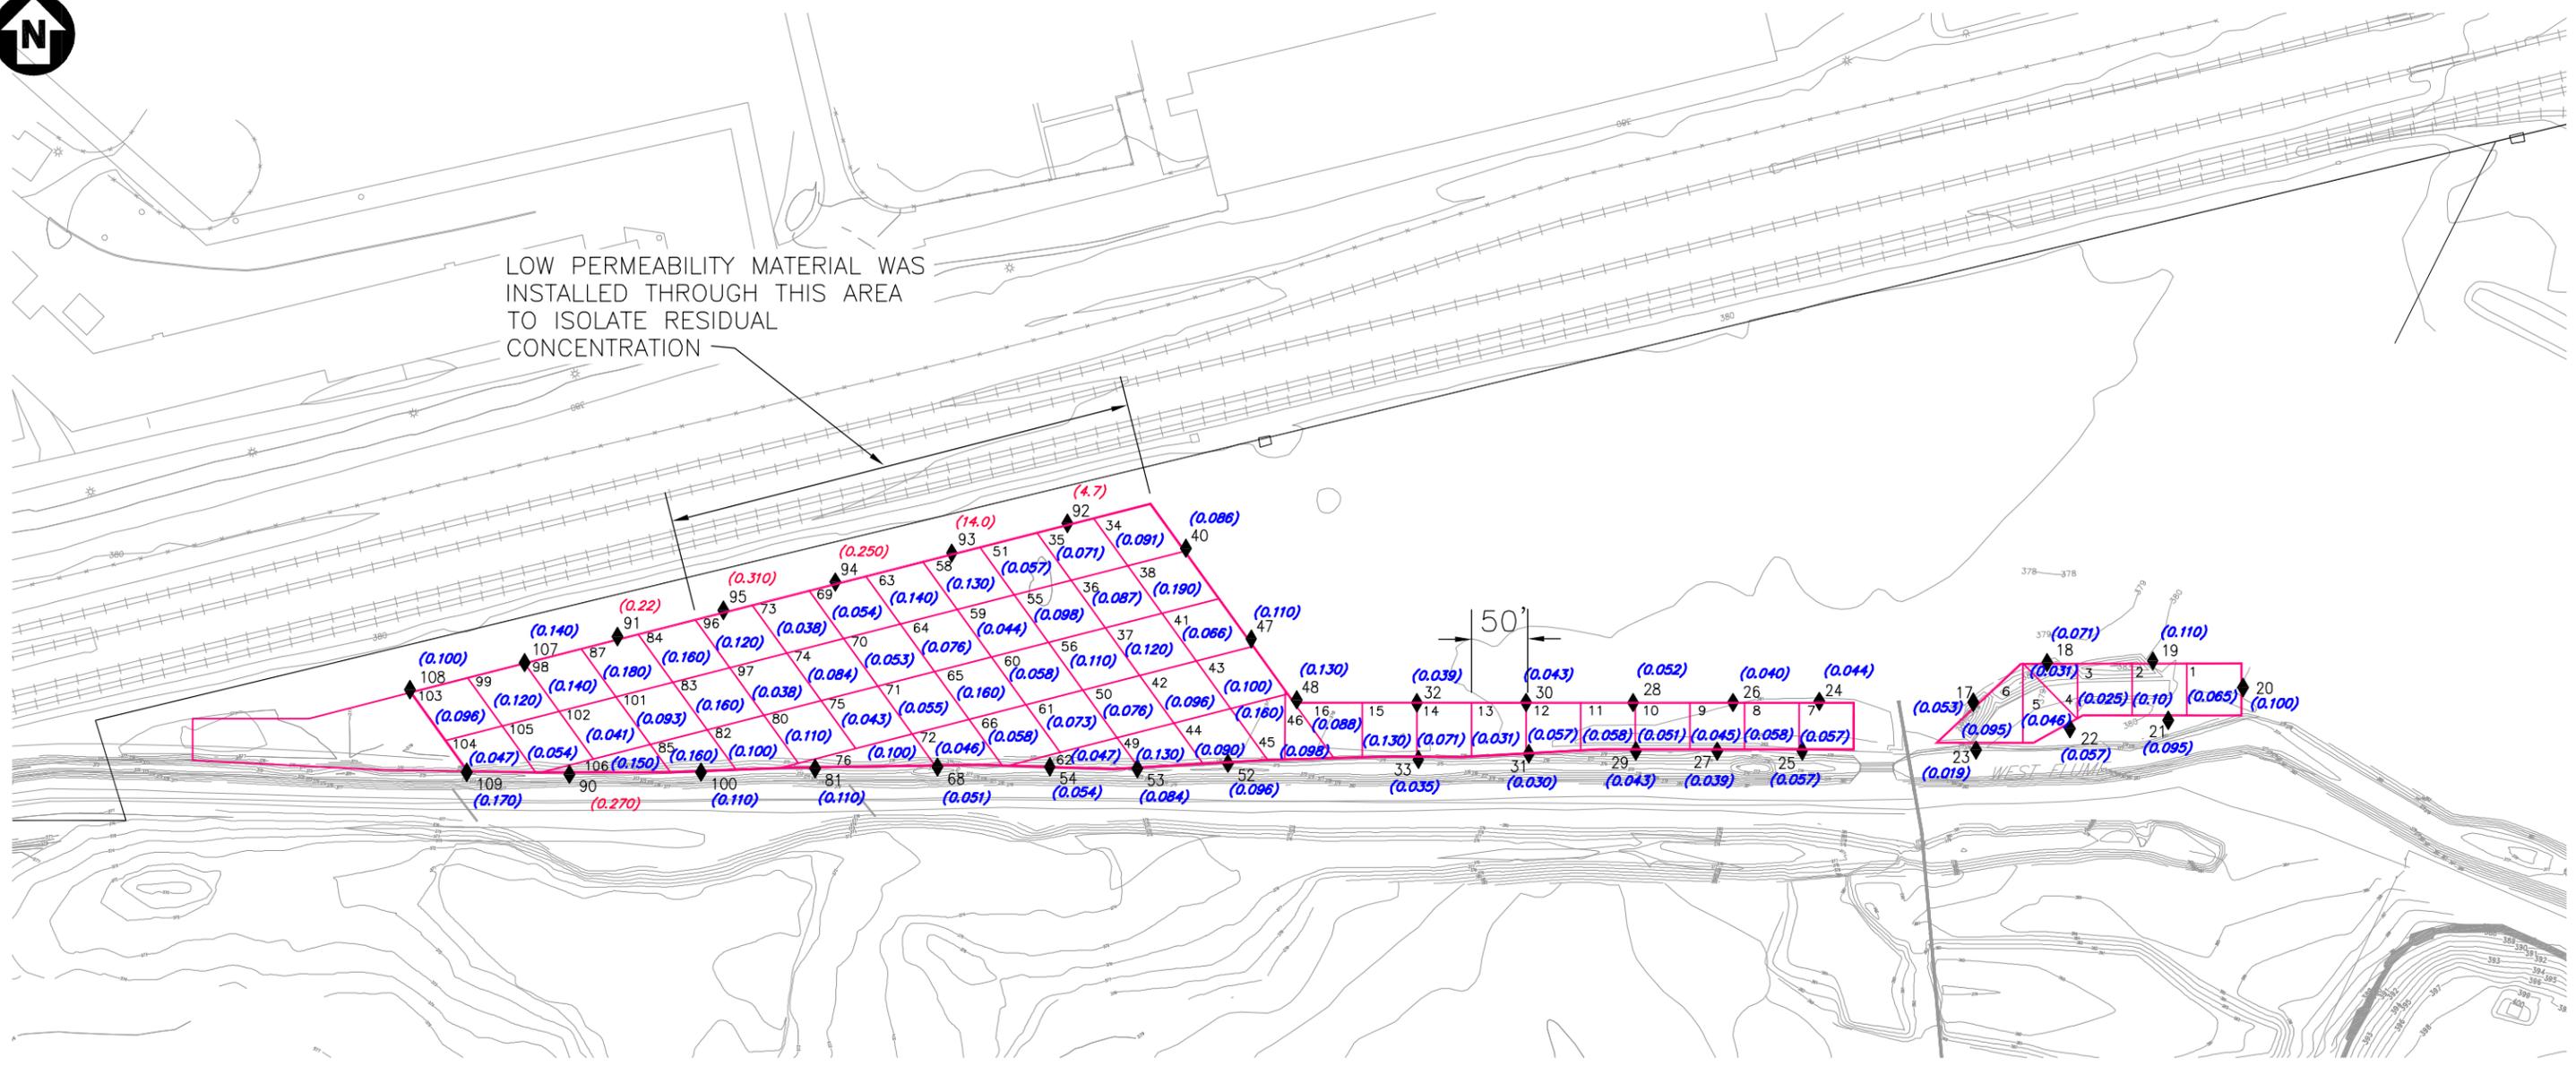
FIGURE 6

LOW PERMEABILITY MATERIAL WAS
INSTALLED THROUGH THIS AREA
TO ISOLATE RESIDUAL
CONCENTRATION

Honeywell
LCP O&M REMOVALS 2011
WEST FLUME SAMPLE RESULTS
AND EXCAVATION PLAN

Several issues during excavation of the Dredge Spoil area north of the West Flume resulted in expansion of the remedial activities. The original scope of work called for the removal of approximately 12,000 to 12,500 CY of material from this area. Previous sampling in the area that was used to delineate remedial areas indicated a clay layer at approximately 2 ft in depth. During remedial construction, it became evident, based upon confirmatory sampling that this was a reworked layer intermingled with mercury-impacted material. Excavation depths increased to remove this impacted material and prevent recontamination of the remediated areas. Excavation depths continued through the reworked material into a native silty clay layer. It was also observed that in areas along the western limits of the excavation the silty clay layer dropped significantly in elevation as it was excavated. Based upon the presence of abandoned utilities, it was believe that this is the result of historic excavation in this area for the installation of these utilities. In addition, areal limits of excavation were expanded in some areas based upon confirmatory sampling results throughout the site. The majority of the samples that failed clean-up goals were composite samples of the reworked and waste materials that were removed in the Dredge Spoils Area. In the West Ditch and Wetland A portions of the site, elevated sidewall samples occurred in mainly fill materials. Some additional areal removals were mitigated by installing a low-permeability material to be protective of existing utilities and infrastructure that were in close proximity to the excavations as shown on Figures 3 and 6. Approximately 10,500 CY of additional material was removed resulting in a total of approximately 25,000 CY of soils/sediments removed during 2011.

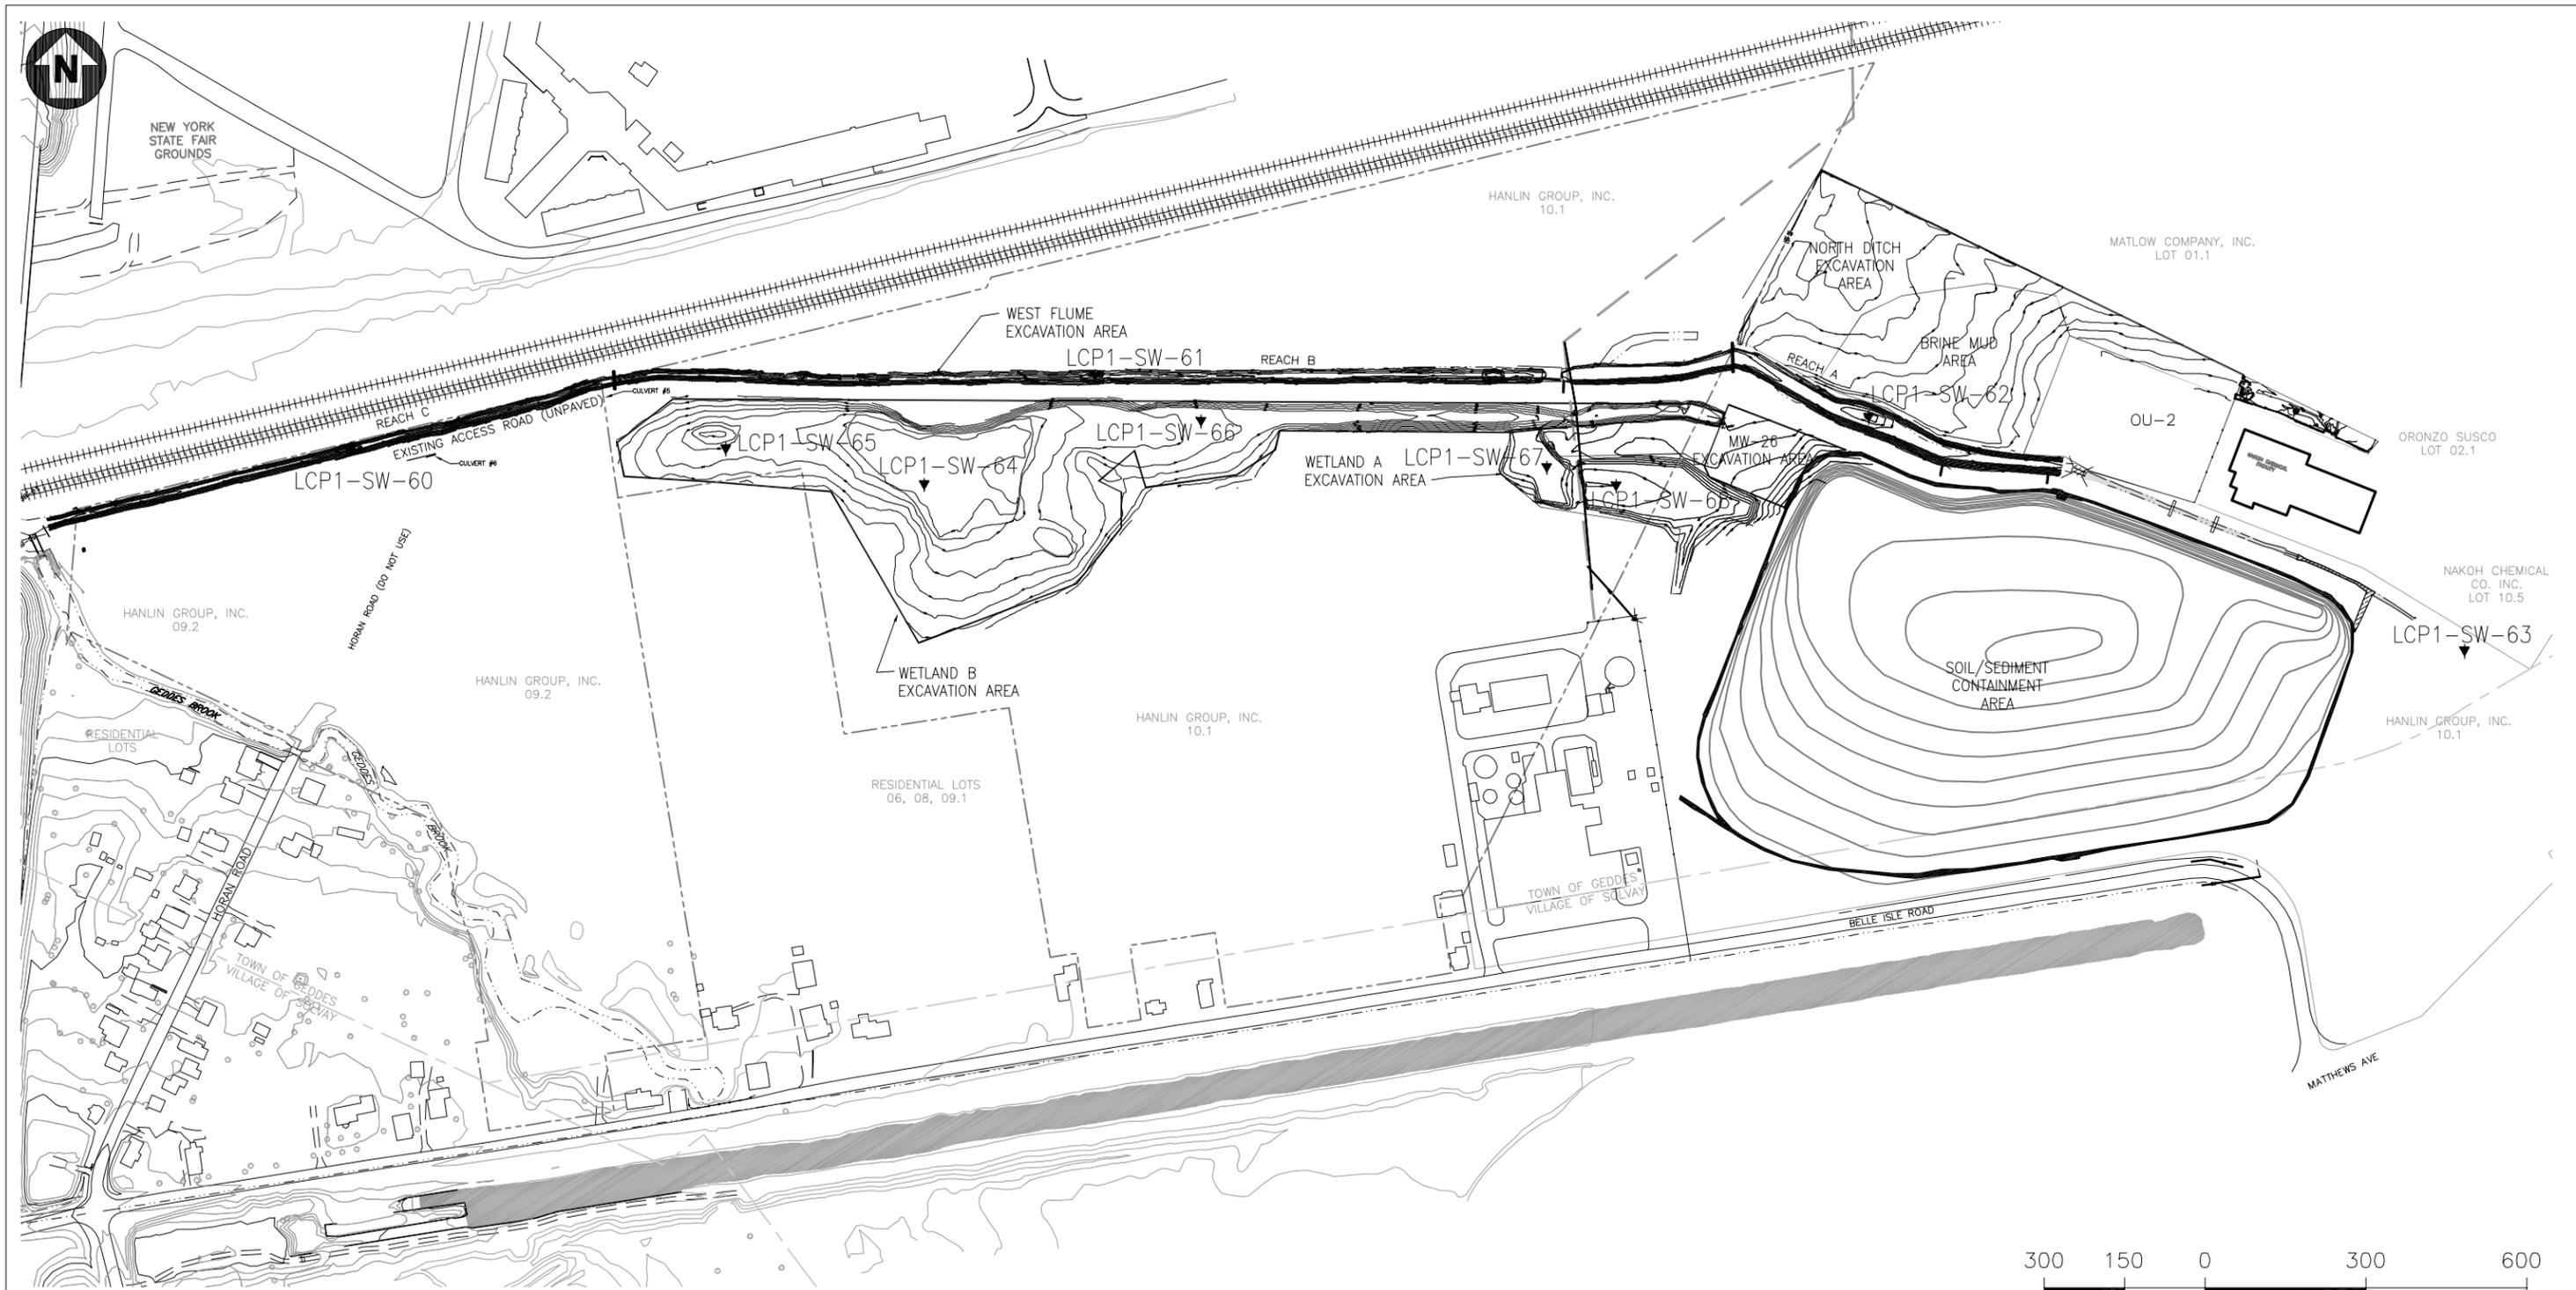
FIGURE 7

ANNUAL SURFACE WATER/SEDIMENT
SAMPLING LOCATION

Nine annual monitoring locations (Figure 7) have been established in the West Flume and Wetland A/B complex for total mercury, methylmercury, and dissolved mercury. Annual surface water samples were collected at the monitoring locations in August 2011. The data range for total mercury from the West Flume (excluding the upstream sample location (LCP1-SW-63)) was 1.8 ng/L to 4.5 ng/L, 16 ng/L to 29 ng/L for Wetland A and 2.7 ng/L to 18 ng/L for Wetland B. Individual sample results are provided in Table 6 of this report.

Sediment was also sampled at the nine annual monitoring locations and analyzed for total and methyl mercury by SW 846 Method 7471 and EPA 1630. Samples were collected in August 2011. The total mercury data ranges for the West Flume (excluding the upstream sample location (LCP1-SW-63)) were 0.24 mg/kg to 0.42 mg/kg, 0.24 to 4.2 mg/kg for Wetland A and 0.075 mg/kg to 0.68 mg/kg for Wetland B. Individual sample results are provided in Table 7 of this report.

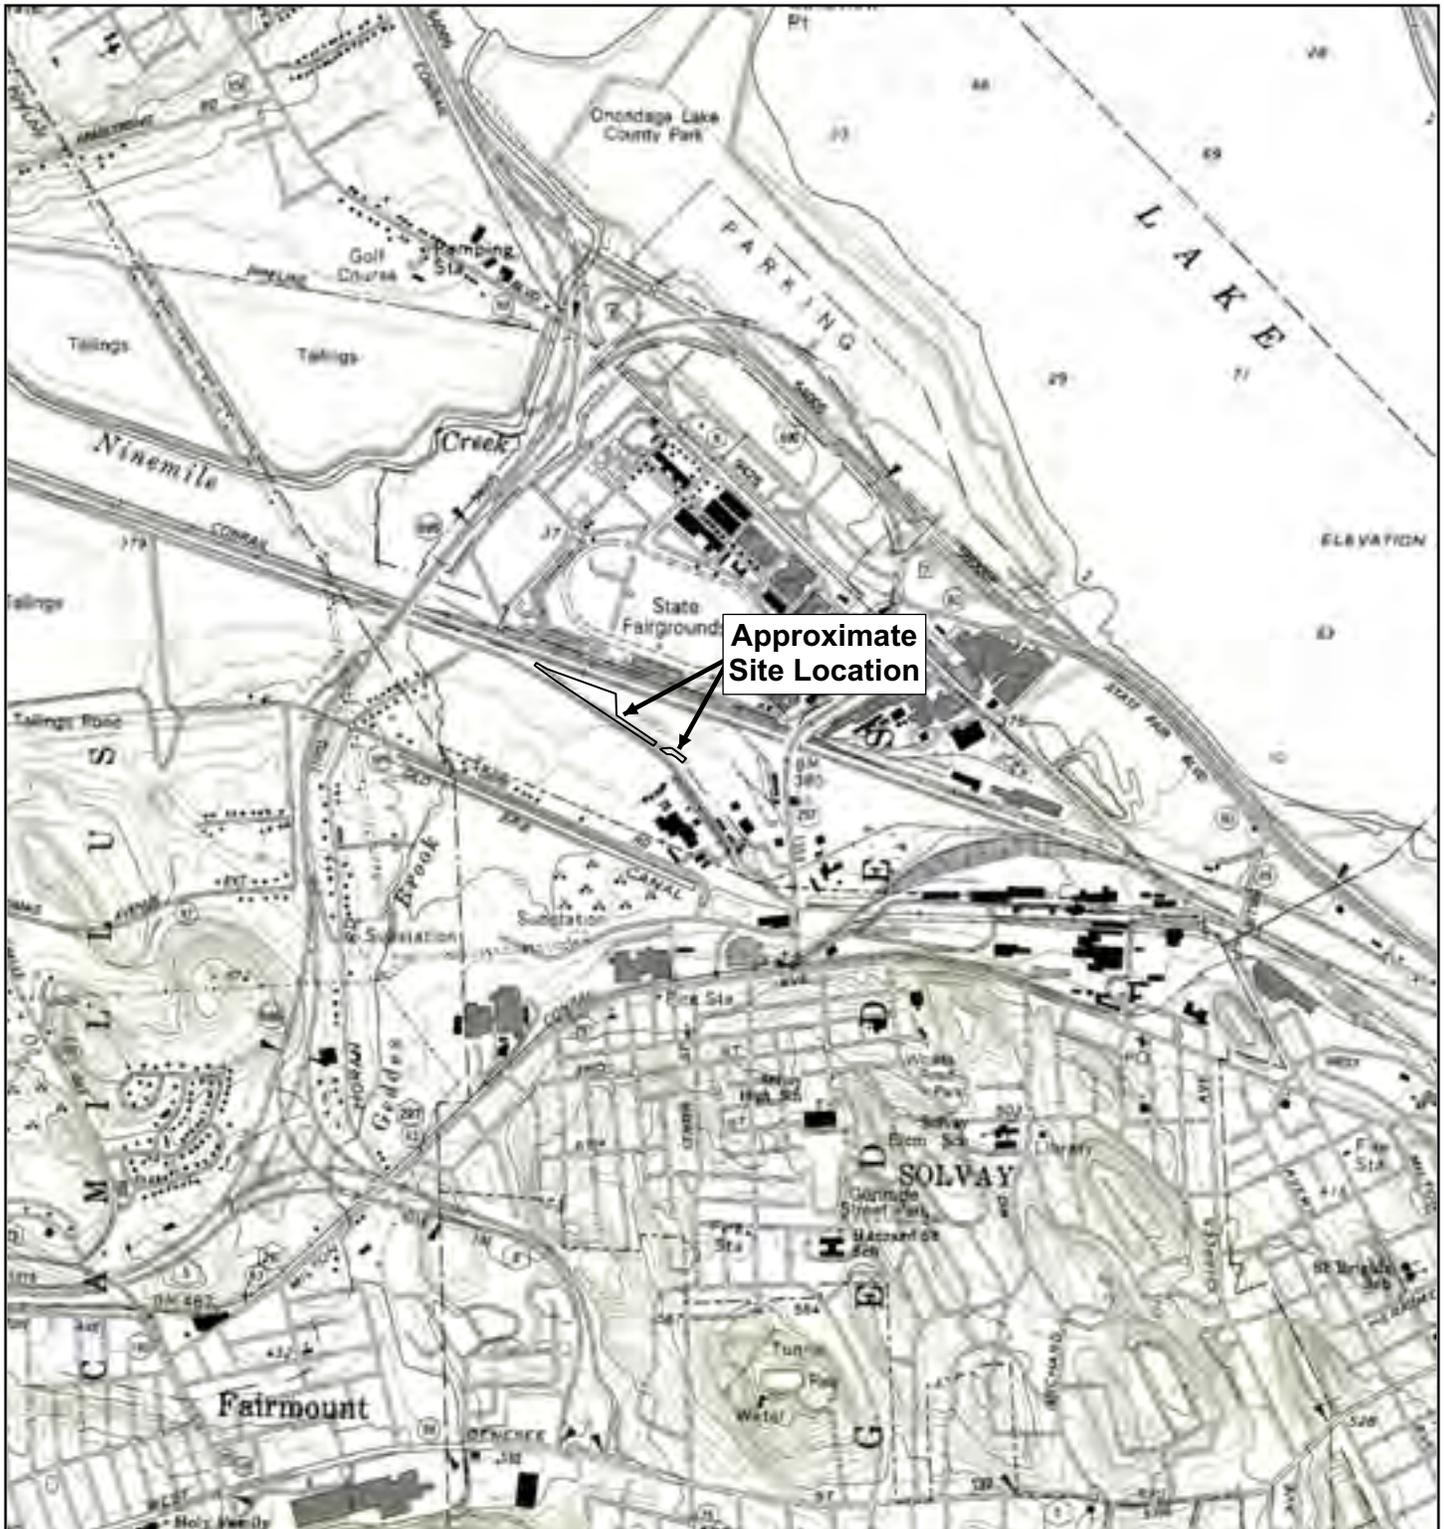
Figure 1.
Site Location, LCP Dredge Spoil Area

Approximate Site Location

- the New York State Department of Transportation (NYSDOT) Topographic map (Syracuse West quadrangle) (Figure 1);
- the New York State Department of Environmental Conservation (NYSDEC) New York State Freshwater Wetlands map (Figure 2);
- the U.S. Fish and Wildlife Service (USFWS) National Wetlands Inventory map (Figure 3);
- the Onondaga County Soil Survey map prepared by the Natural Resources Conservation Service (Figure 4);
- the New York State Surface Water Classification map (Figure 5); and
- a 2009 aerial photograph obtained from the New York State GIS Clearinghouse (Figures 7).
