**2011 ANNUAL OPERATION, MAINTENANCE AND
MONITORING REPORT**

**LCP BRIDGE STREET SITE (OU-1)
Solvay, New York**

PARSONS

JULY 2012

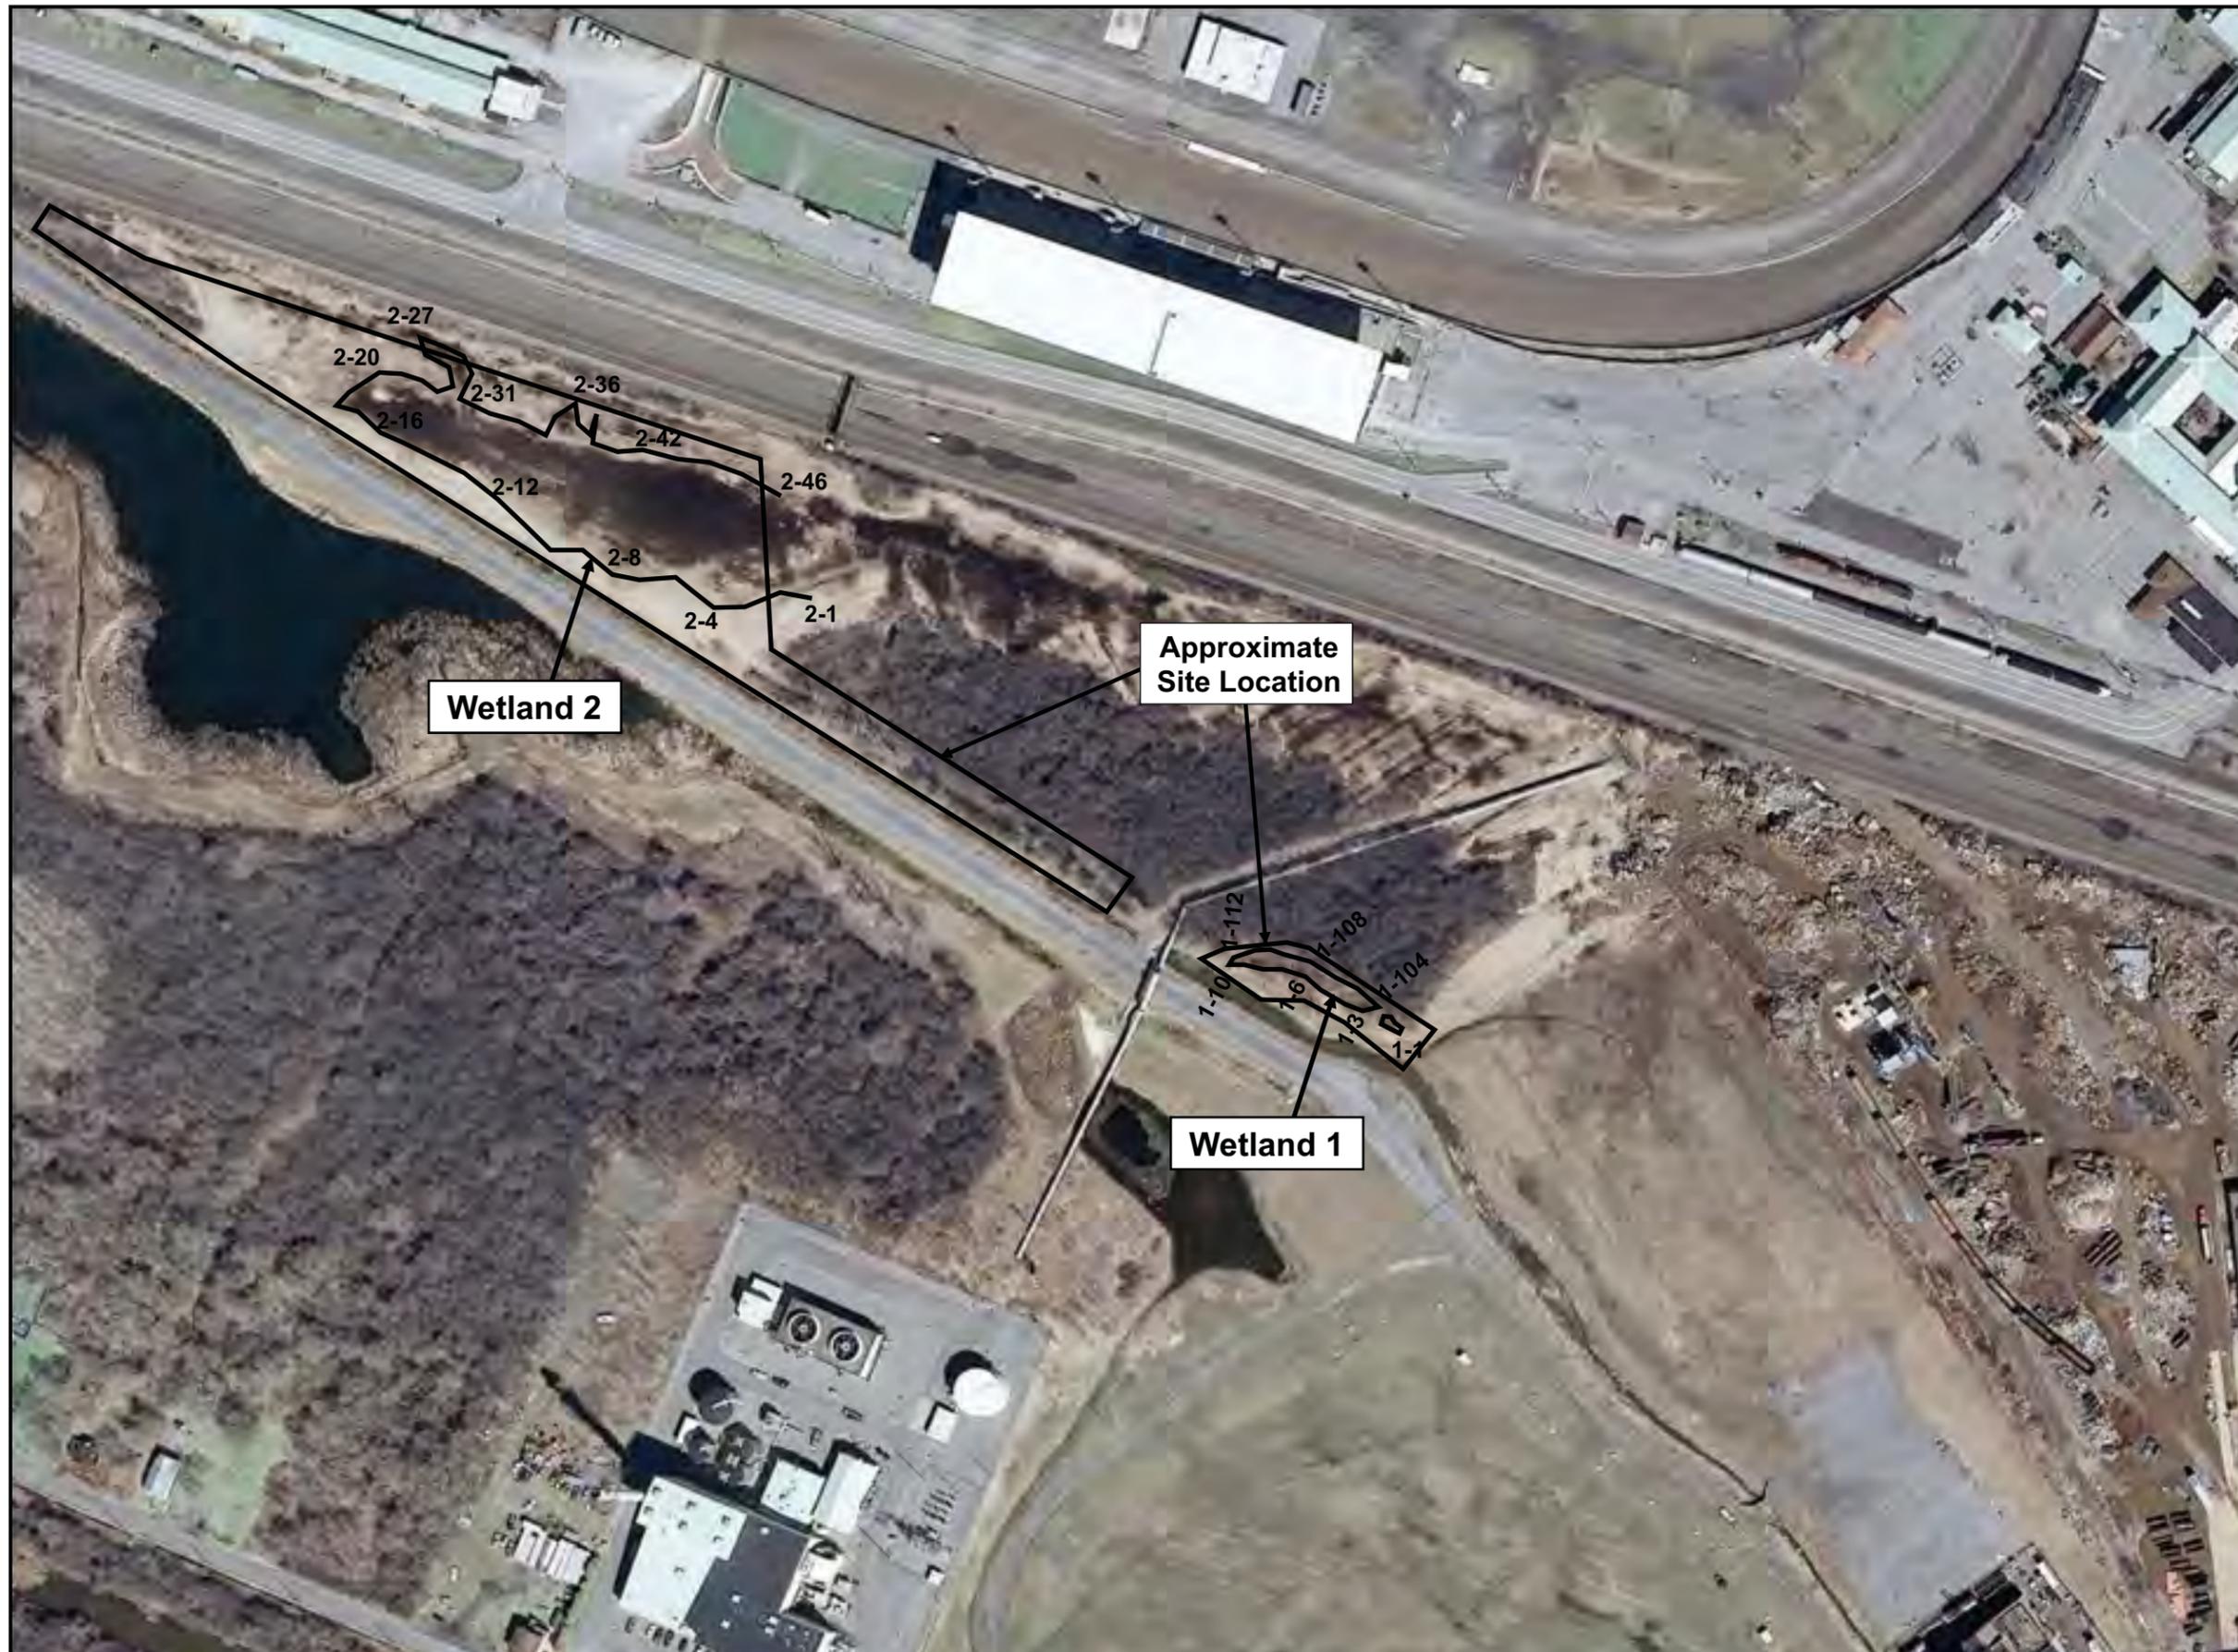
Figure 7.

2009 Aerial Photograph Showing Wetland Locations, LCP Dredge Spoil Area

Wetland 1 is a small swale approximately 0.09 acre in size, and is found in the small portion of the study area (Figure 7). Wetland 1 has two sections connected by a culvert and contained emergent wetlands. This wetland flows west into the West Flume.

Wetland 2 is approximately 1.42 acres in size, and is found along the northwest portion of the study area (Figure 7). Wetland 2 is an emergent wetland and contains no tree or shrub layers. Common reed and Pennsylvania smartweed (*Polygonum pennsylvanicum*) dominated the herbaceous layer.
