**2011 ANNUAL OPERATION, MAINTENANCE AND
MONITORING REPORT**

**LCP BRIDGE STREET SITE (OU-1)
Solvay, New York**

FEBRUARY 2013

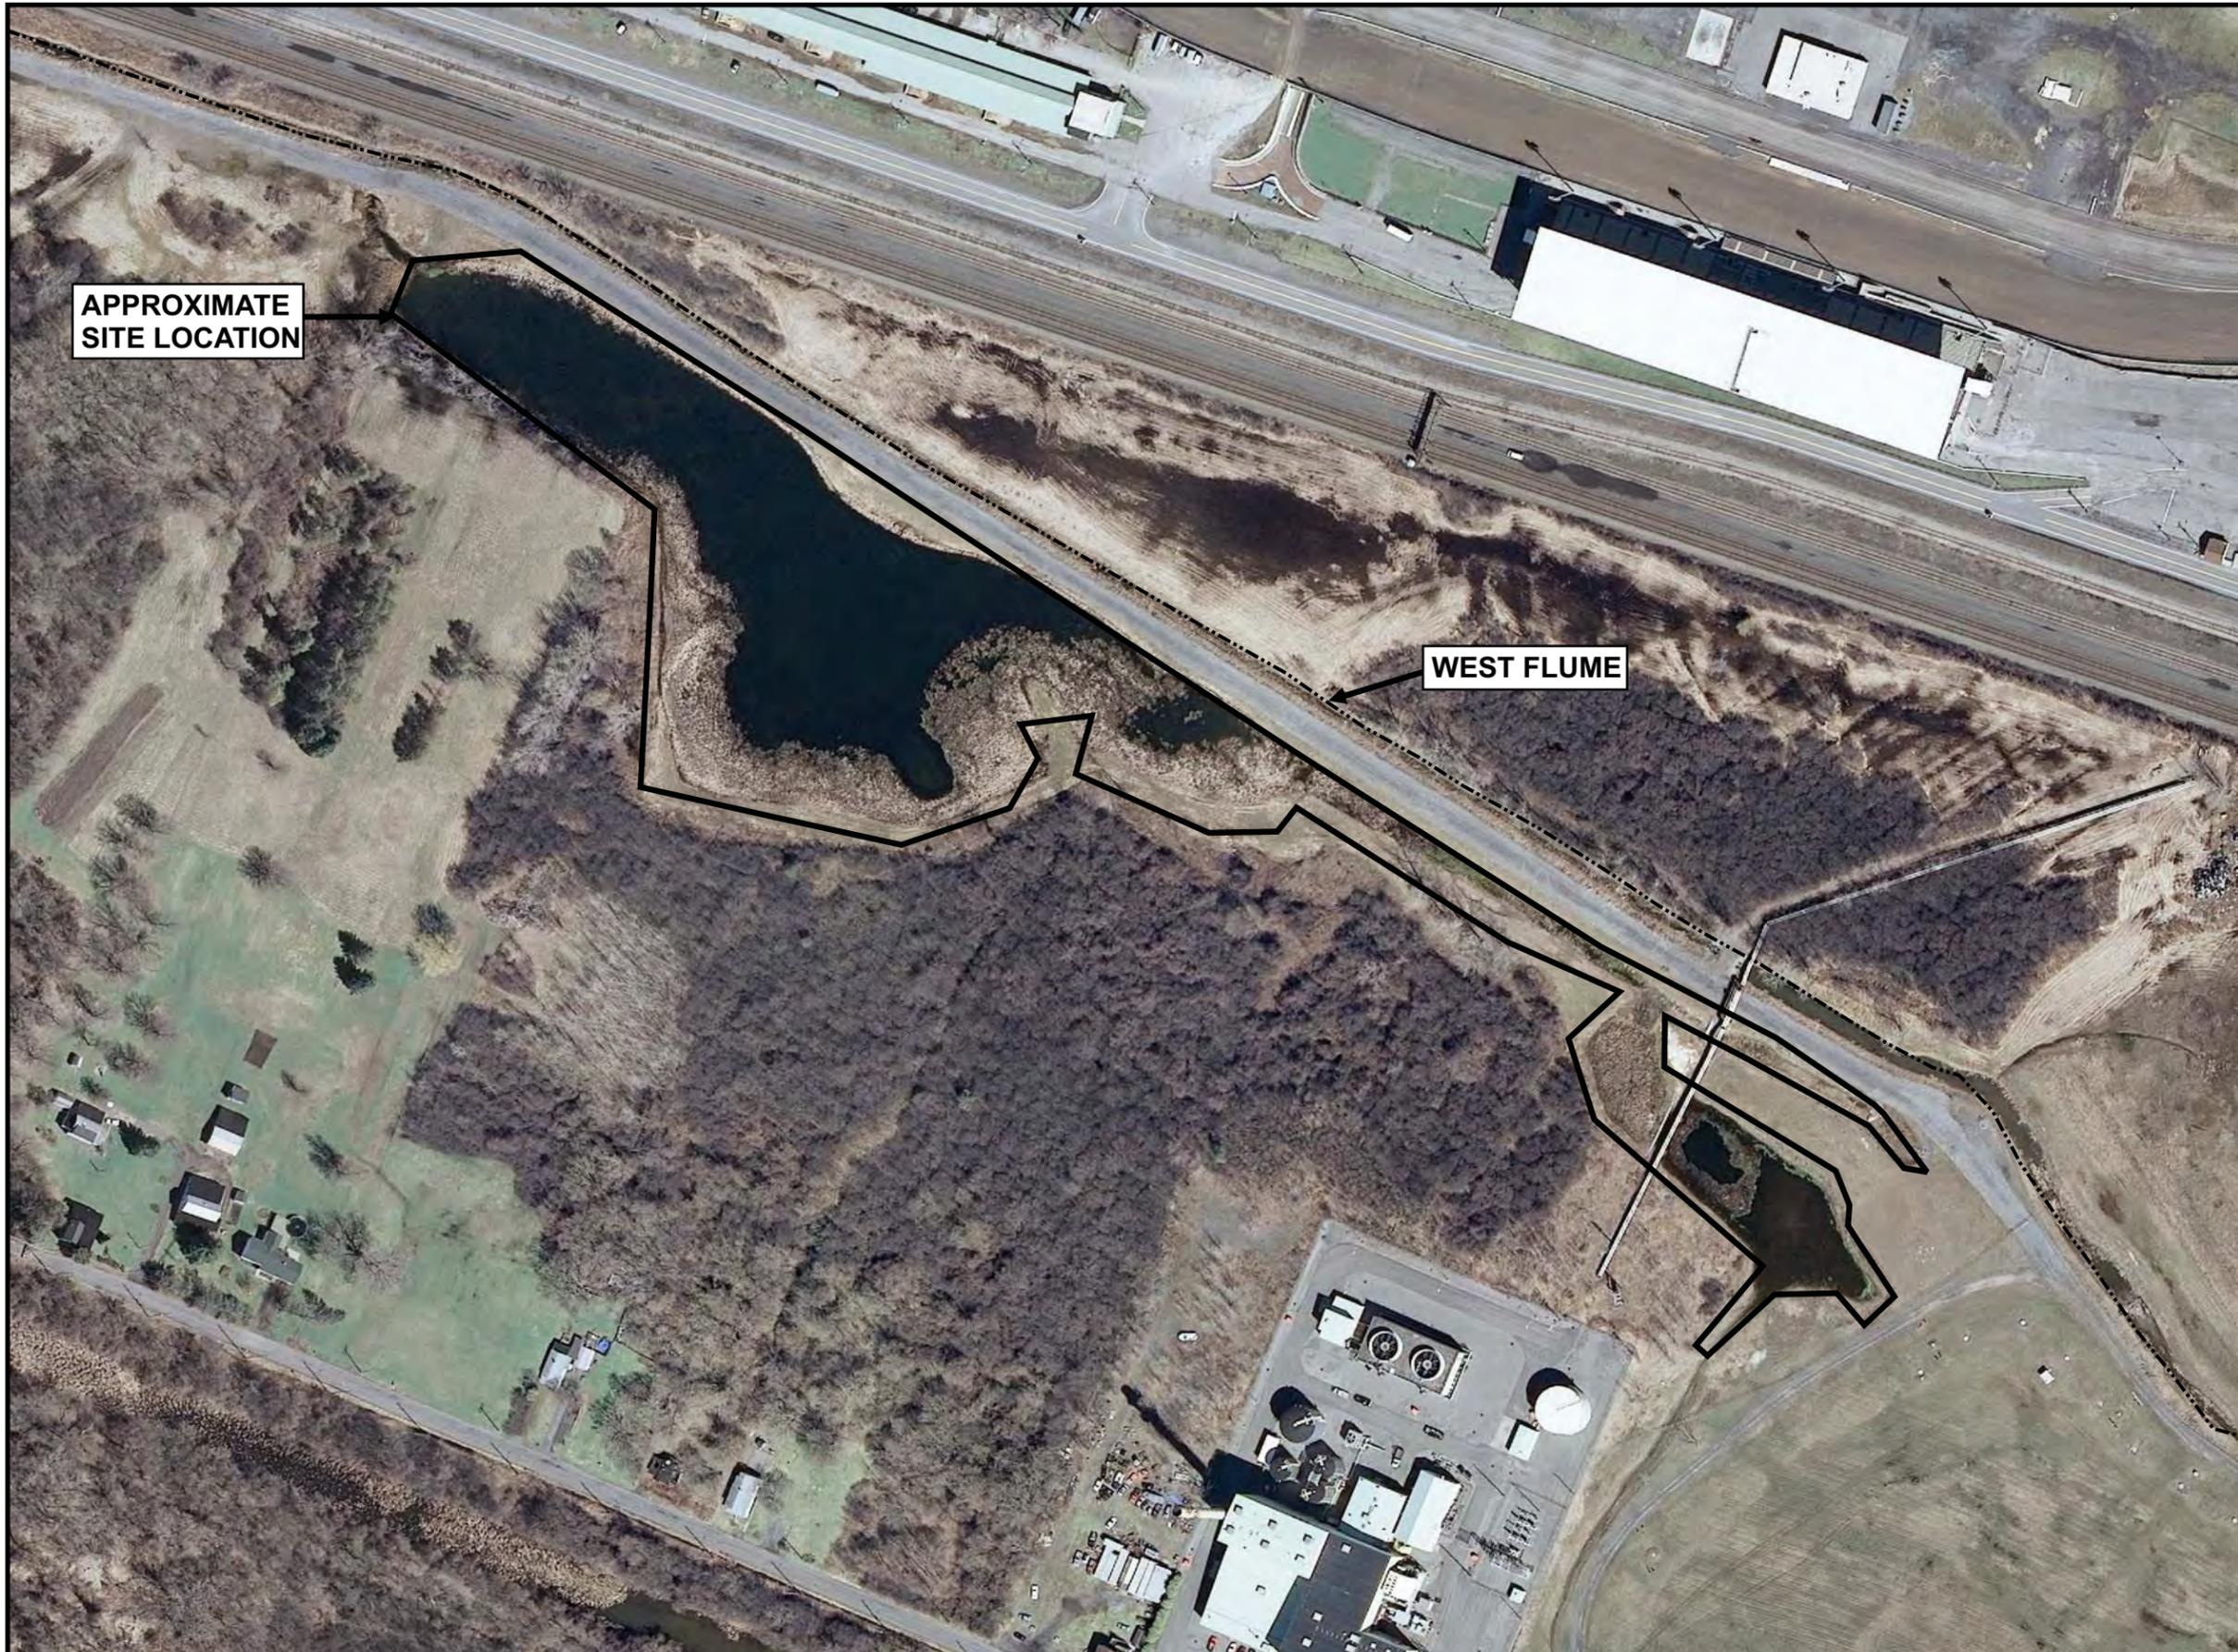
The restoration area is composed of three areas: Wetland A, Wetland B, and the West Flume. An April 2009 aerial photograph (Figure 3a) and a November 2008 oblique aerial photograph (Figure 3b) show the three areas after restoration. The post-remediation grading plan for these three areas is provided as Figure 4. Figure 6 shows the location and extent of the vegetation cover types found in the restoration areas during the 2011 monitoring effort. Plant species observed in the areas are listed in Table 4. The vegetation, hydrology, and wildlife usage of the restored areas is described in the following sections.

Figure 3a.
April 2009
Aerial Photograph
Showing
Remediation Work
(completed)
LCP Bridge Street
Restoration Area

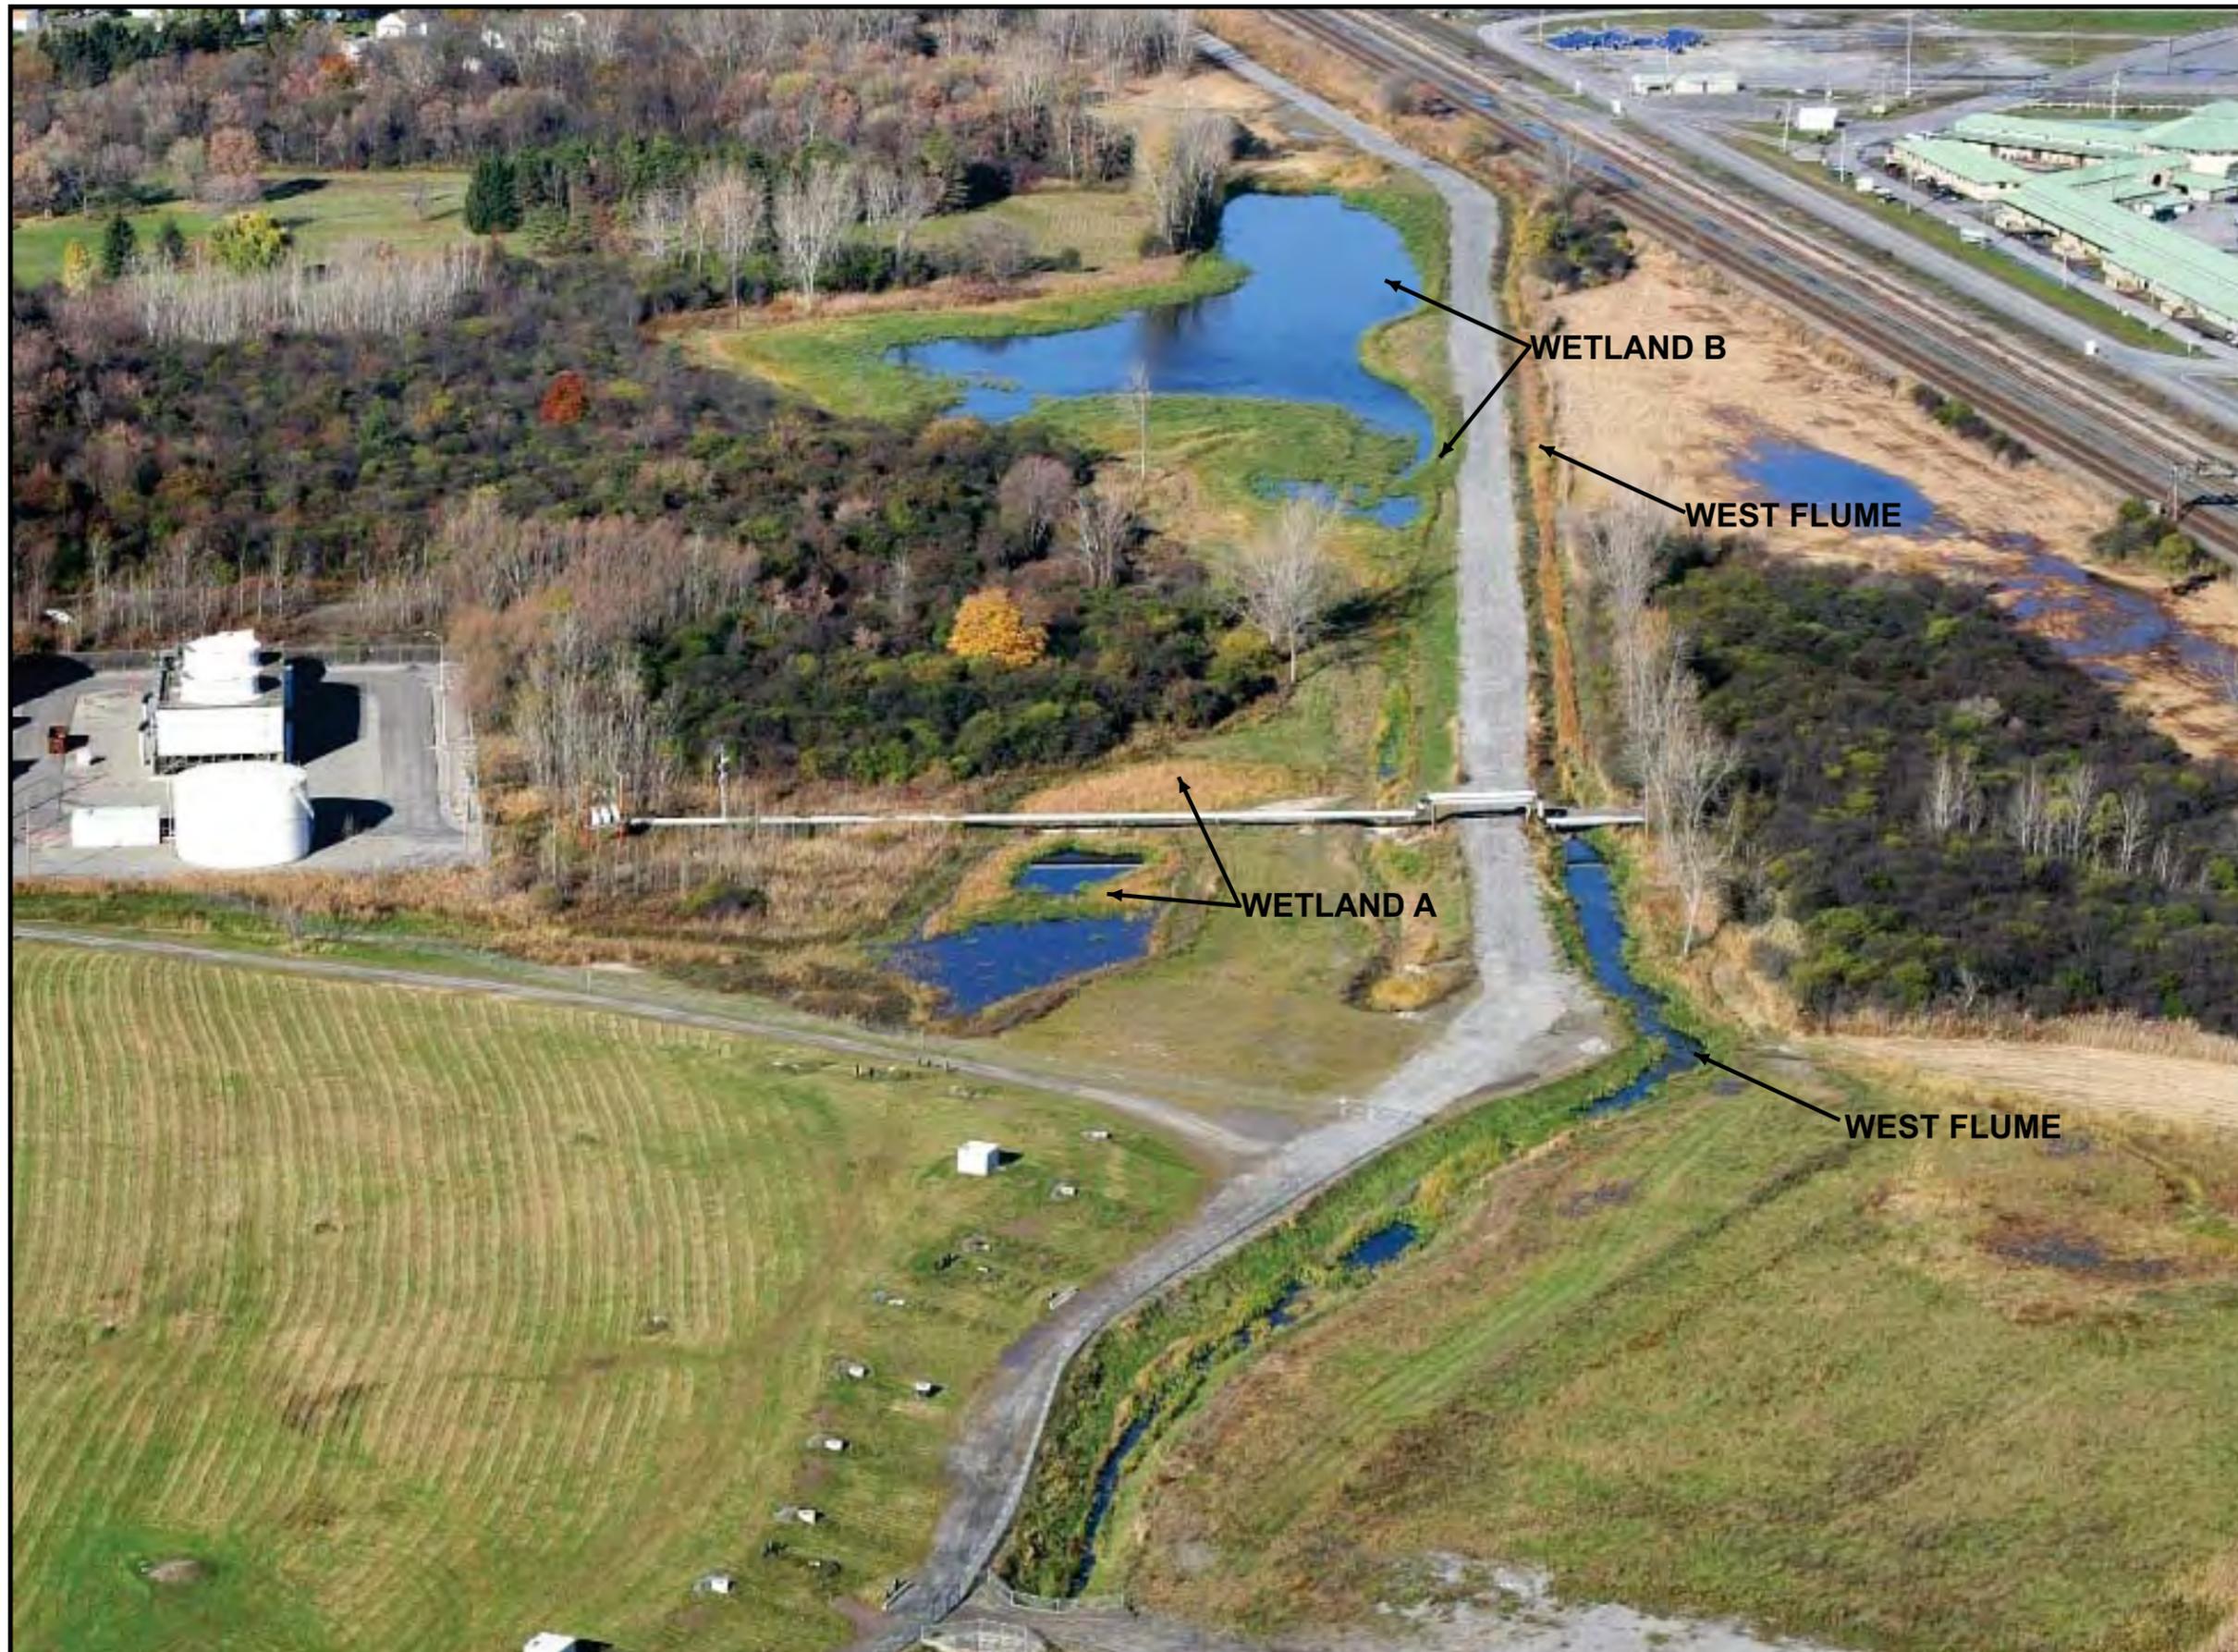
Figure 3b.
November 2008
Oblique
Aerial Photograph
LCP Bridge Street
Restoration Area
