# Final Engineering Report

*330 Maple Road Site  
Amherst, New York  
BCP Site No. C915207*

February 2012

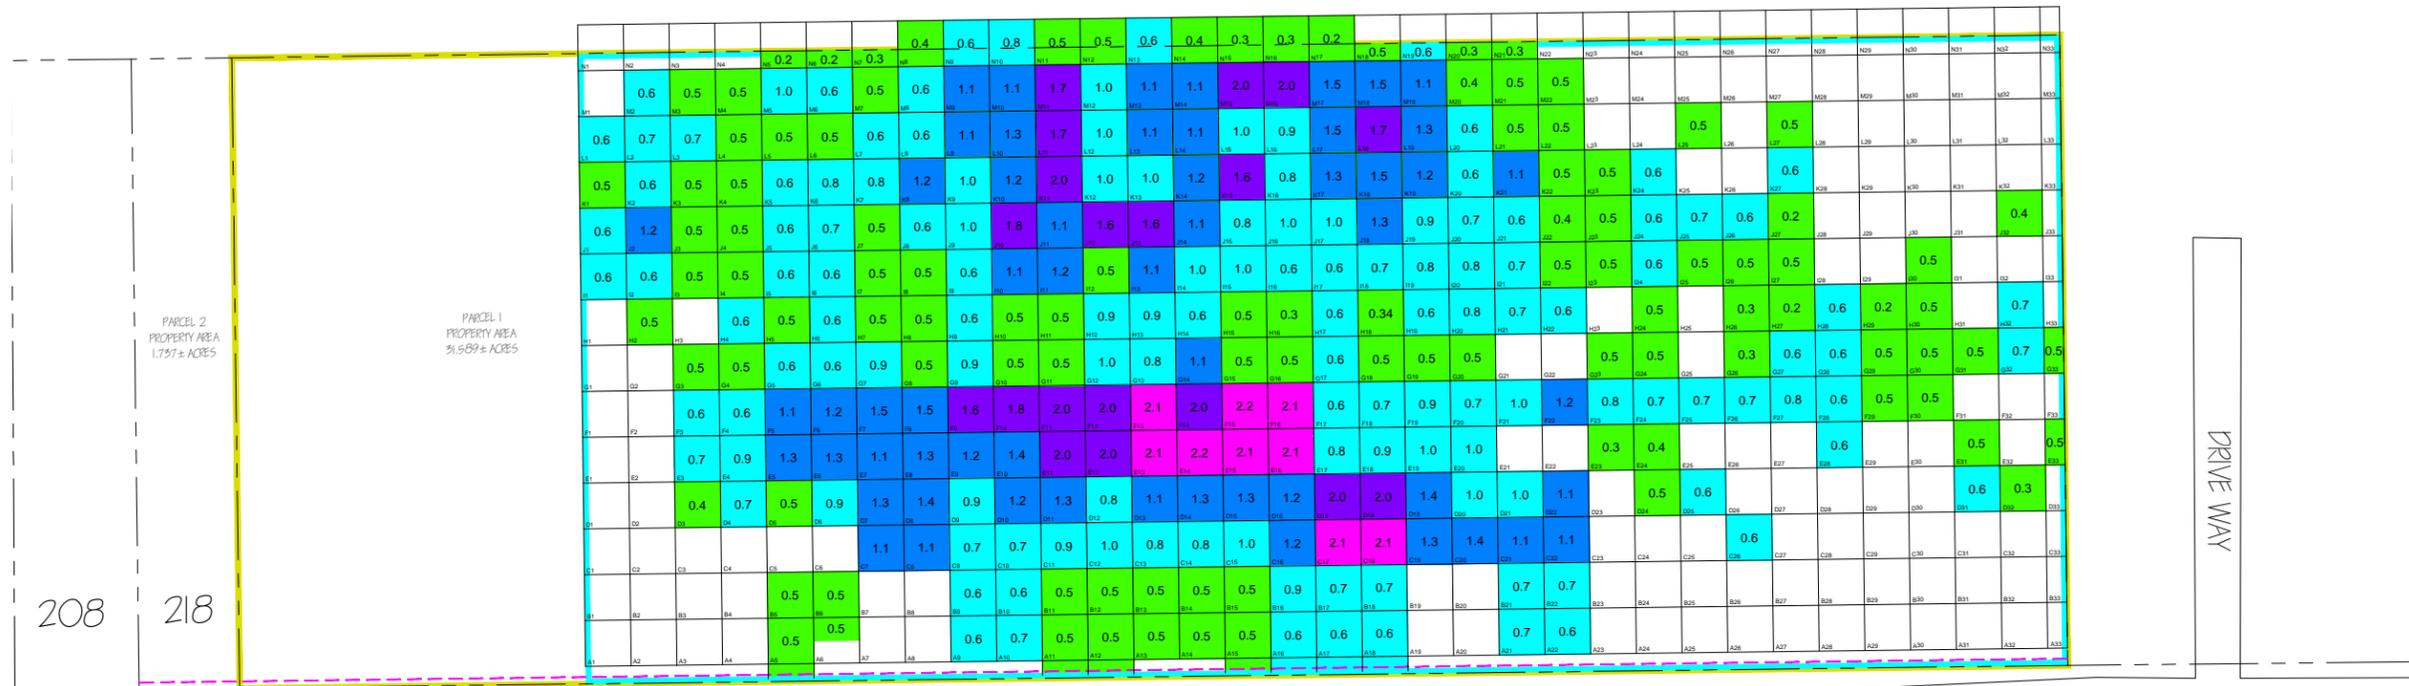
**APPROXIMATE EXCAVATION LIMITS & DEPTHS**  
REMEDIAL WORK PLAN

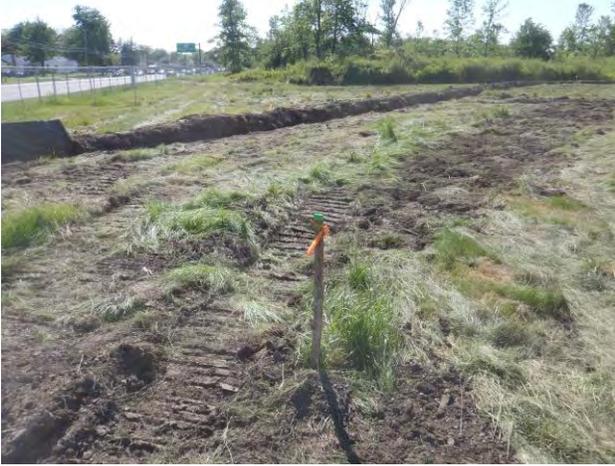
Erosion and sedimentation controls for the Site were constructed from May 31 to June 7, 2011. These controls included the use of silt fence, trenches, and berms to mitigate soil erosion damage, off-site sediment migration, and water pollution from erosion.

Photo 1: Erosion control on west side of Site (looking West).

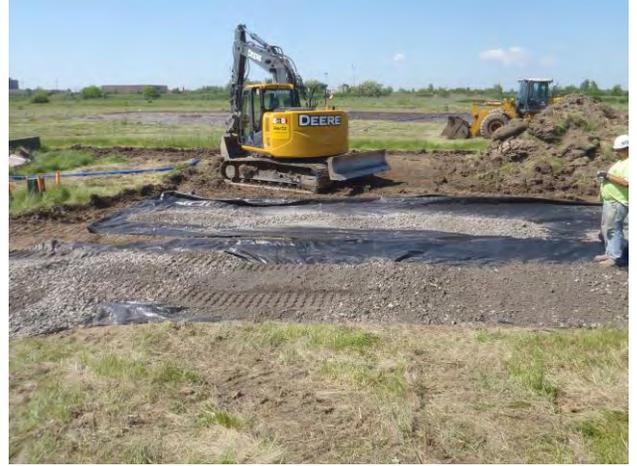
Photo 2: Cutting out impacted soil and building access road for Site (looking North).

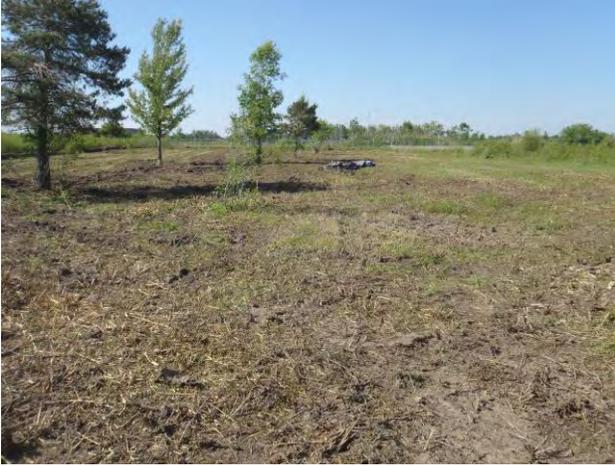
Photo 5: North east portion of the site after grubbing (looking North).

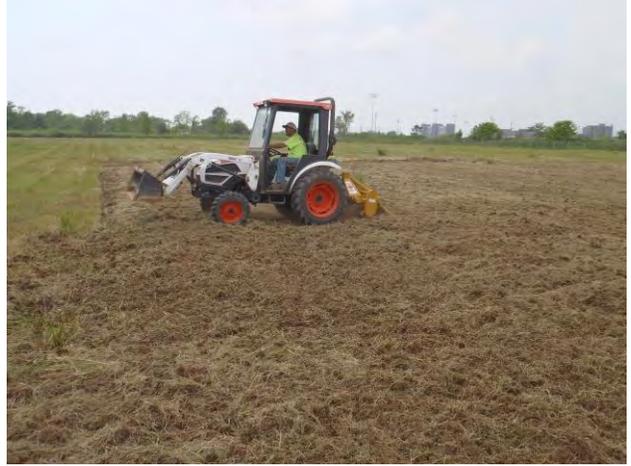
Photo 6: Roto-tilling grids to aid in lead shot recovery (looking Northwest).

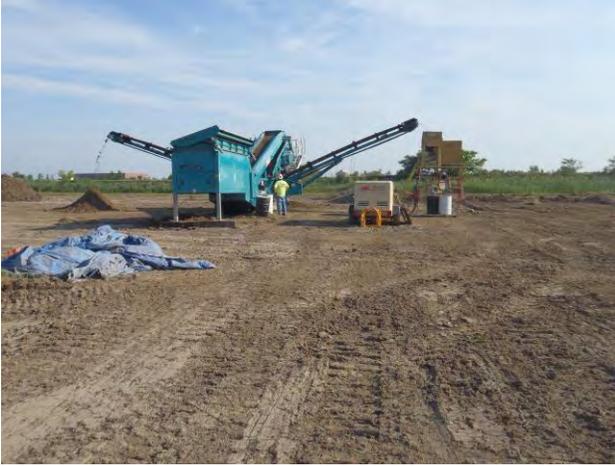
Photo 9: Screen used in lead shot recovery (looking North).

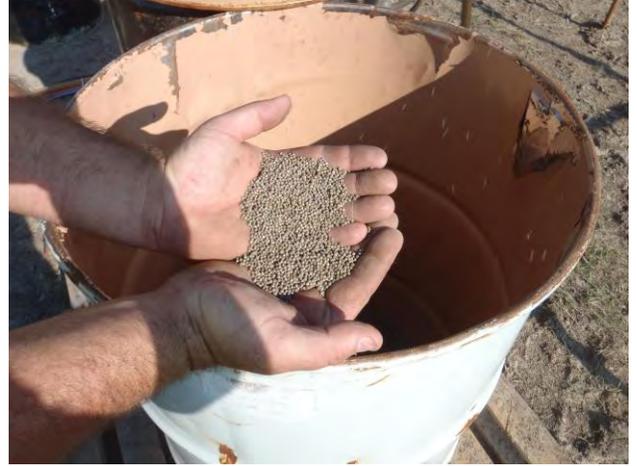
Photo 10: Recovered lead shot.

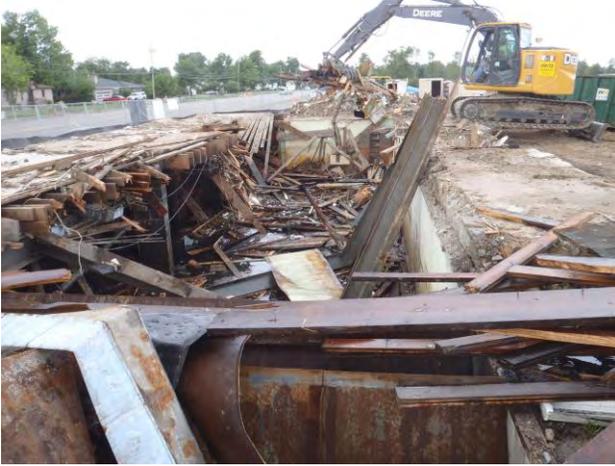
Photo 13: Club house building demolition (looking West).

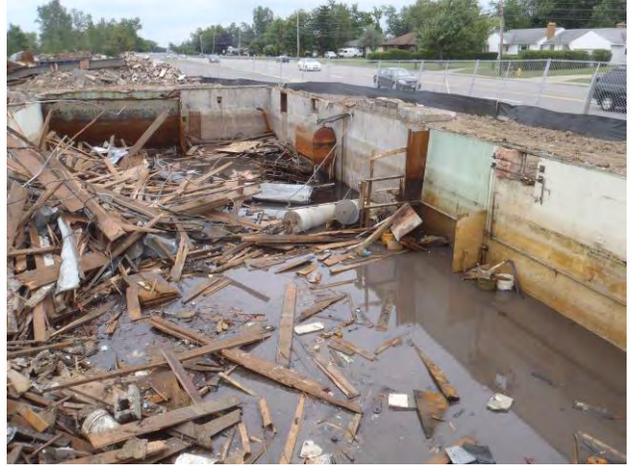
Photo 14: Fuel oil tank found in club house basement (looking East).

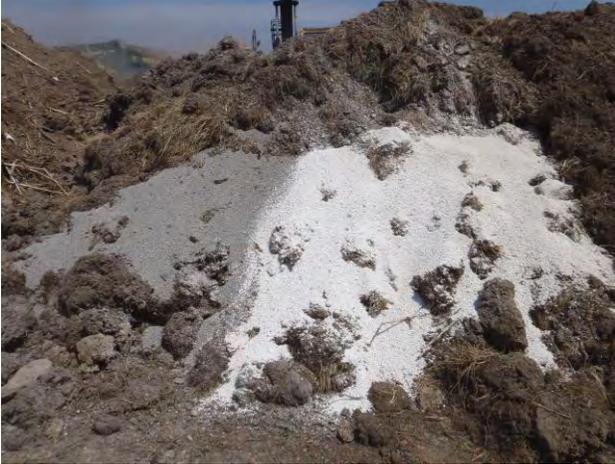
Photo 17: Soil/fill treatment reagents (Ecobond® on left and lime on right).

Between July 20 and November 29, 2011, lead-impacted soil was treated with MT2's proprietary product (EcoBond®) to render non-hazardous. Approximately 20,666-tons of lead-impacted soil required treatment to render soil non-hazardous prior to off-site

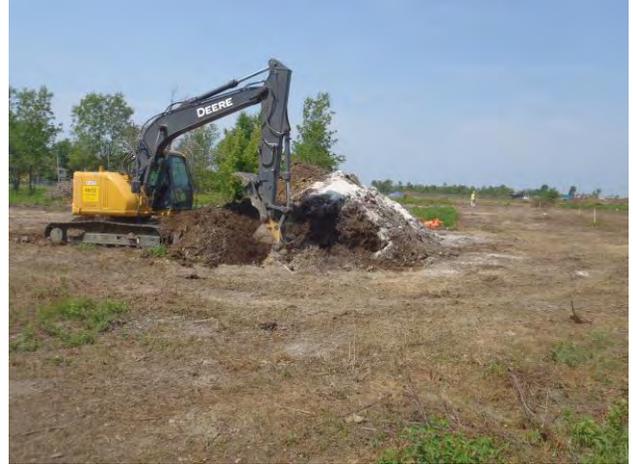
Photo 18: Mixing treatment reagents with excavator.

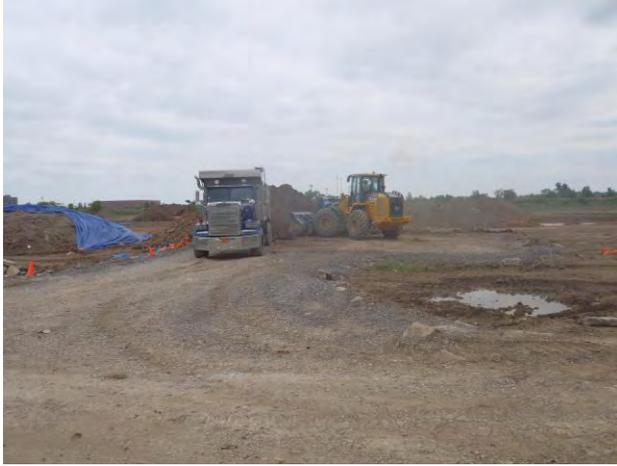
Photo 21: Loading impacted soil/fill into dump trucks (looking North).

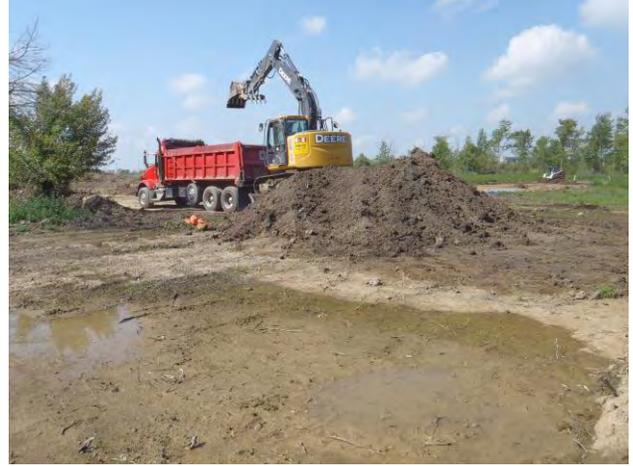
Photo 22: Loading impacted soil into dump truck.

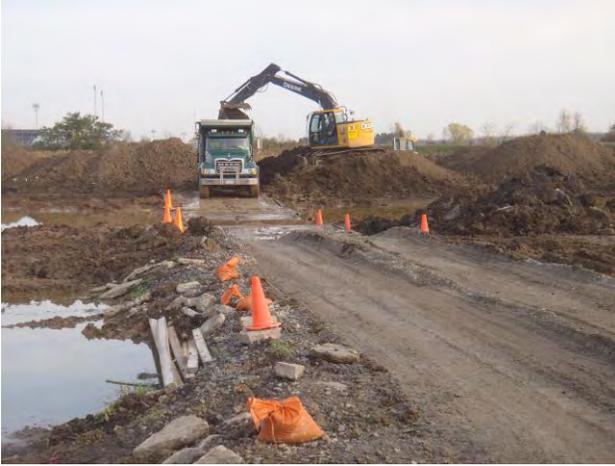
Photo 25: Loading soil/fill in to dump trucks (looking North).

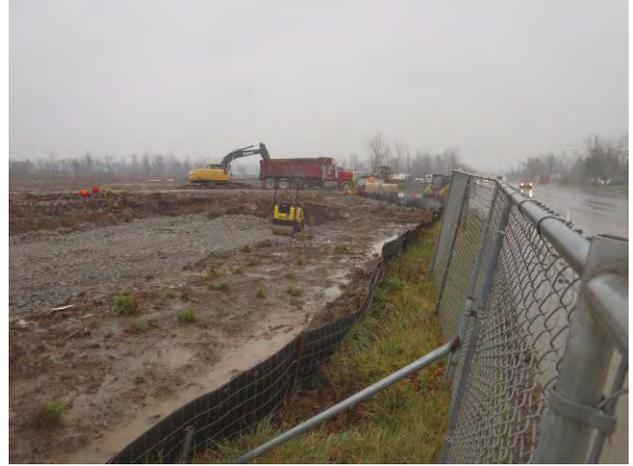
Photo 26: Club house basement being backfilled with crusher and compacted with roller (looking east).

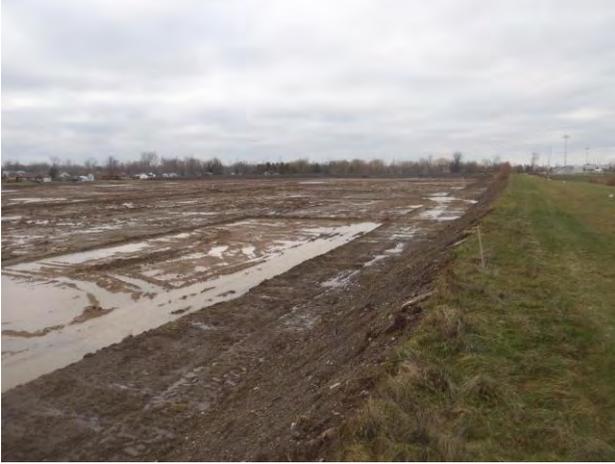
Photo 29: West side of site after excavation complete (looking Southwest).

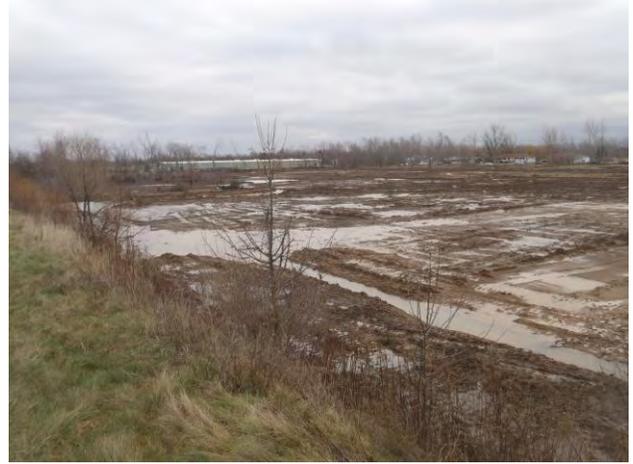
Photo 30: East side of site after excavation complete (looking Southeast).
