Former N.L. Industries
3241 Walden Avenue
Depew, New York

Final Engineering Report

**New York State
Brownfield Cleanup Program**

December 10, 2009

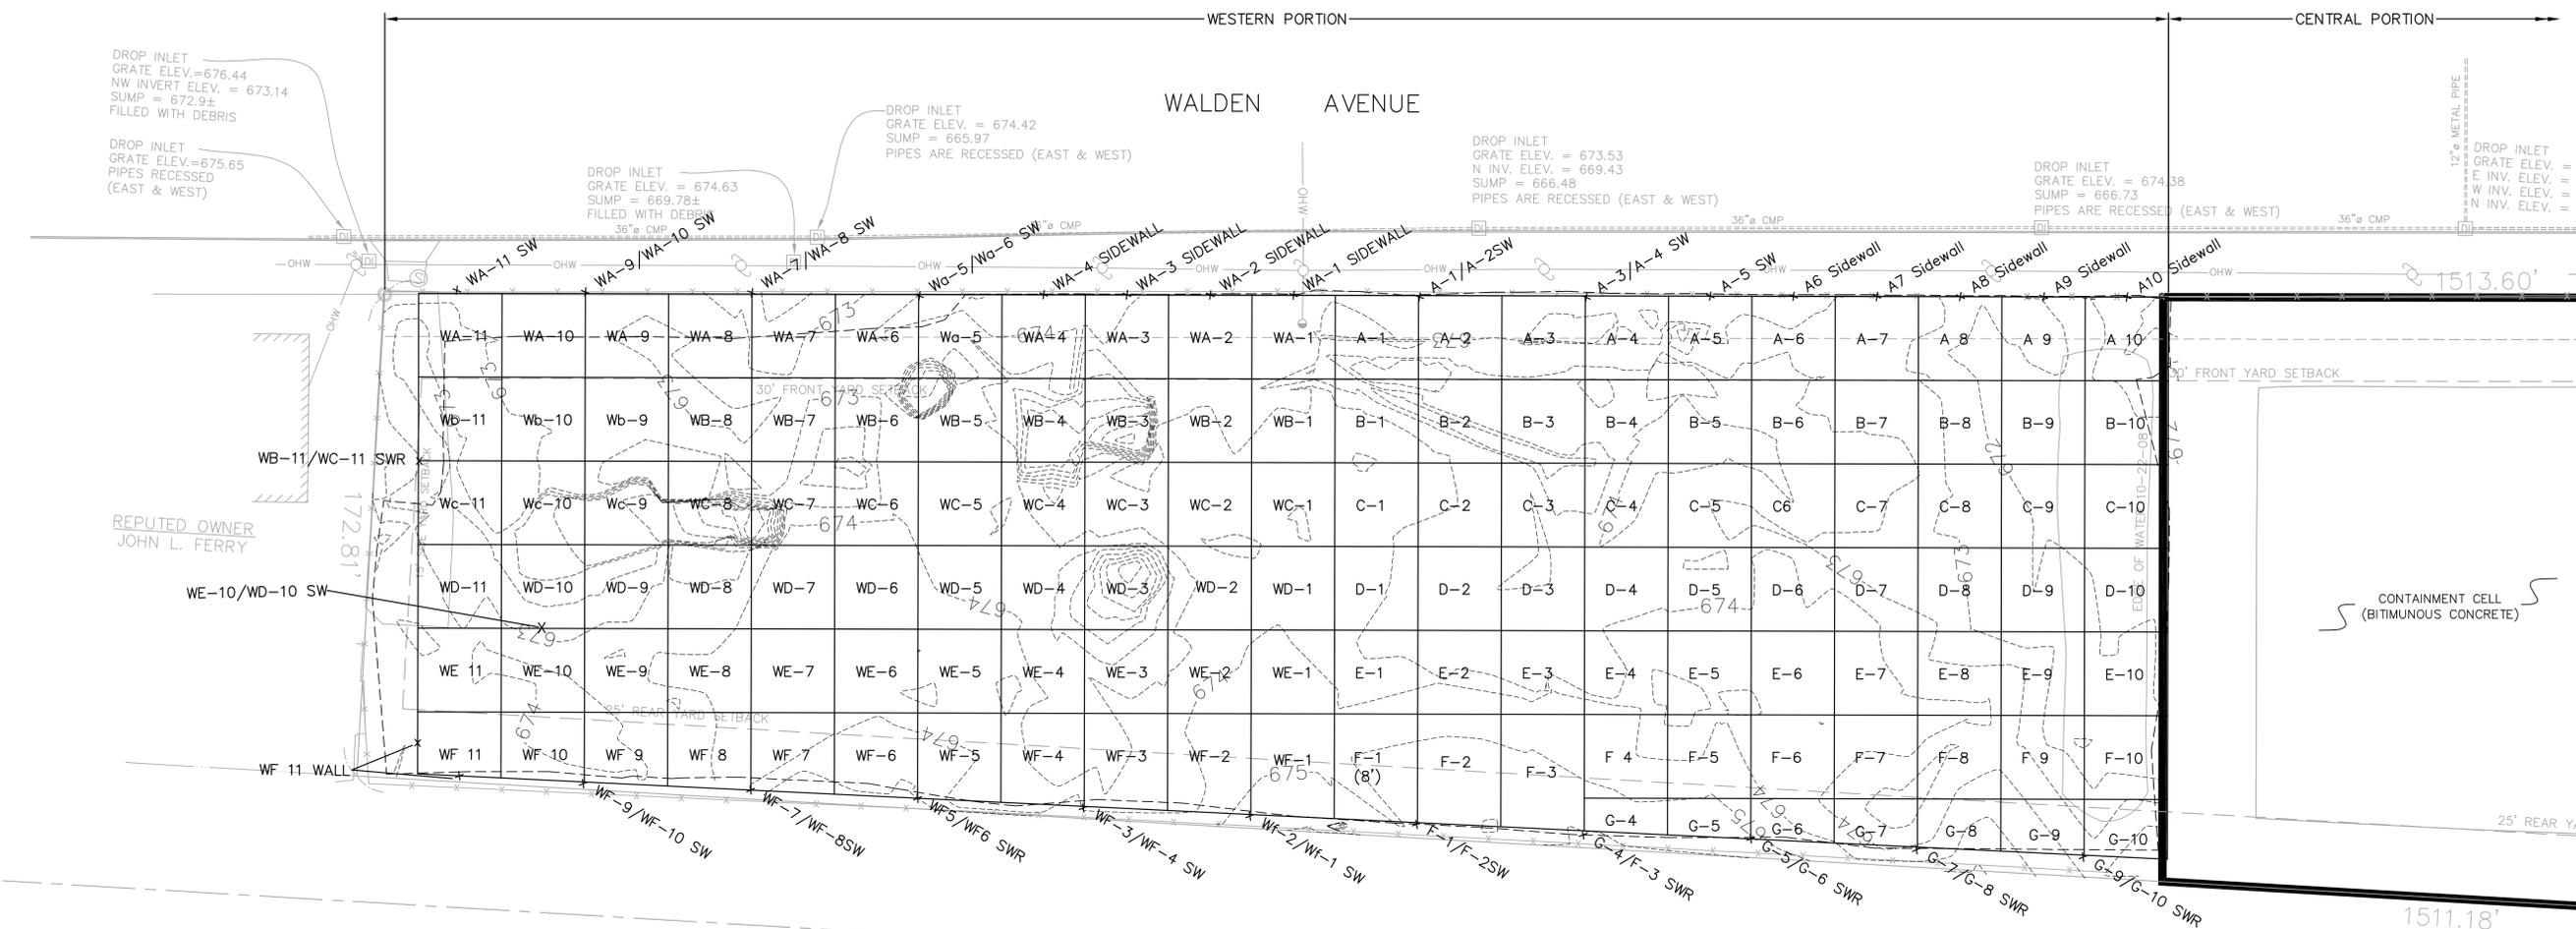
In order to track the remedial efforts efficiently, the western remediation area was broken into 30 foot by 30 foot grids. Each grid was excavated to the designated depth at which time a confirmation soil sample was collected from the floor of the excavated grid. Soil samples were collected from the base of each of the excavations on a grid basis. Wall soil samples were only collected from the perimeter grids, which were typically located along the property boundary. Wall samples were collected at a 60 foot spacing interval. Figure 3 depicts the locations of remediation grids and the final topographic survey of the remediation area at the time the closure samples were collected.

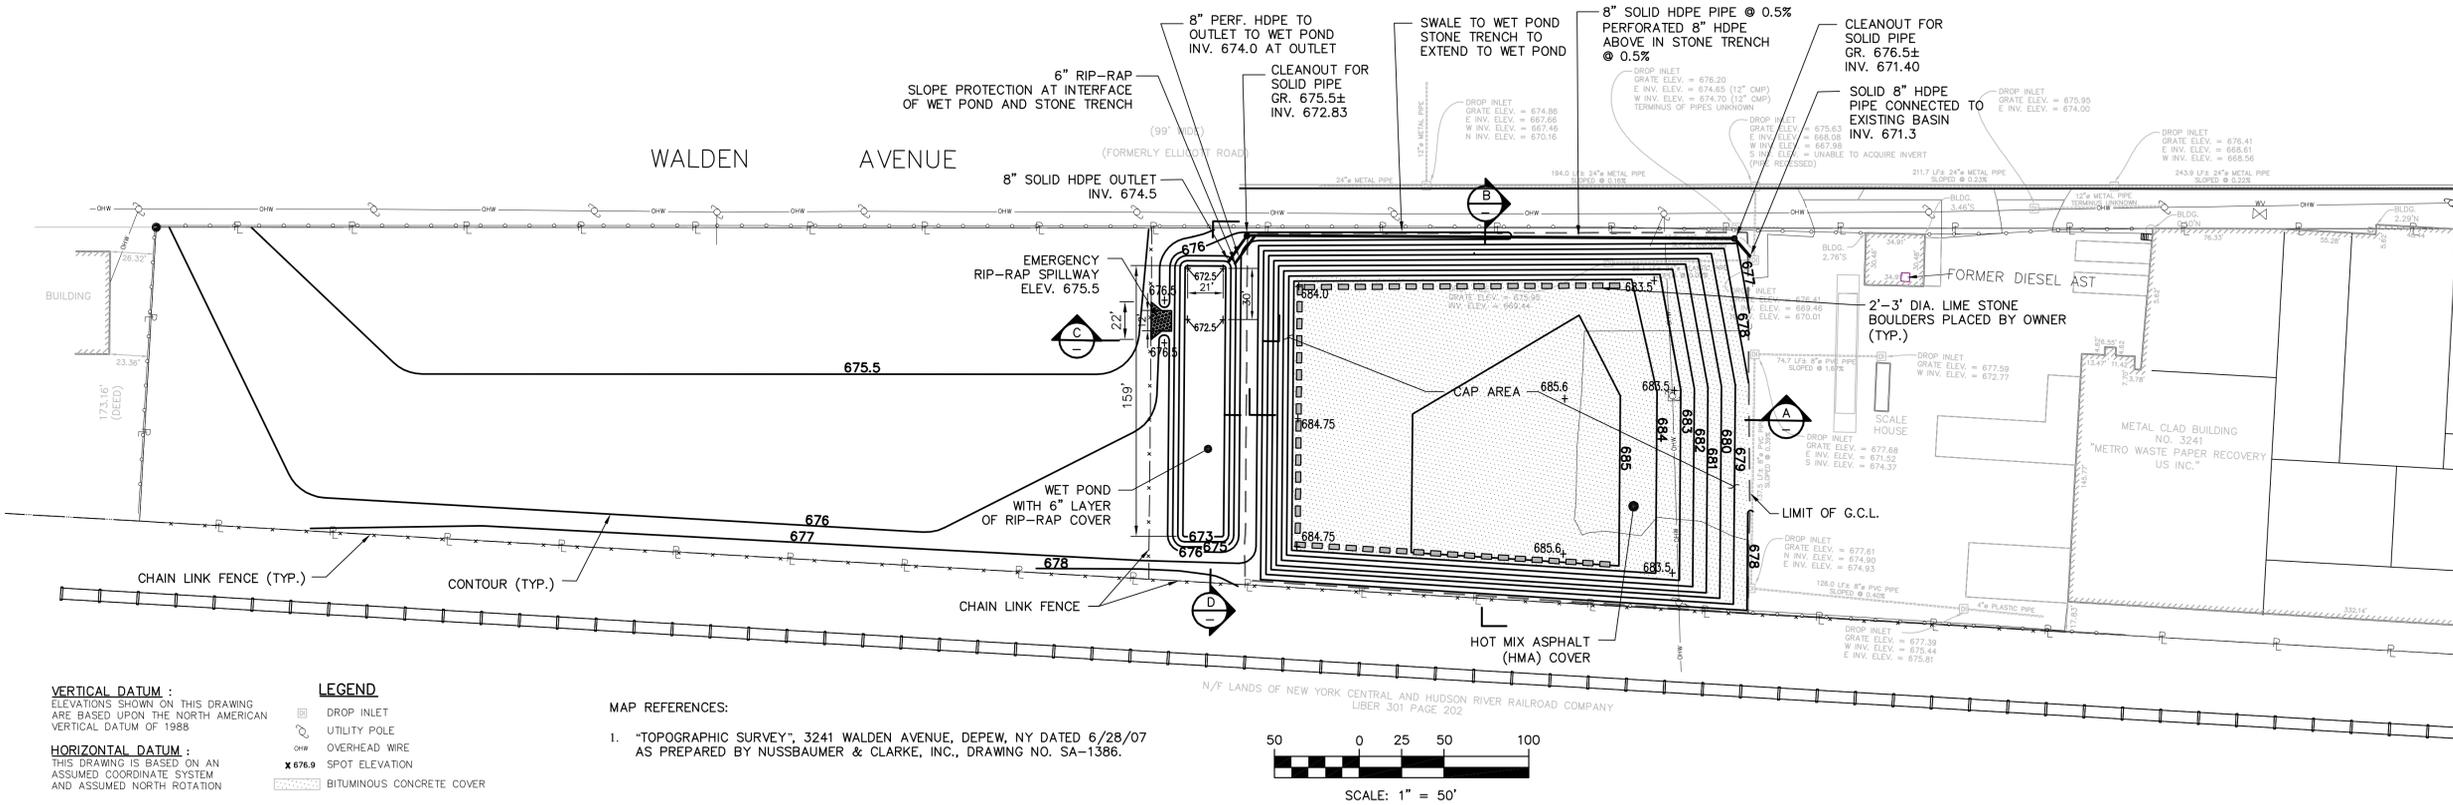
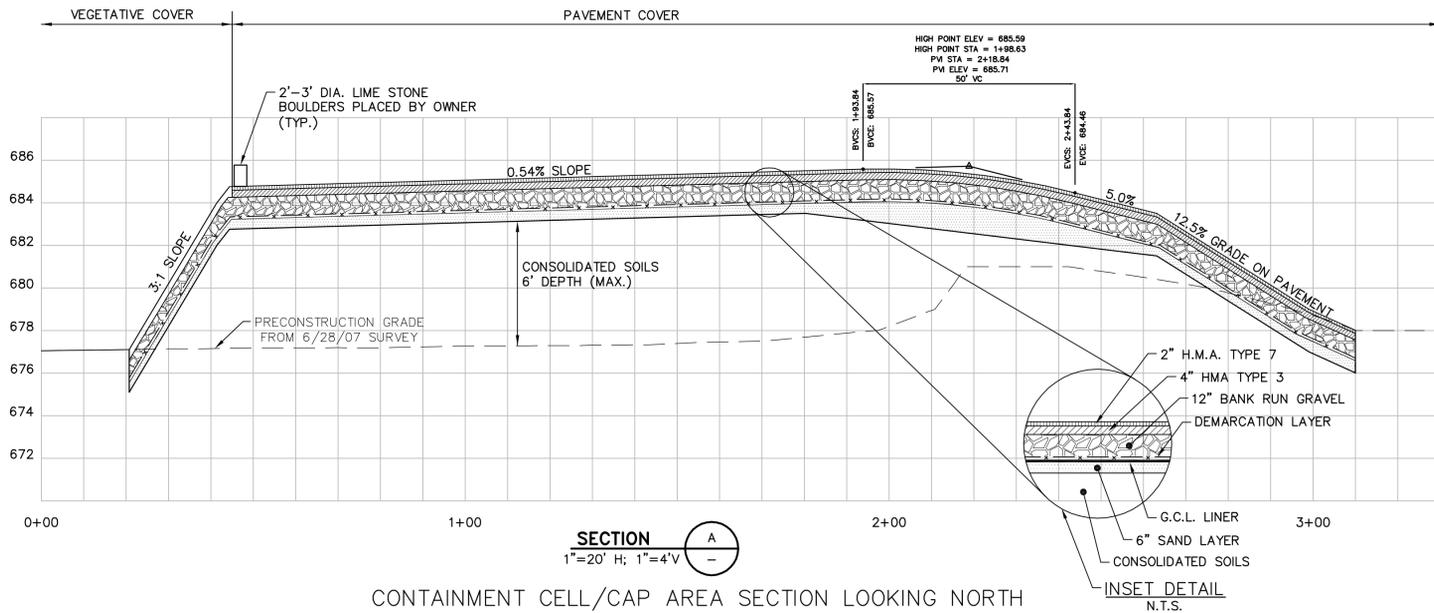
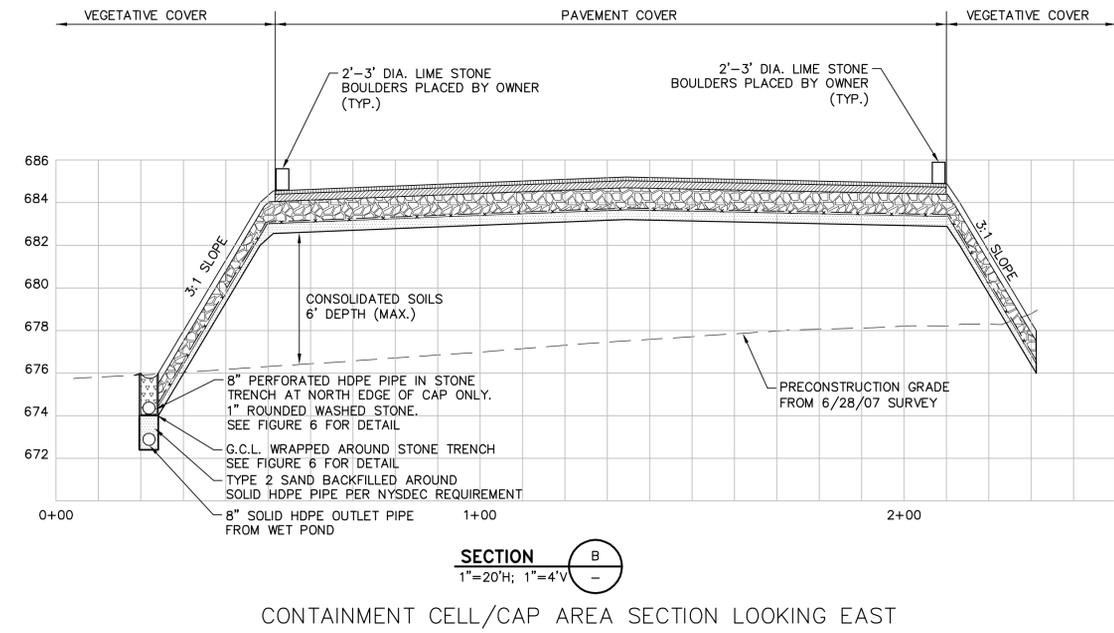
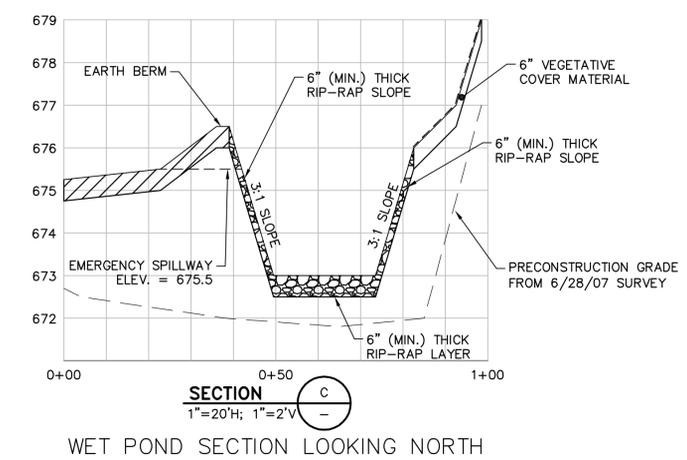
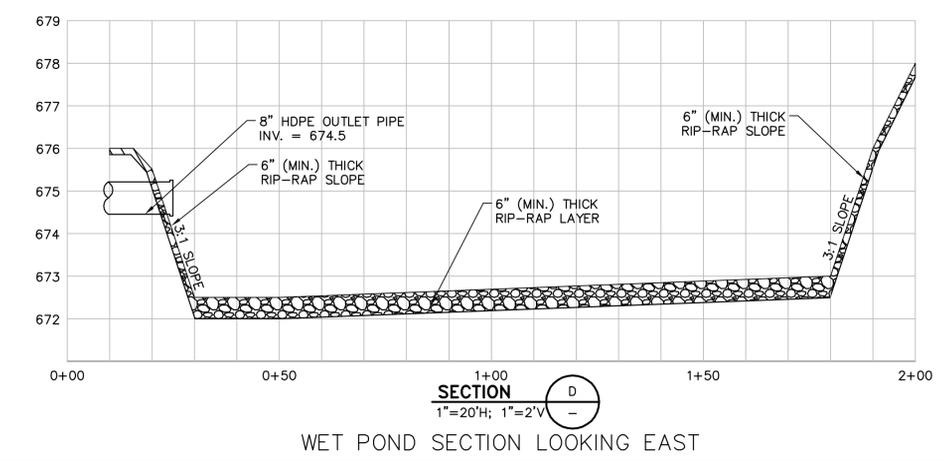
Tighe & Bond Inc. j:\C6254 - former n\Drawings\0_Current\Sheets\FER-126254-04.dwg Layout Name: Figure 5 Plotted by: DSH Plotted on: Nov 25, 2009 - 2:14pm

Based on the revised design, stormwater runoff from the top of the capped area will now primarily flow towards the west and northwest, with the exception of the east ramp. Runoff that flows toward the east will be collected by the existing catch basins in the paved parking area. The area flowing to the east has been sized such that the flow to the existing catch basins is the same under post-construction conditions as it was under pre-construction conditions. Runoff that reaches the south and west slopes of the capped area will be directed to the detention basin through site grading. Runoff that reaches the north slope of the capped area will be intercepted by a stone trench and pipe that will direct runoff to the west and into the detention basin. Stormwater runoff
