**CULTURAL RESOURCE MANAGEMENT REPORT
PHASE 1 RECONNAISSANCE SURVEY**

ONONDAGA LAKE PROJECT, UPLAND AND SHORELINE AREA

LAKESHORE COMPLEX

**TOWN OF GEDDES
ONONDAGA COUNTY
NEW YORK
MCDS 06707**

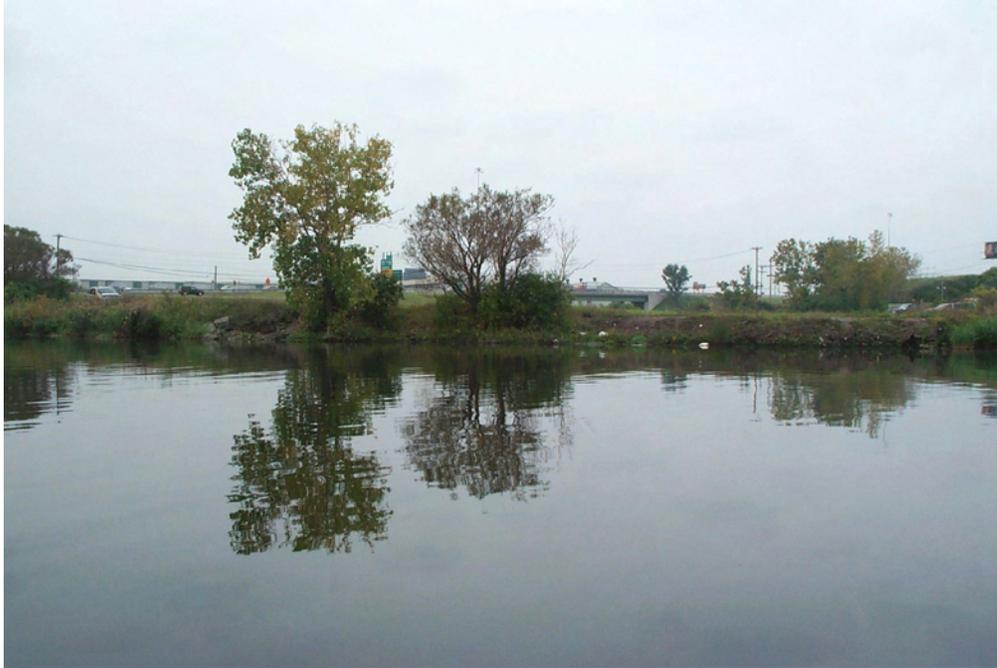
Photo 1. Facing west, shore of present day boat launch area and former location of Syracuse Yacht Club (from Hohman 2004).

The area of potential effect (APE) for the Lakeshore Complex covers approximately 4.4 acres (1.8 hectares) along the western shoreline of Onondaga Lake in the Town of Geddes, Onondaga County, New York (Photos 1-2, p. 13). The proposed impacts include the construction of an asphalt parking and driveway; an asphalt parking lot; a gravel parking lot; a public access kayak launch; a building for the Onondaga Lake Operations Meeting Space; a project support building; and an area for construction support (Figure 14, p. 22). The maximum impacts for any buried utilities and foundations will be 1.2 m (4 ft) below the surface (Petroni, pers. comm 2011).

The Syracuse Yacht Club was constructed between 1898 and 1899 on the western shoreline of Onondaga Lake to the south of Lake View Point. The yacht club consisted of a large clubhouse, as well as several boat houses, all of which were built on wooden piers driven into the lake bottom (Figures 7-8, p. 12). At a cost of \$30,000, the clubhouse was a massive wooden structure (more than two stories in height), which became one of area’s leading social centers. Luncheons and dinners were served daily to a membership that reached 2,000 at one time. By the 1910s, the yacht club also served as a boarding house. On May 10, 1917, a fire destroyed the clubhouse, reducing the large structure to ashes on top of the wooden piers. Nothing was salvageable within the clubhouse. At that time, there were up to 25 boarders within the clubhouse building. The boathouses, which did not burn during the fire, were used for several more years by owners who joined the Onondaga Yacht Club at the southeastern portion of the lake (Thompson 2002). Although it is not known how long these boathouses were used and what became of them, it is likely that they fell into disrepair and collapsed into the lake.

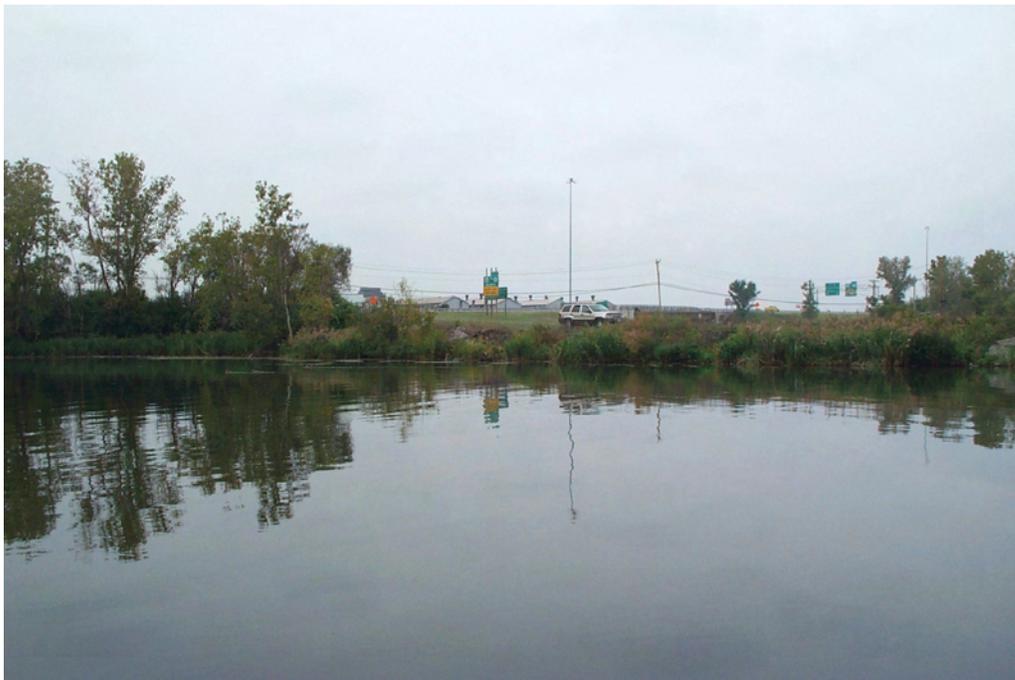
Photo 2. Facing northwest, shore of boat launch area and former location of Syracuse Yacht Club (from Hohman 2004).
