Prepared by:
AECOM
Latham, NY
Project 60222364
January 2012

Construction Completion Report
Farmingdale Plaza Cleaners Site
Soil Vapor Extraction Interim Remedial
Measure
Farmingdale, New York
NYSDEC Site No. 130107

FARMINGDALE PLAZA CLEANERS SITE SOIL VAPOR EXTRACTION IRM NYSDEC SITE ID 1-30-107 Town of Farmingdale, Nassau County New York

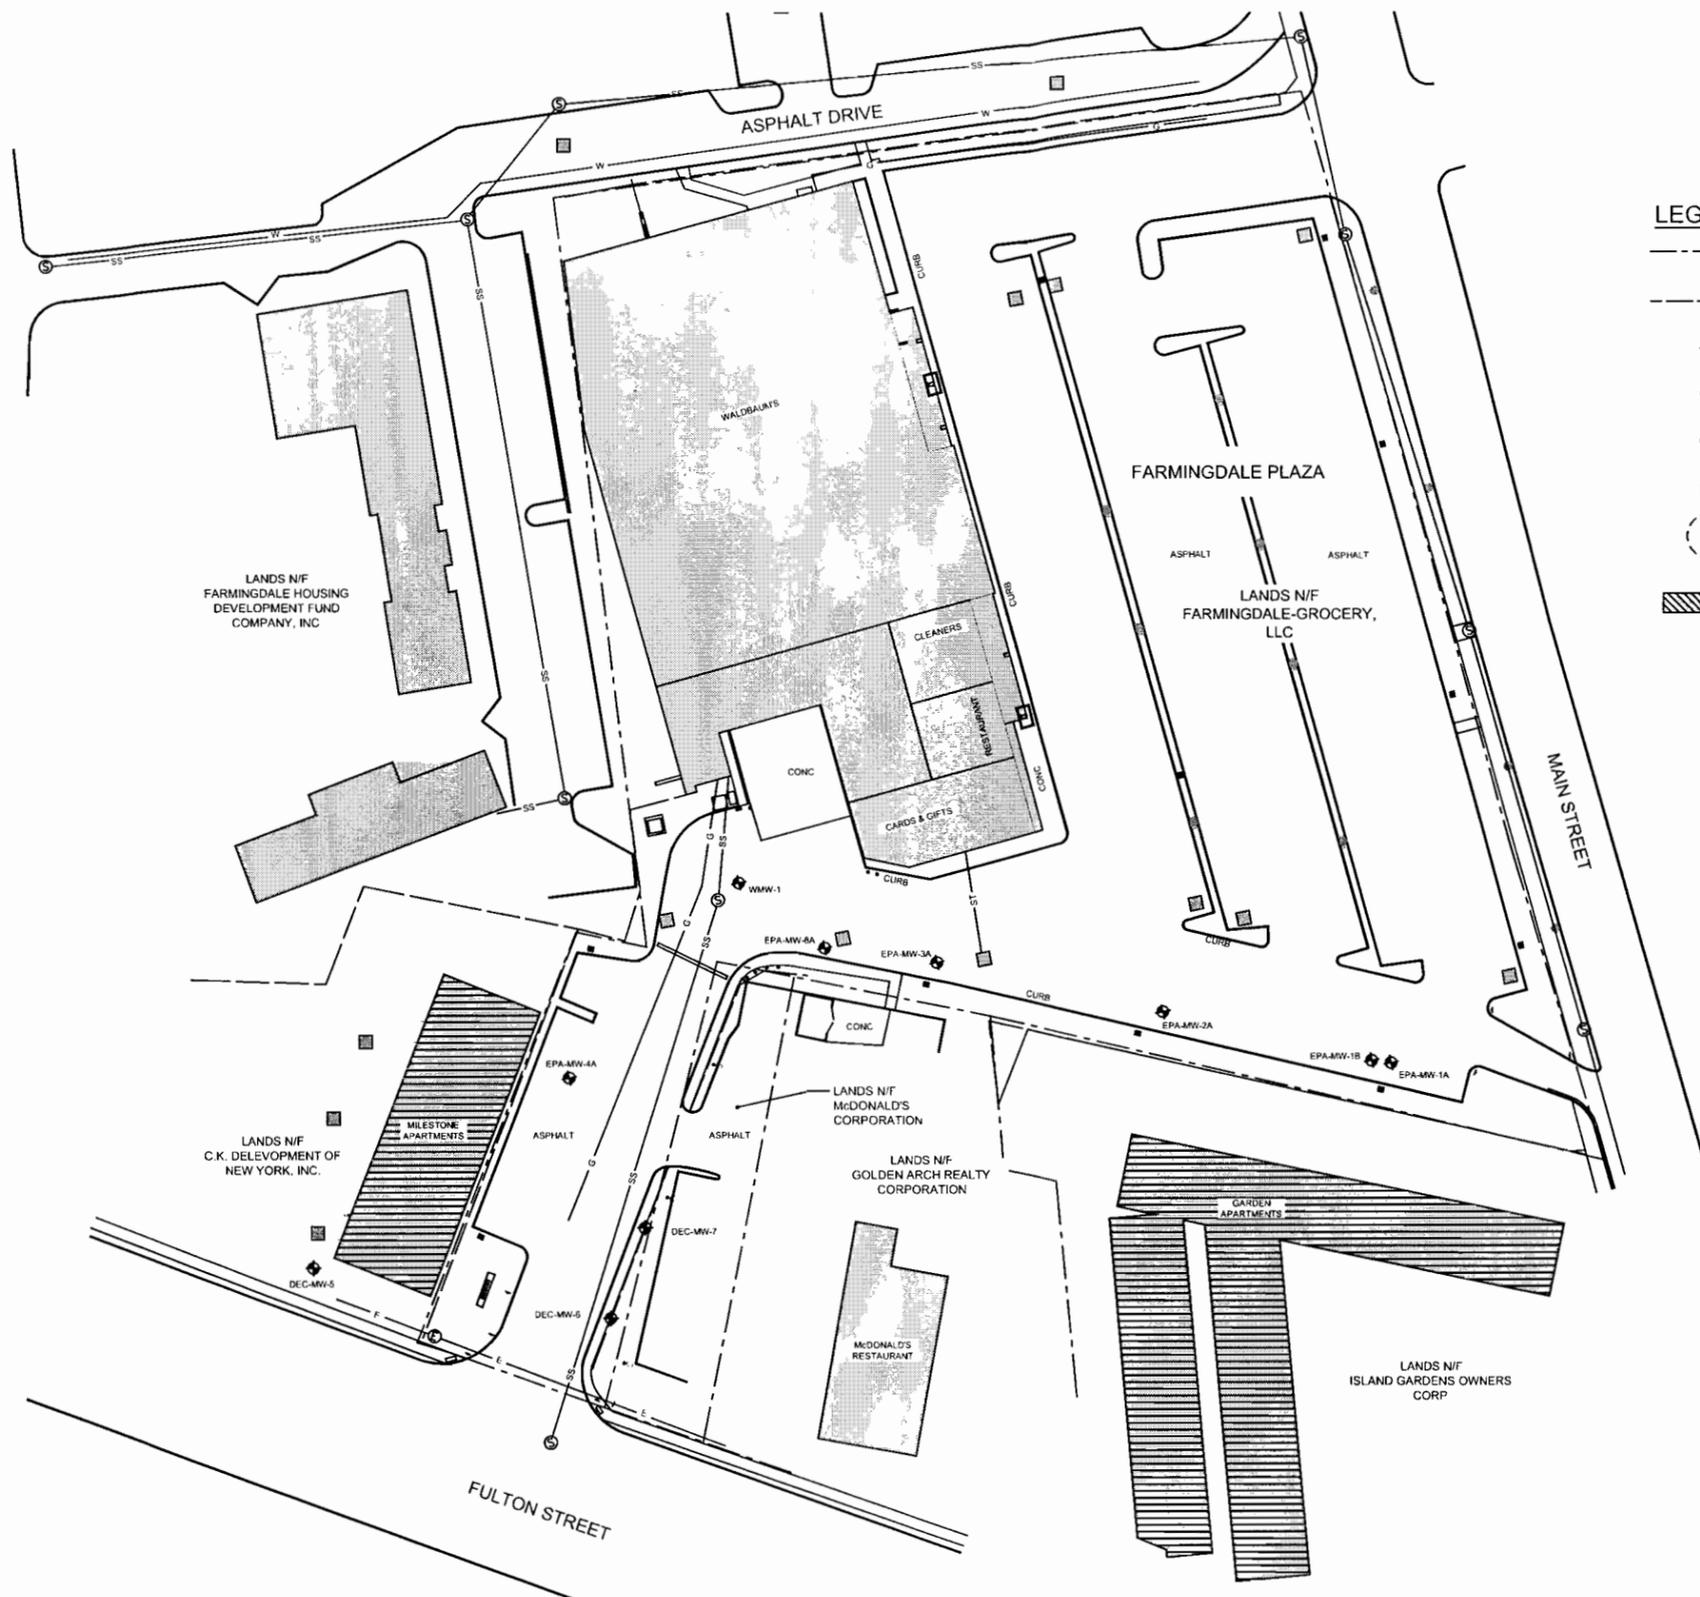
PROJECT START DATE (M/Y)	DECEMBER 2011
PROJECT NO	60134071
FILENAME	
SHEET NO	2
DRAWING NO	2

- APPROXIMATE PROPERTY BOUNDARY
- FENCE
- ◆ MONITORING WELL
- ⊙ SANITARY SEWER MANHOLE
- ⊙ ELECTRIC MANHOLE
- CATCH BASIN (DRY WELL)
- AREA OF SVE TREATMENT
- ▨ AREA OF POTENTIAL SUB-SLAB DEPRESSURIZATION SYSTEM TREATMENT

A pilot study was performed in early 2009 at four SVE wells (SVE-1 through SVE-4). Locations of these wells are shown on Drawing 2. The pilot study was summarized in the 30% design document and was included with design specifications as part of the bid package for remedial construction. High flow rates (85 to 300 scfm) were applied on these four SVE wells and corresponding radius of influence (ROI) varied from 35 feet to 110 feet. In 2011, an IRM work plan was prepared for design and installation of the SVE system at the Farmingdale Plaza, and SSDS at Garden Apartments and McDonalds. The SSDS was planned to be designed after installation of the SVE system if needed.

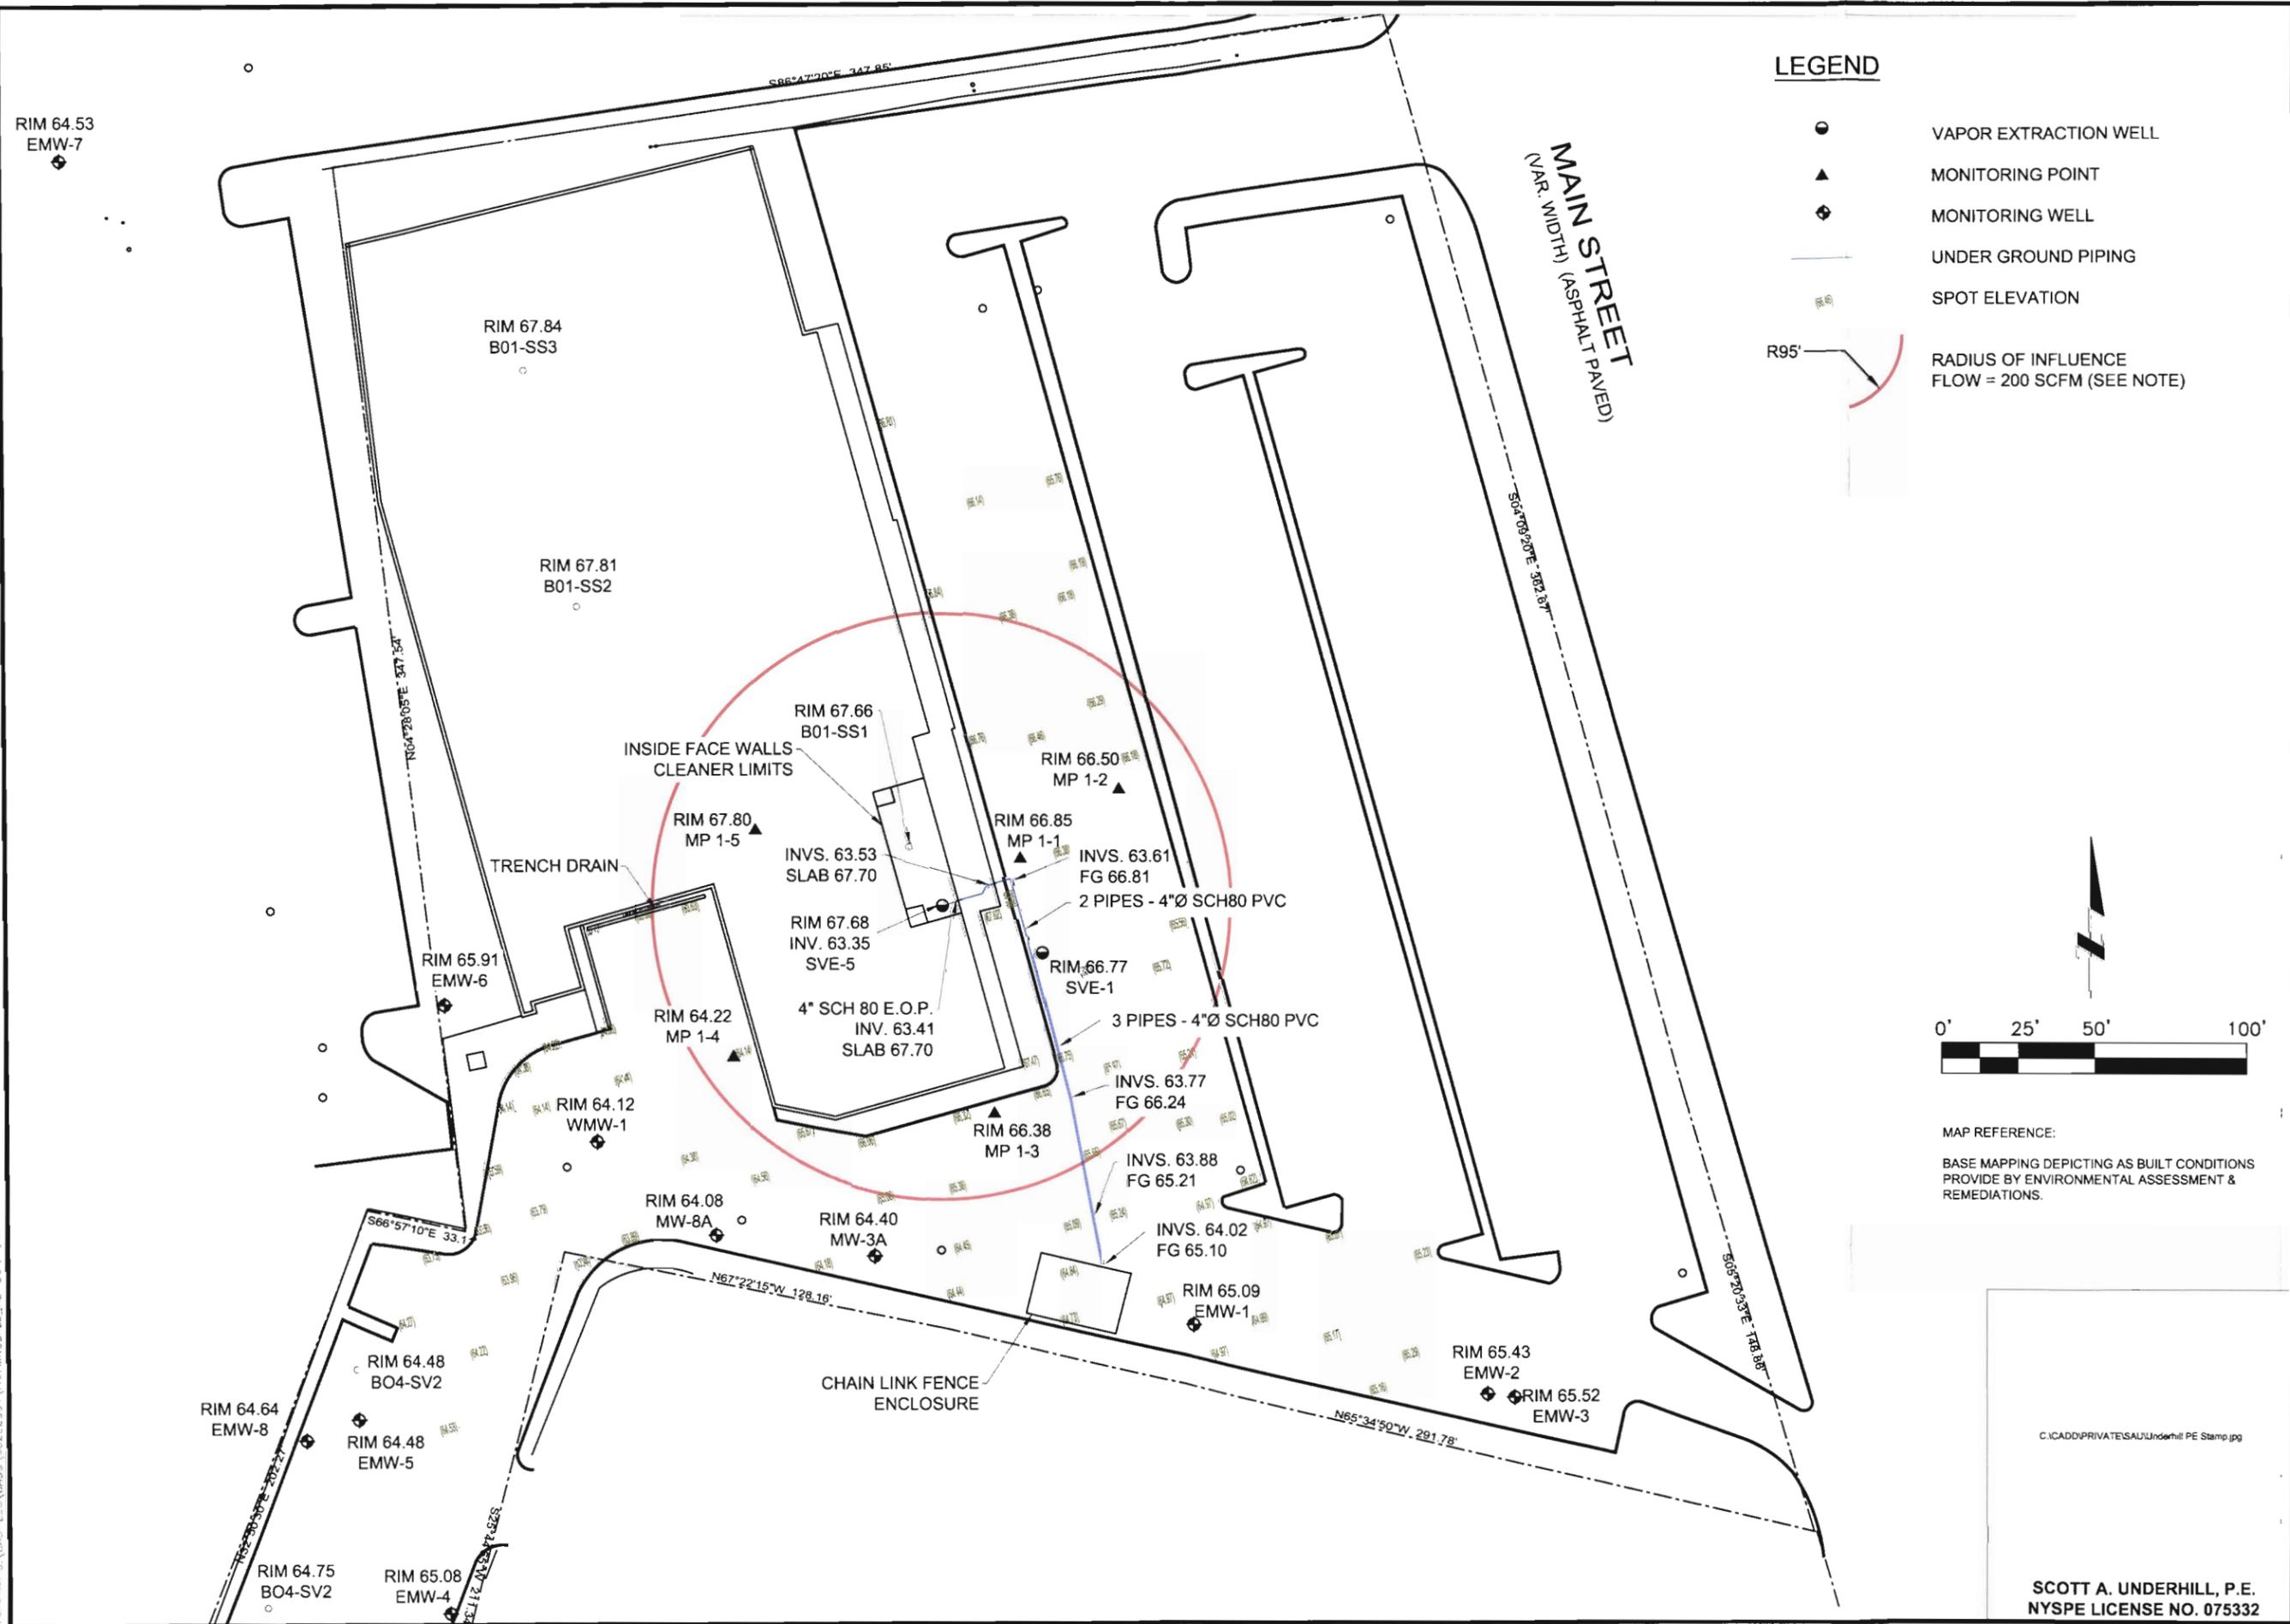
- VAPOR EXTRACTION WELL
- ▲ MONITORING POINT
- ◆ MONITORING WELL
- UNDER GROUND PIPING
- SPOT ELEVATION
- R95' RADIUS OF INFLUENCE FLOW = 200 SCFM (SEE NOTE)

The SVE system was installed in the parking lot of the Farmingdale plaza as shown on Drawing 3. The system was connected to the new SVE well installed inside the plaza (SVE-5) and an existing SVE well (SVE-1 from the pilot study) located in the parking lot, just outside the Farmingdale Plaza Cleaners building. The SVE system was installed with carbon canisters to remove VOCs from the extracted soil vapors. Well Installation, trench excavation, pipe layout, system installation and start up were documented by EAR in their field sheets and by AECOM in their daily reports.

Clear Water Drilling installed five vacuum monitoring points, one SVE well, three sub-slab vapor monitoring points, and two soil vapor monitoring points in conformance with the Boring and Well Installation Plan (EAR, 2011). Two soil vapor monitoring wells were added to the initial plan based on NYSDEC and NYSDOH's request to monitor soil vapor conditions near the Mile Stone Apartments. Locations of the monitoring points and SVE well are shown on Drawing 3.

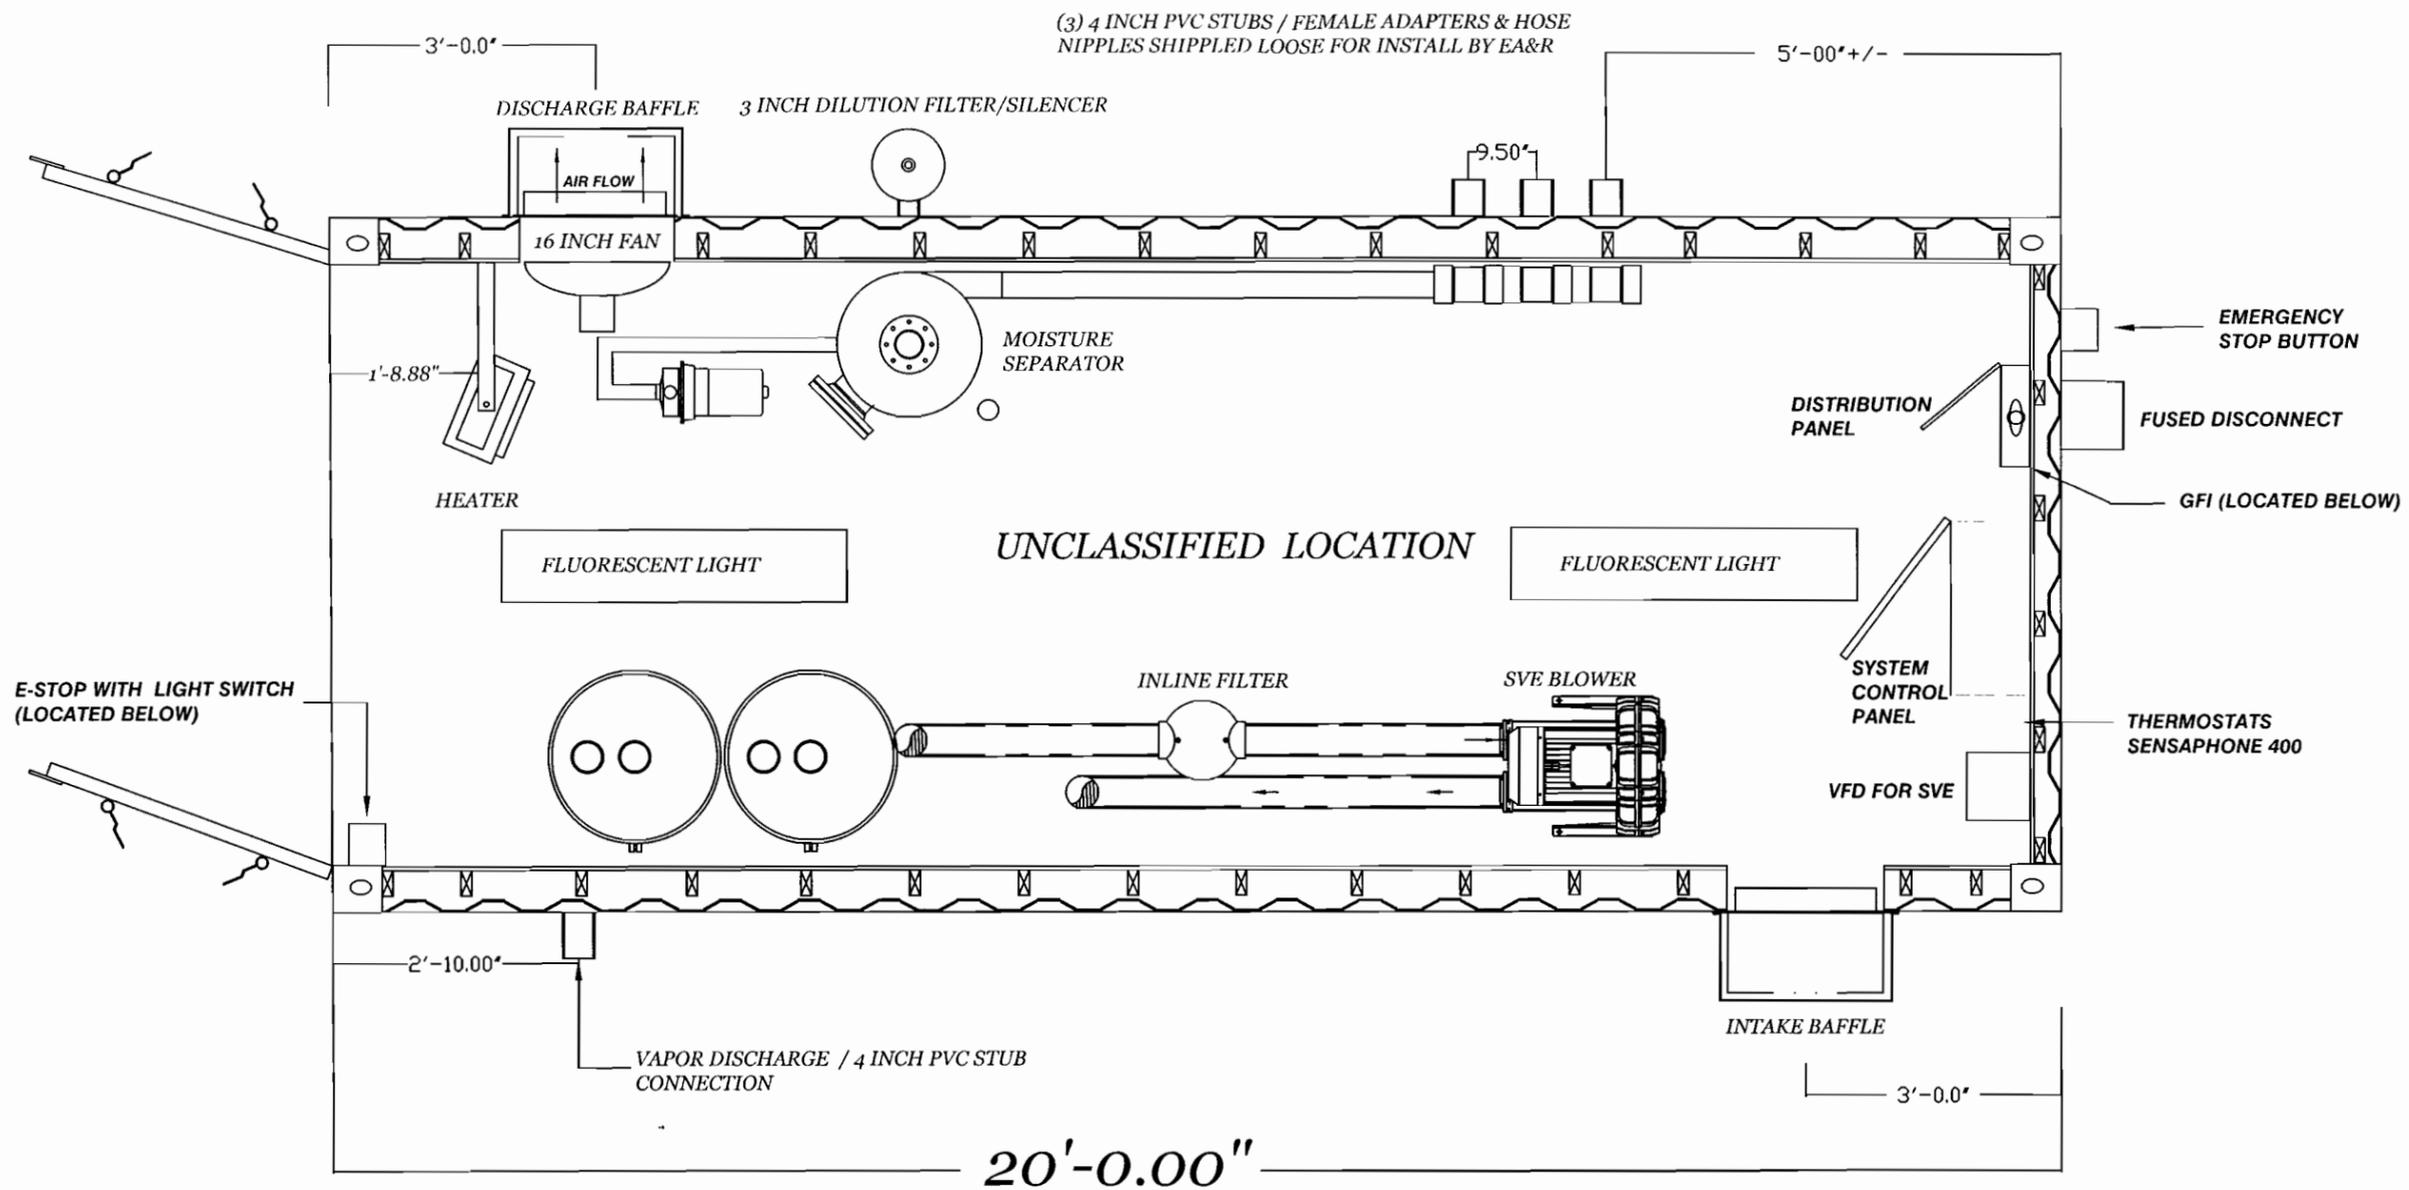
1. EXTERIOR COLOR - GRAY.
2. ALL PENETRATIONS DISCHARGE THROUGH THE CONTAINER SIDE WALLS.
3. DRAWING DEPICTS PRELIMINARY LAYOUT ONLY AND IS SUBJECT TO CHANGES DURING CONSTRUCTION. ANY MAJOR CHANGES WILL BE BROUGHT TO THE ATTENTION OF EA&R.
4. SYSTEM INTERIOR IS CLASSIFIED AS A NON HAZARDOUS LOCATION.
5. SOUND HOODS WILL REQUIRE FIELD INSTALLATION BY EA&R.
6. NES RECOMMENDS THAT TO ENSURE PROPER DOOR OPERATION THAT A SOLID LEVEL BASE BE PROVIDED FOR THE SYSTEM ENCLOSURE.

The system consists of influent piping manifold which allows each of three SVE wells (SVE-1, SVE-5, and future) to be individual controlled with a valve for applied vacuum and resultant flow rate, a 10-hp SVE blower, a 60-gallon moisture separator, a 0.5-hp moisture transfer pump, and two vapor phase carbon drums. The system container is also equipped with an exhaust fan, fan thermostat, lights, and a heater. The system layout and process and instrumentation diagram (P&ID) are included as Drawing 4 and 5. Electrical and control panel components of the system include panel enclosure, EOS programmable logic controller, Sansaphone autodialer, autodialer cellular interface, SVE blower motor hour meter, SVE blower timer, 100 amp distribution panel, fused disconnect, and a variable frequency drive (VFD). The SVE system also contains moisture separator level switch, inline filter for air, dilution filter, vacuum relief valve, 4-inch influent pitot tubes, 3-inch discharge pitot tubes, pitot tube magnehelic gauges, flow transmitters, influent vacuum transmitter, and discharge temperature transmitter. The SVE submittal package containing details of the SVE system components and electrical one-line diagram is included in Appendix L.

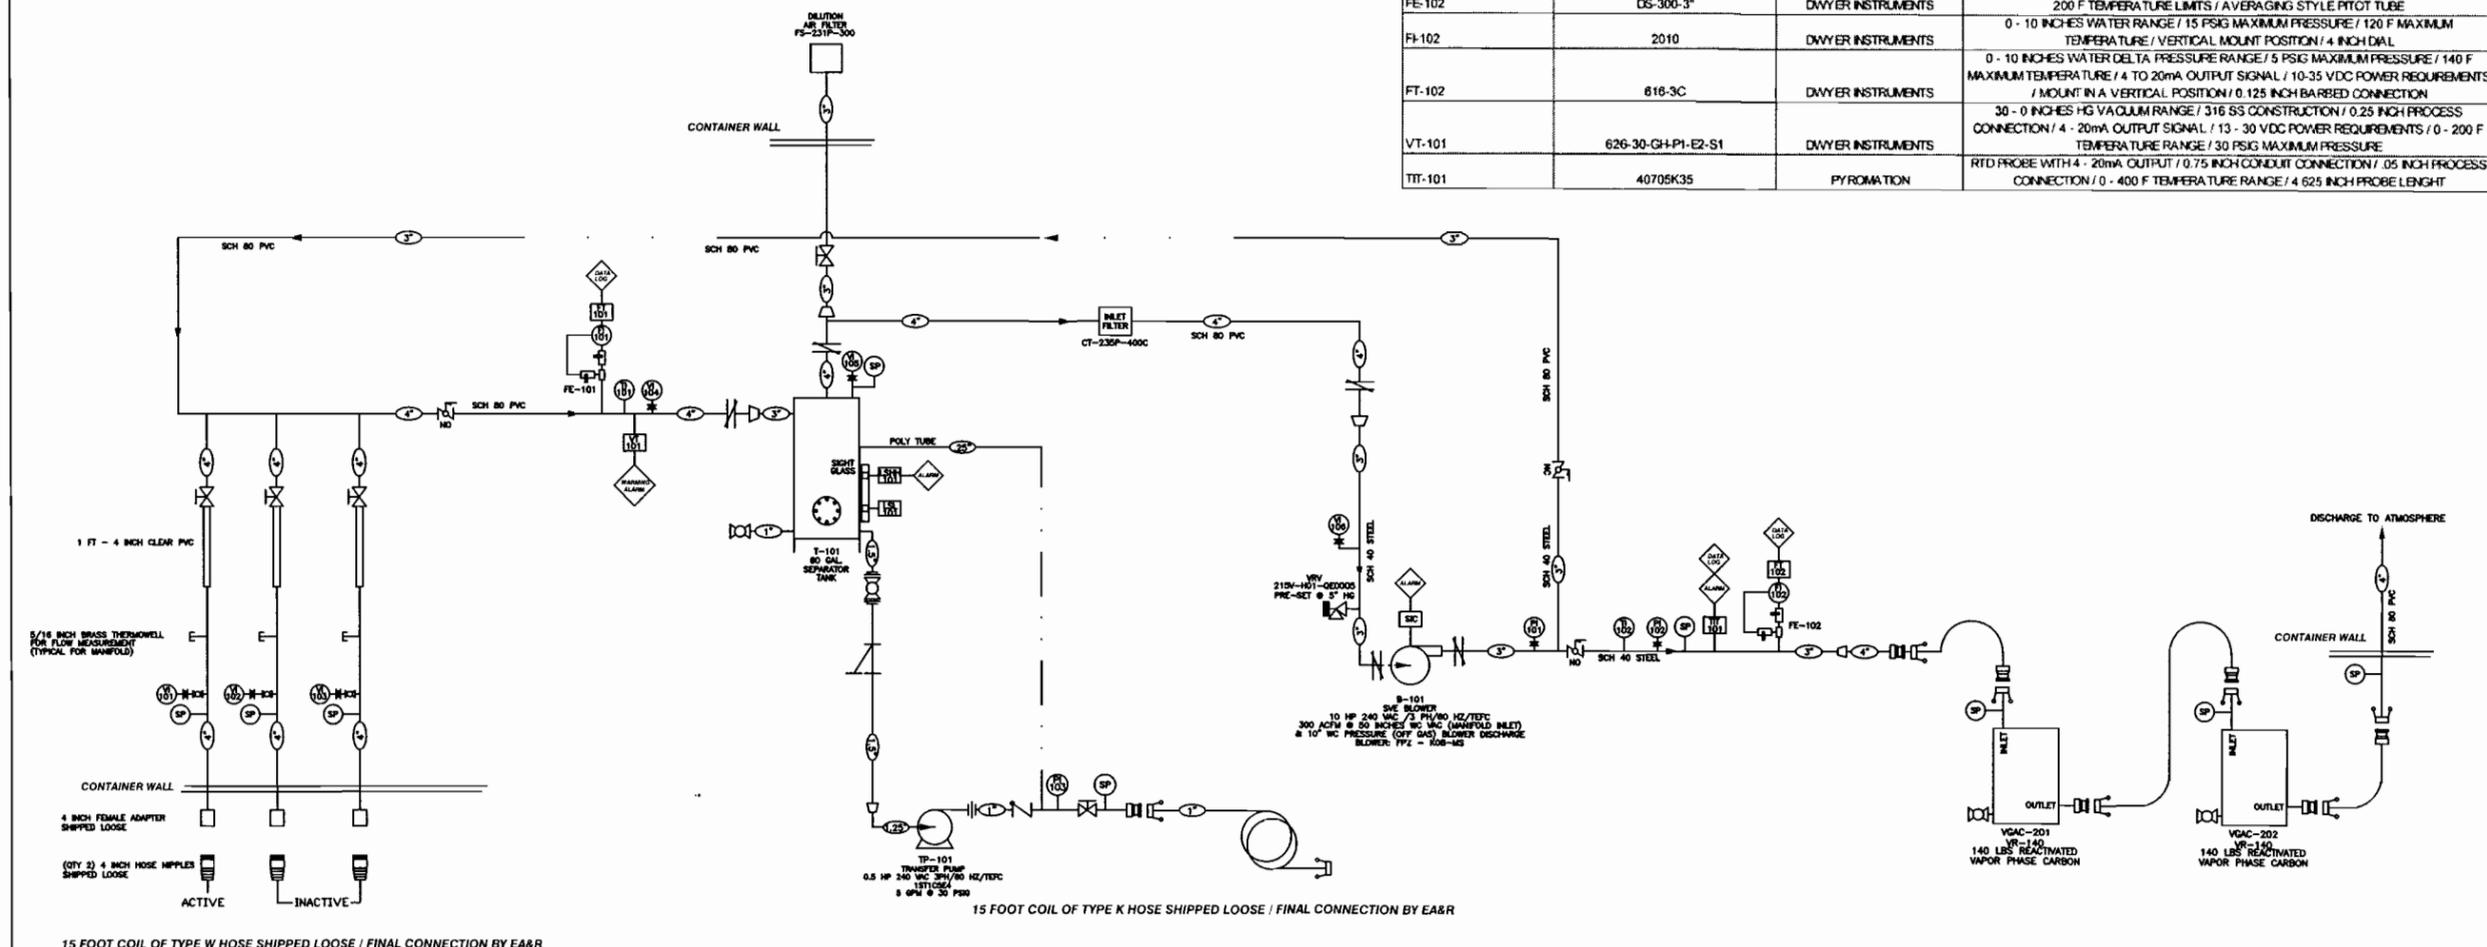
MOISTURE SEPARATOR - HIGH/HIGH LEVEL	(LSHH-101)	SYSTEM SHUTDOWN - RESET TO PUMP DOWN AND RESTART
SVE BLOWER - HIGH DISCHARGE TEMPERATURE	(TIT-101)	SYSTEM SHUTDOWN
SVE BLOWER - LOW VACUUM	(VT-101)	WARNING ONLY
VFD - GENERAL FAULT		SYSTEM SHUTDOWN
EMERGENCY STOP ENGAGED		SYSTEM SHUTDOWN

TI-102	1NFY4	GRAINGER	0 - 250 F RANGE / 2.5 INCH STEM LENGTH / 3 INCH DIAL / 0.5 INCH BACK MOUNT CONNECTION / STAINLESS STEEL CONSTRUCTION
FE-101	DS-300-4	DAVYER INSTRUMENTS	4 INCH LINE LINE / STAINLESS STEEL CONSTRUCTION WITH BRASS ISOLATION VALVE / 0 - 200 F TEMPERATURE LIMITS / AVERAGING STYLE PITOT TUBE
FI-101	2010	DAVYER INSTRUMENTS	0 - 10 INCHES WATER RANGE / 15 PSIG MAXIMUM PRESSURE / 120 F MAXIMUM TEMPERATURE / VERTICAL MOUNT POSITION / 4 INCH DIAL
FT-101	616-3C	DAVYER INSTRUMENTS	0 - 10 INCHES WATER DELTA PRESSURE RANGE / 5 PSIG MAXIMUM PRESSURE / 140 F MAXIMUM TEMPERATURE / 4 TO 20mA OUTPUT SIGNAL / 10-35 VDC POWER REQUIREMENTS / MOUNT IN A VERTICAL POSITION / 0.125 INCH BARBED CONNECTION
FE-102	DS-300-3"	DAVYER INSTRUMENTS	3 INCH LINE LINE / STAINLESS STEEL CONSTRUCTION WITH BRASS ISOLATION VALVE / 0 - 200 F TEMPERATURE LIMITS / AVERAGING STYLE PITOT TUBE
FI-102	2010	DAVYER INSTRUMENTS	0 - 10 INCHES WATER RANGE / 15 PSIG MAXIMUM PRESSURE / 120 F MAXIMUM TEMPERATURE / VERTICAL MOUNT POSITION / 4 INCH DIAL

FT-102	616-3C	DAVYER INSTRUMENTS	0 - 10 INCHES WATER DELTA PRESSURE RANGE / 5 PSIG MAXIMUM PRESSURE / 140 F MAXIMUM TEMPERATURE / 4 TO 20mA OUTPUT SIGNAL / 10-35 VDC POWER REQUIREMENTS / MOUNT IN A VERTICAL POSITION / 0.125 INCH BARBED CONNECTION
VT-101	626-30-GH-P1-E2-S1	DAVYER INSTRUMENTS	30 - 0 INCHES HG VACUUM RANGE / 316 SS CONSTRUCTION / 0.25 INCH PROCESS CONNECTION / 4 - 20mA OUTPUT SIGNAL / 13 - 30 VDC POWER REQUIREMENTS / 0 - 200 F TEMPERATURE RANGE / 30 PSIG MAXIMUM PRESSURE
TIT-101	40705K35	PYROMAT	RTD PROBE WITH 4 - 20mA OUTPUT / 0.75 INCH CONDUIT CONNECTION / 0.5 INCH PROCESS CONNECTION / 0 - 400 F TEMPERATURE RANGE / 4.625 INCH PROBE LENGTH

The system contains an EOS Protocol (EOS) programmable logic control system that allows users to access and view system status as well as select operational data, in addition to alerting designated parties of alarm conditions. To check the EOS, alarm conditions were manually triggered with system operating. Following each alarm condition simulation and confirmation of proper response, the system was reset and restarted prior to the next alarm condition simulation.

Critical system alarms including the moisture separator high level condition, low vacuum level condition, high discharge temperature condition, VFD fault condition, and emergency stop activation, were tested. At each alarm condition the system automatically shutdown, a panel indicator light was turned on, and the autodialer called the EAR project manager's programmed number.
