**METAL ETCHING STATE SUPERFUND SITE
NASSAU COUNTY, FREEPORT, NEW YORK**

FINAL ENGINEERING REPORT

**NYSDEC Site Number: 130110
Remedial Action Contract D007938**

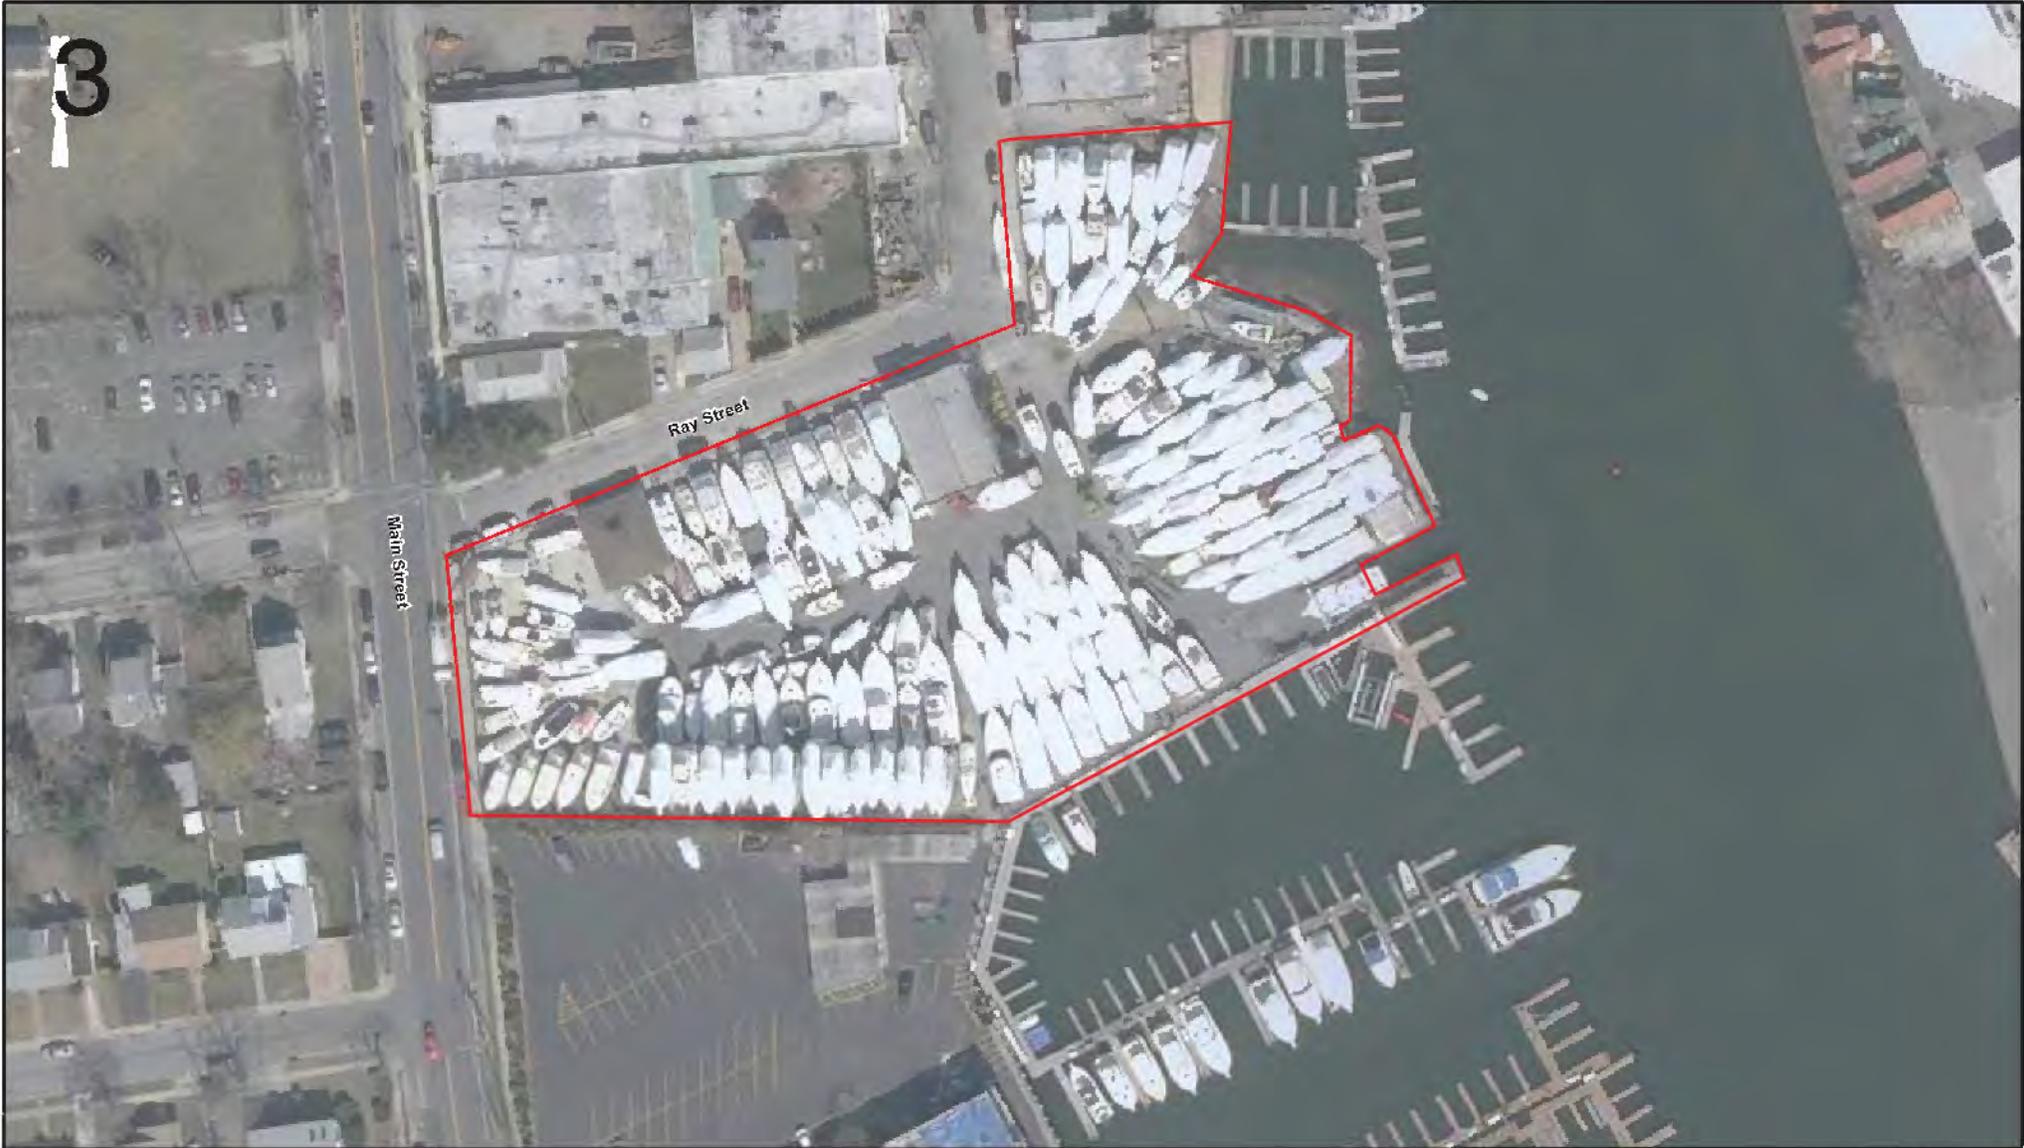
METAL ETCHING SITE (130110) FINAL ENGINEERING REPORT FREEPORT, NEW YORK NASSAU COUNTY				FIGURE 2 Site Boundary Map

The Metal Etching site is currently a Class 2 Site listed on the NYSDEC Registry of Inactive Hazardous Waste Sites (No. 130110). The site is located adjacent to Freeport Creek at 435 South Main Street, Freeport, Nassau County, New York. A site location map is presented in Figure 1. The site is currently owned by Freeport Creek Associates and leased by Main Street Marina, 500 South Main Street, Freeport, New York. The Metal Etching property is designated as Section 62, Block 45; and Lots 144, 145, and 158 on the tax maps. The Metal Etching property is approximately 1.05 acres; however, the area investigated in the remedial investigation (RI) was 2.06 acres. The additional 1.01 acres includes several properties designated as Section 62, Block 45; and Lots 24, 25, 54, 155, and 157. These properties are located immediately to the south and east of the subject property along Freeport Creek. The term “site” collectively includes these additional properties. Figure 2 depicts the site and study area boundaries.

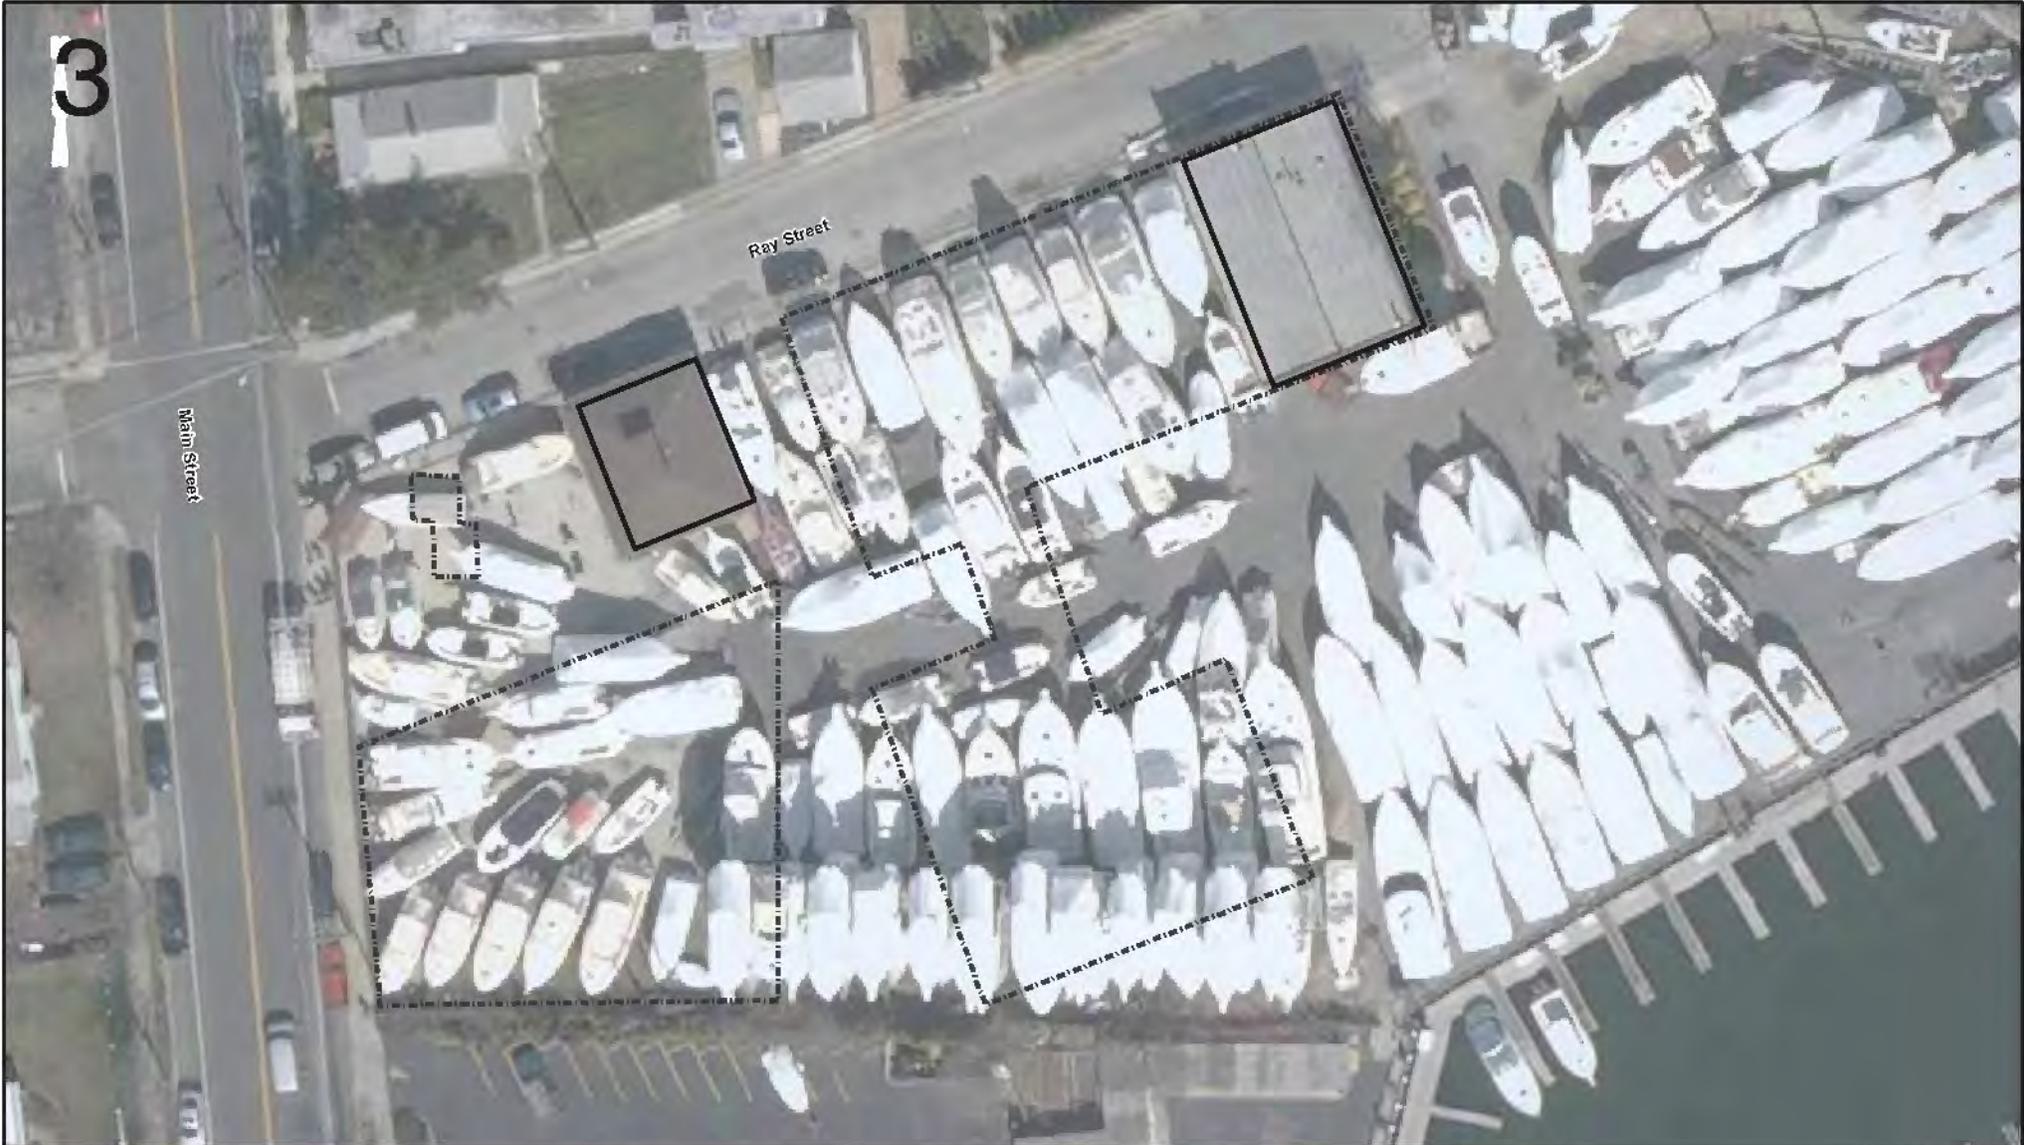
FIGURE 3
 Locations of Existing and
 Former Buildings

The former Metal Etching buildings at the site were erected prior to 1954; however, the exact date of construction is unknown. These connected buildings occupied approximately 26,650 ft² of the property (approximately 60 percent of the Metal Etching portion of the site). Aside for the 2,400 ft² building, which was a portion of the Metal Etching quarters, the Metal Etching buildings were demolished in 2001; however, the concrete slabs and footings of the buildings remained in place at the site. A 6-in. thick concrete slab covering an approximate area of 7,750 ft² was the foundation of the Metal Etching plating slab and is visible to the west of the 2,400 ft² building. Locations of existing and former buildings at the site are presented in Figure 3.

Legend
 — Existing Buildings
 - - - Approximate Footprint of Former Buildings

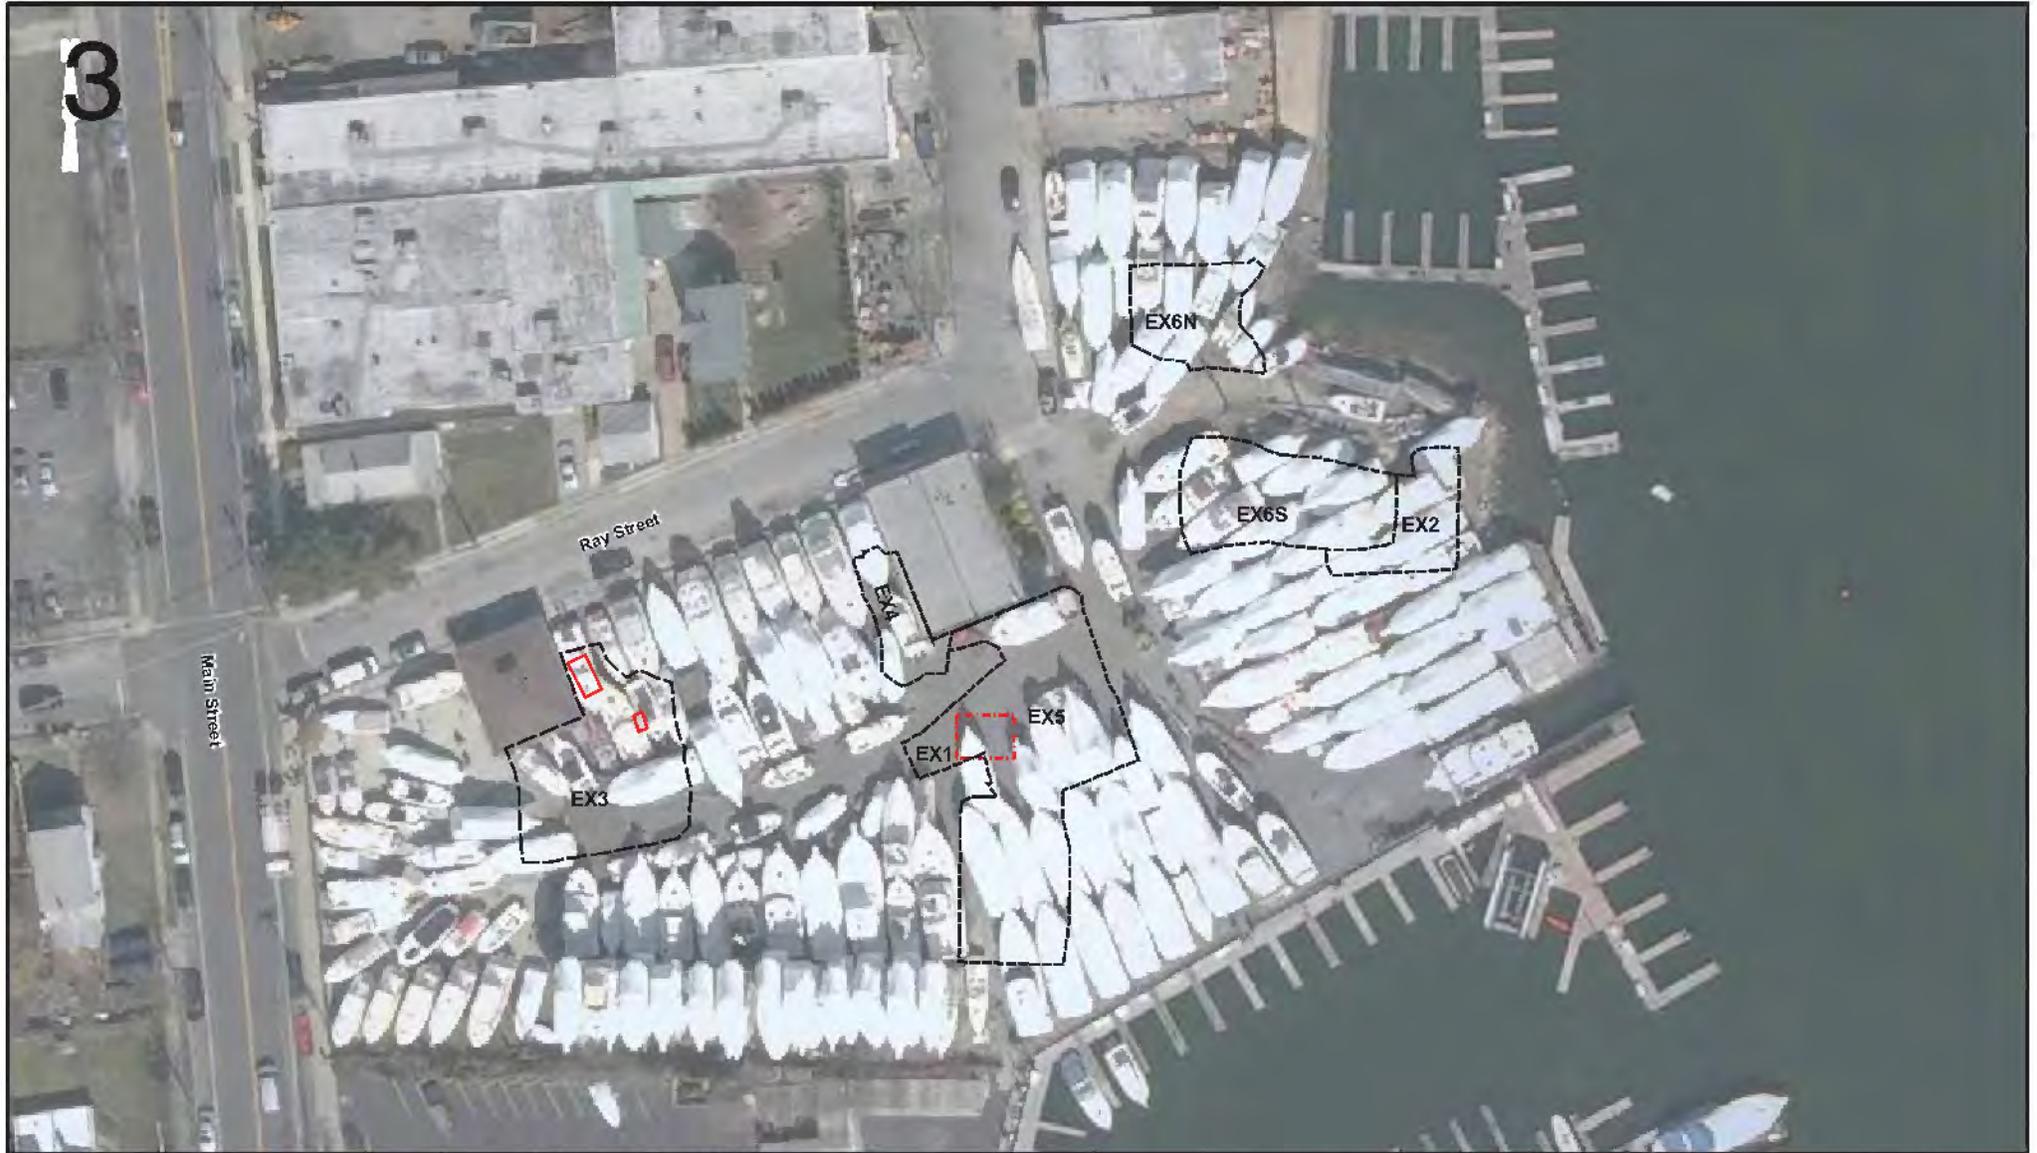
Remedial activities at the site consisted of excavation of non-hazardous soil within areas EX1 through EX6 shown on Figure 4 and offsite disposal and defined by Contract Drawing 4. Each

During excavation activities, a total of four USTs were encountered and removed from within the excavations, and disposed offsite. UST 1, a 3,000 gal tank, and UST 2, a 550 gal tank, were found within EX3 to the east of the one-story brick office building, at the location shown on Figure 4. During excavation of EX5, UST 3, a 1,000 gal tank, and UST 4, a 2,000 gal tank, were found directly below the area enclosed by points EX5-11, EX5-12, and EX5-13 and were observed to extend within EX1, which was defined by Contract drawing 4 as a 1-ft deep excavation. The approximate locations of USTs 3 and 4 are shown on Figure 4; however, these USTs were not able to be surveyed due to scheduling issues.

- Pre-Remediation Location of Underground Storage Tanks 1 & 2
- - - Excavation Area Boundaries
- Approximate Location of Underground Storage Tanks 3 & 4

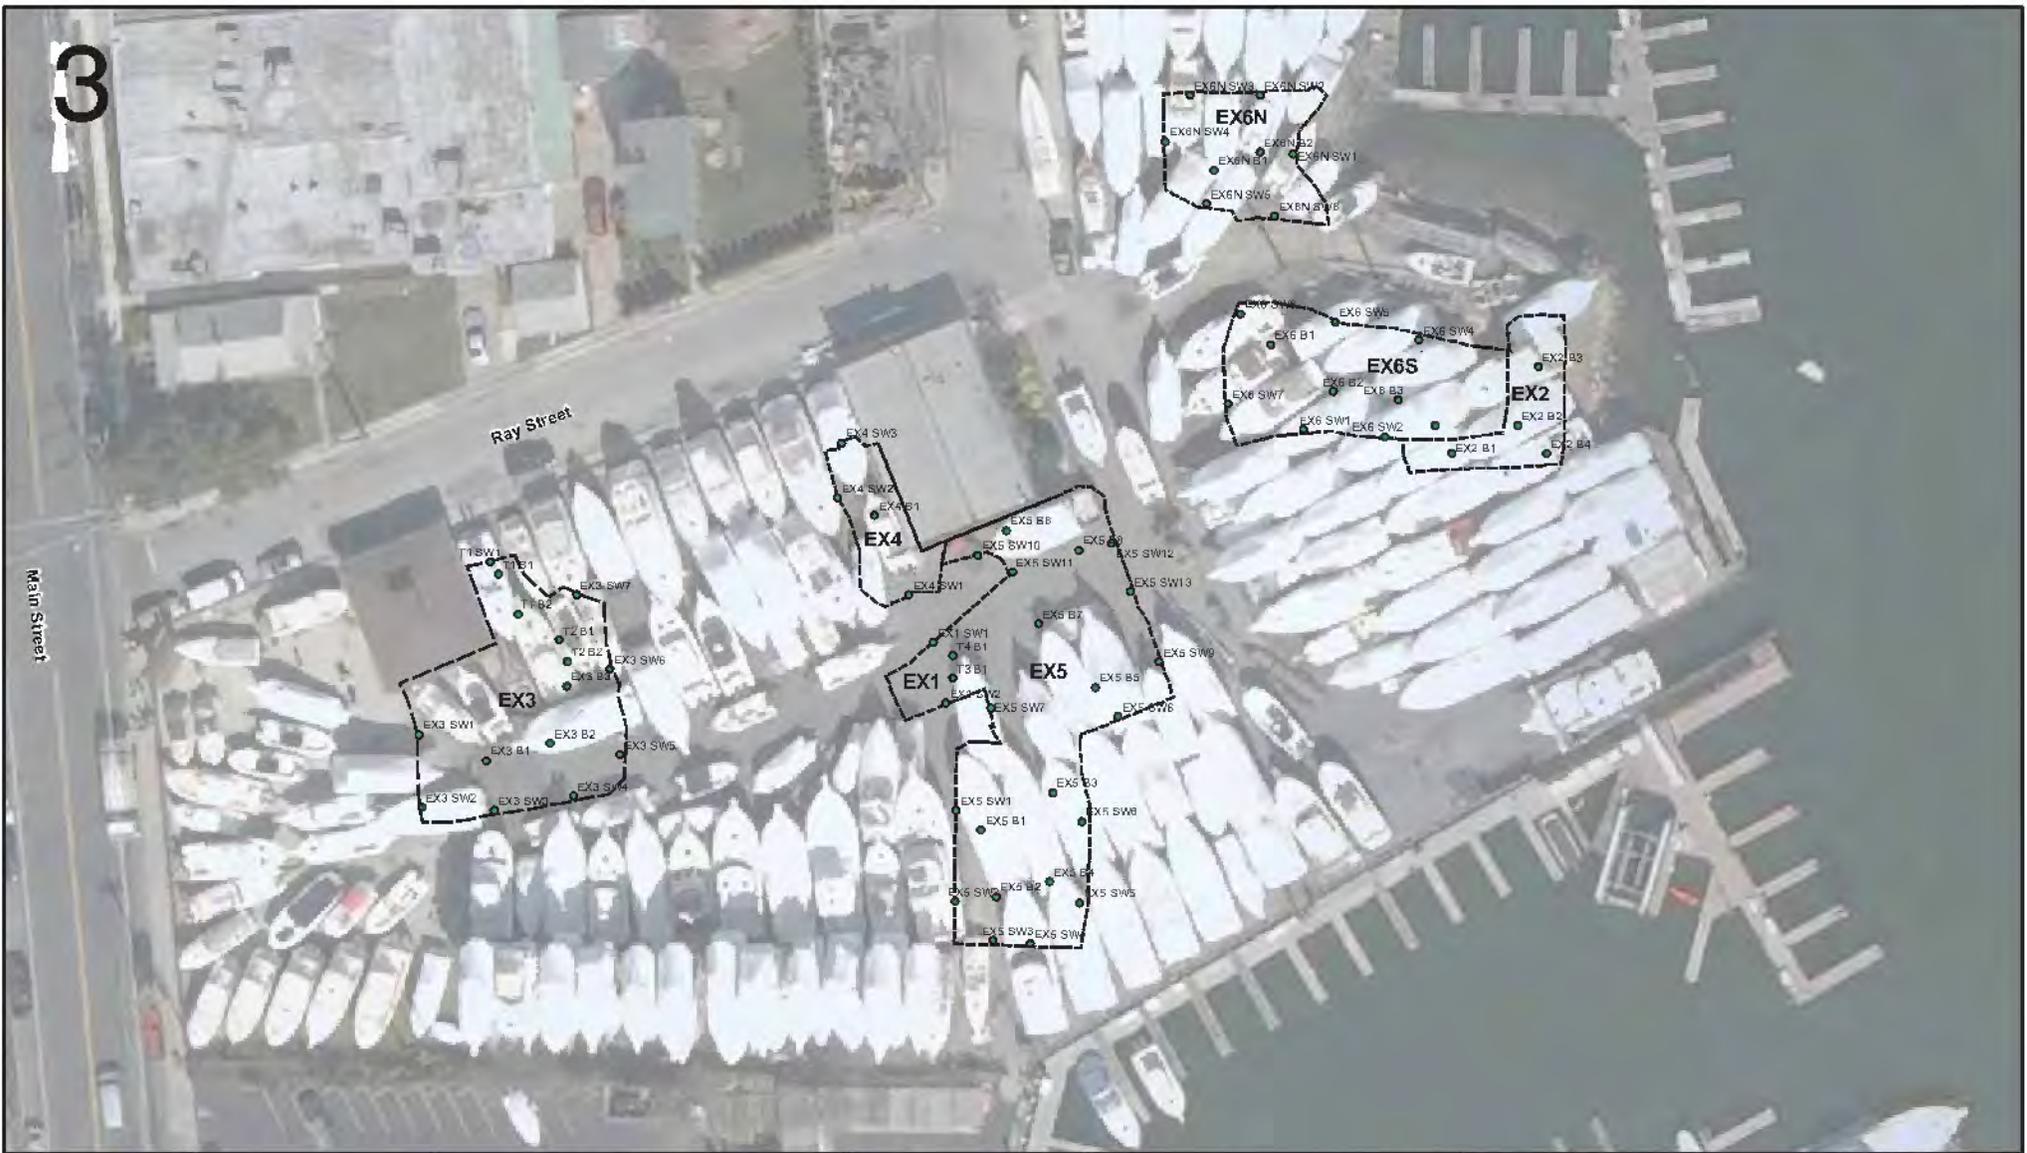
METAL ETCHING SITE (130110) FINAL ENGINEERING REPORT FREEPORT, NEW YORK NASSAU COUNTY			FIGURE 5 Documentation Sample Locations

Legend ● Documentation Sample Locations --- Excavation Area Boundaries		Source: NYS GIS Clearing House
		PROJECT MGR: RSC	DESIGNED BY: RSC	CREATED BY: MEM	CHECKED BY: RSC	PROJECT NO: 14474.37	DATE: OCTOBER 2012	SCALE: AS SHOWN	FILE NO: G:\Projects\Fig5

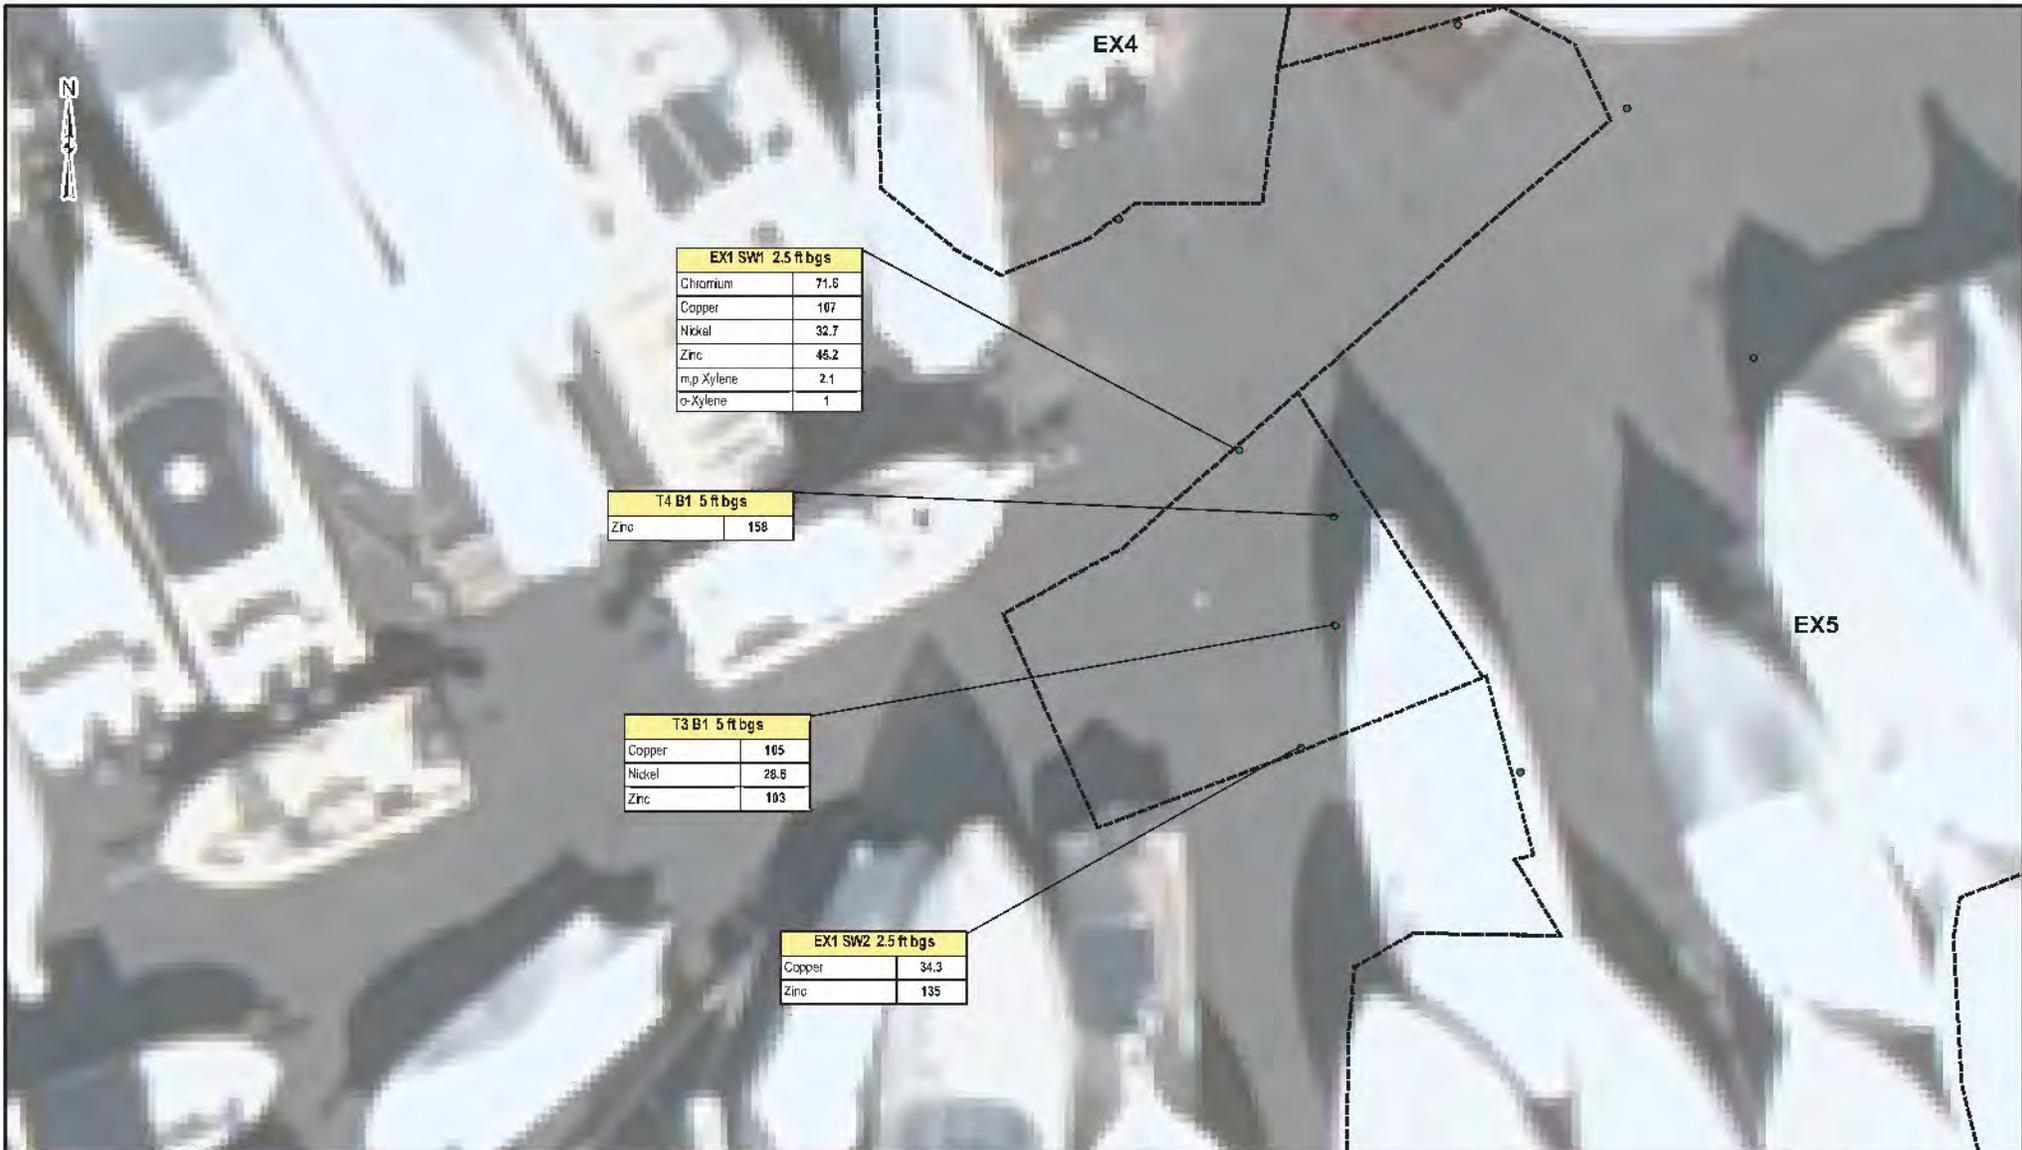
FIGURE 5A
 Documentation Sample Locations
 with Exceedances of
 Site-Specific SCG's
 EX1

Excavation within EX1 coincided with excavation of EX5, and took place on August 24 and 25, 2011. No dewatering was necessary during this excavation. Two endpoint sidewall samples were collected 2.5 ft bgs along the northern and southern side walls prior to laying geotextile and backfilling. Bottom endpoint samples were collected associated with the USTs within the EX1 footprint 5 ft bgs. The final excavation area was 250 ft^2 down to 5 ft bgs; 46 yd^3 of non-hazardous soil, USTs, and C&D material were removed from EX1.

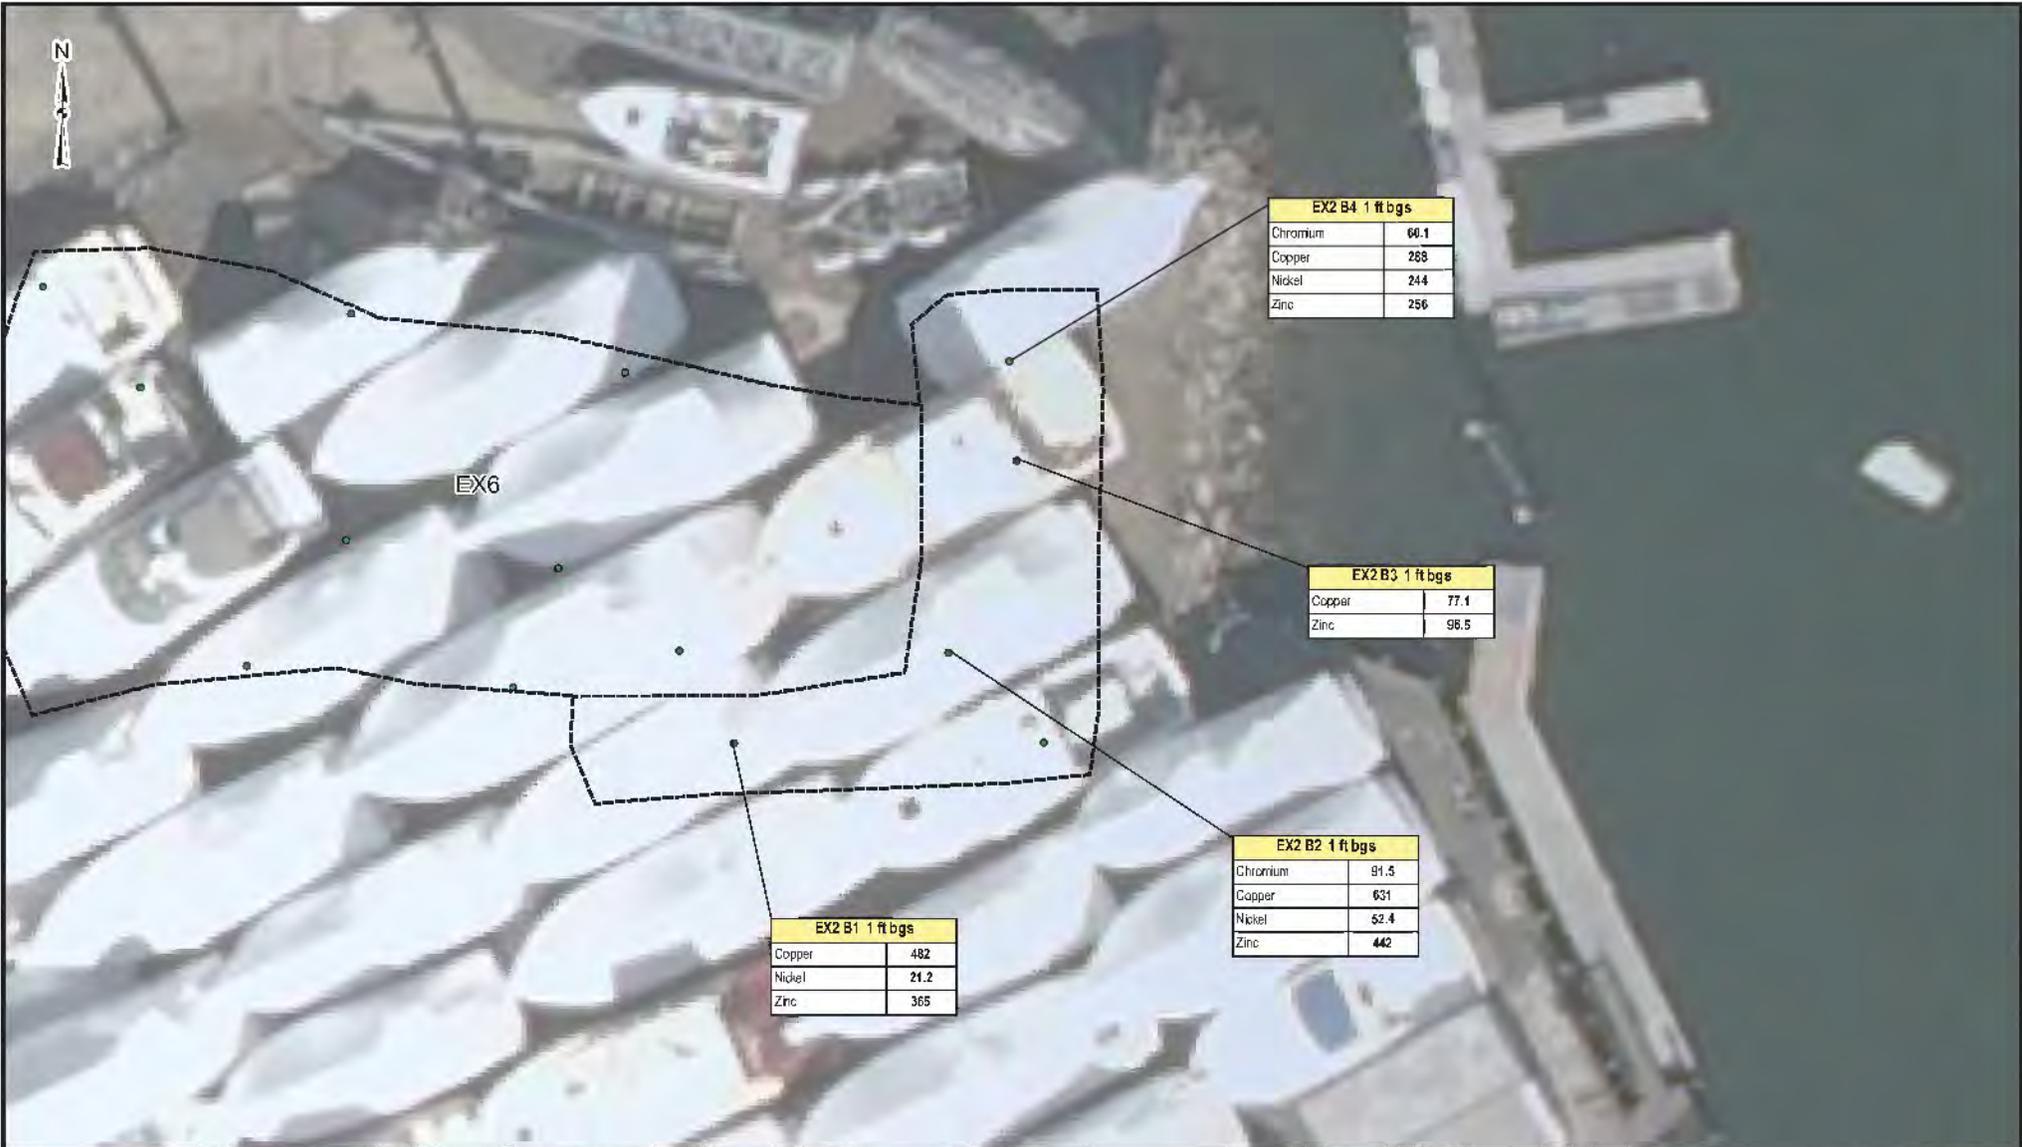
FIGURE 5B
 Documentation Sample Locations
 with Exceedances of
 Site-Specific SCG's
 EX2

Excavation within EX2 coincided with excavation of EX6 and started on June 16, 2011; 46 yd^3 of non-hazardous soil and C&D material were removed from EX2. Excavation dewatering was not necessary during this excavation as groundwater is 3–5 ft bgs in this area. Four bottom endpoint samples were collected 1 ft bgs within this area prior to laying geotextile and backfilling. No sidewall samples were collected due to the shallow depth of the excavation.

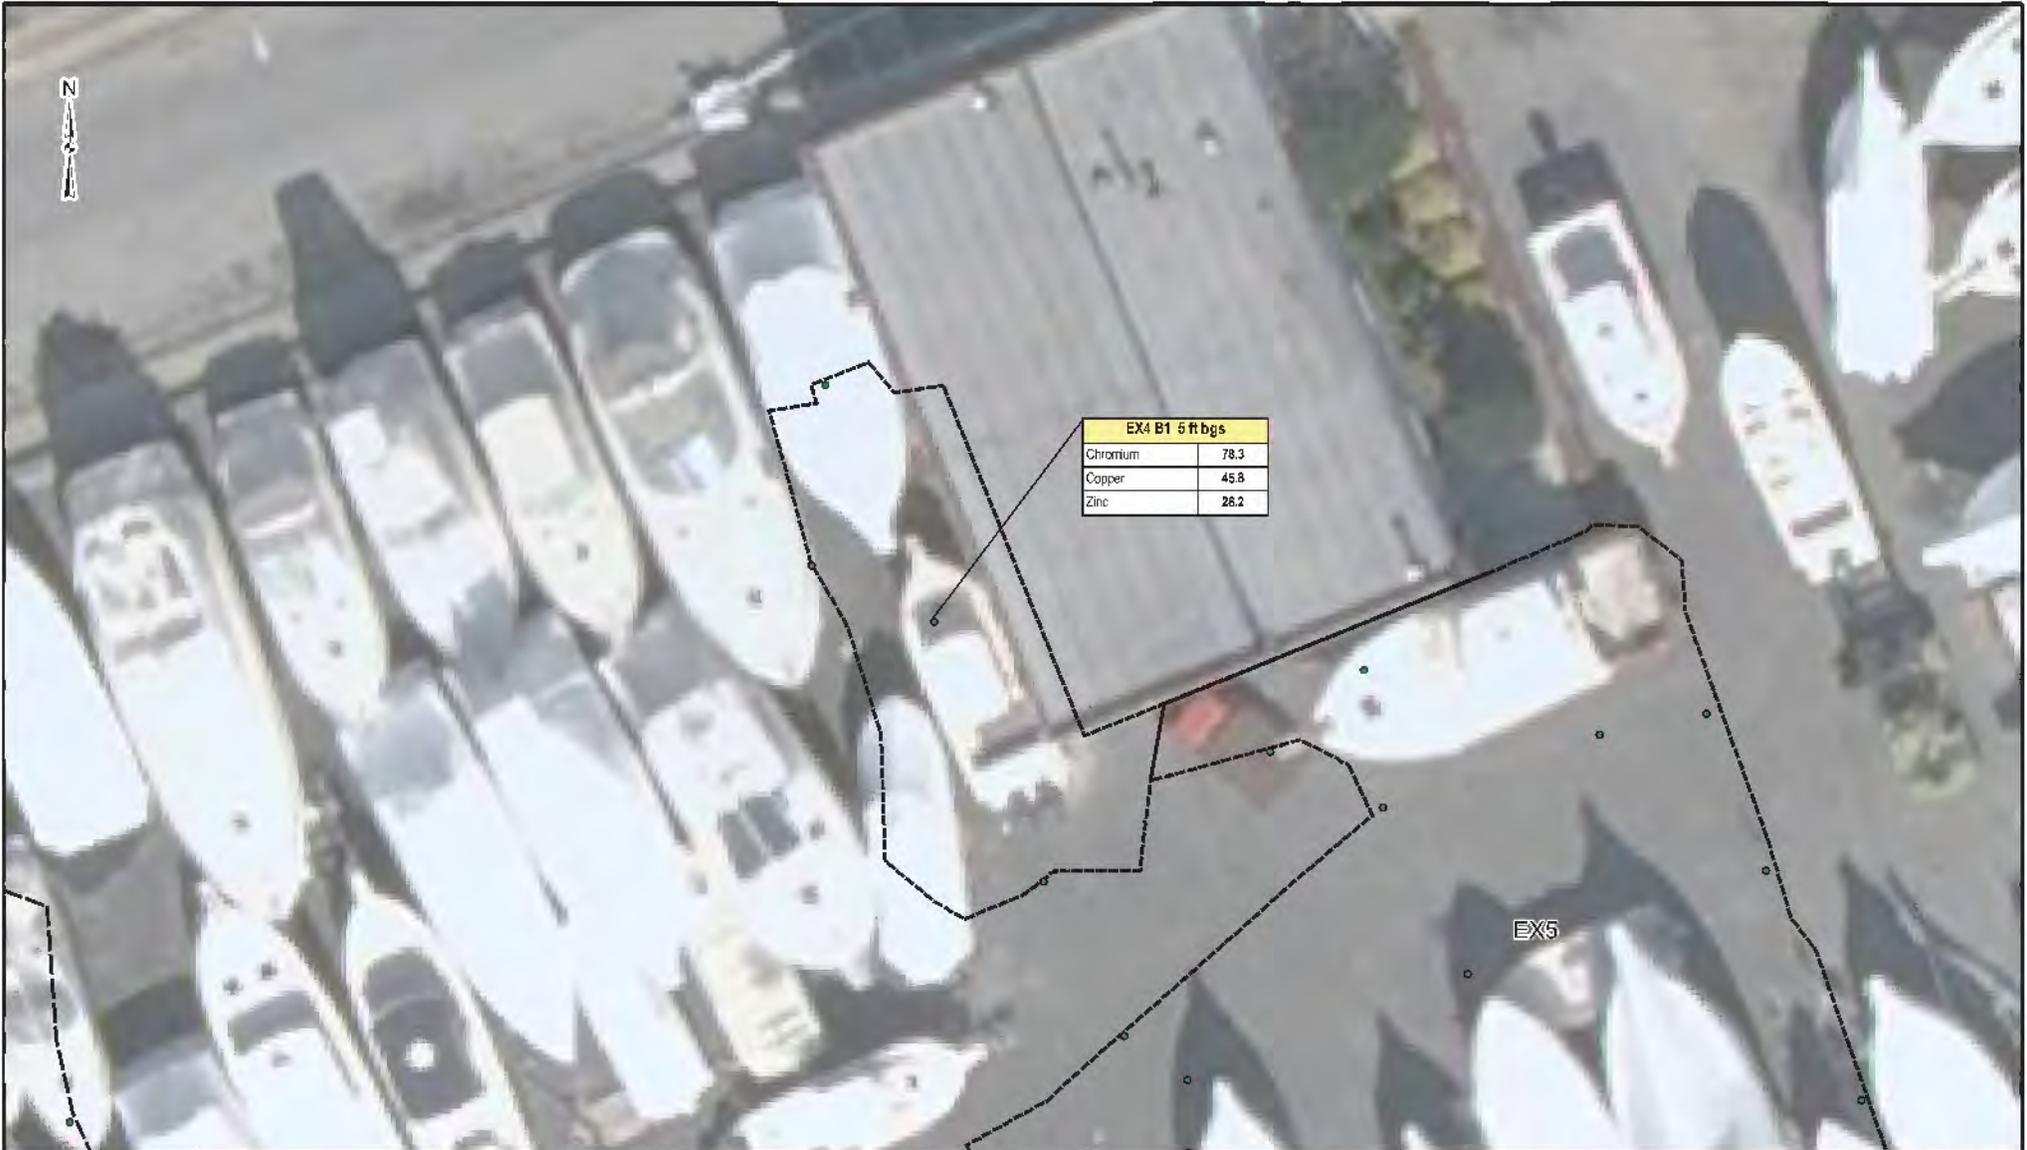
FIGURE 5D
 Documentation Sample Locations
 with Exceedances of
 Site-Specific SCG's
 EX4

The soil removed from EX4 was disposed of as non-hazardous waste. The former foundation wall was removed and disposed of with other C&D material. No odors were observed during excavation activities. Dewatering was required prior to endpoint sample collection and excavation backfilling due to above average rainfall over the weekend. Three sidewall samples were collected along the northern, western, and southern limits at 2.5 ft bgs; and one bottom endpoint sample was collected from EX4 at 5 ft bgs.

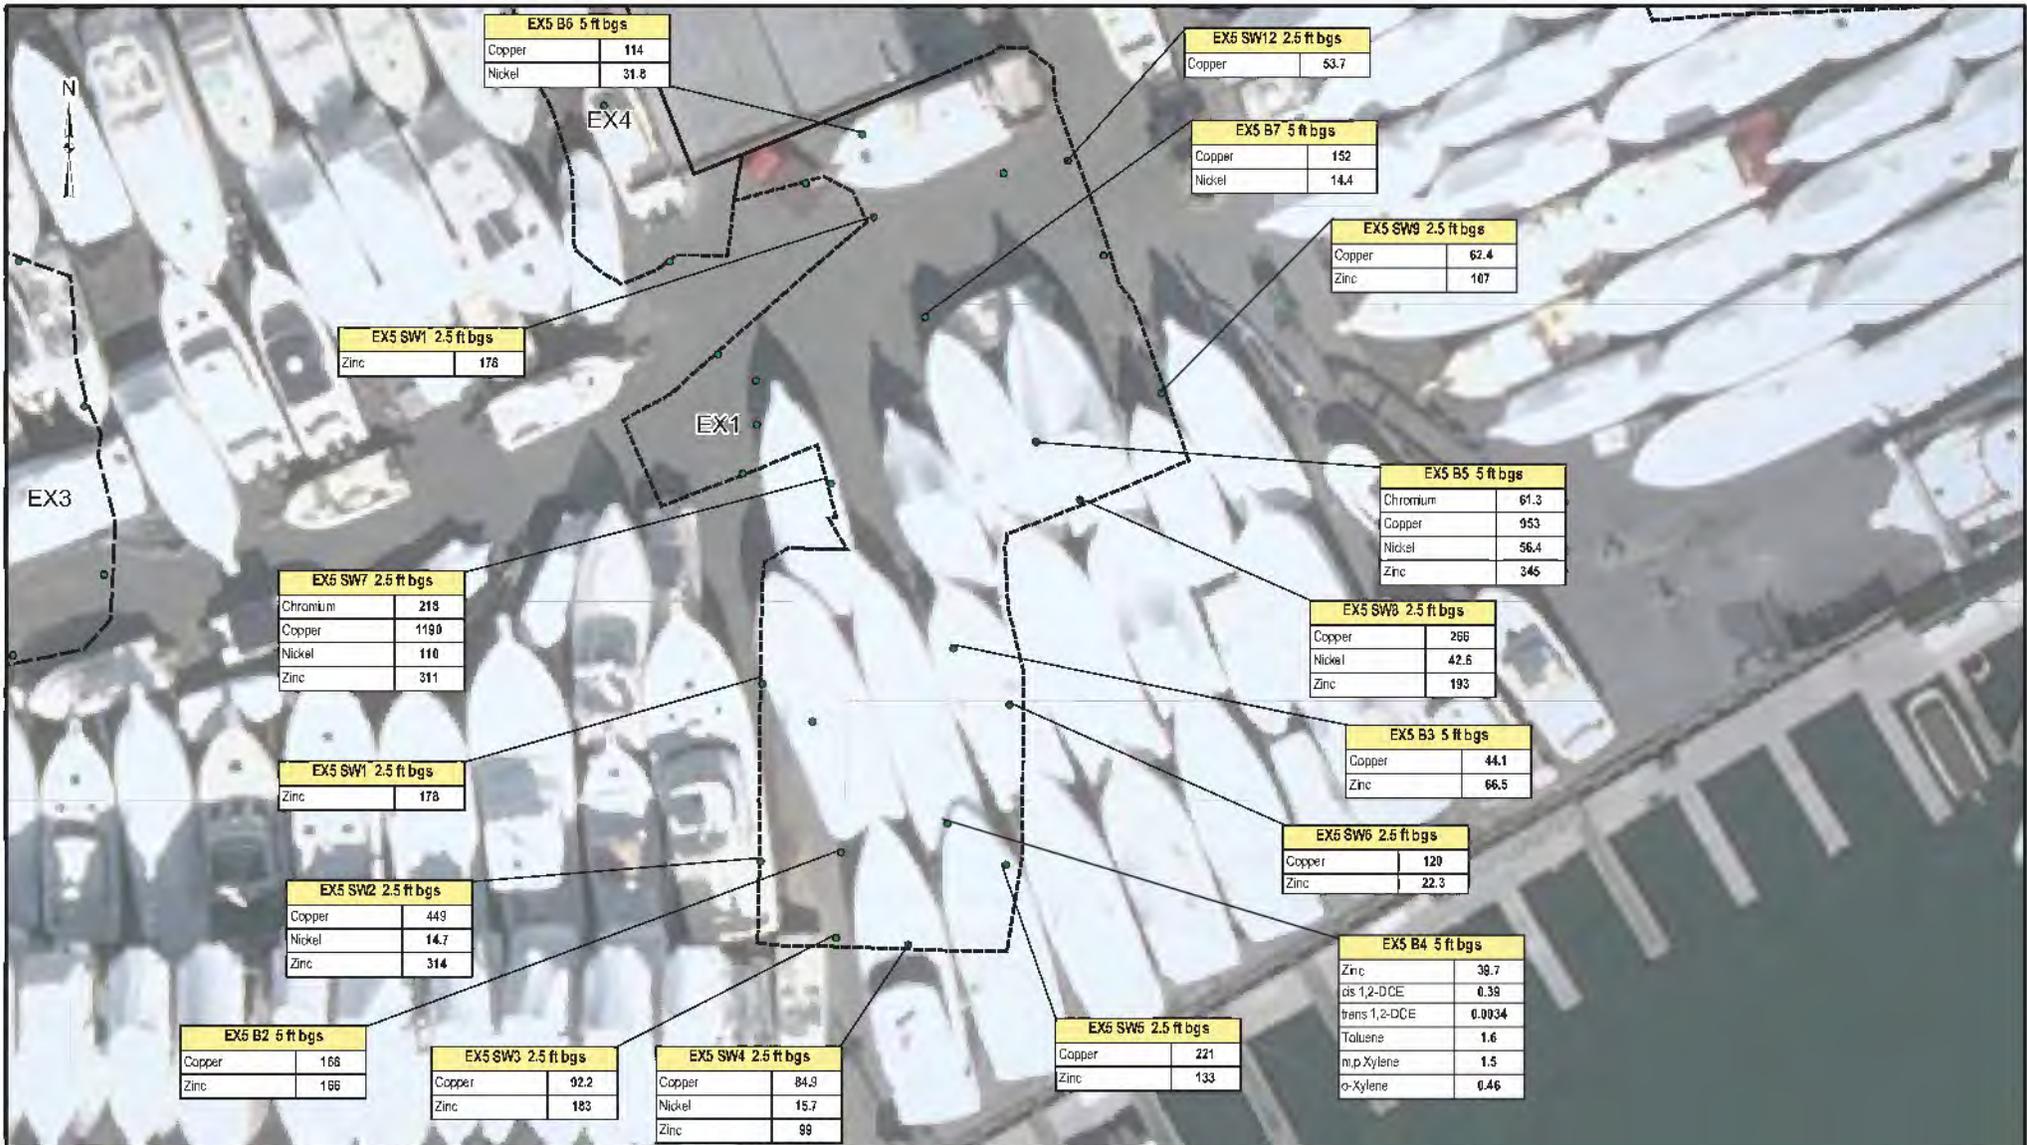
Dewatering was required during excavation due to frequent rainfall. During excavation, USTs 3 and 4 were uncovered near the border of EX1, as noted in the EX1 discussion above. Some odors were observed while excavating within this area. The final area of EX5 was 5,682 ft², for a total of 1,052 yd³ of non-hazardous soil and C&D material removed from EX5. Twelve sidewall samples were collected along the unshared limits of EX5 from 2.5 ft bgs. Five bottom endpoint samples were collected from 5 ft bgs throughout EX5 following excavation completion.

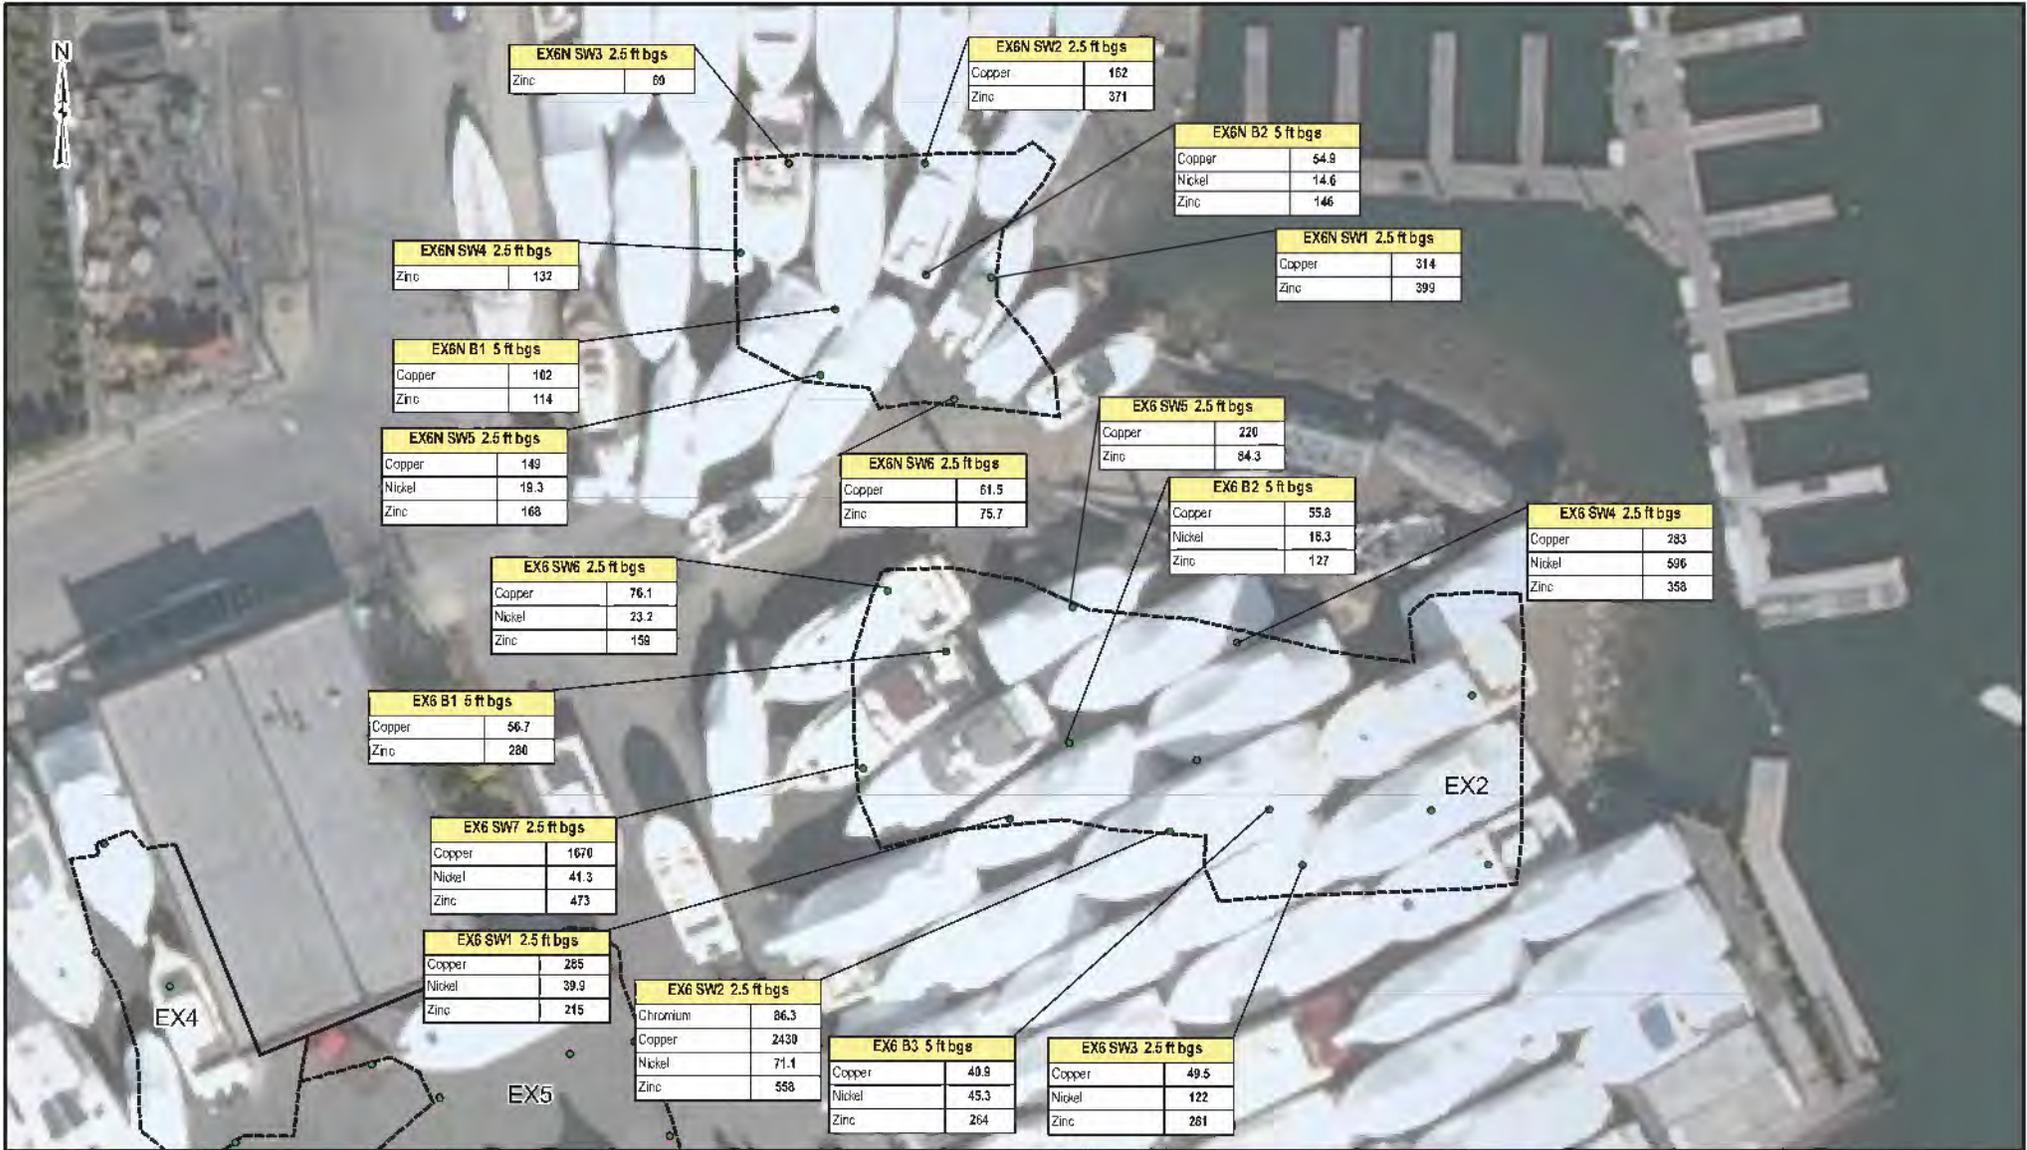
During excavation of EX6, stained soil and a petroleum odor were observed within the southern portion of the excavation on the east side. Stained soil was removed from EX6 and extended within the EX2 area, with which EX6 shared a boundary. Visually impacted soil was removed and stockpiled separately for separate characterization on July 20, 2011; though, all soil was disposed of as non-hazardous waste. Dewatering was required due to the proximity of the excavation to the Freeport Creek, as well as a storm drain that directly connected the excavation to the creek.
