**METAL ETCHING STATE SUPERFUND SITE
NASSAU COUNTY, FREEPORT, NEW YORK**

FINAL ENGINEERING REPORT

**NYSDEC Site Number: 130110
Remedial Action Contract D007938**

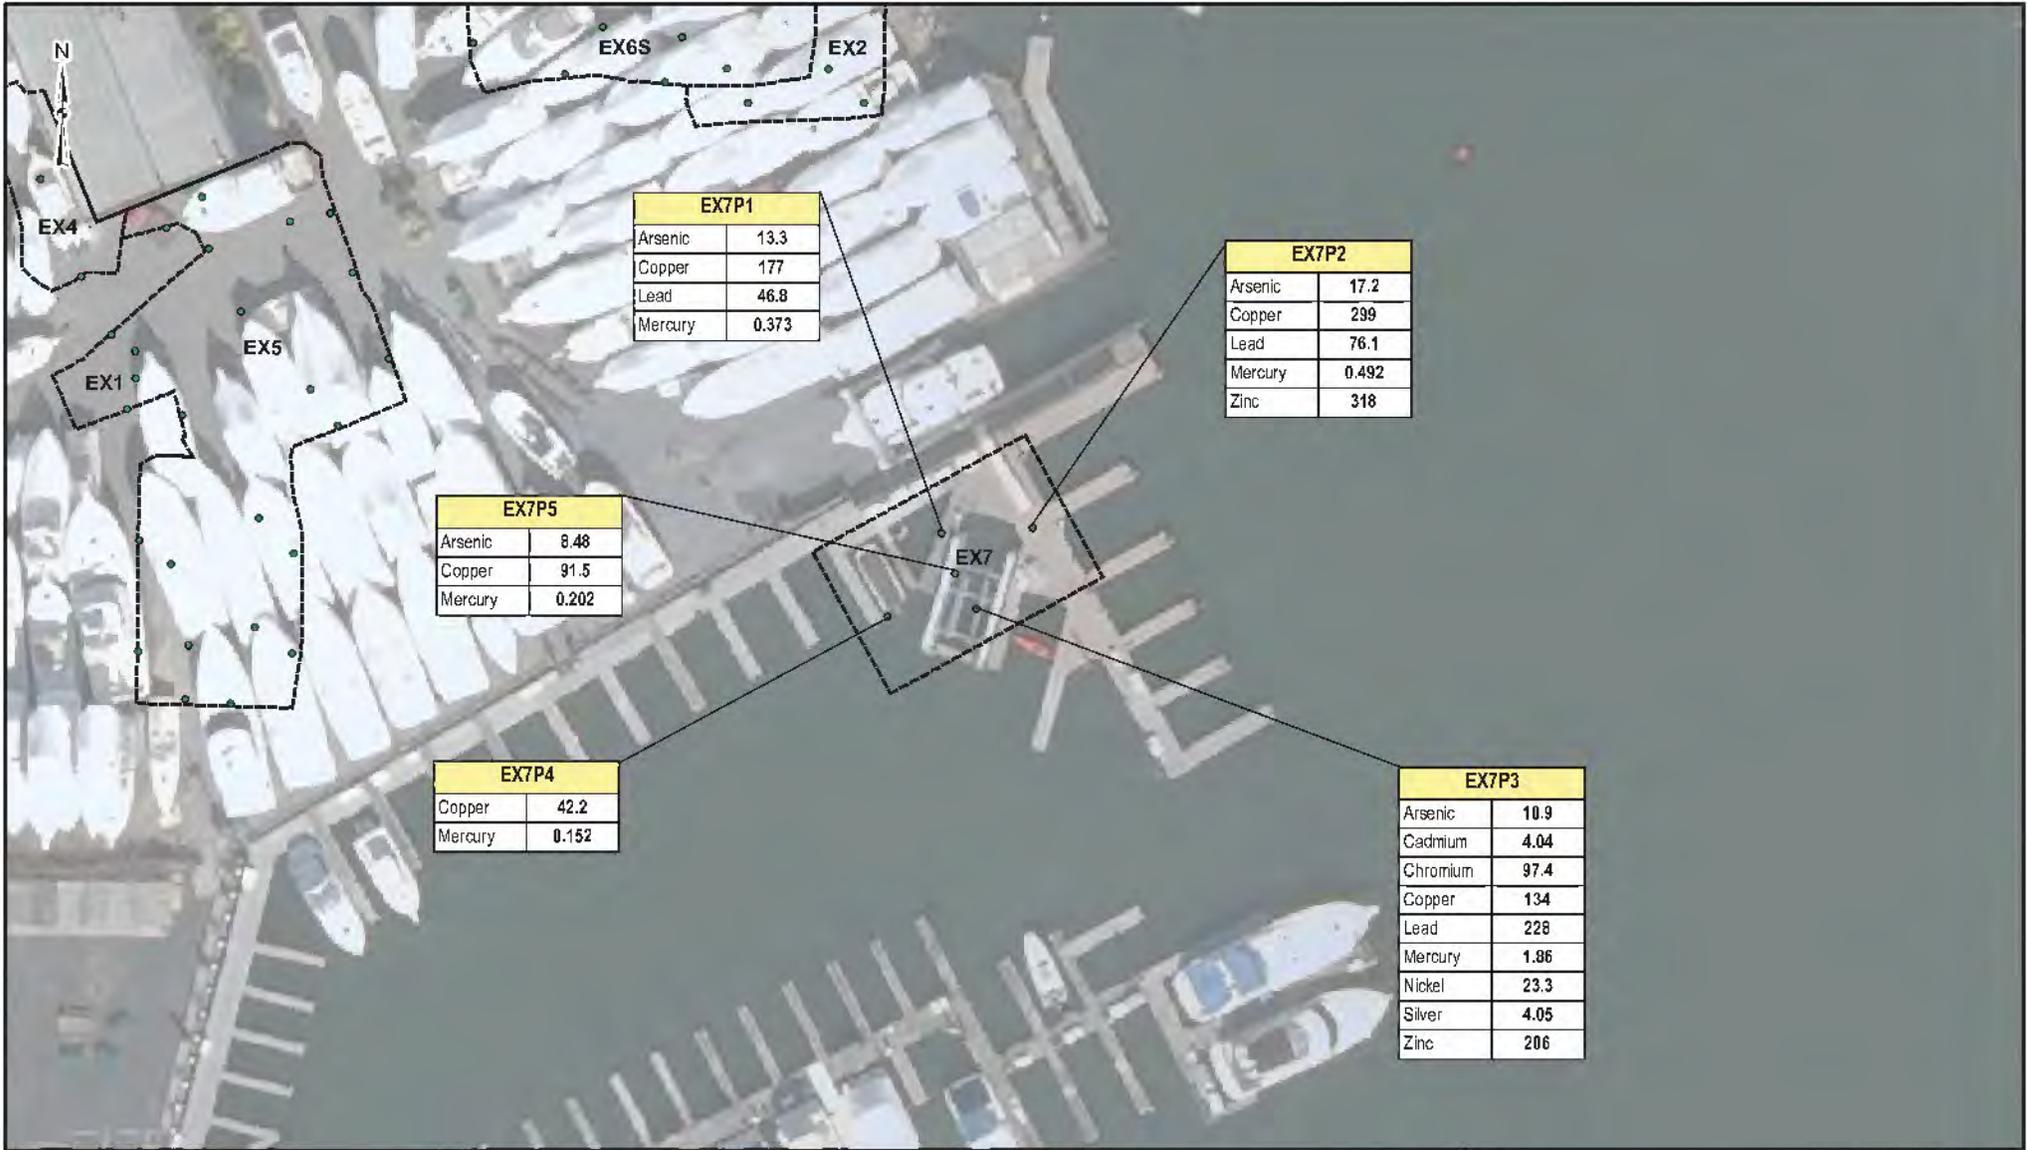
FIGURE 5G
 Documentation Sample Locations
 With Exceedences of SCCs in EX7

Dredging of contaminated sediment located in the 40 ft × 60 ft targeted area within Freeport Creek defined as EX7 by Contract Drawing 4 was performed from January 11 to 20, 2012. During the RA, it was determined that limited dock removal would need to take place before dredging of the Contract defined area could take place in order to allow for barge access and mobility during the completion of the work task. A meeting was held with the Engineer, Owner, Contractor, and dredging subcontractor (Hancock Bulkhead) on November 2, 2011 to coordinate dock removal and replacement tasks. The Owner set the schedule for dock removal based on dock use, and instructed the Contractor and dredging subcontractor on the steps necessary for proper dock removal. These steps included disconnection and dismantling of electrical and water supply at multiple boat slips, pier removal, and dock and slip removal. The Contractor and dredging subcontractor worked with the Owner's electrical subcontractor (Trius Electrical) in completing the electrical and plumbing disconnection work prior to dock removal.

Pre- and post-dredging surveys of EX7 were performed by Alphonse Pesce Land Surveying to verify the sediment removal limits and the volume of sediment removed. Approximately 250 tons of dredged non-hazardous sediment was transported and disposed offsite. Following sediment dredging, the docks were installed back in place by Hancock Bulkhead, and electrical and plumbing was reconnected to the satisfaction of the Owner.

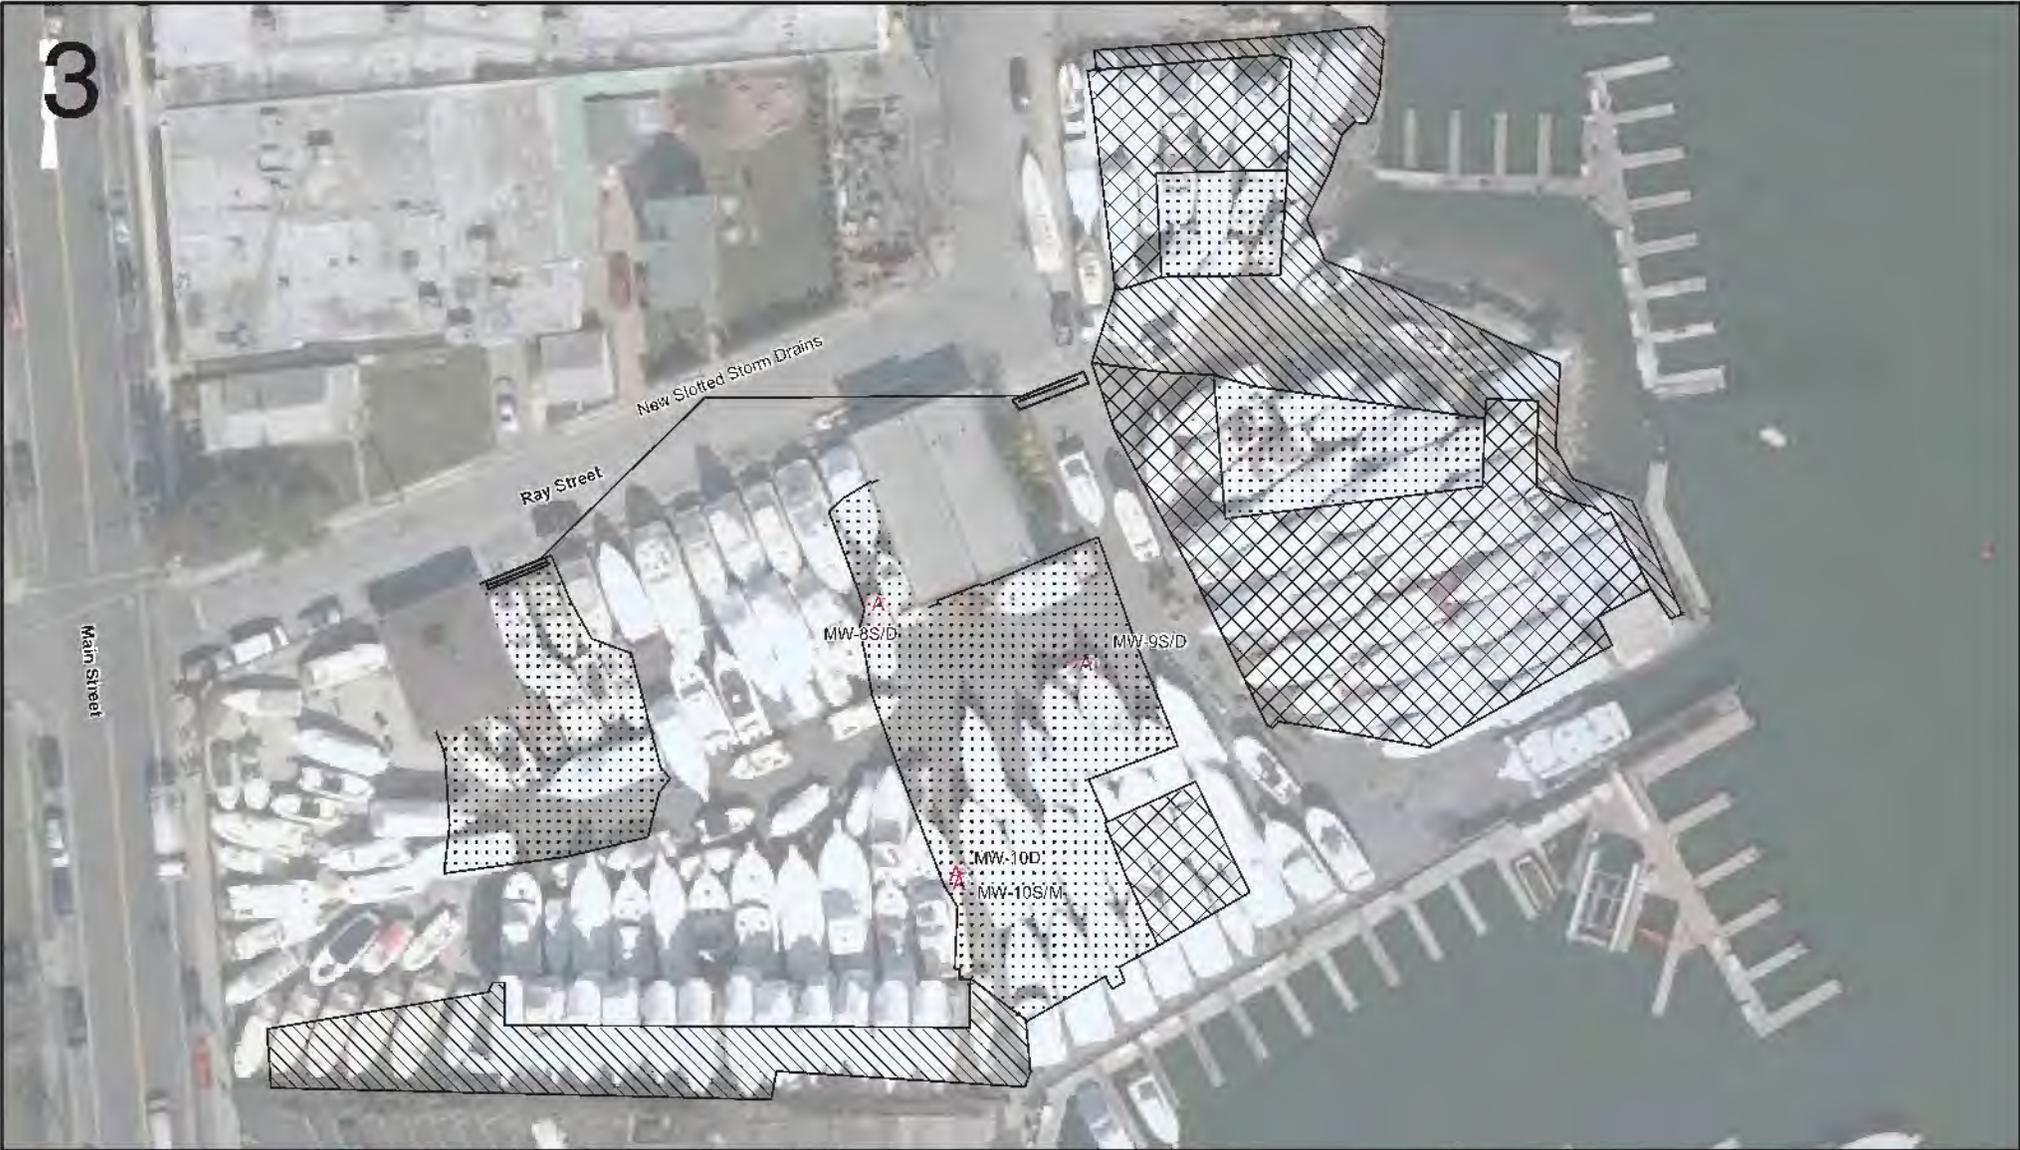
METAL ETCHING SITE (130110) FINAL ENGINEERING REPORT FREEPORT, NEW YORK NASSAU COUNTY				FIGURE 6 Site Restoration

Following paving and site restoration activities, monitoring wells MW08S/MW08D, MW09S/MW09D, MW10S/MW10D were installed in accordance with Contract Documents to replace decommissioned wells MW02S/MW02D, MW03S/MW03D, and MW07S/MW07D which were within the excavation areas. Monitoring wells were purged and developed in accordance with Contract specifications. The Monitoring Well Installation Report is included as Appendix W.

Figure 6 shows the as-built site restoration conditions, including cover types, the slotted drain systems, and new monitoring wells.

Asphalt pavement was not installed in a small area to the north and northeast portions of the site (to the north of EX6 – north of the Freeport Electric right-of-way) due to discovering unexpected electrical conduits while stripping the top 12 in. of ballast material, approximately 2-3 in. below grade. The asphalt pavement limit was revised in this area to prevent damage to these electrical conduits as shown on the Record Drawings (Appendix C) and Figure 6.
