# RECORD OF DECISION

Levey Property  
Operable Unit Number 01: Remedial Program- Onsite  
State Superfund Project  
Copiague, Suffolk County  
Site No. 152201  
February 2016

Prepared by  
Division of Environmental Remediation  
New York State Department of Environmental Conservation

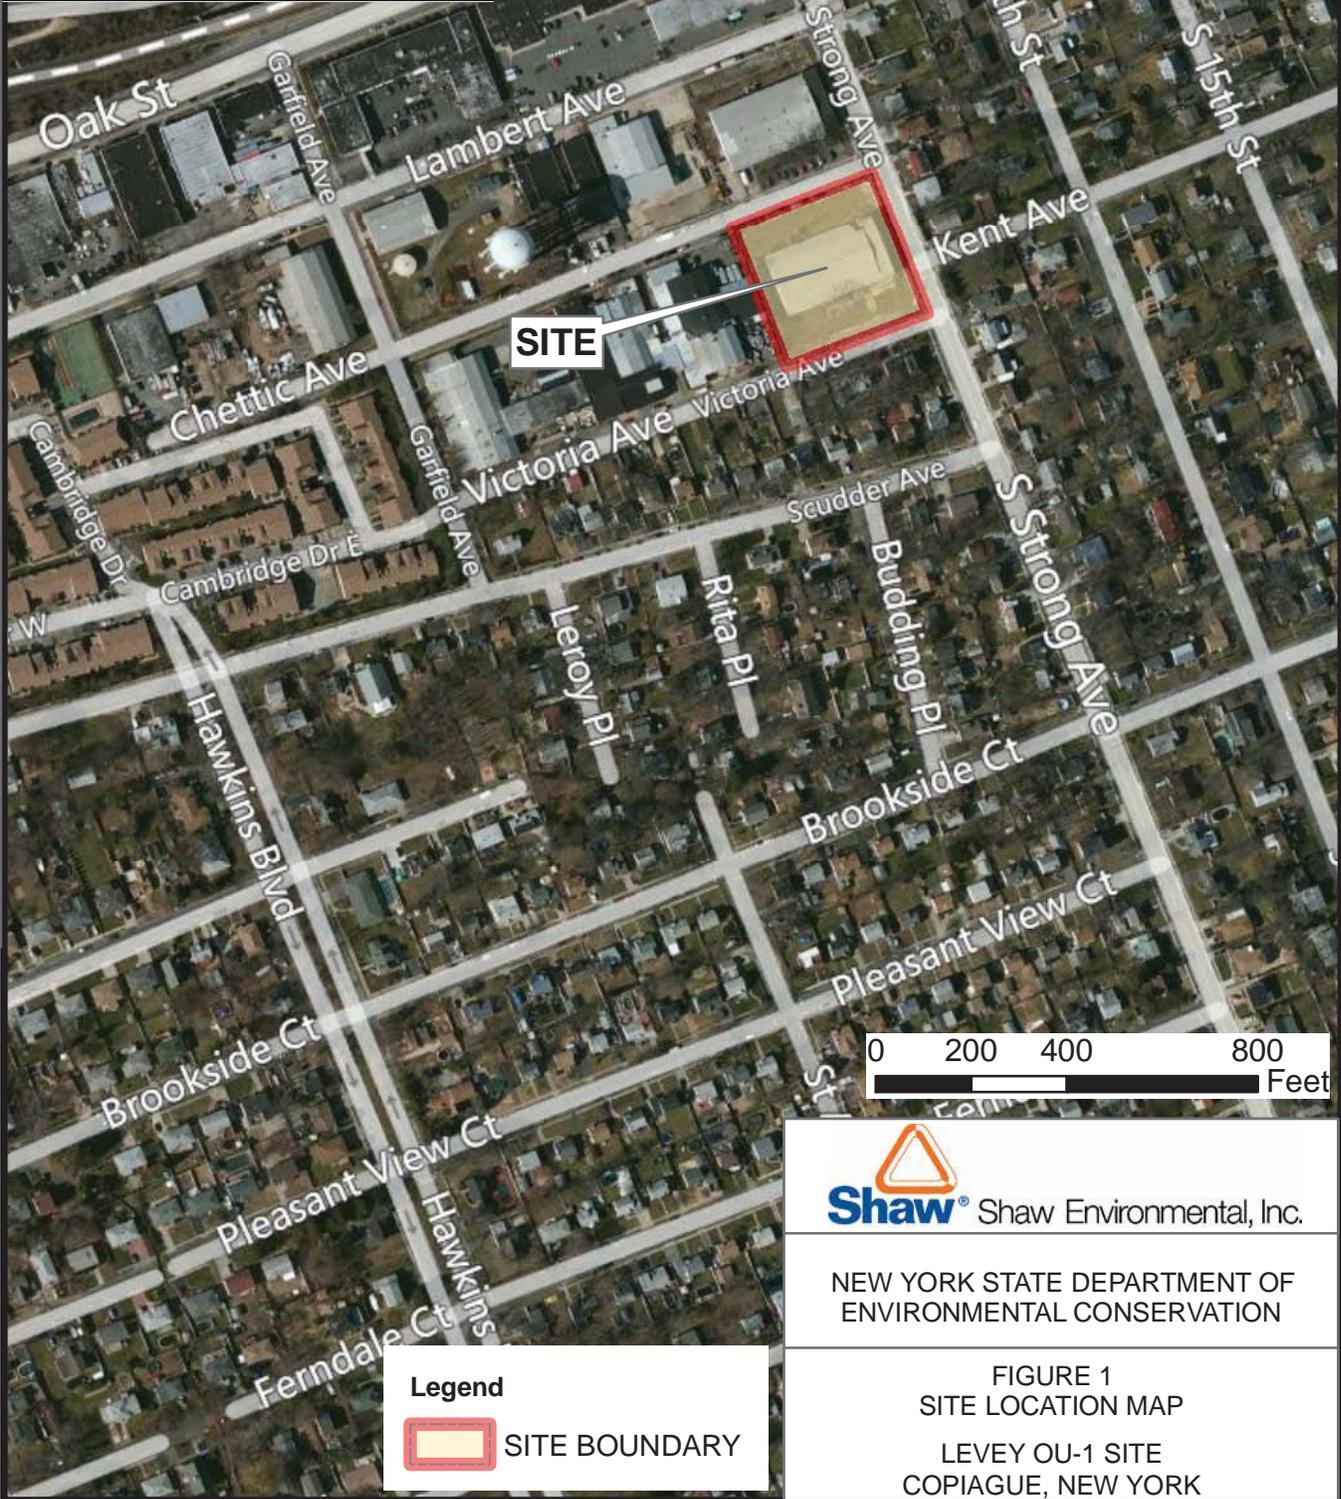
OFFICE	DATE	DESIGNED BY	DRAWN BY	CHECKED BY	APPROVED BY	DRAWING NUMBER
LATHAM, NY	03/15/12	MJS	MJS	MJS	DS	134685-07A1

Sub-slab soil vapor, indoor air and outdoor ambient air samples were collected from the on-site building to assess the potential for soil vapor intrusion. The results indicate that four VOC were detected at elevated levels in the sub-slab vapor: Freon 113, PCE, TCE and 1,1,1-TCA. The likely source of the vapors is Cesspool #5 which, until remediated, contained the same VOCs. When compared to SCGs for sub-slab vapor, the results indicate that no action is required, but further monitoring is recommended. The building is derelict and needs renovation. The soil vapor evaluation was conducted prior to the removal of Cesspool #5, and another SVI evaluation will be necessary prior to re-occupancy of the building. Figure 7 shows the results of the soil vapor evaluation.

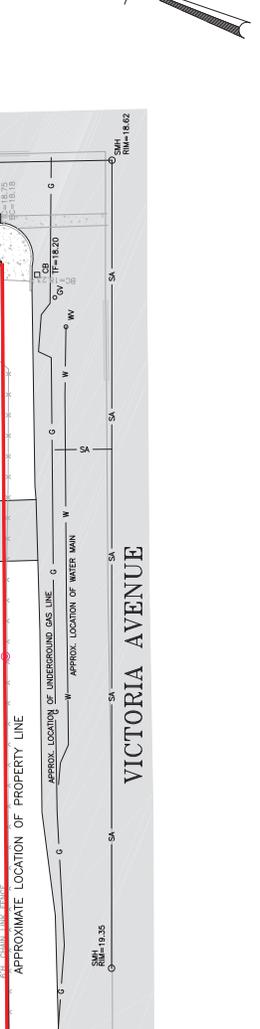
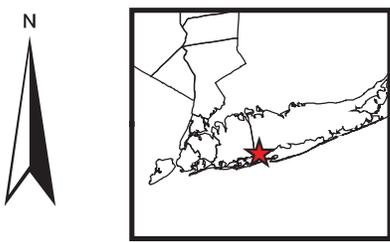
Remedial Investigation  
 On-site Groundwater Sample Results  
 VOC Detections in Groundwater  
 Sample Date: June 9, 2015  
**Figure 3**

Well ID	MW-1S	MW-1D	MW-2S	MW-2D	MW-3S	MW-3D
Depth (feet)	(10-25)	(60-70)	(10-25)	(60-70)	(10-25)	(60-70)
Sampling Date	NYS Criteria*		6/9/2015		6/9/2015	
<b>VOA-8260C-WATER</b>	µg/l		Result (µg/l)	Result (µg/l)	Result (µg/l)	Result (µg/l)
1,1,1-Trichloroethane	5	nd	<b>0.42J</b>	nd	<b>5.6</b>	<b>13</b>
1,1,2-Trichloro-1,2,2-trifluoroethane	5	nd	nd	nd	nd	0.35J
1,1-Dichloroethane	5	nd	<b>0.72J</b>	nd	1.1	1.1
1,1-Dichloroethene	5	nd	nd	nd	<b>0.43</b>	<b>0.43J</b>
1,4-Dichlorobenzene	5	<b>0.95J</b>	nd	nd	nd	nd
Benzene	0.7	nd	nd	nd	nd	nd
Chlorobenzene	5	nd	nd	nd	nd	nd
Chloroform	7	nd	nd	nd	<b>0.33J</b>	nd
cis-1,2-Dichloroethene	5	nd	<b>0.41J</b>	nd	<b>0.89J</b>	<b>4.0</b>
Methyl tert-butyl ether	10	nd	<b>0.44J</b>	nd	<b>0.50J</b>	<b>0.51J</b>
Tetrachloroethene	5	<b>42</b>	<b>0.99J</b>	nd	<b>1.6</b>	<b>3.4</b>
Trichloroethene	5	<b>0.44J</b>	<b>0.71J</b>	nd	<b>1.4</b>	<b>0.62J</b>
Vinyl chloride	2	nd	nd	nd	nd	nd

Total VOCs (6/9/2015)	NA	44.39	3.69	0	11.85	17.62
Total VOCs (12/28/2011)	NA	0.54	7	11	17.5	2.2

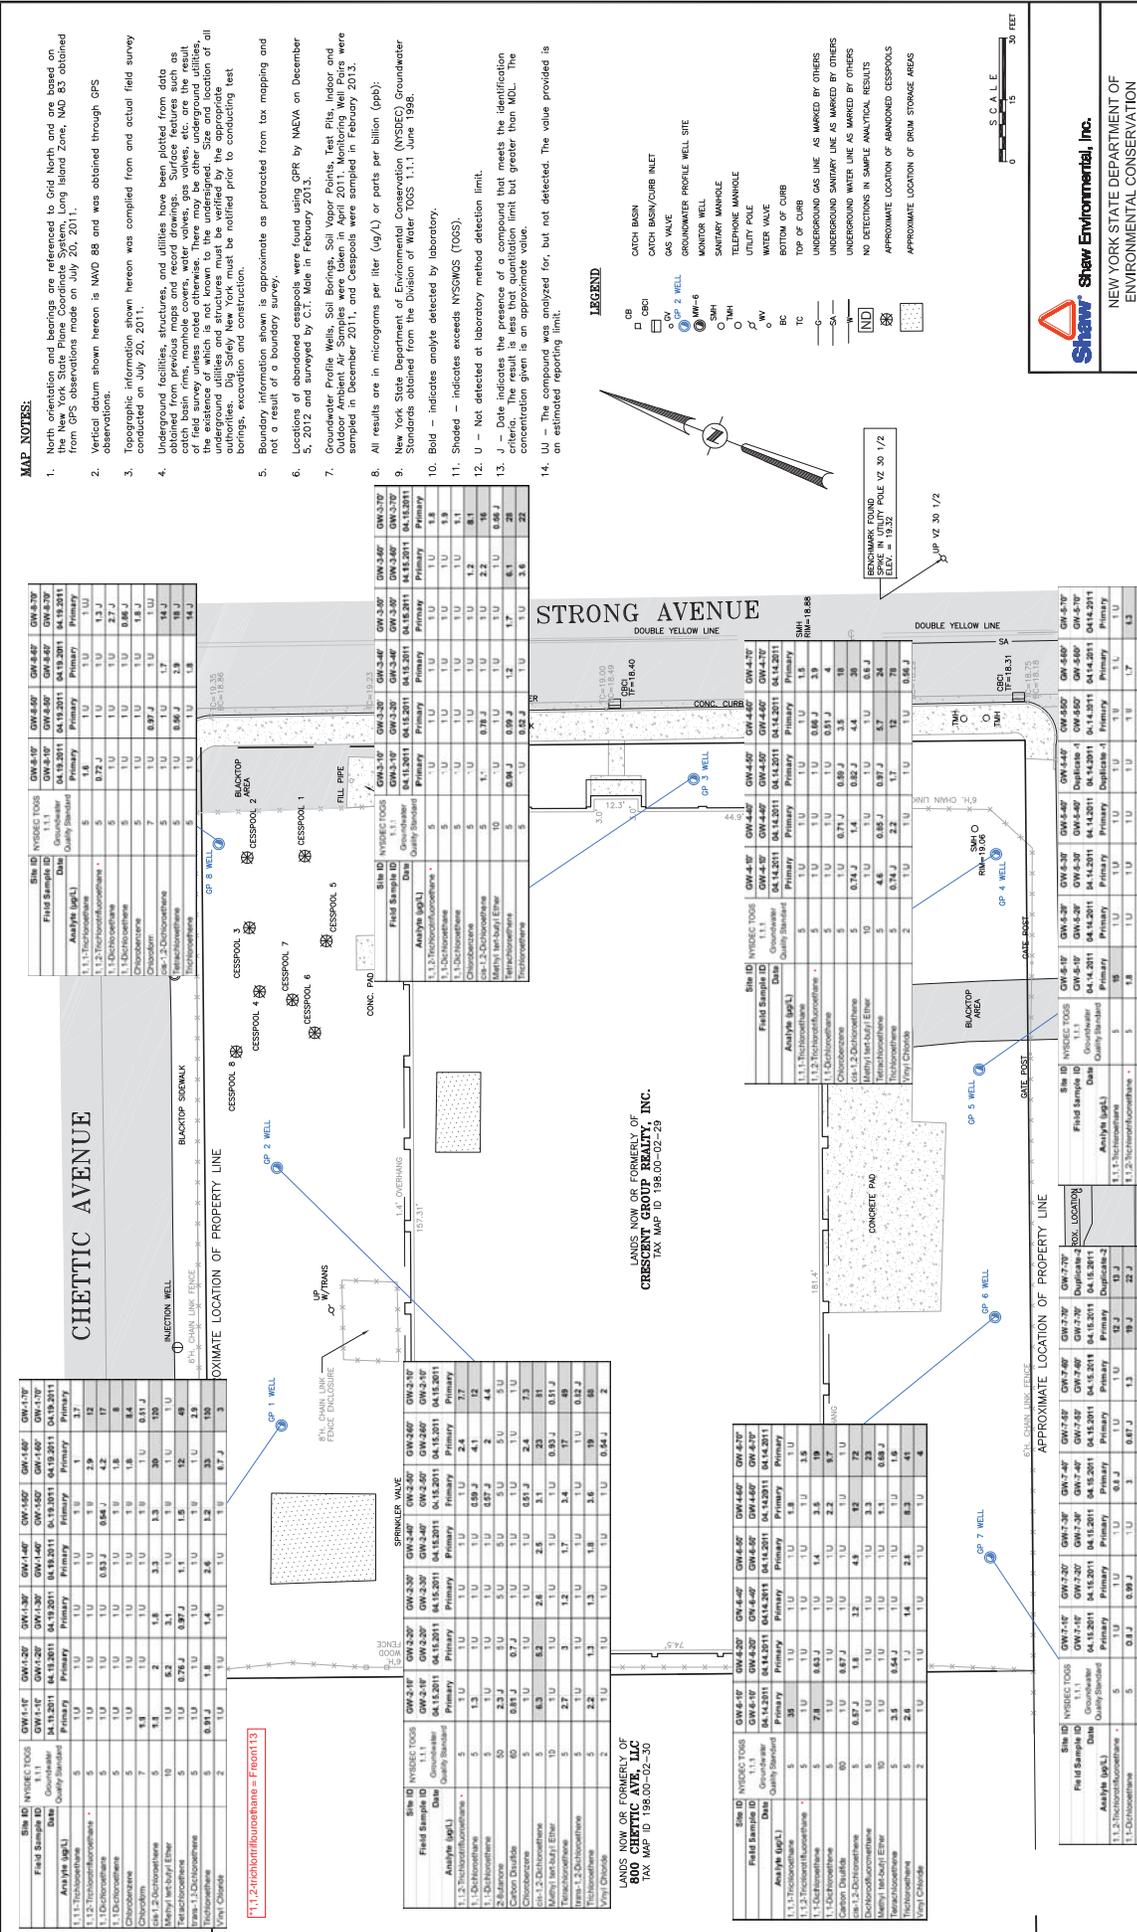
**Figure 4**  
GROUNDWATER VOC RESULTS  
DECEMBER 2011  
1305 SOUTH STRONG STREET  
SUFFOLK COUNTY COPIAQUE, NEW YORK

Site ID	NYSDEC TOGS	MW-25	MW-20
Field Sample ID	Quality Standard	Shallow (20ft) Depth (ft)	Primary
1.1, Dichloroethane	5	1.0	1.1
1.1, Chloroform	5	1.0	0.48 J
1.1, Trichloroethylene	5	1.0	0.14
1.1, 1,1-Dichloroethene	5	8.3	0.1 J
1.1, 1,2-Dichloroethane	5	1.0	2.7
1.1, Toluene	5	2.4	2.6
1.1, Xylenes	5	2.8	3.4
1.1, Benzene	2	0.71 J	1.0

Site ID	NYSDEC TOGS	MW-40	MW-400N
Field Sample ID	Quality Standard	Shallow (20ft) Depth (ft)	Primary
1.1, Dichloroethane	5	1.0	1.1
1.1, Chloroform	5	1.0	0.48 J
1.1, Trichloroethylene	5	1.0	0.14
1.1, 1,1-Dichloroethene	5	8.3	0.1 J
1.1, 1,2-Dichloroethane	5	1.0	2.7
1.1, Toluene	5	2.4	2.6
1.1, Xylenes	5	2.8	3.4
1.1, Benzene	2	0.71 J	1.0

Site ID	NYSDEC TOGS	MW-45	MW-450N
Field Sample ID	Quality Standard	Shallow (20ft) Depth (ft)	Primary
1.1, Dichloroethane	5	1.0	1.1
1.1, Chloroform	5	1.0	0.48 J
1.1, Trichloroethylene	5	1.0	0.14
1.1, 1,1-Dichloroethene	5	8.3	0.1 J
1.1, 1,2-Dichloroethane	5	1.0	2.7
1.1, Toluene	5	2.4	2.6
1.1, Xylenes	5	2.8	3.4
1.1, Benzene	2	0.71 J	1.0
