RECORD OF DECISION

Chalmers Building
Environmental Restoration Project
Amsterdam, Montgomery County
Site No. E429011
September 2013

Prepared by
Division of Environmental Remediation
New York State Department of Environmental Conservation

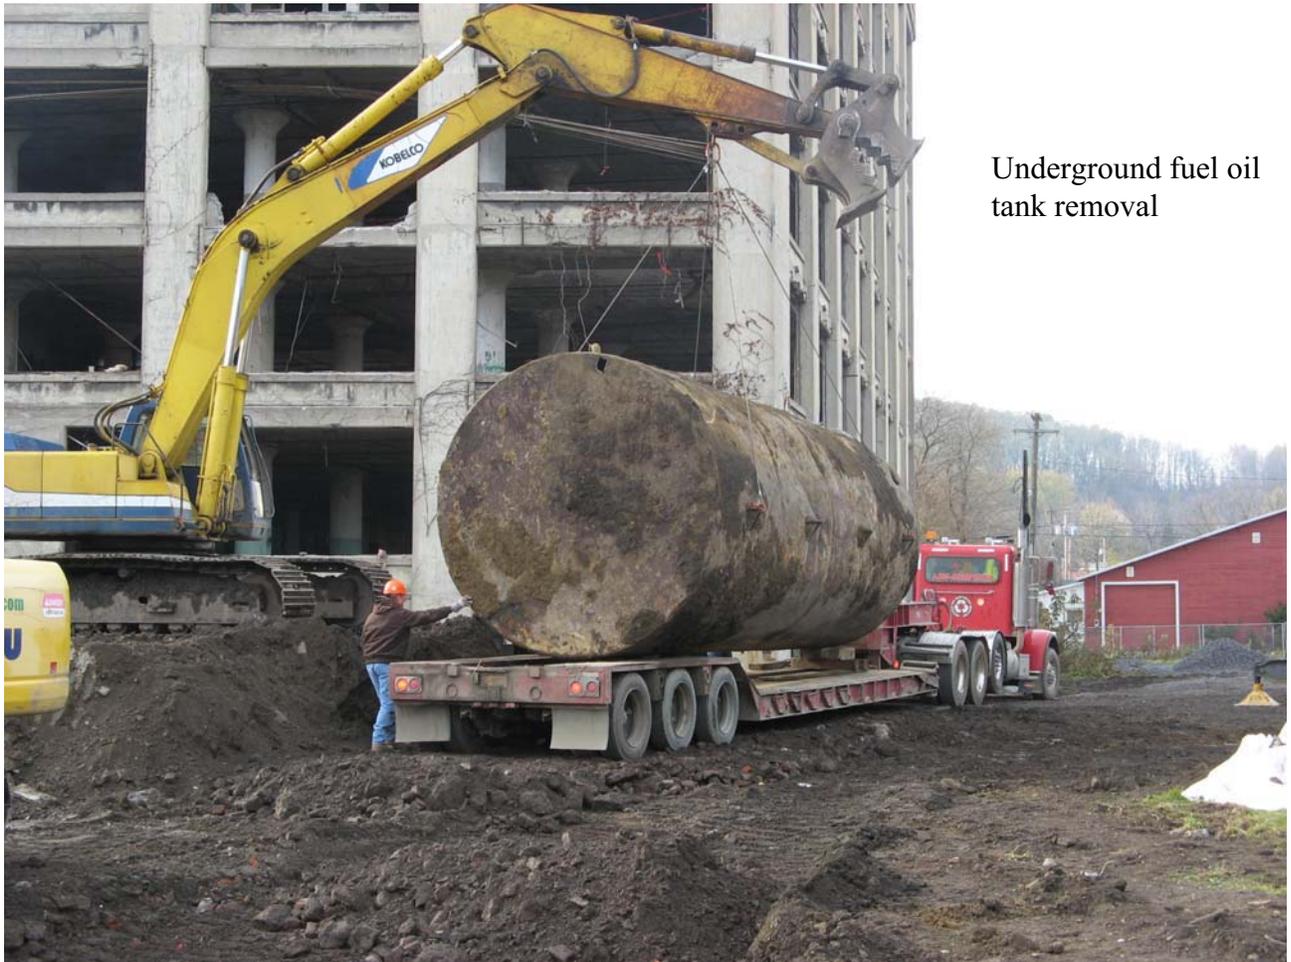
FIGURE 3

Underground fuel oil tank removal

The IRM consisted of investigation, excavation, and removal of two 20,000-gallon underground storage tanks and associated contaminated soil. Removal of six 130-gallon PCB transformers from the central courtyard of the buildings was followed by demolition of the buildings, with associated asbestos abatement, to facilitate hazardous substance investigation and removal. Building demolition started in the spring of 2011 and was largely complete by the summer of 2012. Clean brick and concrete from the building demolition were used to backfill the basements and regrade the site. A demarcation layer (woven filter fabric) and a one-foot layer of clean soil (meeting commercial soil cleanup objectives as set forth in 6 NYCRR Part 375-6.7(d)) were placed over the contaminated soil areas.

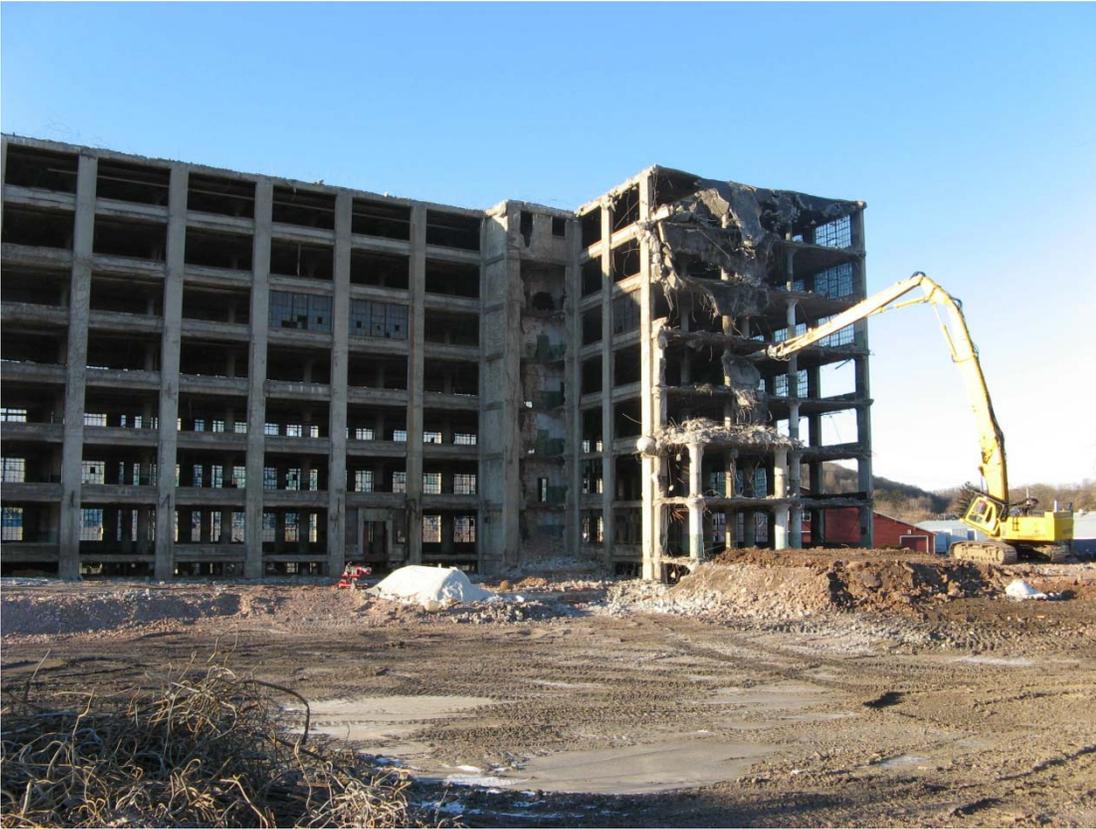
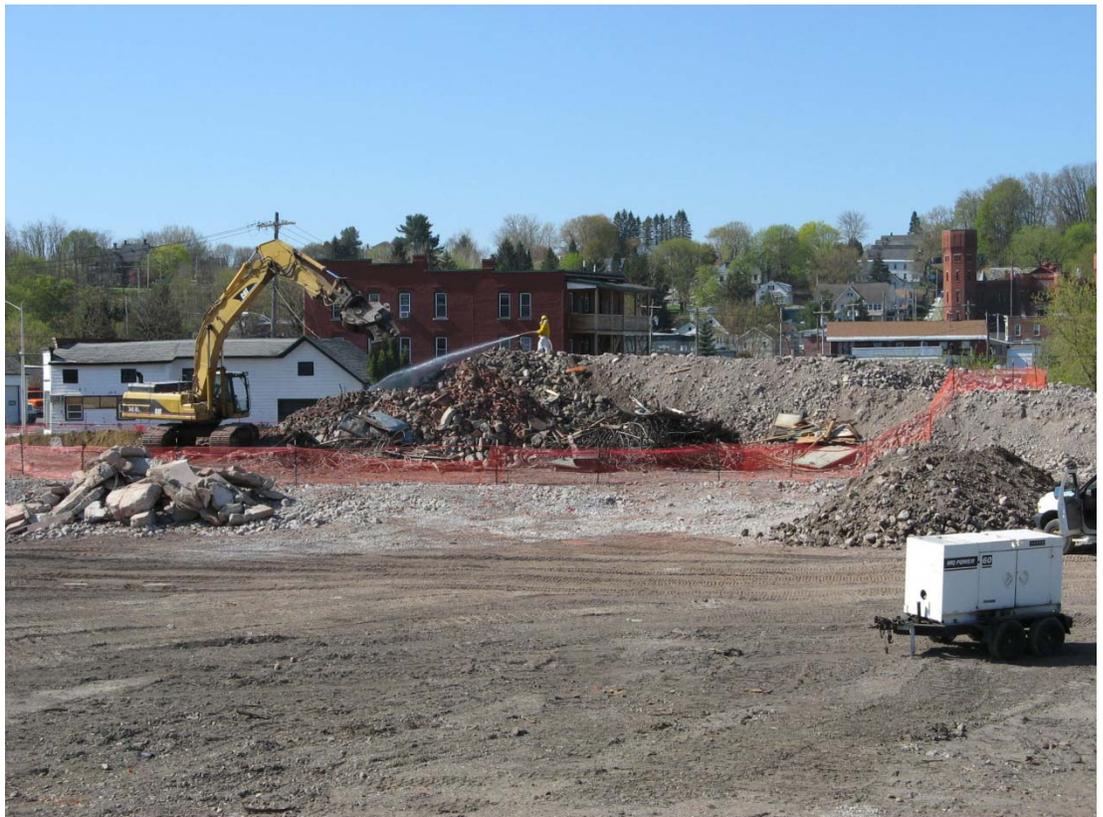
FIGURE 4

Demolition activities

Rubble pile

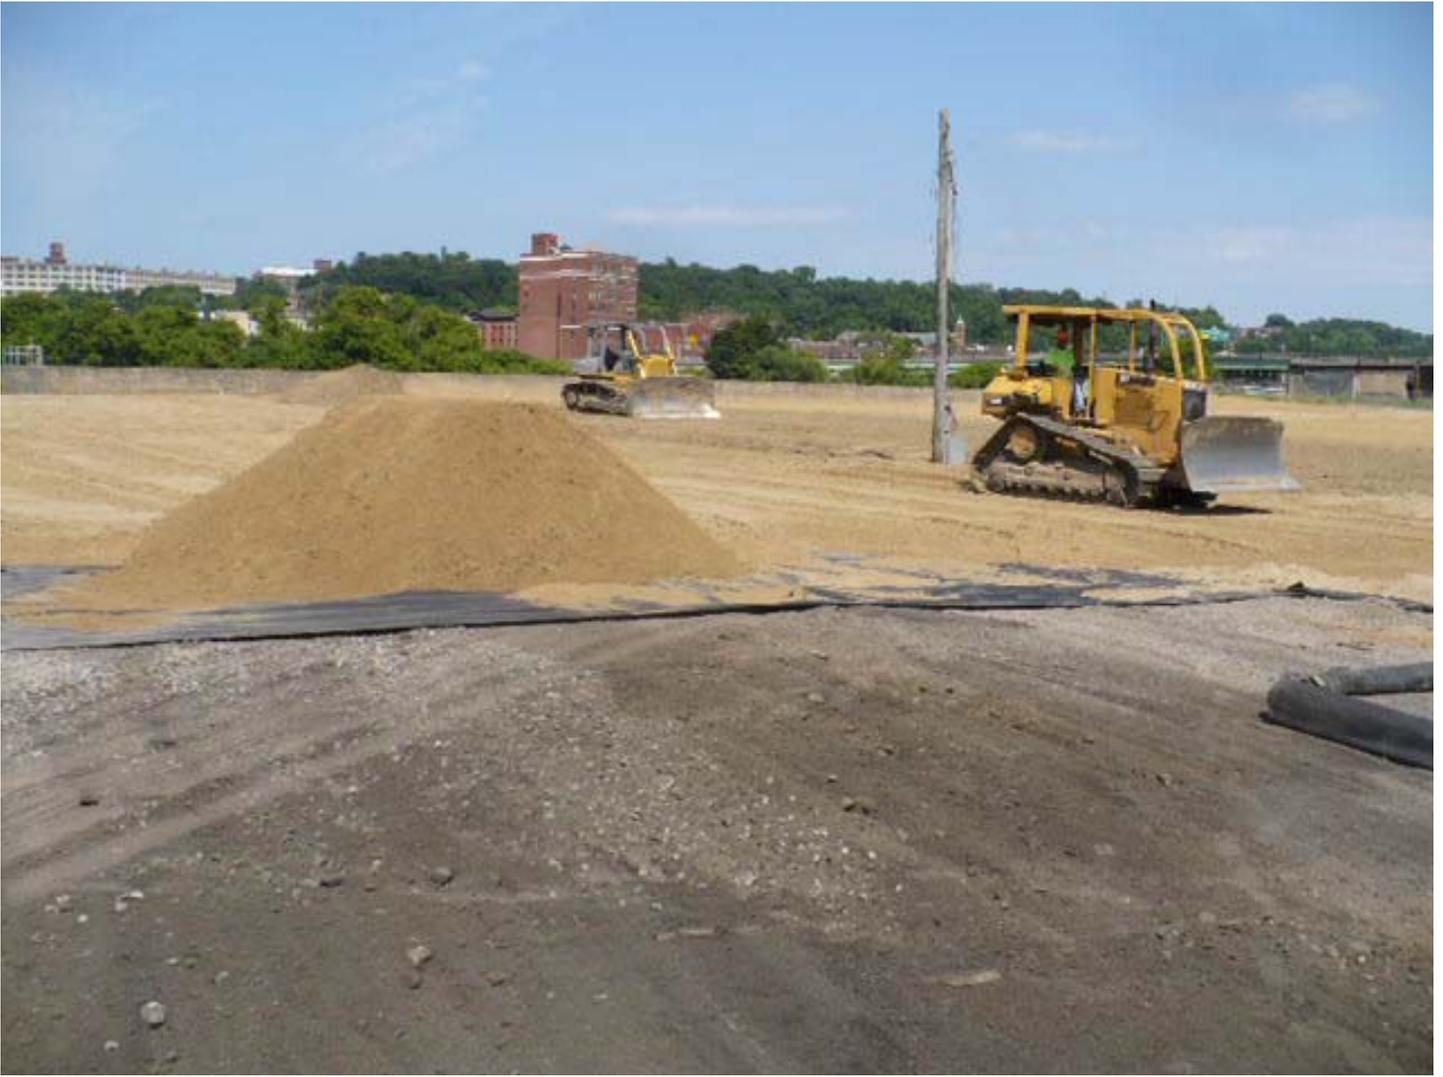
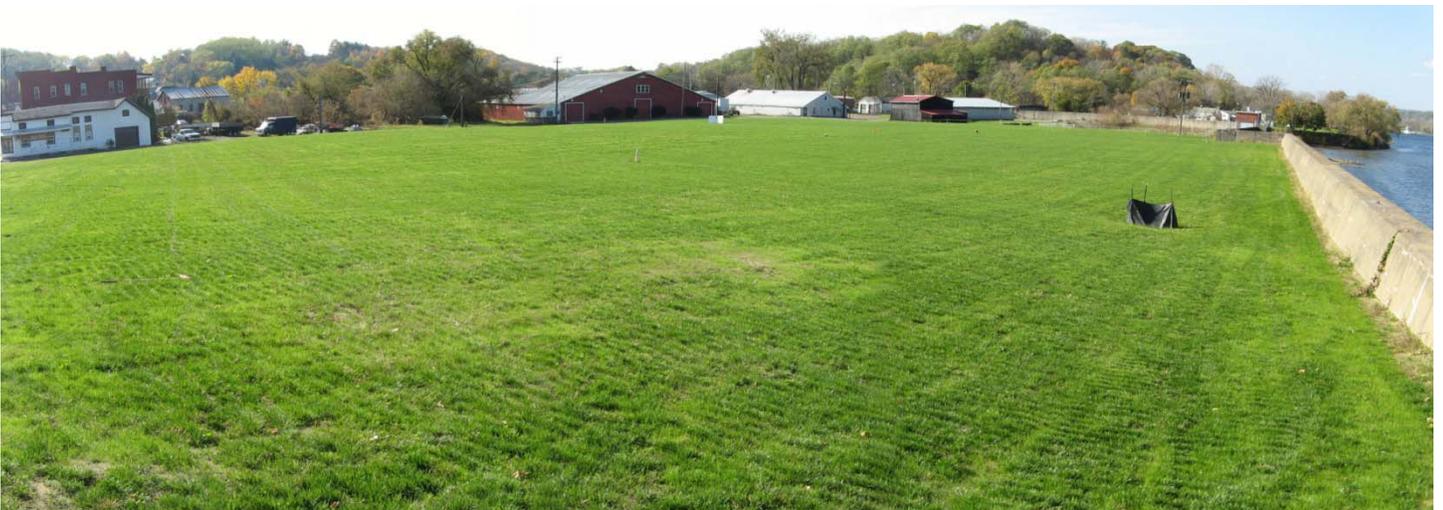
FIGURE 5

Placement of soil cover on graded site

Site with vegetative cover

A one-foot soil cover currently exists and will be maintained to allow for commercial or industrial use of the site. Any future site redevelopment will maintain a site cover, which may consist either of the structures such as buildings, pavement, sidewalks comprising the site development or a soil cover in areas where the upper one foot of exposed surface soil will exceed the applicable soil cleanup objectives (SCOs). Where a soil cover is required it will be a minimum of one foot of soil, meeting the SCOs for cover material as set forth in 6 NYCRR Part 375-6.7(d) for commercial use. Where a soil cover is required, a demarcation layer will first be constructed before placement of the cover system. The present clean soil cover has been placed over a demarcation layer, with the upper six inches of the soil of sufficient quality to maintain a vegetation layer. Any fill material brought to the site met the requirements for the identified site use as set forth in 6 NYCRR Part 375-6.7(d).

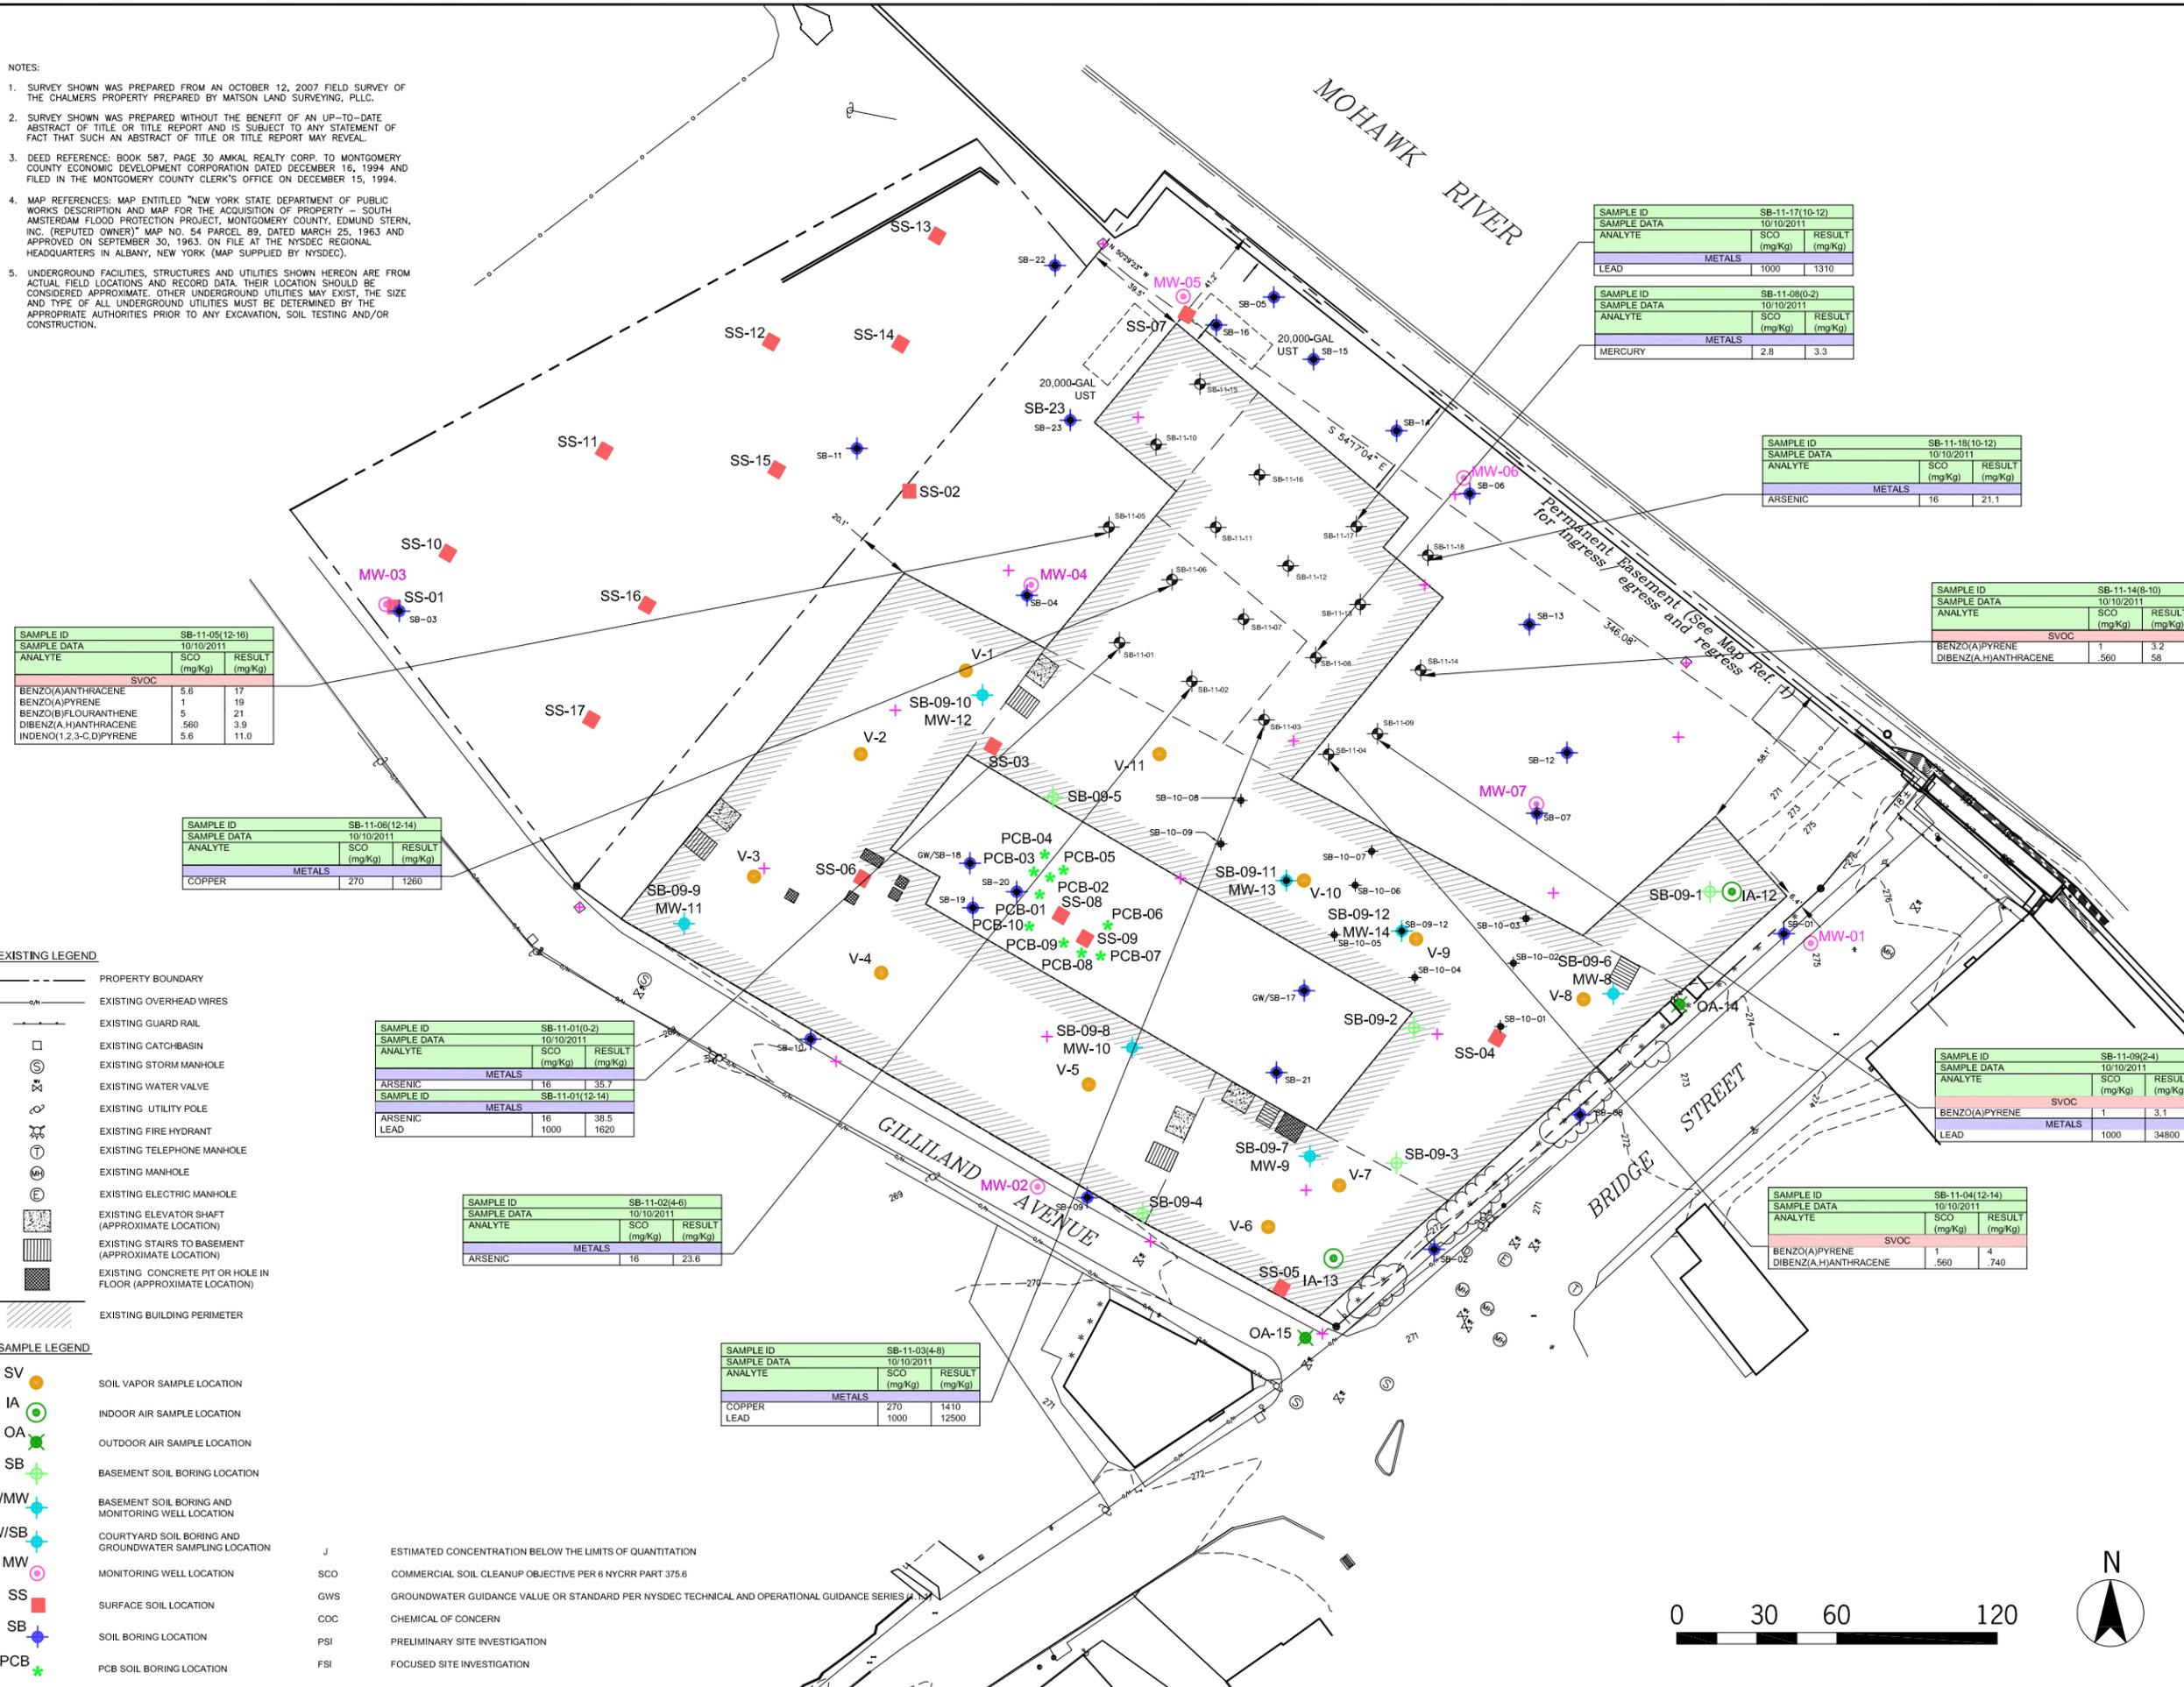
SAMPLE ID SB-11-05(12-16)			
SAMPLE DATA 10/10/2011			
ANALYTE	SCO (mg/Kg)	RESULT	(mg/Kg)
METALS			
LEAD	1000	1310	
SVOC			
BENZO(A)ANTHRACENE	5.6	17	
BENZO(A)PYRENE	1	19	
BENZO(B)FLUORANTHENE	5	21	
DIBENZO(A,H)ANTHRACENE	.560	3.9	
INDENO(1,2,3-C,D)PYRENE	5.6	11.0

SAMPLE ID SB-11-06(12-14)			
SAMPLE DATA 10/10/2011			
ANALYTE	SCO (mg/Kg)	RESULT	(mg/Kg)
METALS			
COPPER	270	1260

Subsurface soil samples were collected from the building footprint in an effort to determine if fabric dyeing operations contaminated the soil. While there are sporadic detections of several metals, there is no general pattern to these detections which would be indicative of gross contamination from dyeing operations. In fact, with the exception of an area of lead-contaminated soil beneath Structure 2, it appears that the contamination found in the subsurface soil is the result of historic fill material used when the building was built. The ubiquitous presence of PAHs also points to historic fill material.

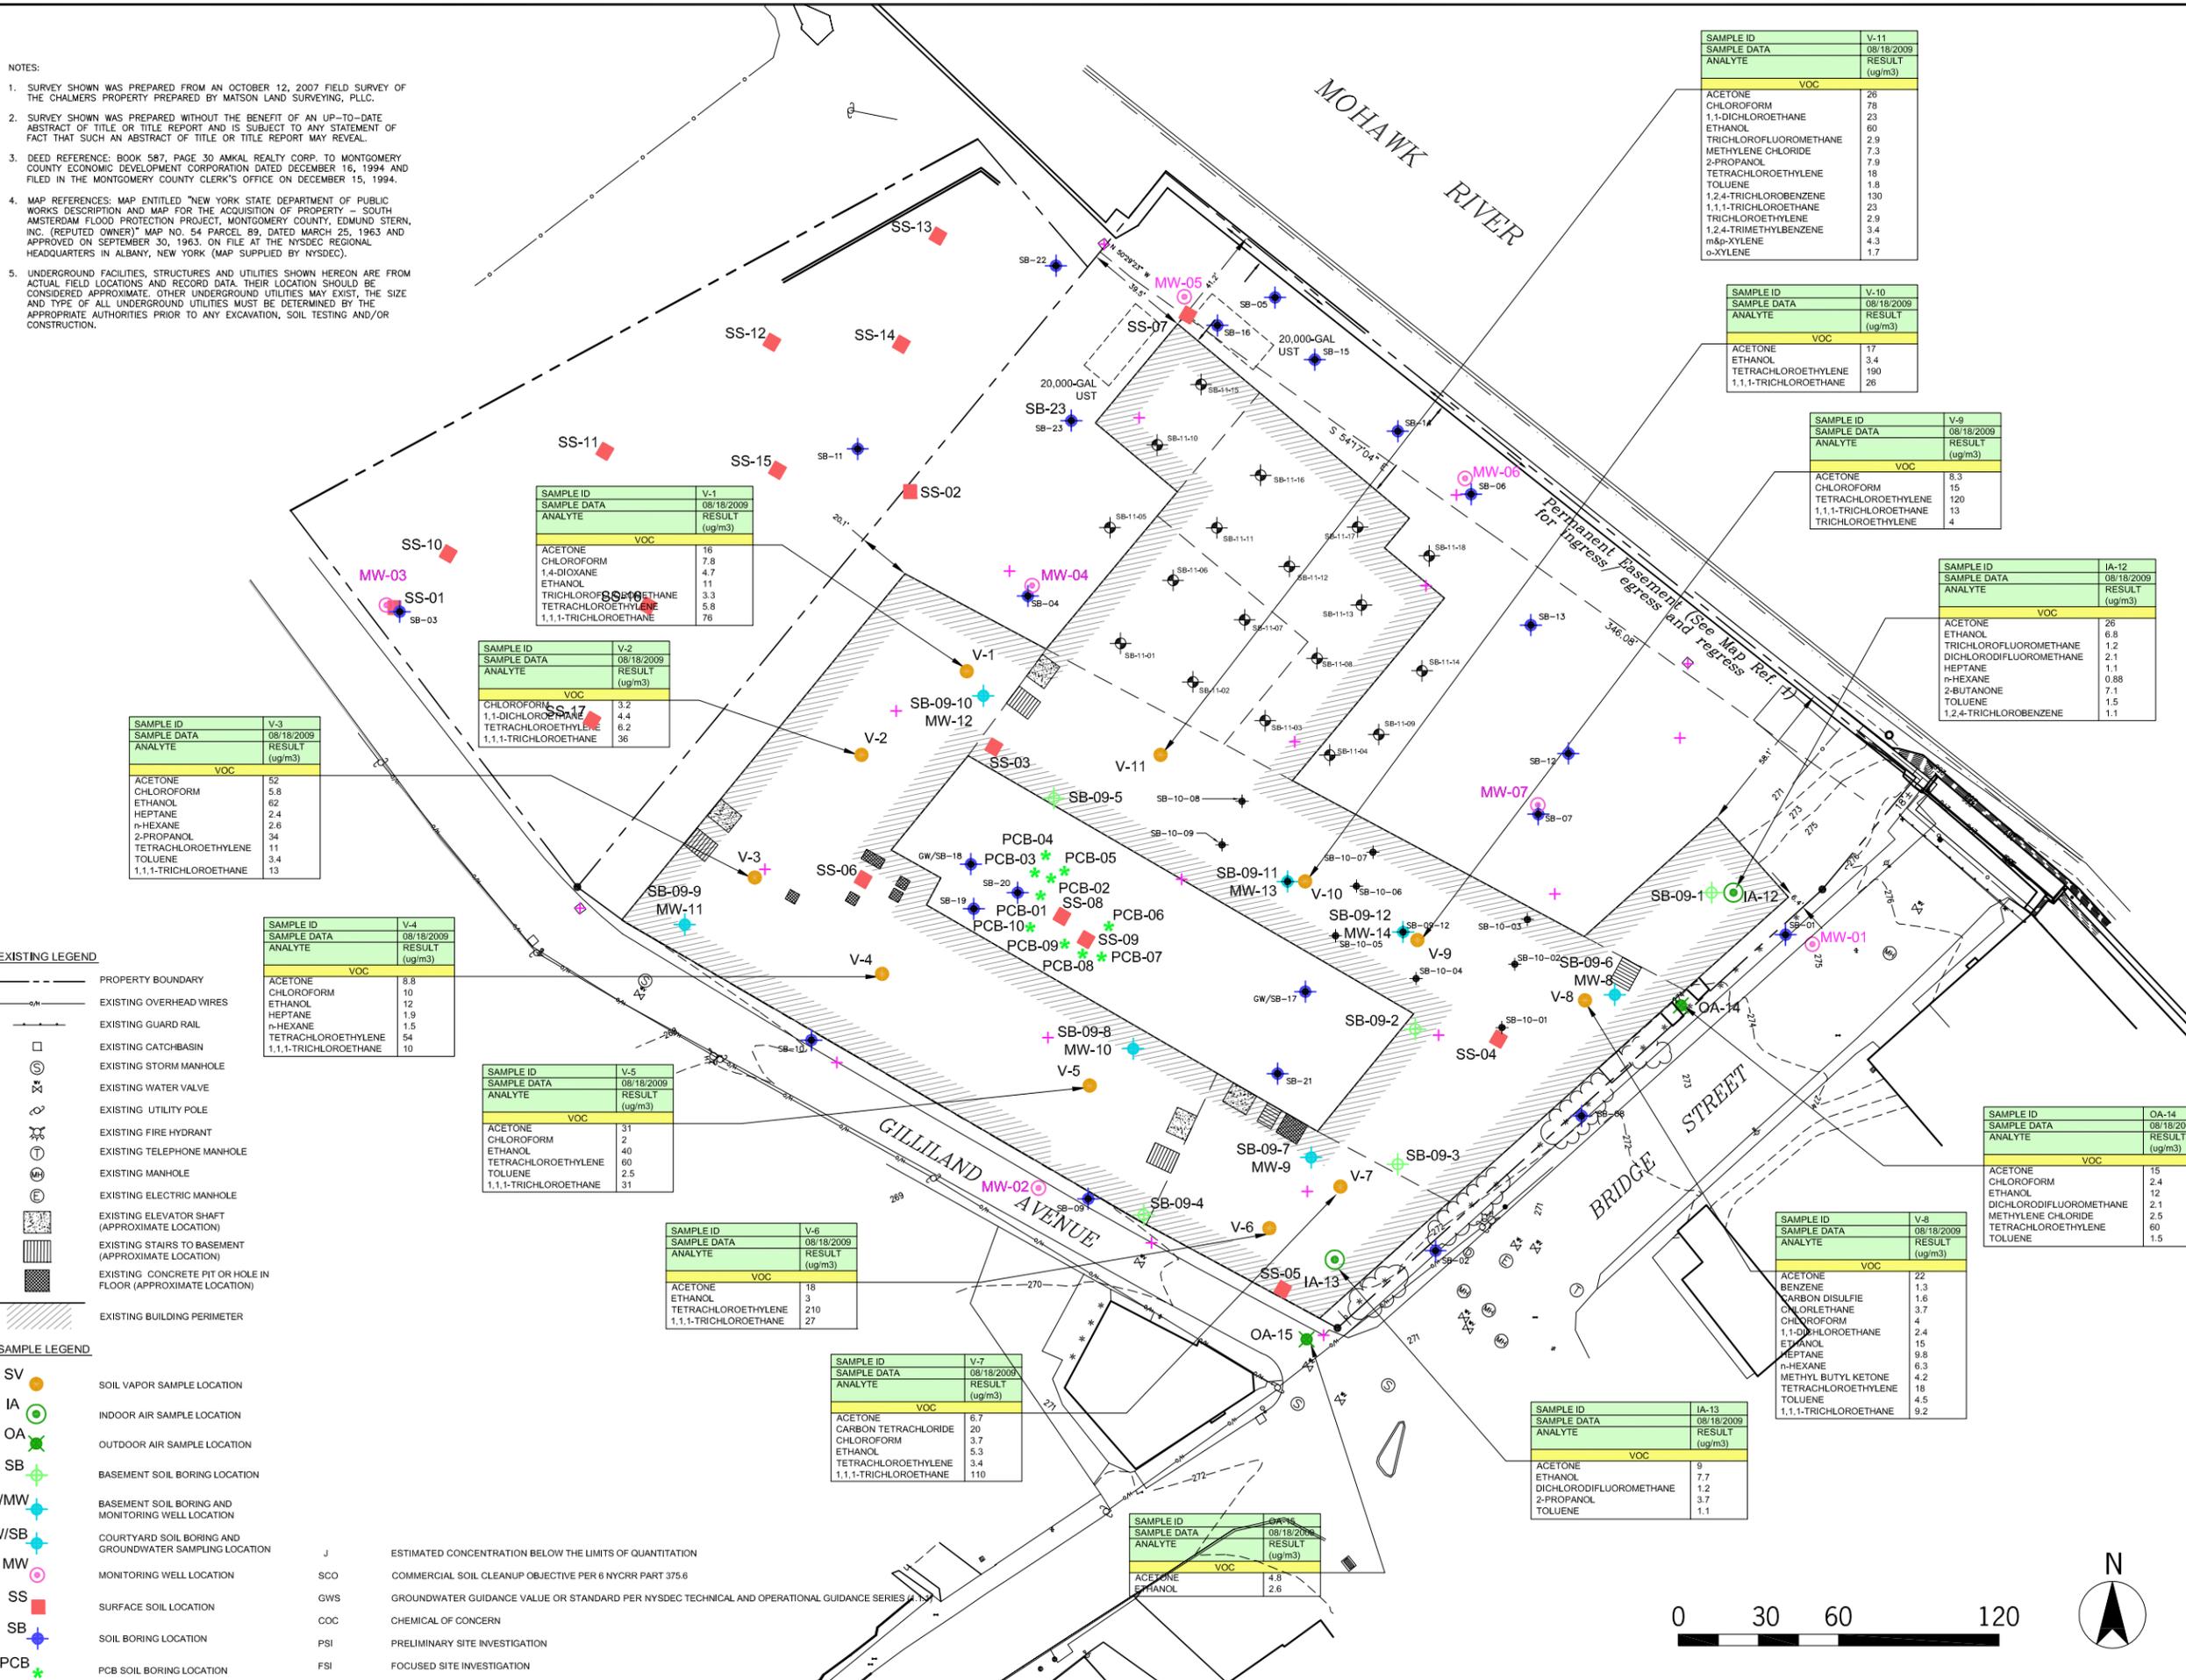
SAMPLE ID	V-11
SAMPLE DATA	08/18/2009
ANALYTE	RESULT (ug/m3)
VOC	
ACETONE	26
CHLOROFORM	78
1,1-DICHLOROETHANE	23
ETHANOL	60
TRICHLOROFLUOROMETHANE	2.9
METHYLENE CHLORIDE	7.3
2-PROPANOL	7.9
TETRACHLOROETHYLENE	18
TOLUENE	1.8
1,2,4-TRICHLOROBENZENE	130
1,1,1-TRICHLOROETHANE	23
TRICHLOROETHYLENE	3.4
1,2,4-TRIMETHYLBENZENE	4.3
m&p-XYLENE	4.3
o-XYLENE	1.7

SAMPLE ID	V-10
SAMPLE DATA	08/18/2009
ANALYTE	RESULT (ug/m3)
VOC	
ACETONE	17
ETHANOL	3.4
TETRACHLOROETHYLENE	190
1,1,1-TRICHLOROETHANE	26

Figure 11 shows the locations of the soil vapor samples and the chemicals detected. Based on the concentration detected, and in comparison with the NYSDOH Soil Vapor Intrusion Guidance, no site-related soil vapor contamination of concern was identified during the RI. However, a few on-site soil vapor samples detected elevated levels of chlorinated VOCs. Soil vapor intrusion will need to be evaluated in any future construction or development on this site prior to occupation. Soil vapor is not a concern for off-site structures based on the soil vapor sample data and since no occupied structures are in close proximity to the site.
