RECORD OF DECISION

Pioneer Street Mill
Environmental Restoration Project
Amsterdam, Montgomery County
Site No. E429013
March 2013

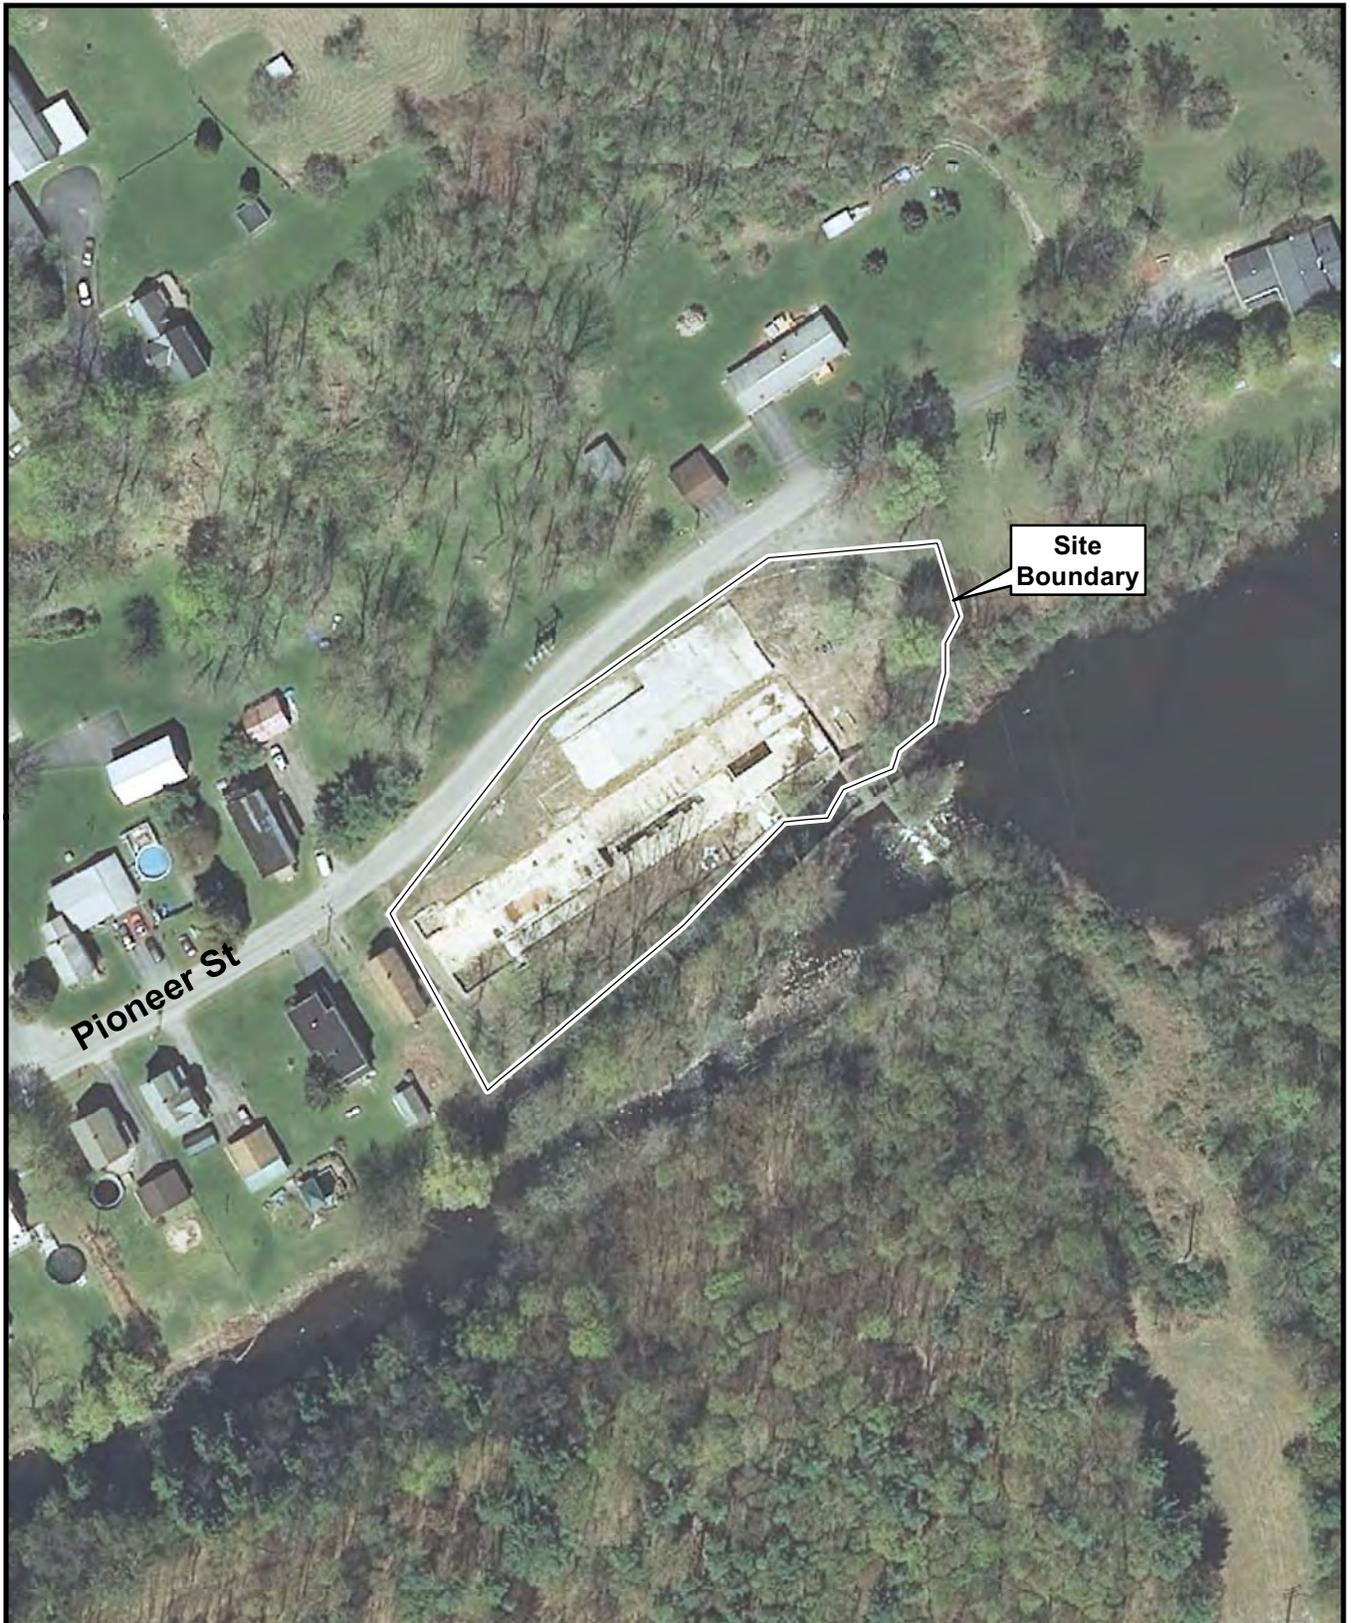
Figure 2 Site Map

Pioneer Street Mill
Town of Amsterdam, Montgomery County
Site No. E429013

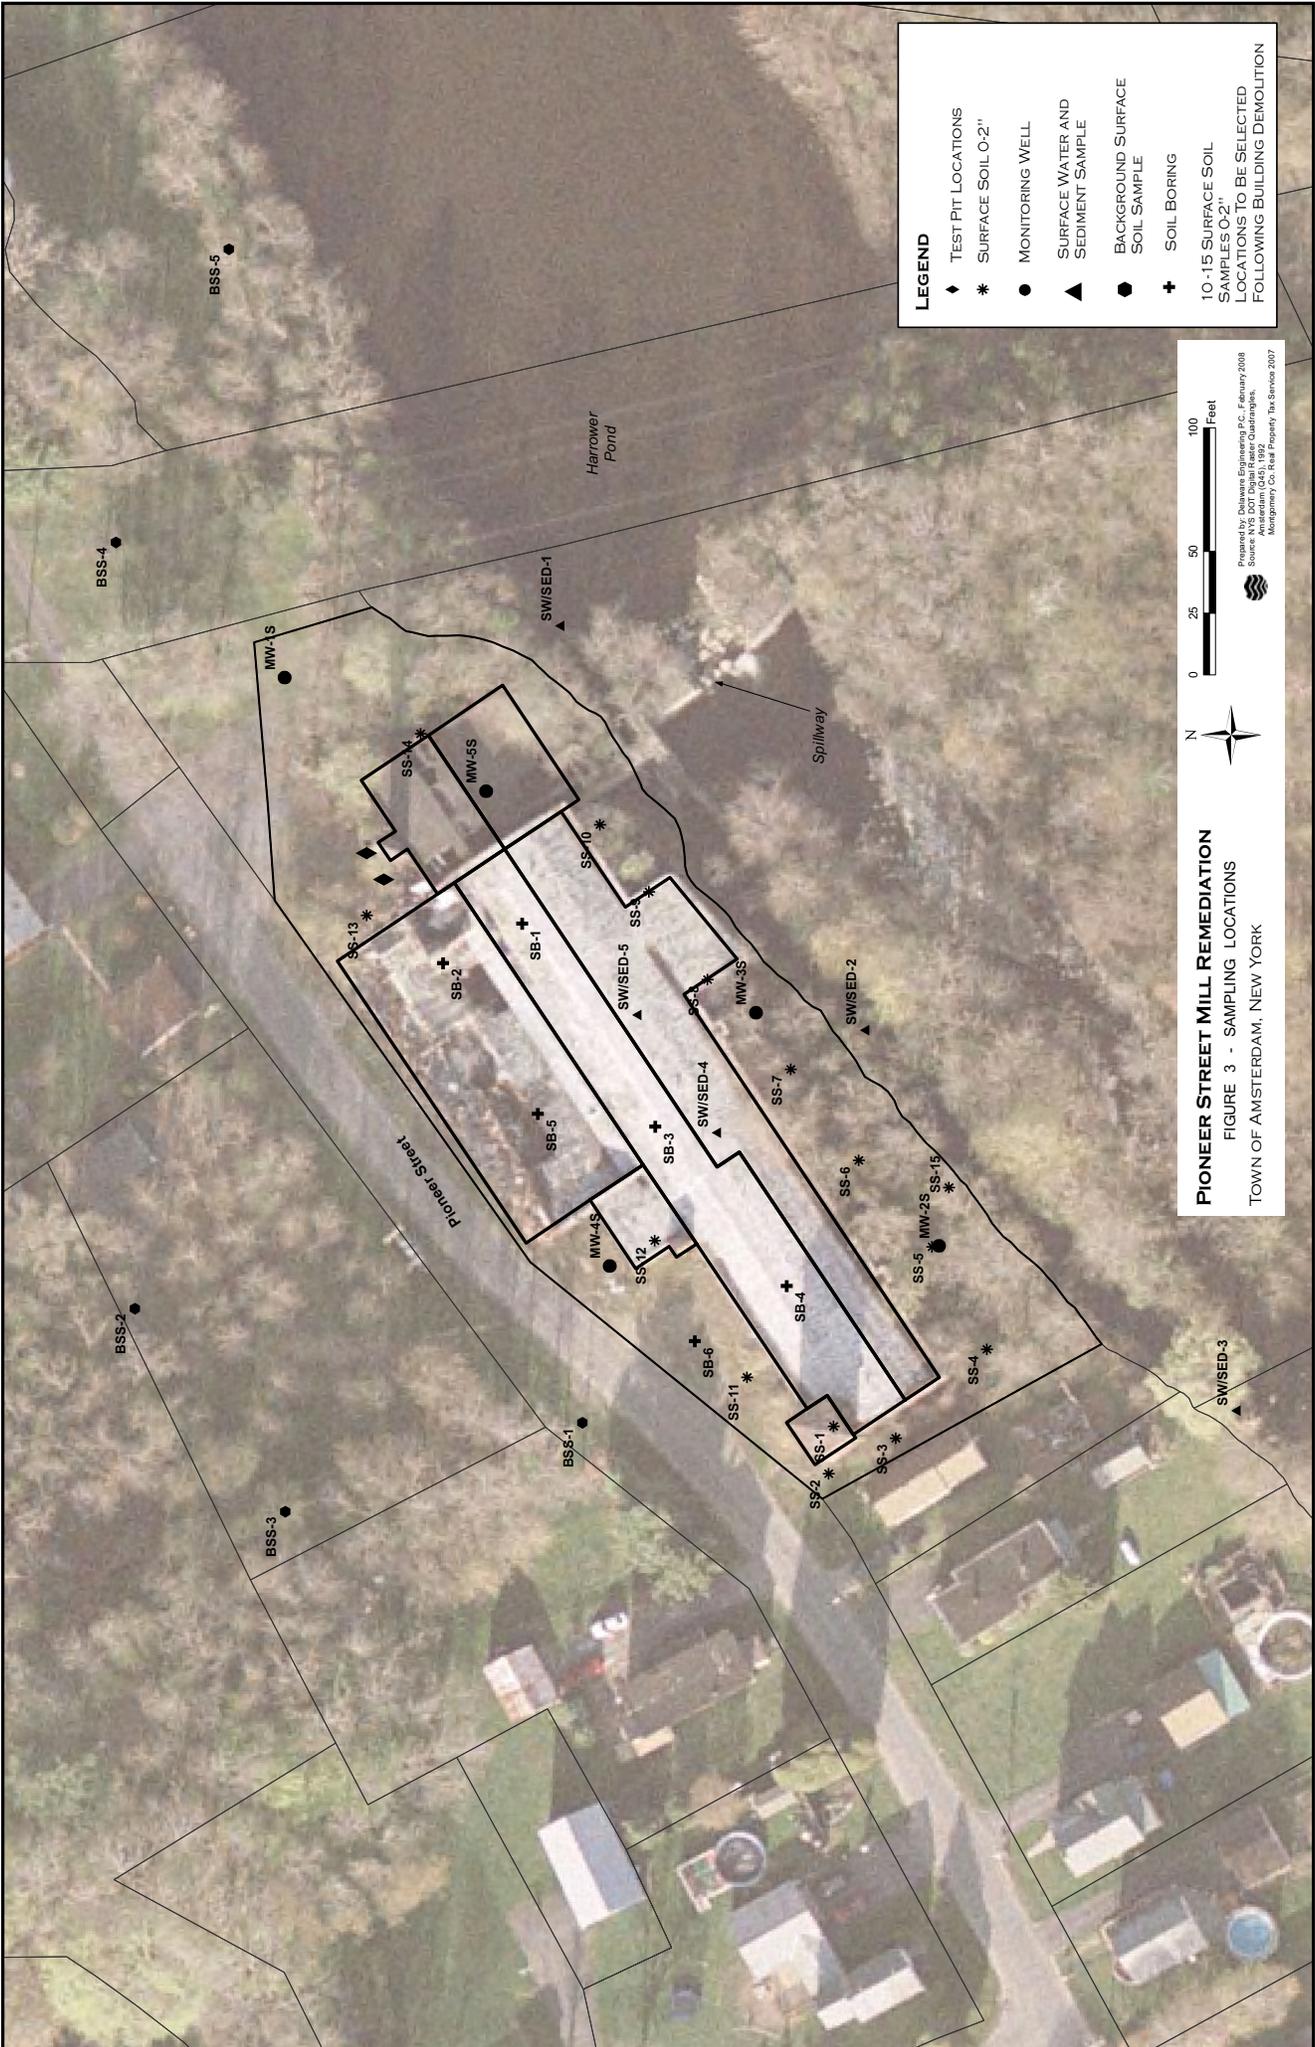
Waste material removed during the demolition Interim Remedial Measure (IRM) consisted of solvents, paints, adhesives, compressed gas cylinders, and fluorescent light ballasts. Contaminated soil was removed from two sump pits. Figure 3 shows where samples were collected during the RI.
