RECORD OF DECISION

Econo Quick Gas & Car Wash Property
Environmental Restoration Project
Warrensburg, Warren County
Site No. E557021
March 2012

Prepared by
Division of Environmental Remediation
New York State Department of Environmental Conservation

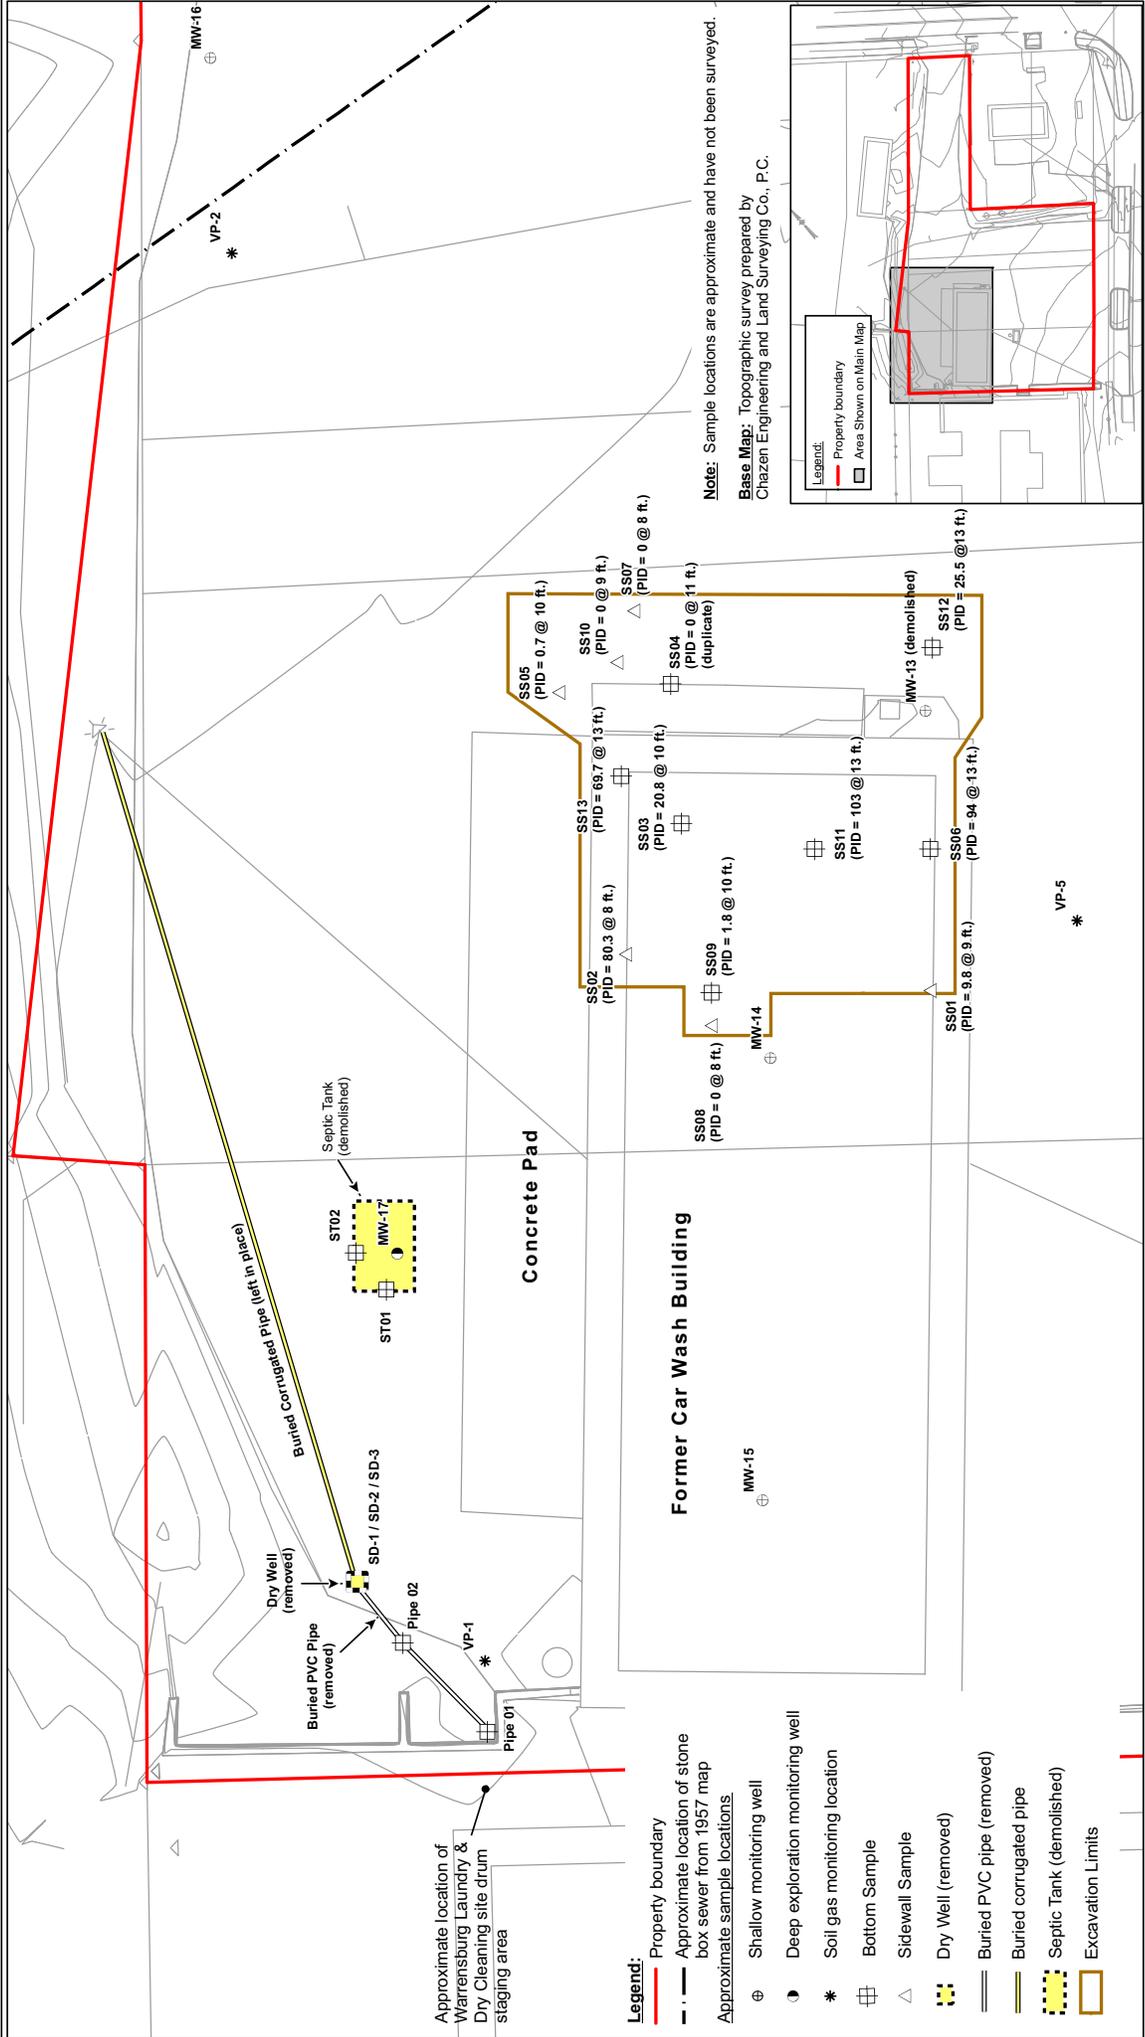
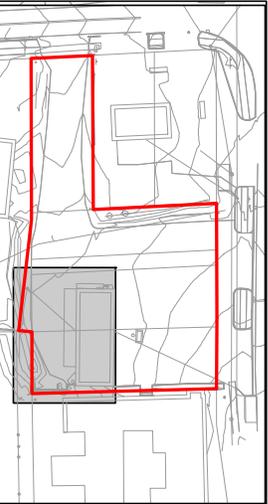
Drawn:	CLC
Date:	04/28/2010
Scale:	1" = 10 feet
Project:	96255.00
Figure:	3

Econoquick Gas & Car Wash
IRM Dry Well, Septic Tank, Soil Excavation
Sample Location Map
 Town of Warrensburg
 Warren County, New York

The only other area that could constitute a source area was the dry well inlet structure that received drainage from the adjacent property (Figure 3). Sediments in the bottom of the inlet structure contained tetrachloroethene, a VOC used in dry cleaning, above unrestricted use SCGs. An IRM was undertaken to over-excavate to remove the drain line, inlet structure, dry well, and surrounding soil. This IRM was successful and post-excavation sampling indicated no further VOC contamination existed above unrestricted use SCGs in this area.

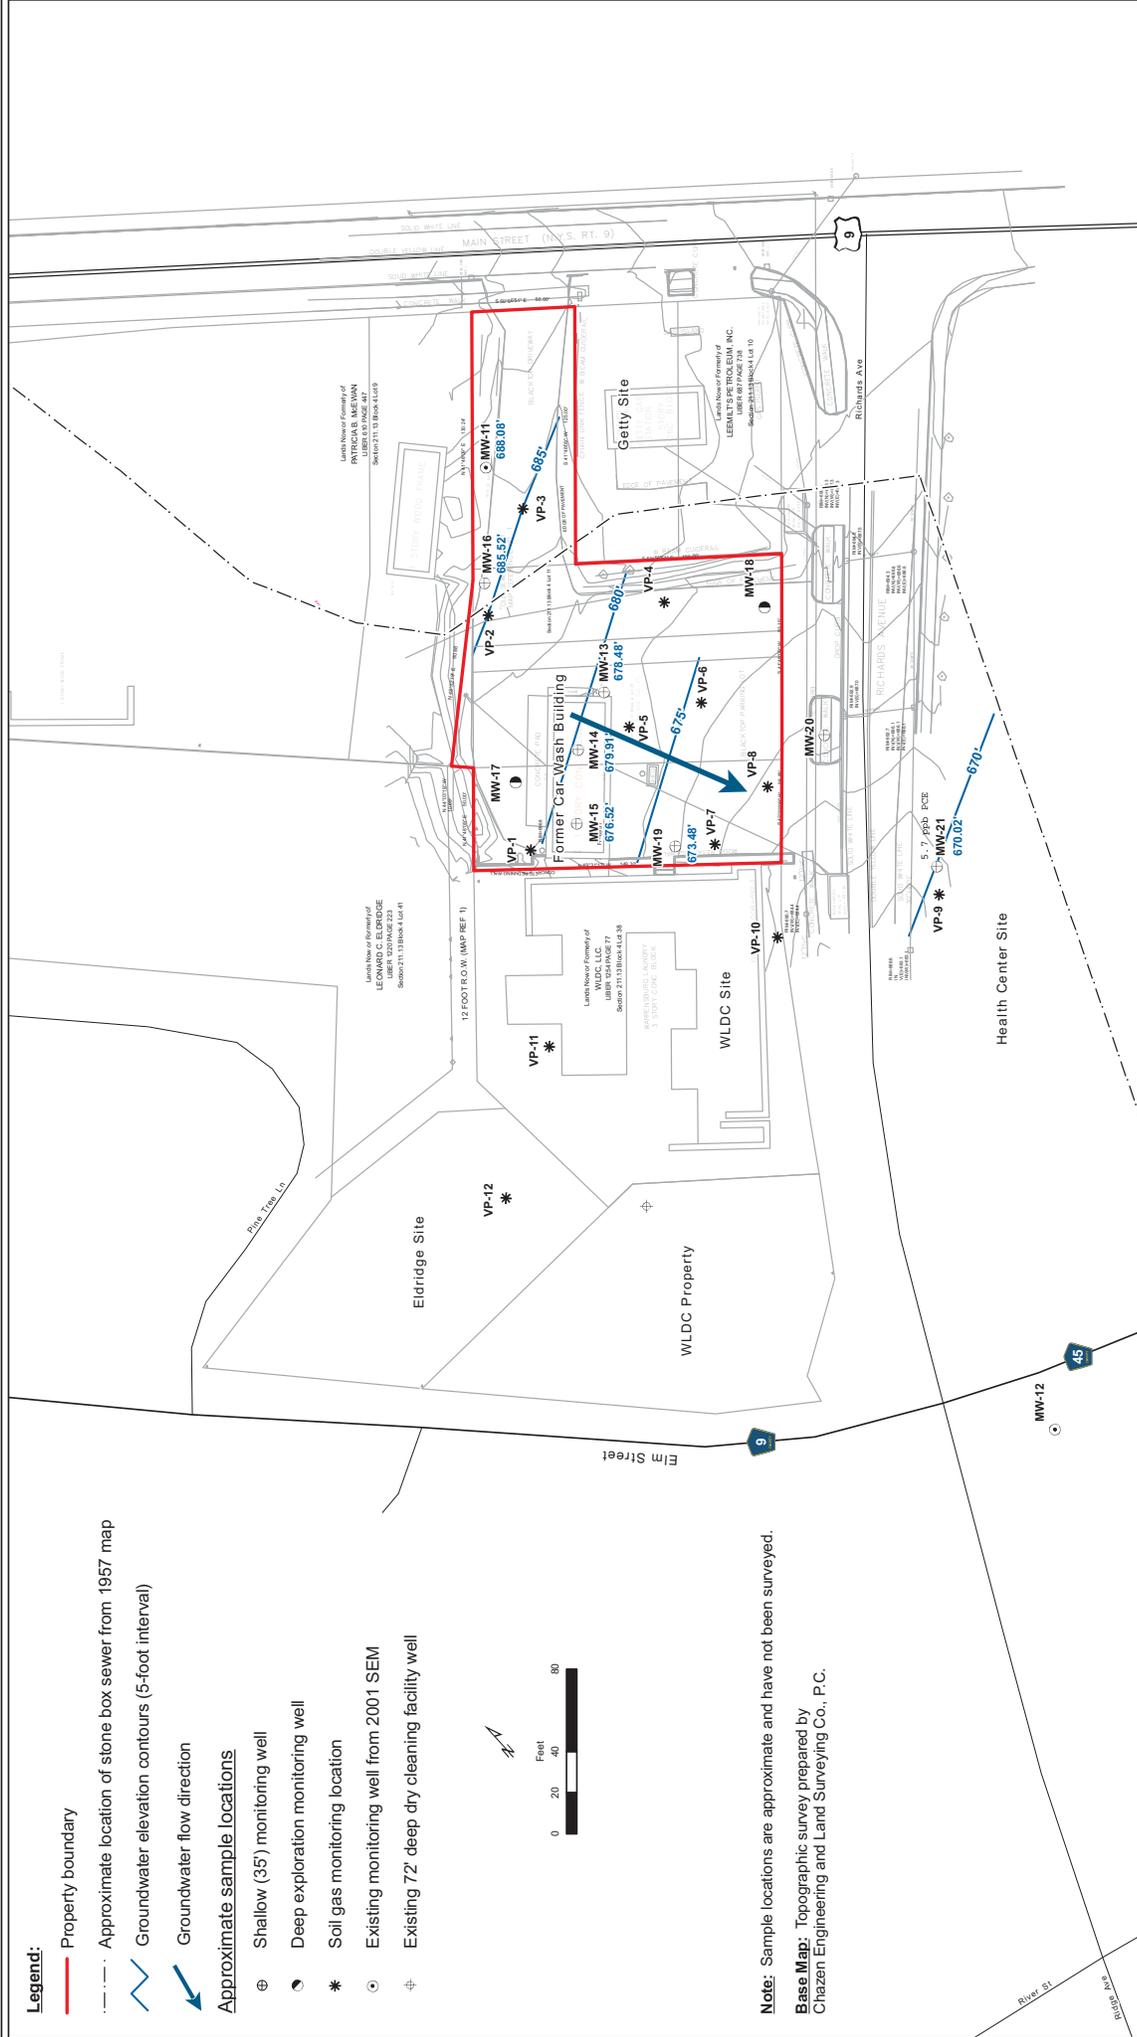
Owner:	CLC
Date:	04/08/2010
Scale:	1/2" = 1/2" = 80 feet
Project:	96255.00
Figure:	5

Econoquick Gas & Car Wash
Groundwater Gradient Map
 Town of Warrensburg
 Warren County, New York

Groundwater samples were collected from shallow and deep groundwater wells both on the site and off the site (see Figure 4) to assess the local groundwater condition. The deep groundwater wells were established above bedrock at depths to 90 feet. The results show that the shallow and deeper aquifers in this region are in communication and that contamination in both shallow and deep groundwater exceeds SCGs for VOCs and inorganics (metals). The groundwater flow direction is shown in Figure 5.
