Re: Supplemental Site Characterization Report

Former Nash Road Landfill

SUPPLEMENTAL SITE CHARACTERIZATION REPORT

Former Nash Road Landfill Town of Wheatfield Niagara County, New York NYSDEC Site #932054

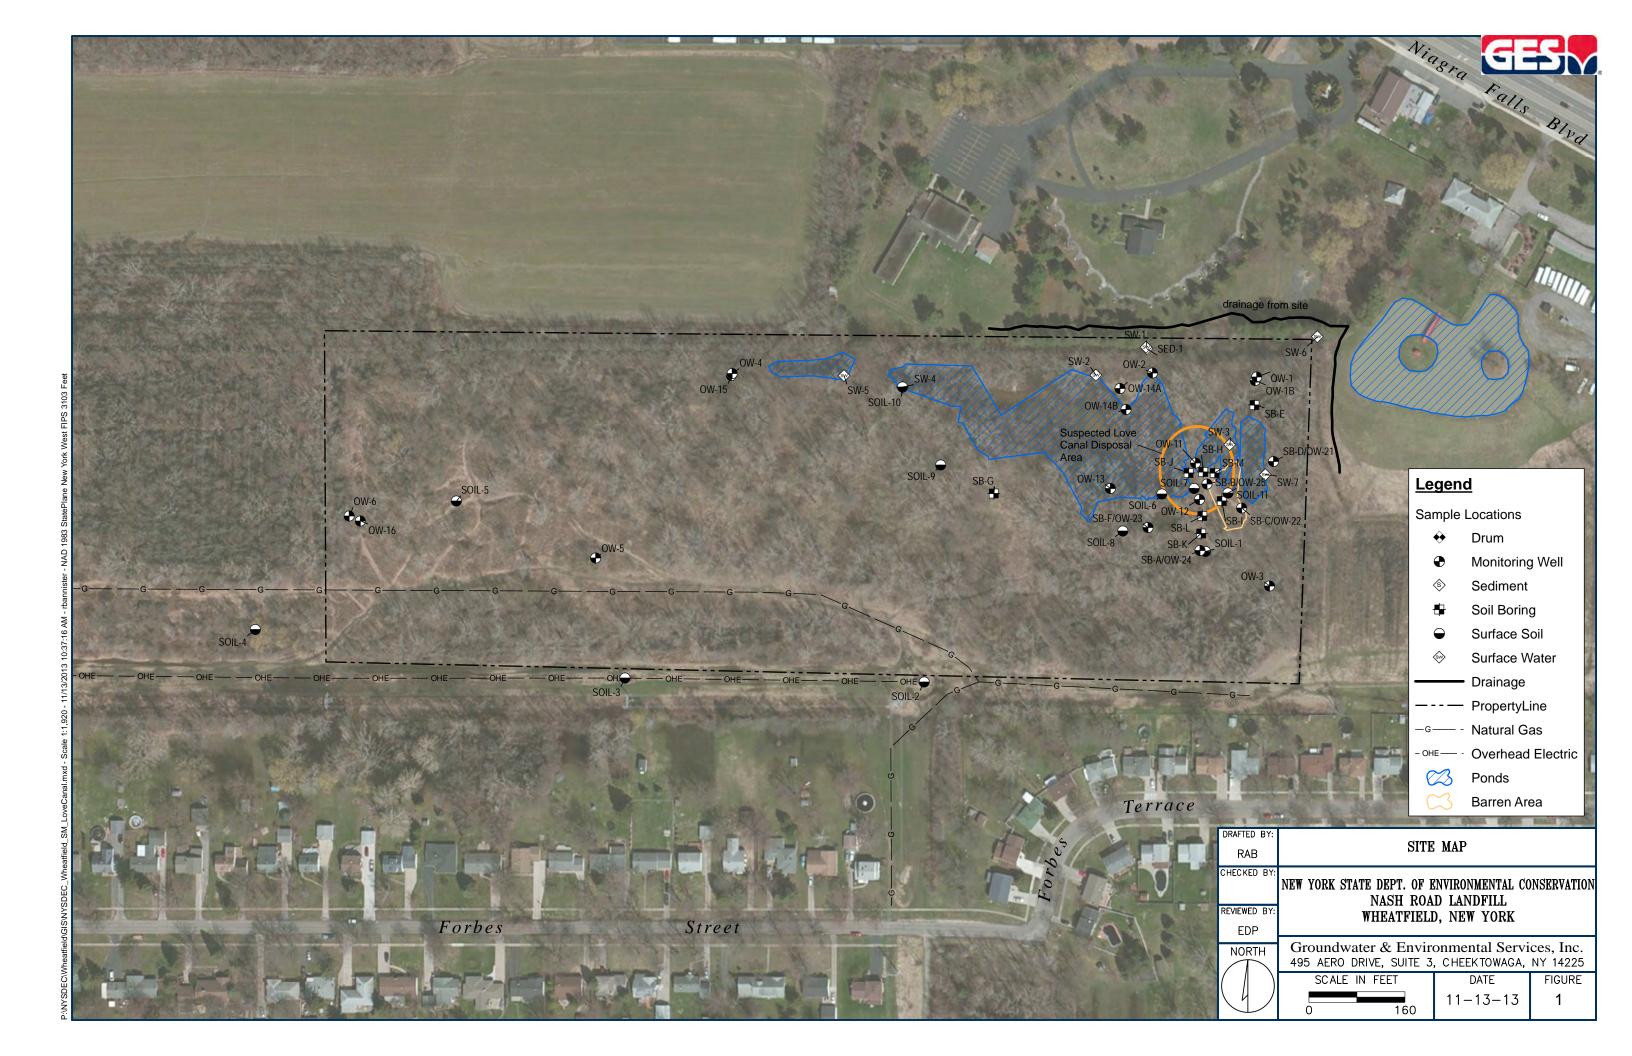
The site is wooded with mature trees, dense brush, and patches of phragmites in wet areas, as shown in **Figure 1**.

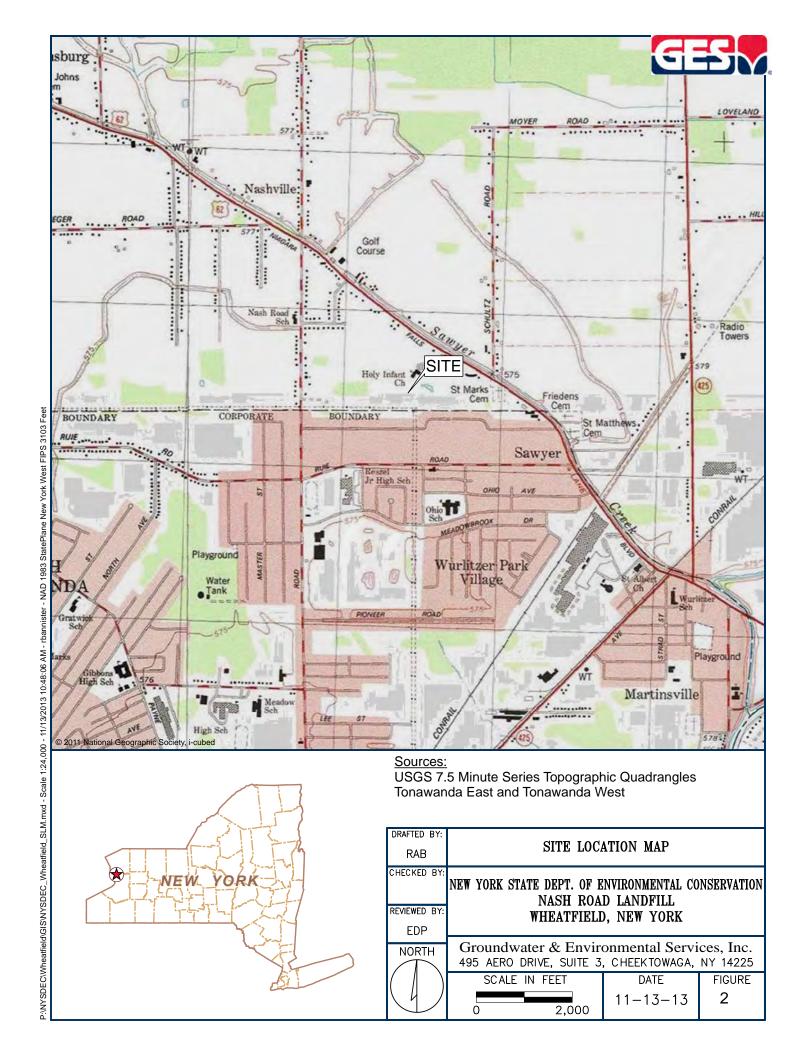
The site is bordered to the north by the Holy Infant Shrine, to the east by a cemetery as well as property that contains a motel and livery service, to the south by utility right-of-ways (both overhead electric and underground natural gas and brine lines), followed by residences, and to the west by Nash Road, followed by residences. A site location map for the site is provided in **Figure 2**.

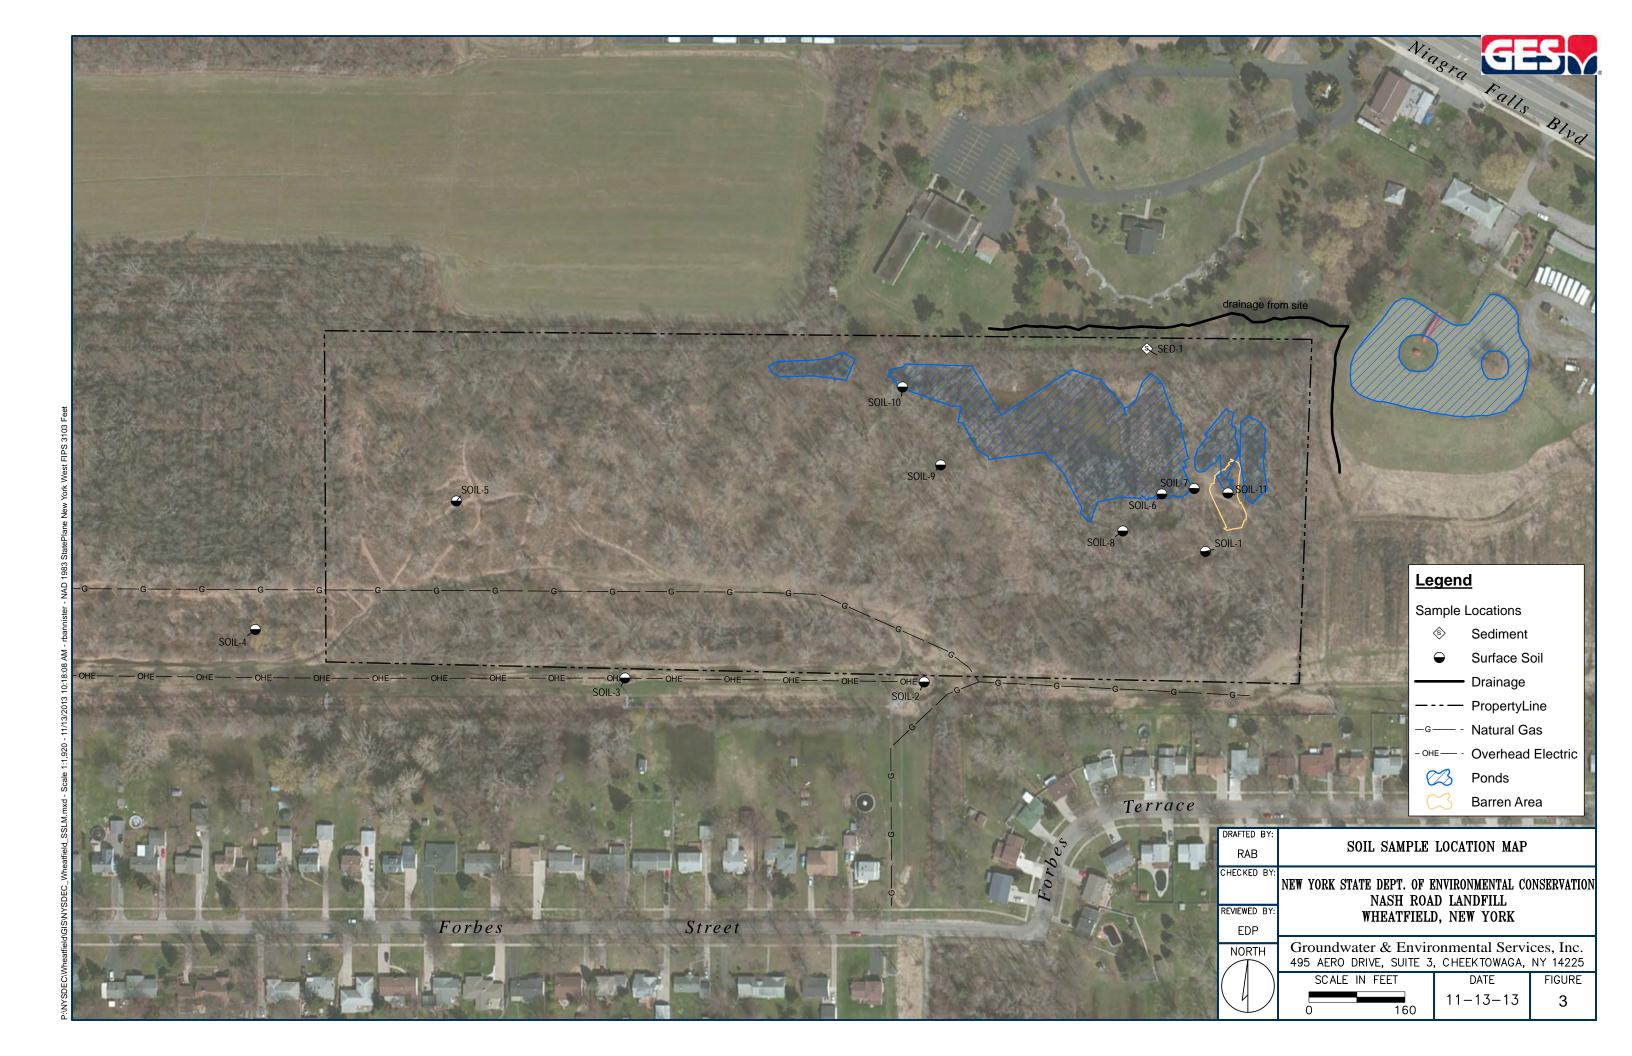
The surface soil sample locations, with respect to the site layout are illustrated on **Figure 3**. Surface soil analytical data are tabulated in **Table 2**. The laboratory analytical reports are included in **Appendix C**. Surface soil analytical results were compared to residential guidelines provided in Title 6 of the Official Compilation of New York State Codes, Rules and Regulations (6 NYCRR) Part 375, Restricted Use Soil Cleanup Objectives (SCOs). A summary of the analyzed compounds is provided below:

- Metals Concentrations of metals were detected above residential SCOs at soil sample SOIL-9 (battery casings along path), including cadmium, mercury, and total chromium. While concentrations of lead at this location were the highest detected on-site, the concentration was below residential SCOs.
- SVOCs Concentrations of SVOCs were detected above residential SCOs at soil samples SOIL-3 (proximate to Nimo Electric Tower #364), SOIL-8 (mound of fill material), SOIL-9 (battery casings along path), and SOIL-10 (near drums at the edge of one of the ponds). Typical compounds that were detected above residential SCOs included polycyclic aromatic hydrocarbons. (PAHs).

As described in Section 6.1, concentrations of metals were detected above residential SCOs at soil sample SOIL-9. This sample was located at an area along one of the trails where black, broken battery casings were observed. Concentrations of SVOCs were detected above residential SCOs at soil samples SOIL-3 (proximate to Nimo Tower #364), SOIL-8 (mound of fill materials), SOIL-9 (battery casings along path), and SOIL-10 (near drums at the edge of one of the ponds). Typical compounds that were detected included PAHs.

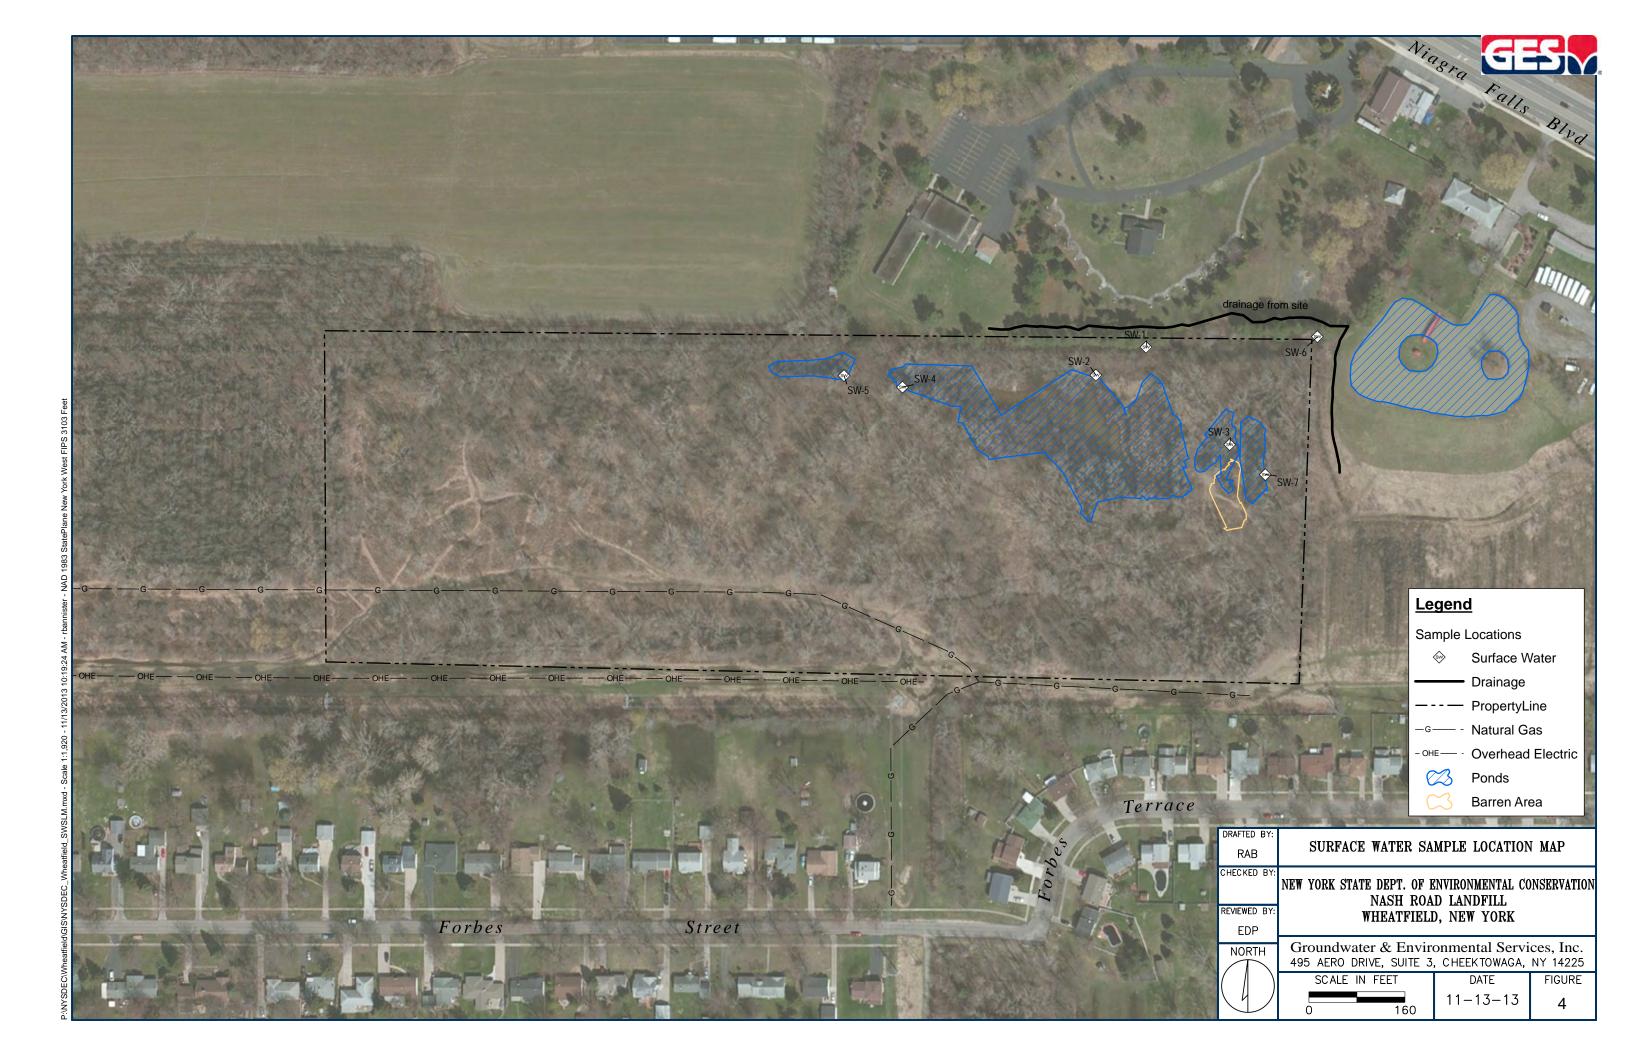
The surface water sample locations, with respect to the site layout are illustrated on **Figure 4**. Surface water sample analytical data are tabulated in **Table 3**. The laboratory analytical reports are included in **Appendix C**. All surface water analytical results were compared to NYSDEC Technical and Operational Guidance Series (TOGS) 1.1.1 standards (or guidance values where no standard exists). A summary of the analyzed compounds is provided below:

- Pesticides Concentrations of pesticides were detected above TOGS 1.1.1 standards or guidance values at water samples SW-2 (pond sample), SW-3 (pond sample), and SW-5 (pond sample).
- Herbicides Herbicides were not detected above laboratory detection limits in any of the surface water samples.
- VOCs VOCs were not detected above laboratory limits in any of the surface water samples.
- SVOCs SVOCs were not detected above laboratory limits in any of the surface water samples.

As described in Section 6.2, concentrations of pesticides were detected above TOGS 1.1.1 standards or guidance values at water samples SW-2, SW-3, and SW-5. All three samples were collected from the ponds on-site. Apart from the drainage pipe that was found at the northeast corner of the site, the site is relatively isolated hydraulically from outside sources of surface water. The drainage ditch along the north side of the site provides a hydraulic barrier from surface drainage from the neighboring property to the north (religious shrine). There does not appear to be any other surface water bodies that supply the site,

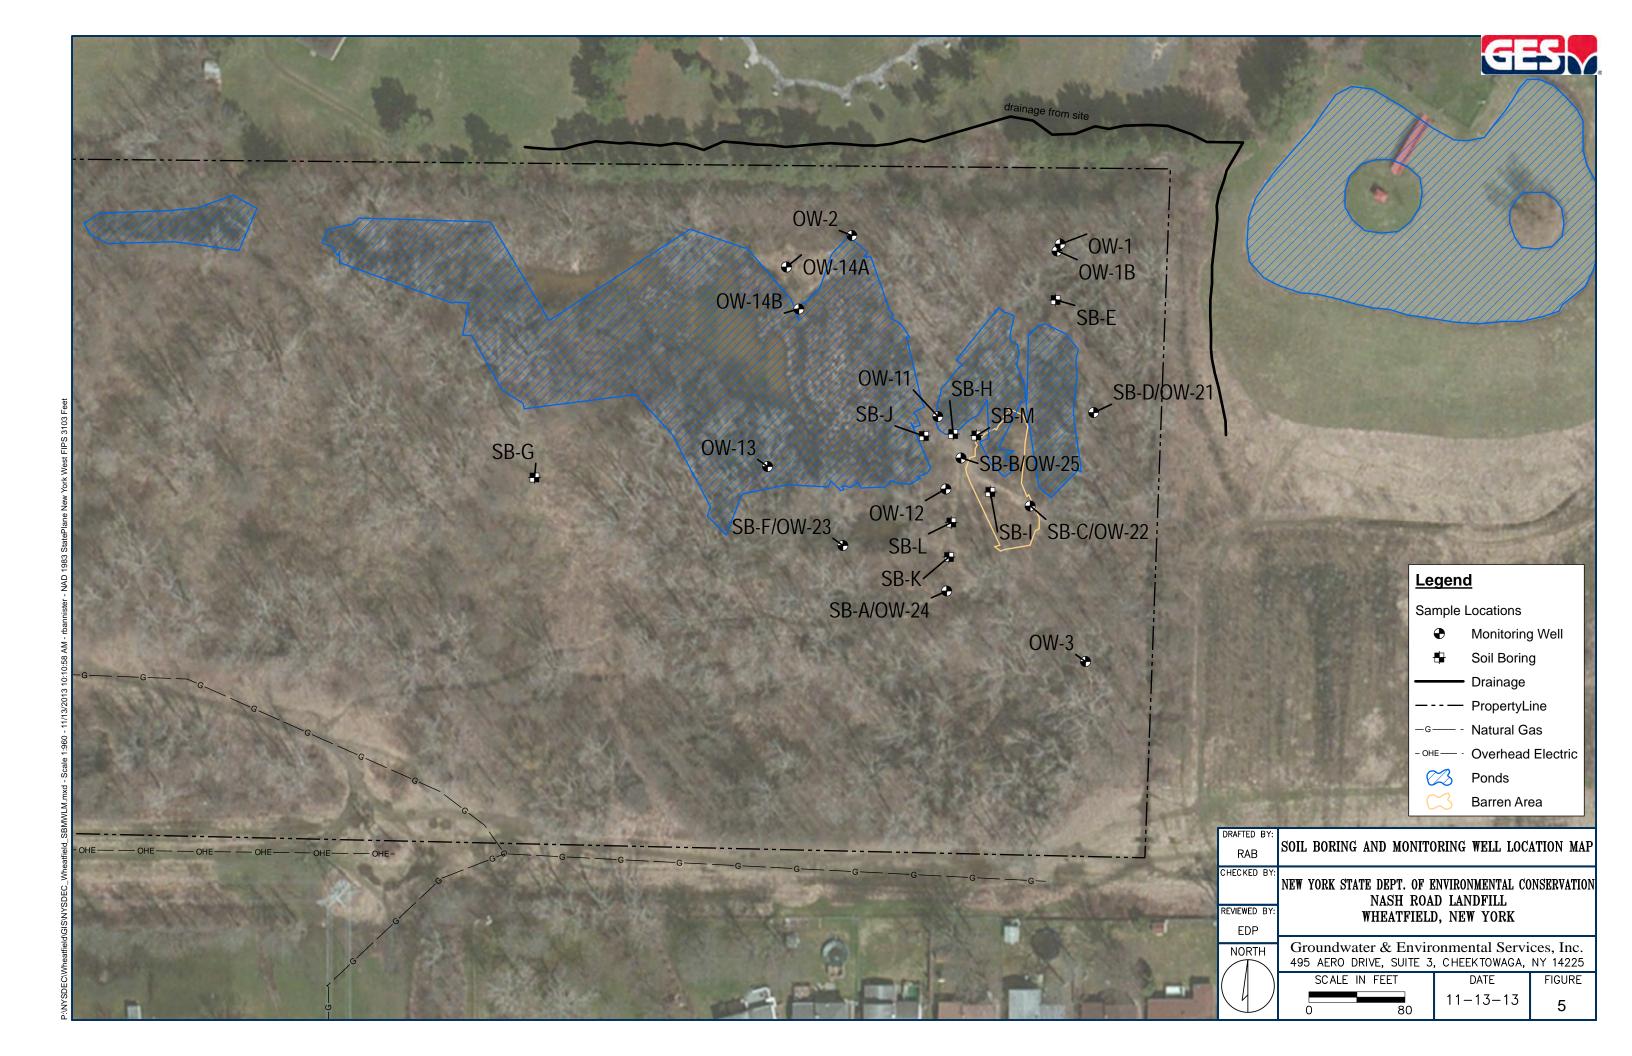
The soil boring locations, with respect to the site layout are illustrated on **Figure 5**. Soil boring logs containing soil lithology, field screening readings and general observations are included in **Appendix D**.

The soil boring locations, with respect to the site layout are illustrated on **Figure 5**. Coordinates for all soil boring locations were collected using the GPS unit and are provided in **Appendix B** for future reference. Soil boring logs containing soil lithology, field screening readings and general observations are included in **Appendix D**.

The monitoring well locations, with respect to the site layout are illustrated on **Figure 5**. Groundwater gauging and analytical data are tabulated in **Table 5**. The laboratory analytical reports are included in **Appendix C**. All groundwater analytical results were compared to NYSDEC TOGS 1.1.1 standards (or guidance values where no standard exists) Class GA, type H(WS) for protection of drinking water. A summary of the analyzed compounds is provided below:

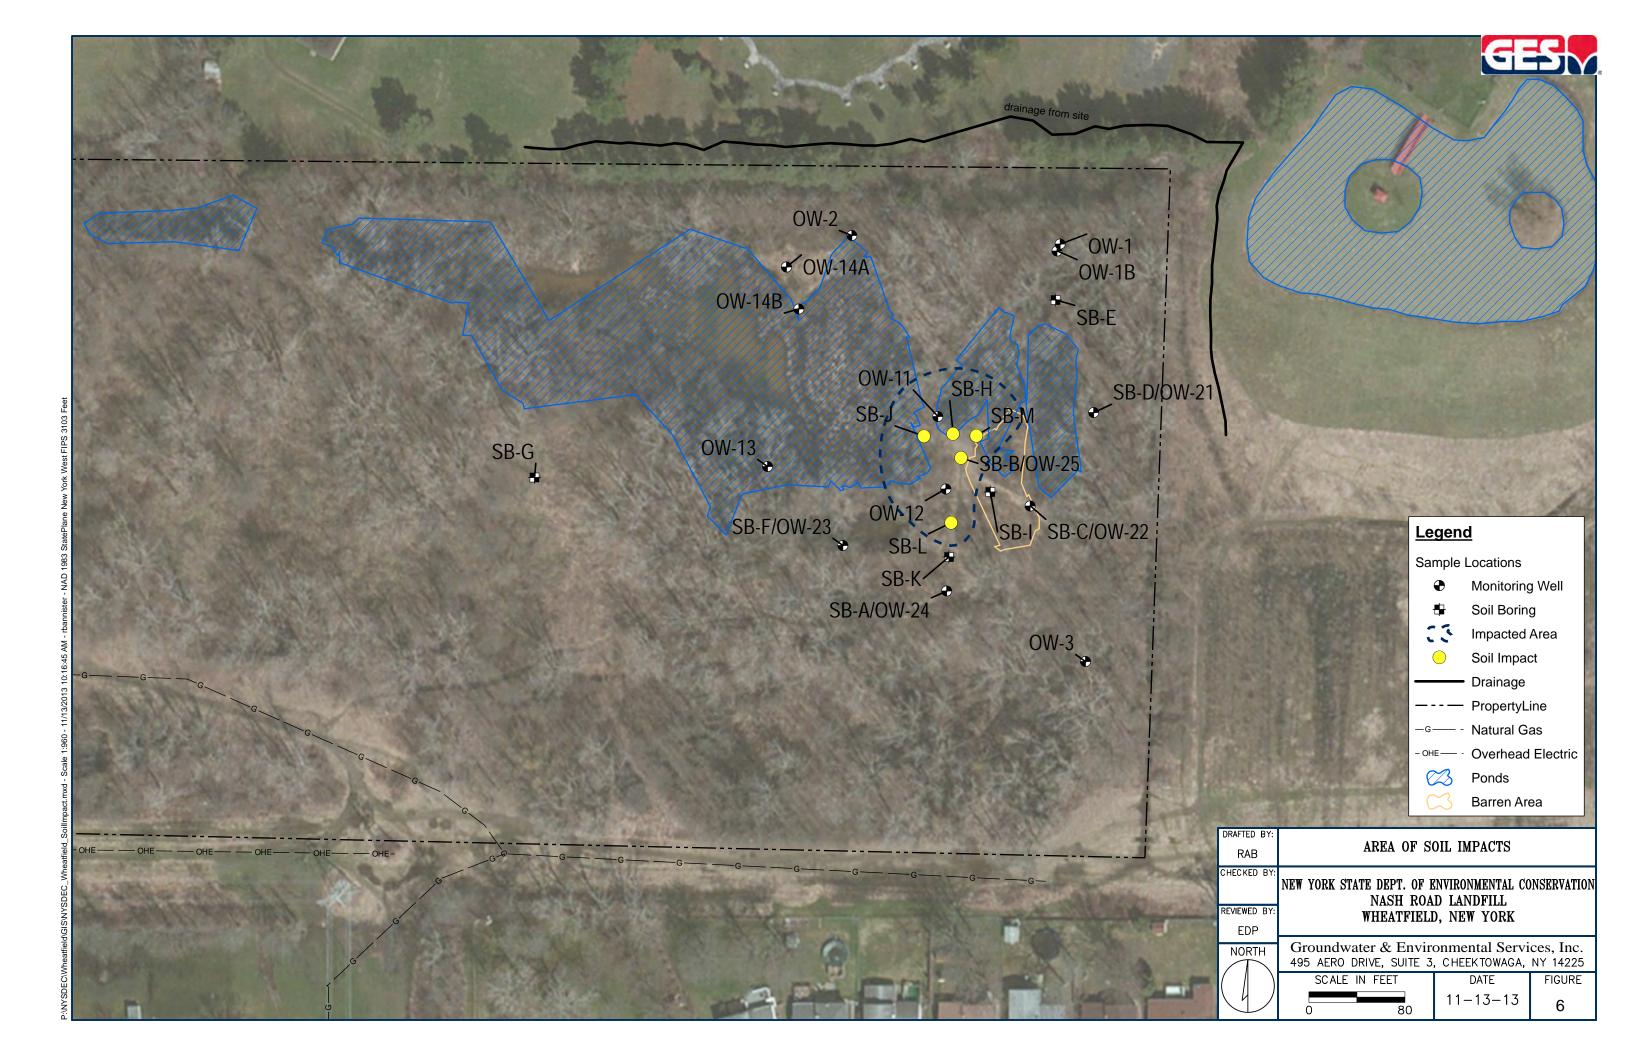
Figure 6 shows the approximate delineated limits of the area of the site that are impacted by Pesticides, VOCs, and SVOCs based on the soil boring analytical results of the investigation as well as previous site investigations. The limits were based on analytical exceedences above residential SCOs. It should be noted that the western and northern bounds of the delineated area are estimated, as site access was limited due to ponding and heavy brush.

As described in Section 8.2, elevated concentrations of contaminants, including pesticides, VOCs, SVOCs, and metals were detected in the area identified in **Figure 6**. The investigation delineated the impacts to the south and east, and to a less precise degree to the west and north due to limiting factors including ponds and dense brush. Exposure to the public may lie in the fact that at several of the soil borings discussed in Section 8.1, the highest contaminant impacts (based on field observations and PID readings) were often located in the top four feet. Shallow surface penetrations or erosion may lead to exposure to high concentrations of pesticides, VOCs, SVOCs, and metals. Several of the pesticides that were detected in elevated concentrations are known persistent organic pollutants and banned substances. Several trails run near or through this part of the site and may present an exposure risk if the surface is penetrated or exposed through erosion.

It is recommended that additional soil borings are advanced along the north and west sides of the area identified in **Figure 6** to more precisely delineate the impacts in this area. It is also recommended that site access be restricted in this area including the construction of fencing due to the shallow impacts.

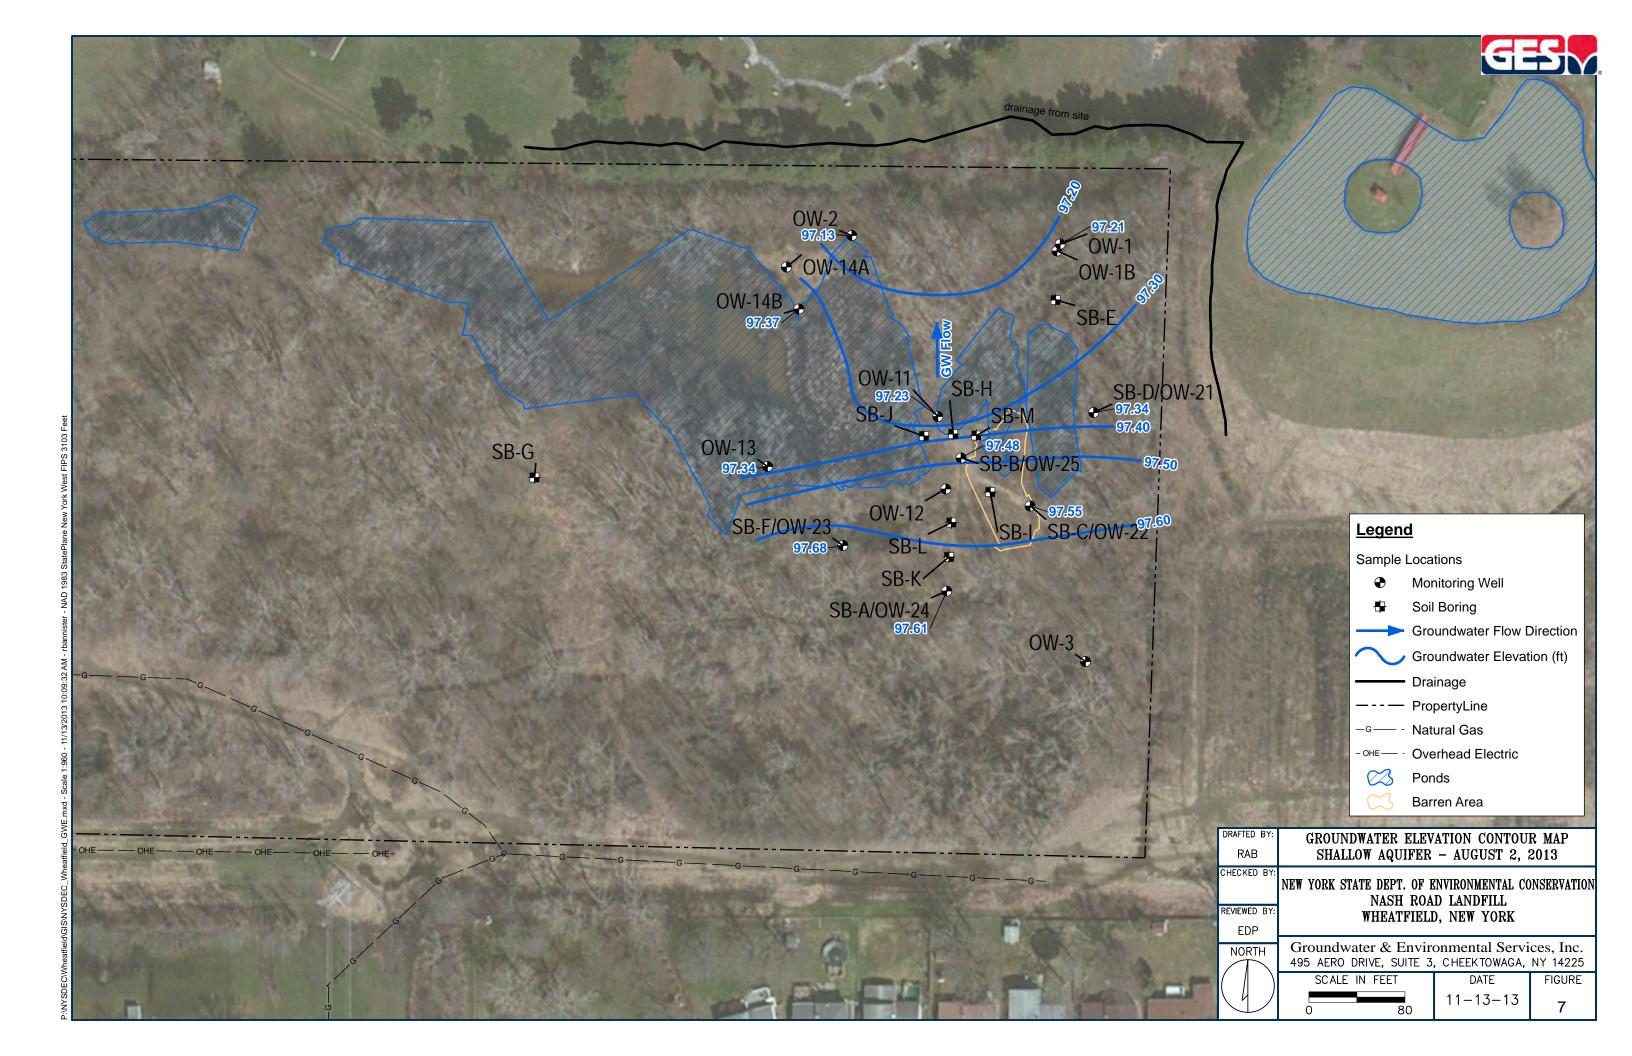
Groundwater gauging and analytical data are tabulated in **Table 5**. The monitoring well locations, with respect to the site layout are illustrated on **Figure 5**. Groundwater elevation contours based on the monitoring well gauging data from the shallow aquifer wells on the eastern side of the site are presented on **Figure 7**. As shown on **Figure 7**, at the time of the investigation, groundwater in the shallow aquifer flows to the north. Groundwater flow may be influenced by surface hydrology, including the large pond in northeastern area of the site, as groundwater flow mimics the surface drainage pattern of the northeast area of the site.

While exposure of groundwater to the public is likely limited (as area residents are served by public water), it is recommended that an additional monitoring well be installed to further characterize and delineate the plume to the north of OW-11, as well as additional groundwater sampling to evaluate seasonal changes in the groundwater flow and groundwater quality on-site.
