# Flood Damage Reduction Segment / System Inspection Report

Name of System: Northeast Binghamton System (Suquehanna & Chenango River)

Corps of Engineers Inspector: Alfred Zarnoski, P.E. ; William Wynn ; Joseph Reed ; Larry Mathena Date of Inspection: 9/16/2008

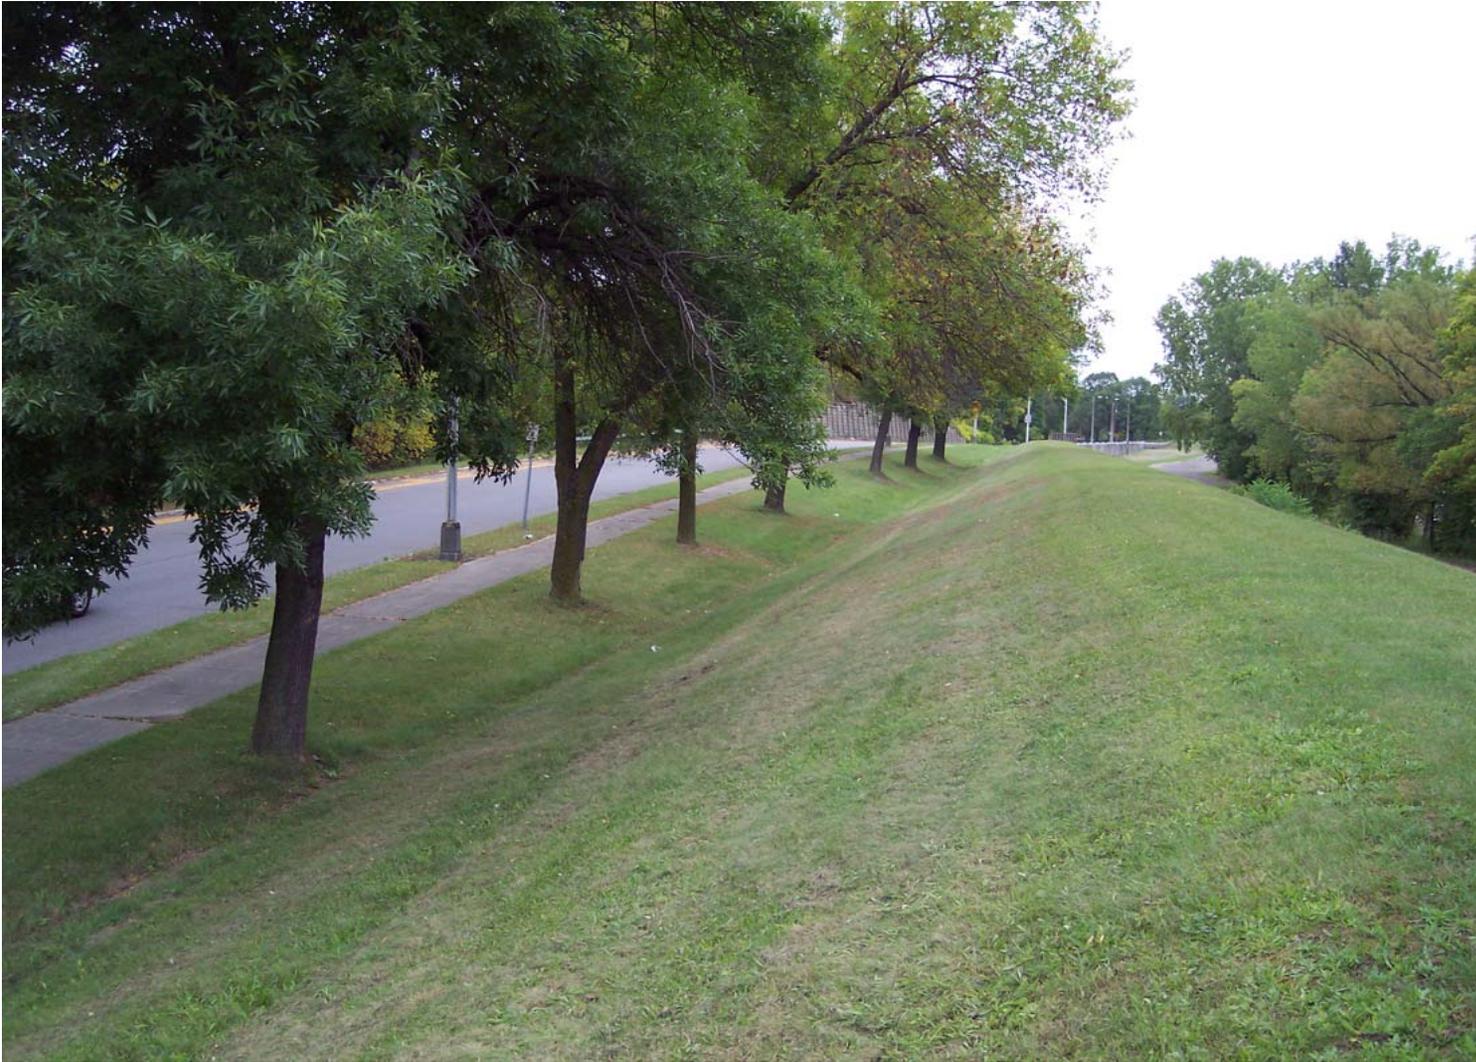
**Inspect ID:** BNGE\_2008\_a\_0008 **Name:** Levee Embankment **Caption:** Trees near the Exchange Street Bridge that could potentially be infringing on 15' from toe of levee clear zone.

Rated Item	Rating	Rating Guidelines		Location/Remarks/Recommendations
1. Unwanted Vegetation Growth <sup>1</sup>	<b>M</b>	<b>A</b>	The levee has little or no unwanted vegetation (trees, bush, or undesirable weeds), except for vegetation that is properly contained and/or situated on overbuilt sections, such that the mandatory 3-foot root-free zone is preserved around the levee profile. The levee has been recently mowed. The vegetation-free zone extends 15 feet from both the landside and riverside toes of the levee to the centerline of the tree. If the levee access easement doesn't extend to the described limits, then the vegetation-free zone must be maintained to the easement limits. Reference EM 1110-2-301 or Corps policy for regional vegetation variance.	1.) Remove vegetation a few feet further past the point that it is already cleared to along the downstream Chamberlain Creek tie-out at the section adjacent to the railroad; Remove additional vegetation at the tie-in to existing ground. 2.) Define Property lines and remove trees East of Exchange Street Bridge, adjacent to N. Shore Drive (See Photo BNGE_2008_a_0008). 3.) Define Property lines and remove vegetation on land side toe of the levee slope between the riverwalk floodwall crossing and the I-81 Bridge (K-Mart Plaza Area). 4.) Trees alongside levee in Port Dickinson have been cleared back to a more than acceptable state, excluding two trees which are in need of further investigation for property limits that are located at the downstream tie-out of the levee (Watson Avenue Area).

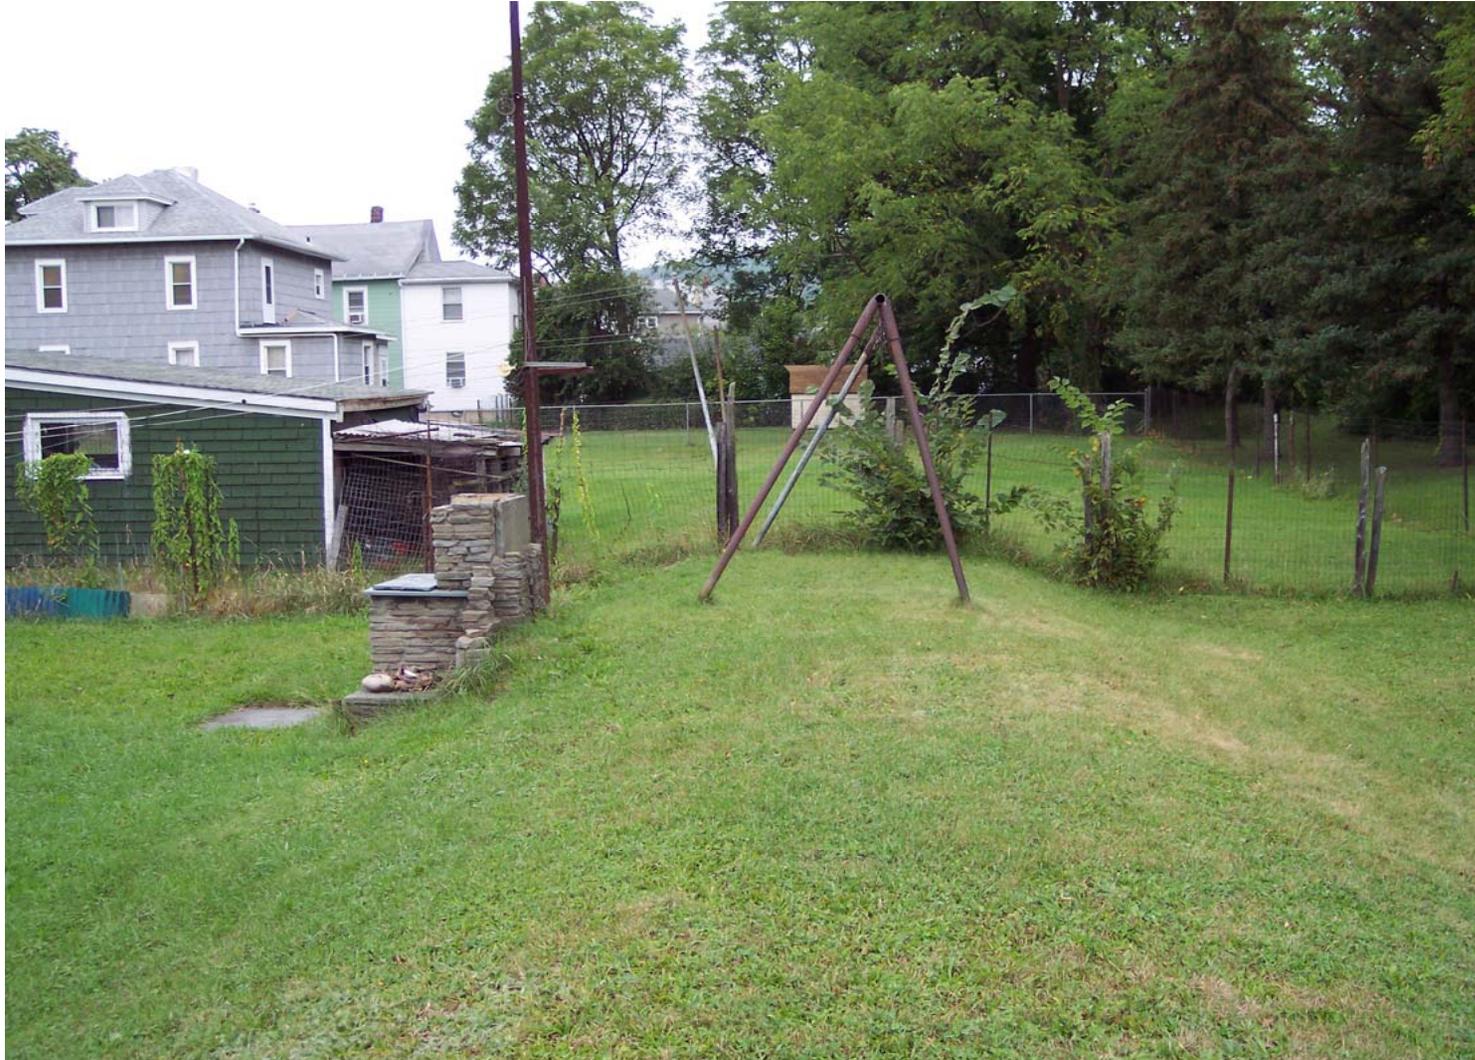
**Inspect ID:** BNGE\_2008\_a\_0003 **Name:** Levee Embankments **Caption:** Various encroachments on levee adjacent to the end of the FDR Channel carrying Chamberlain Creek.

3. Encroachments	<b>M</b>	<b>A</b>	No trash, debris, unauthorized farming activity, structures, excavations, or other obstructions present within the easement area. Encroachments have been previously reviewed by the Corps, and it was determined that they do not diminish proper functioning of the levee.	At the upper end of FDR Channel (Chamberlain Creek); Fence, Swingset, and fireplace are in violation of 15' clear zone from toe of levee. Define property lines and remove accordingly. (See photo BNGE_2008_a_0003).
		<b>M</b>	Trash, debris, unauthorized farming activity, structures, excavations, or other obstructions present, or inappropriate activities noted that should be corrected but will not inhibit operations and maintenance or emergency operations. Encroachments have not been reviewed by the Corps.	
		<b>U</b>	Unauthorized encroachments or inappropriate activities noted are likely to inhibit operations and maintenance, emergency operations, or negatively impact the integrity of the levee.

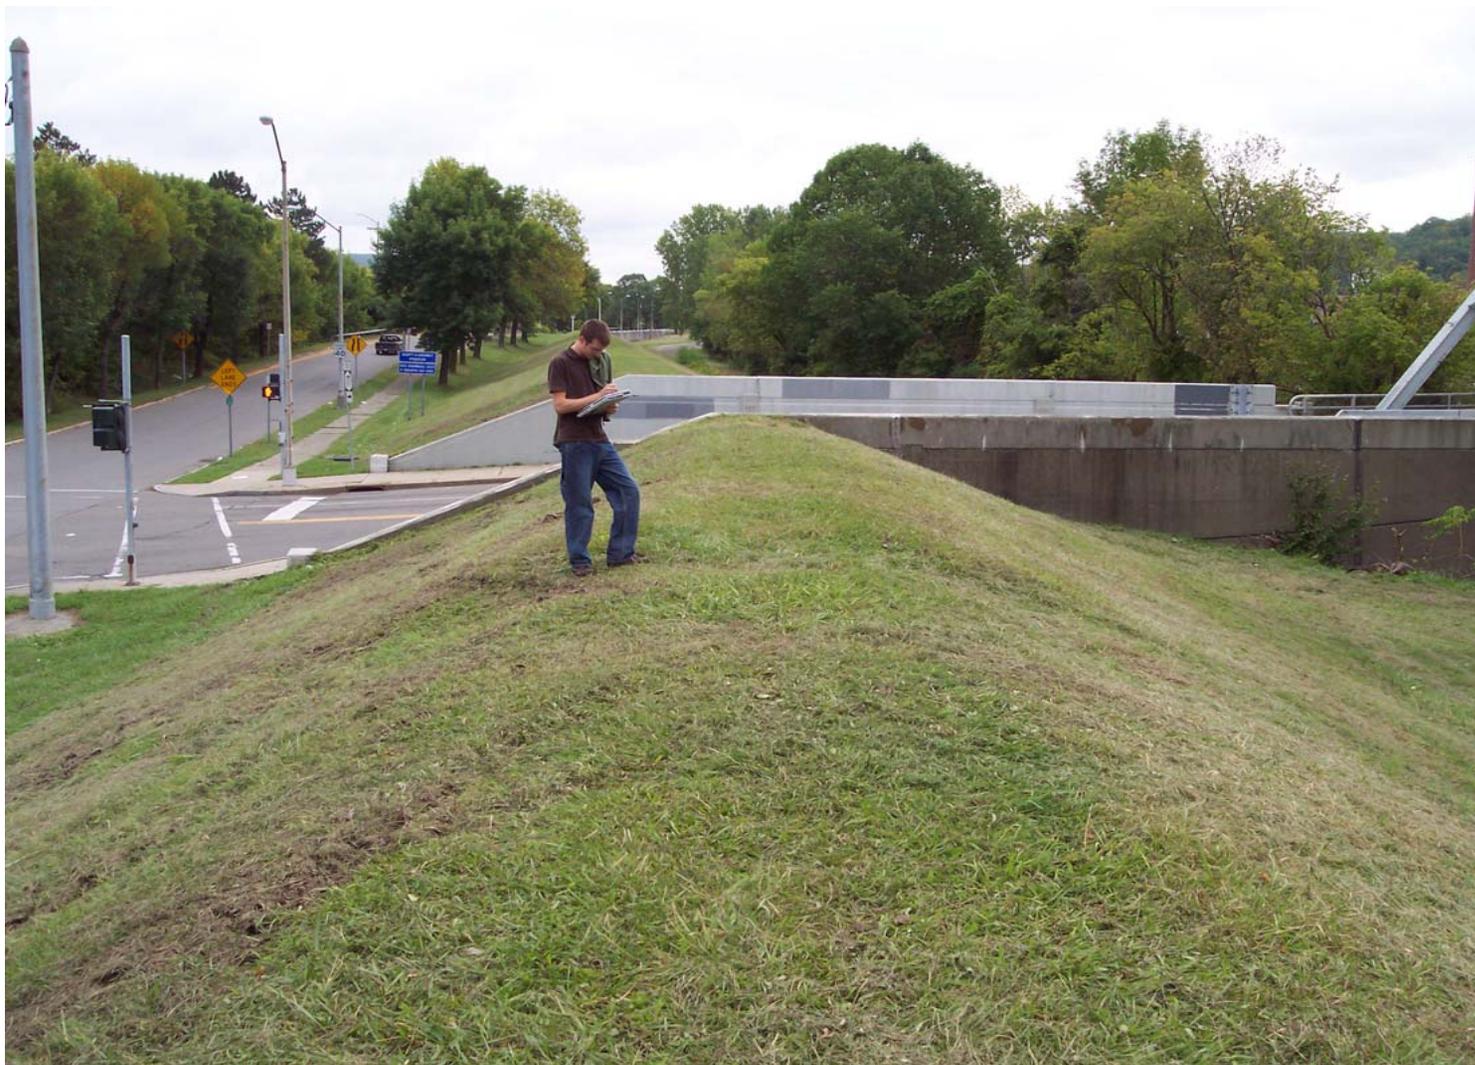
**Inspect ID:** BNGE\_2008\_a\_0009 **Name:** Levee Embankment **Caption:** Depression in levee crown (area where inspector is standing).

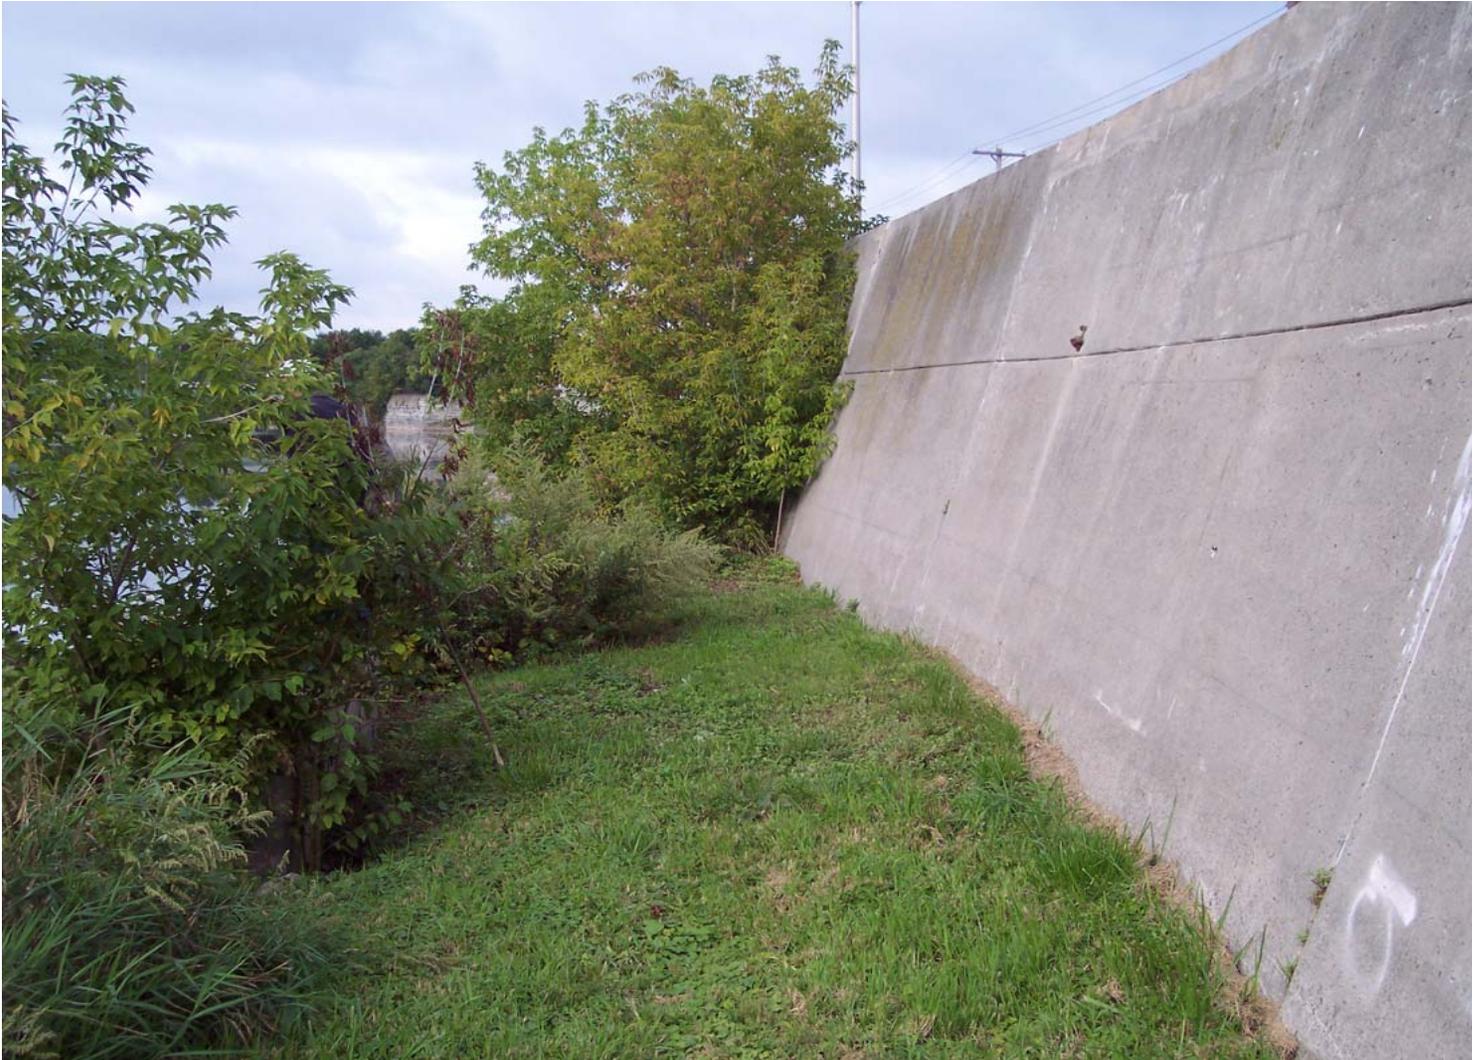
**Inspect ID:** BNGE\_2008\_a\_0005 **Name:** Floodwalls **Caption:** Unwanted Vegetation adjacent to floodwall approximately 720' East from Tompkins Street Bridge or 50' West of DS#27.

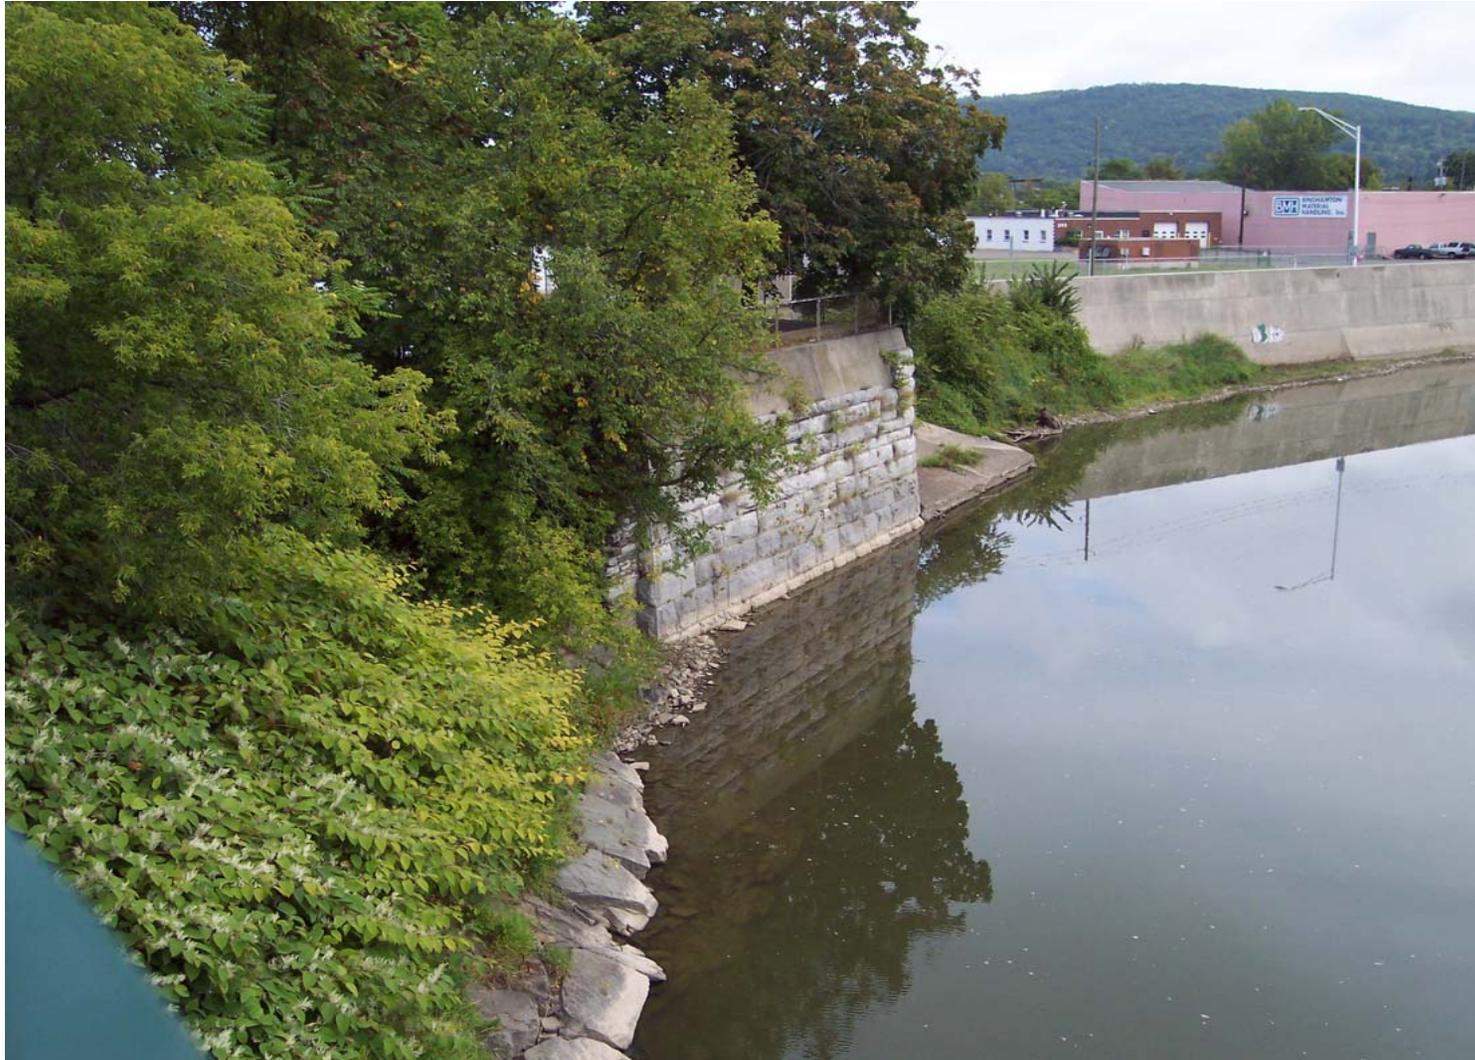
**Inspect ID:** BNGE\_2008\_a\_0005 **Name:** Floodwalls **Caption:** Unwanted vegetation adjacent to storm pumping station near Tompkins Street Bridge.

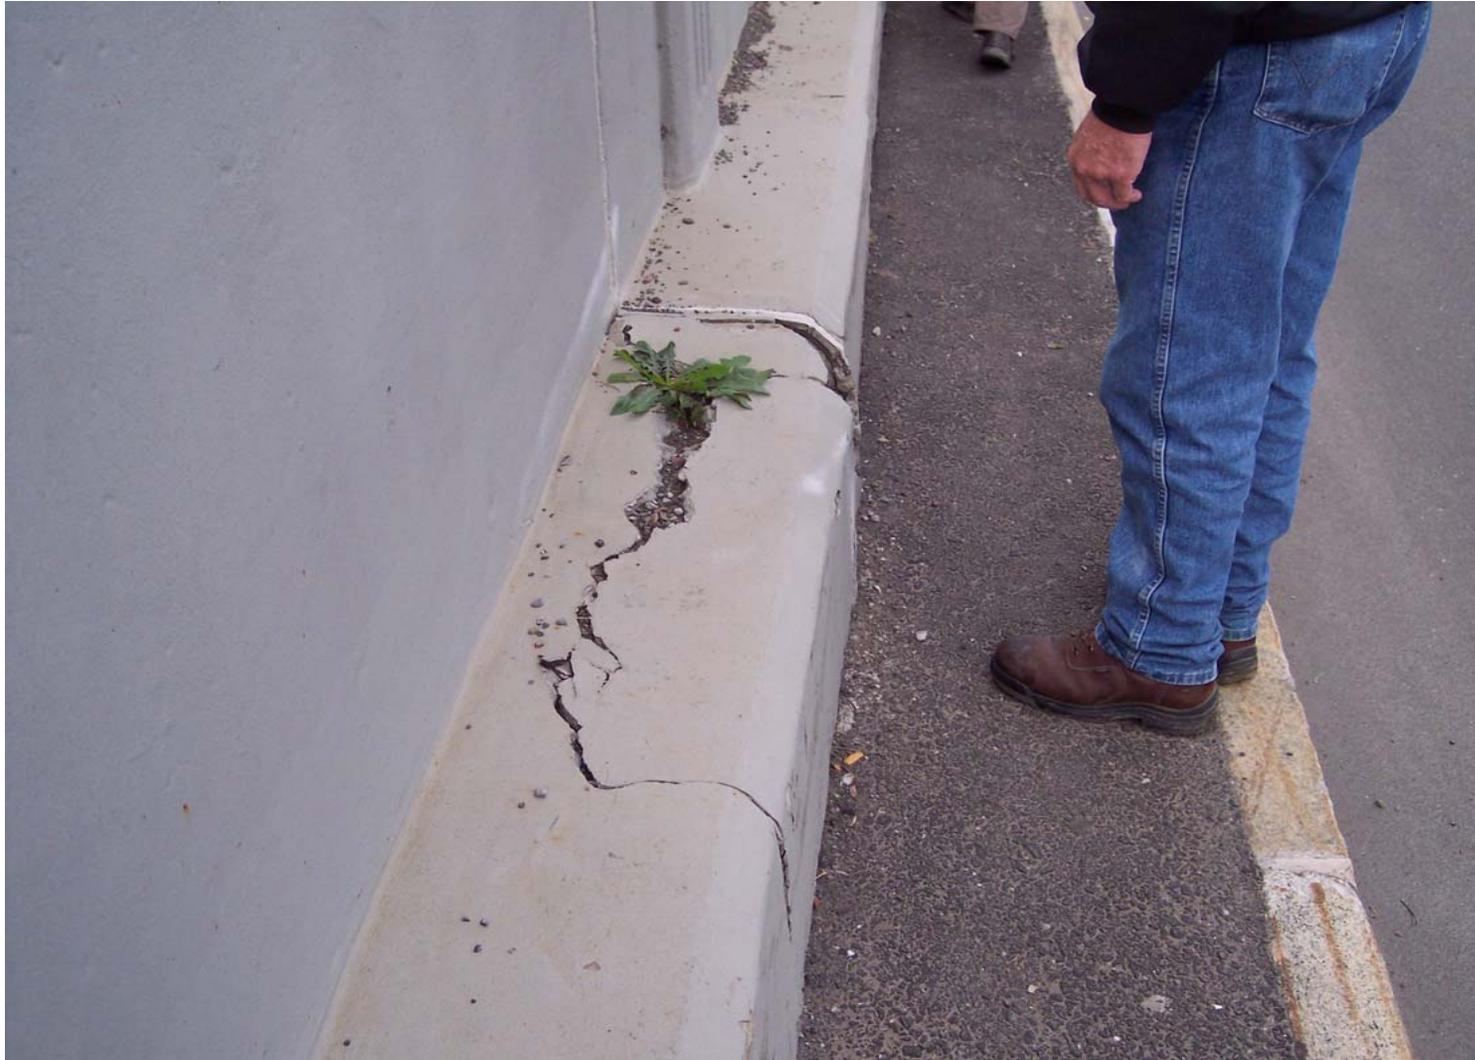
**Inspect ID:** BNGE\_2008\_a\_0006 **Name:** Floodwalls **Caption:** Large Crack developing in concrete Surface on L/S of floodwall near Sta. 7+00.

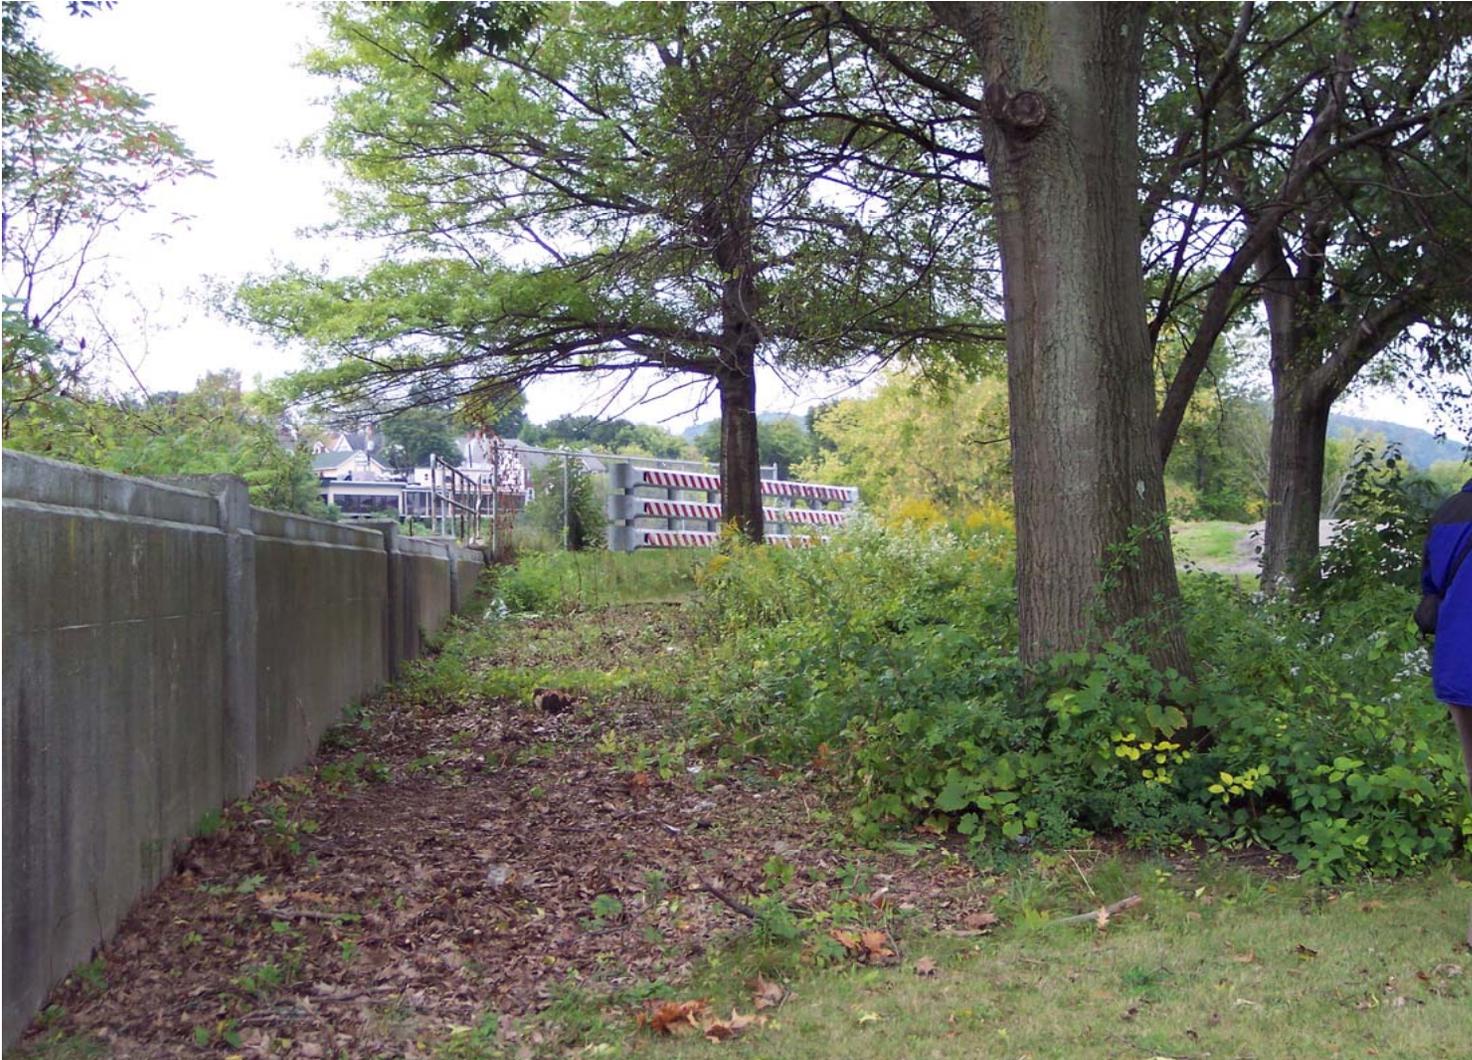
**Inspect ID:** BNGE\_2008\_a\_0007 **Name:** Floodwall **Caption:** Bridge abutment which may be lower than level of protection of surrounding floodwall.

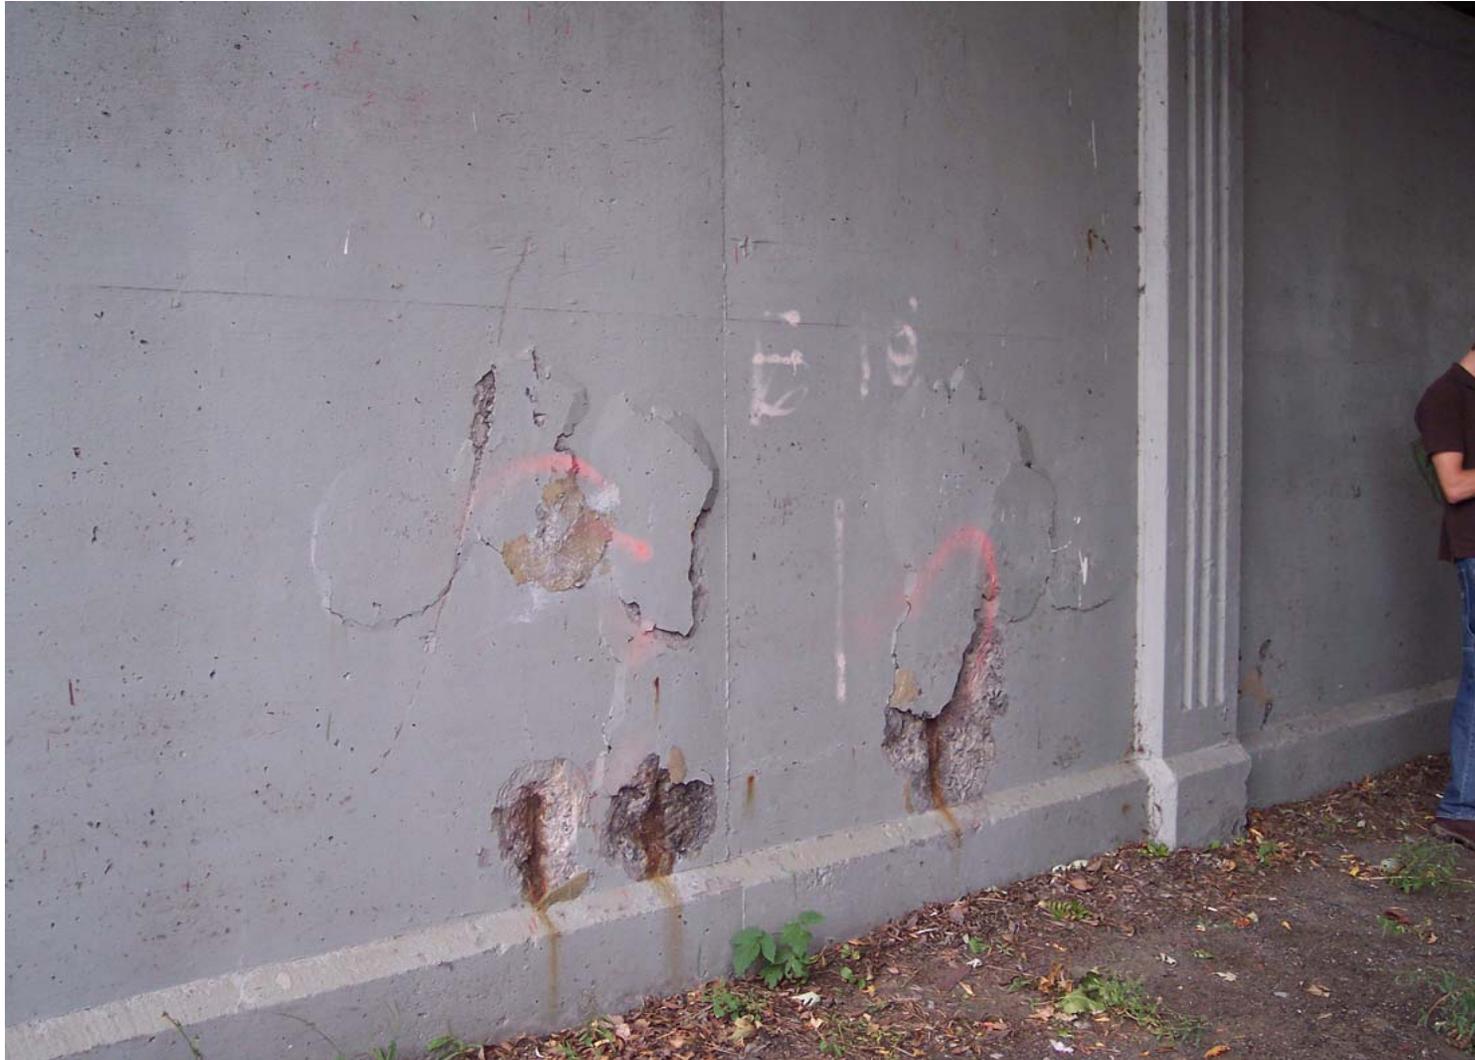
**Inspect ID:** BNGE\_2008\_a\_0010 **Name:** Floodwalls **Caption:** Spalling on floodwall underneath Rte. 434 Bridge.

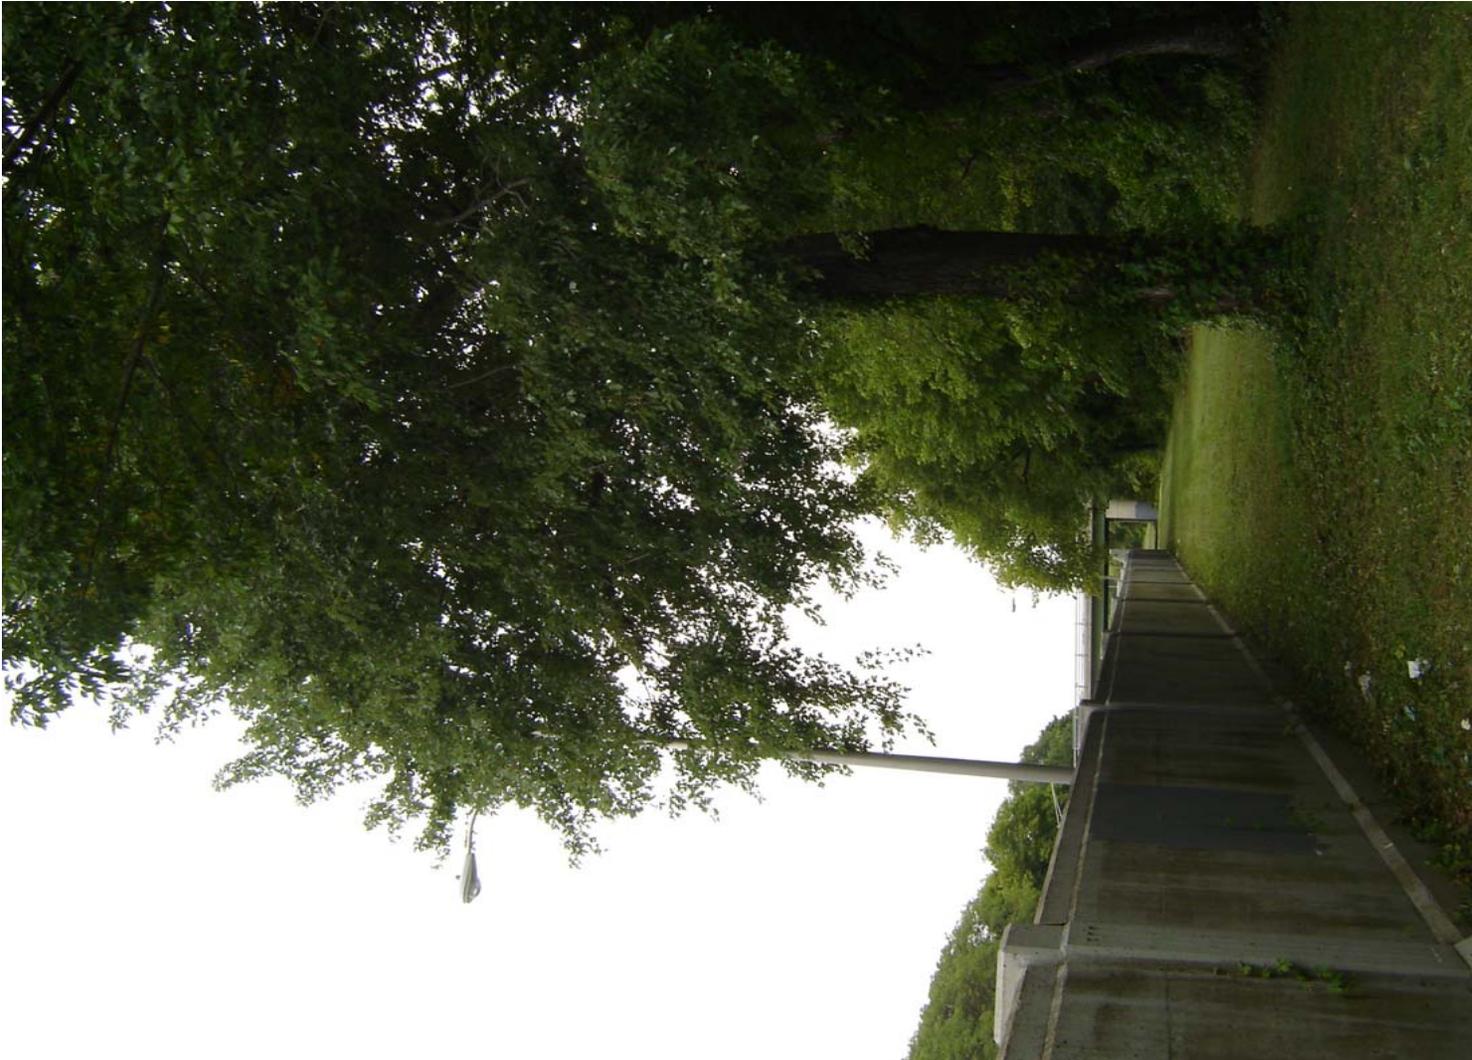
**Inspect ID:** BNGE\_2008\_a\_0011 **Name:** Floodwalls **Caption:** Tree between Washington Street Bridge and Rte. 434 overpass in need of removal.

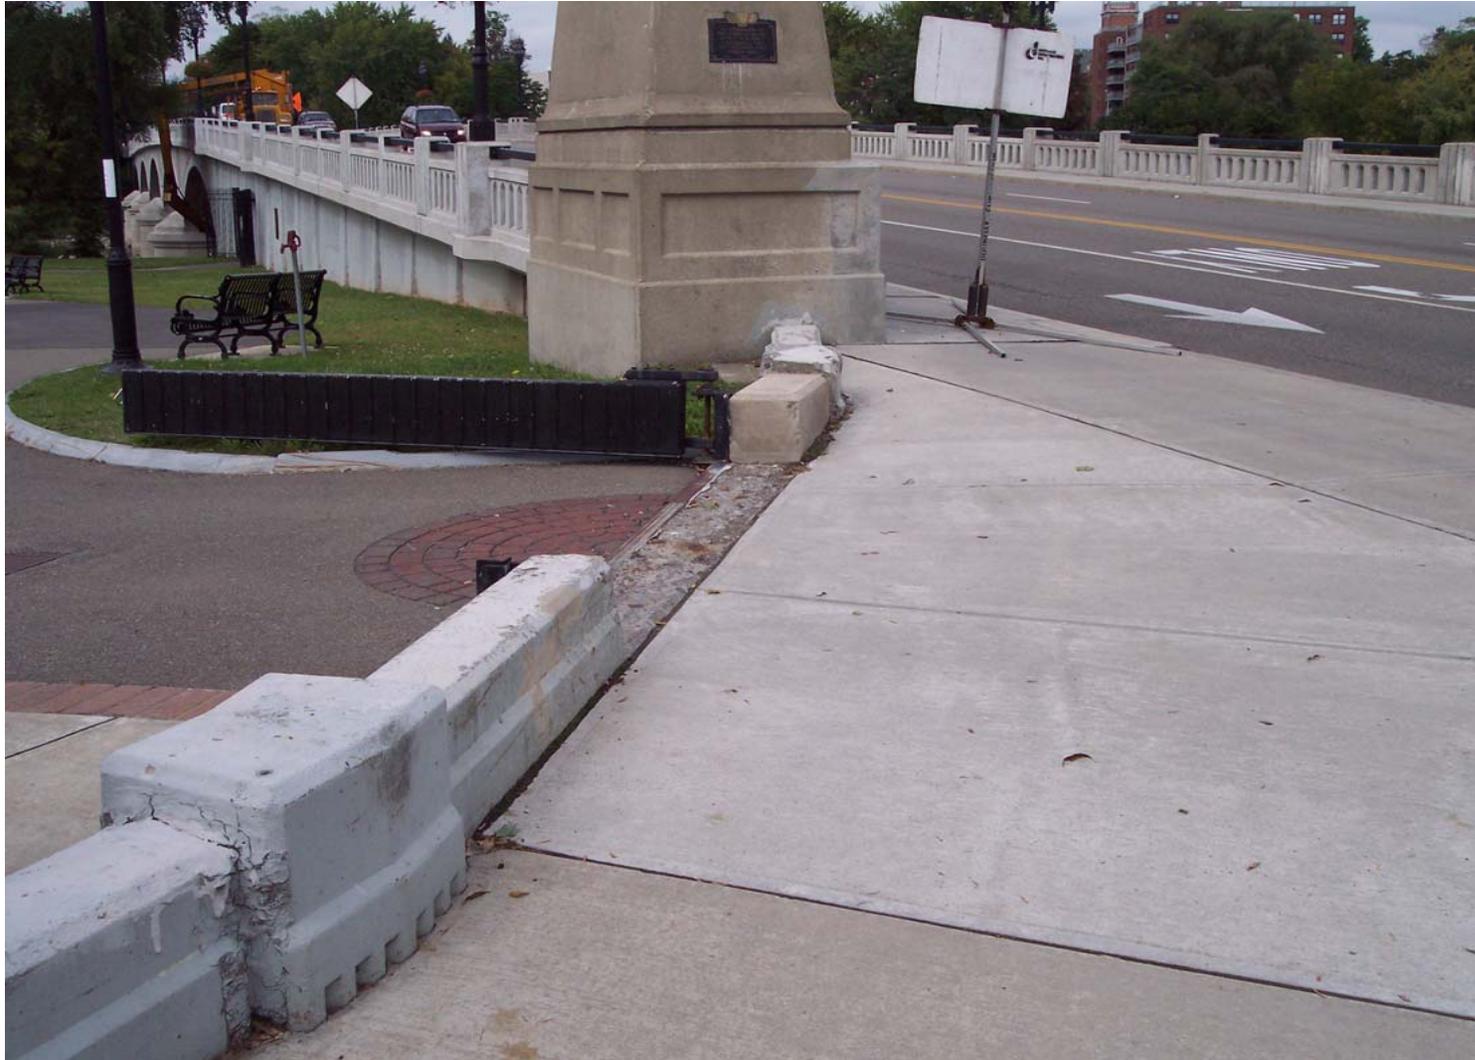
**Inspect ID:** BNGE\_2008\_a\_0012 **Name:** Floodwalls **Caption:** Closure Structure in need of repair to assure security of equipment.

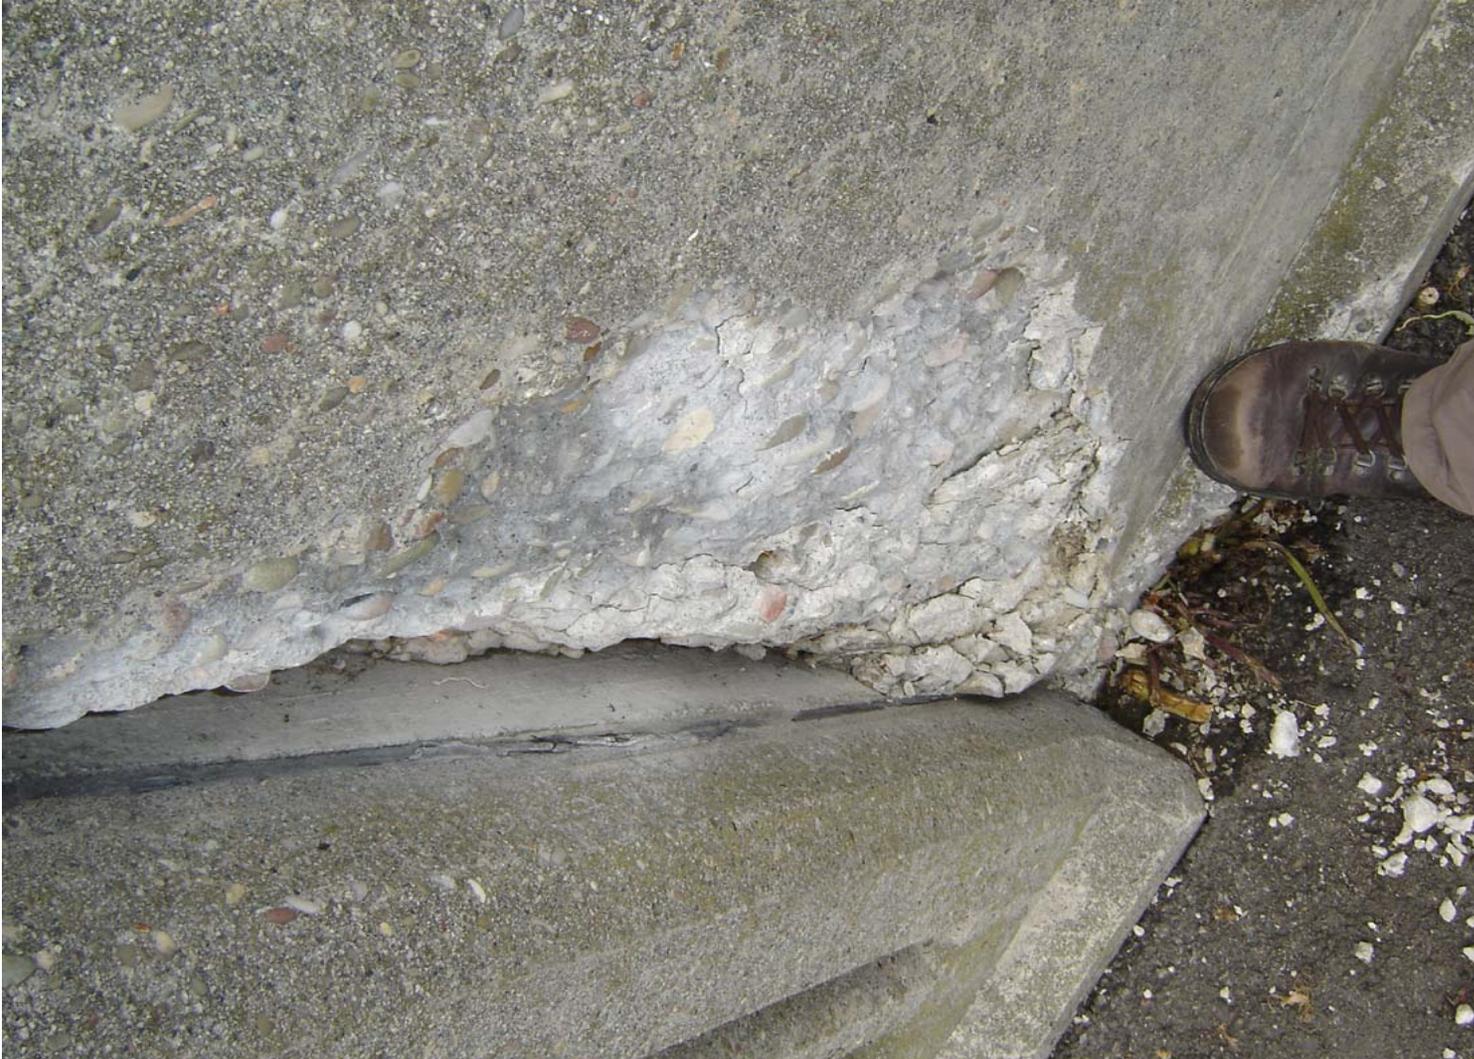
**Inspect ID:** BNGE\_2008\_a\_0013 **Name:** Floodwalls **Caption:** Concrete surface deterioration at base of floodwall approximately 275' North of Riverside Drive Bridge.

Rated Item	Rating	Rating Guidelines		Location/Remarks/Recommendations
		U	Surface deterioration or deep cracks present that may result in an unreliable structure. Any surface deterioration that exposes the sheet piling or lies adjacent to monolith joints may indicate underlying reinforcement corrosion and is unacceptable.	floodwall. (See photo BNGE_2008_a_0007). 3.) Sponsor should repair spalling on floodwall on L/S underneath Rte. 434 Bridge (two affected areas). (See photo BNGE_2008_a_0010). 4.) Approx. Sta. 218+00 (Approx. 275' North of Riverside Drive Bridge- located on riverside promenade) Concrete Deterioration at base of floodwall R/S is in need of repair. (See photo BNGE_2008_a_0013).

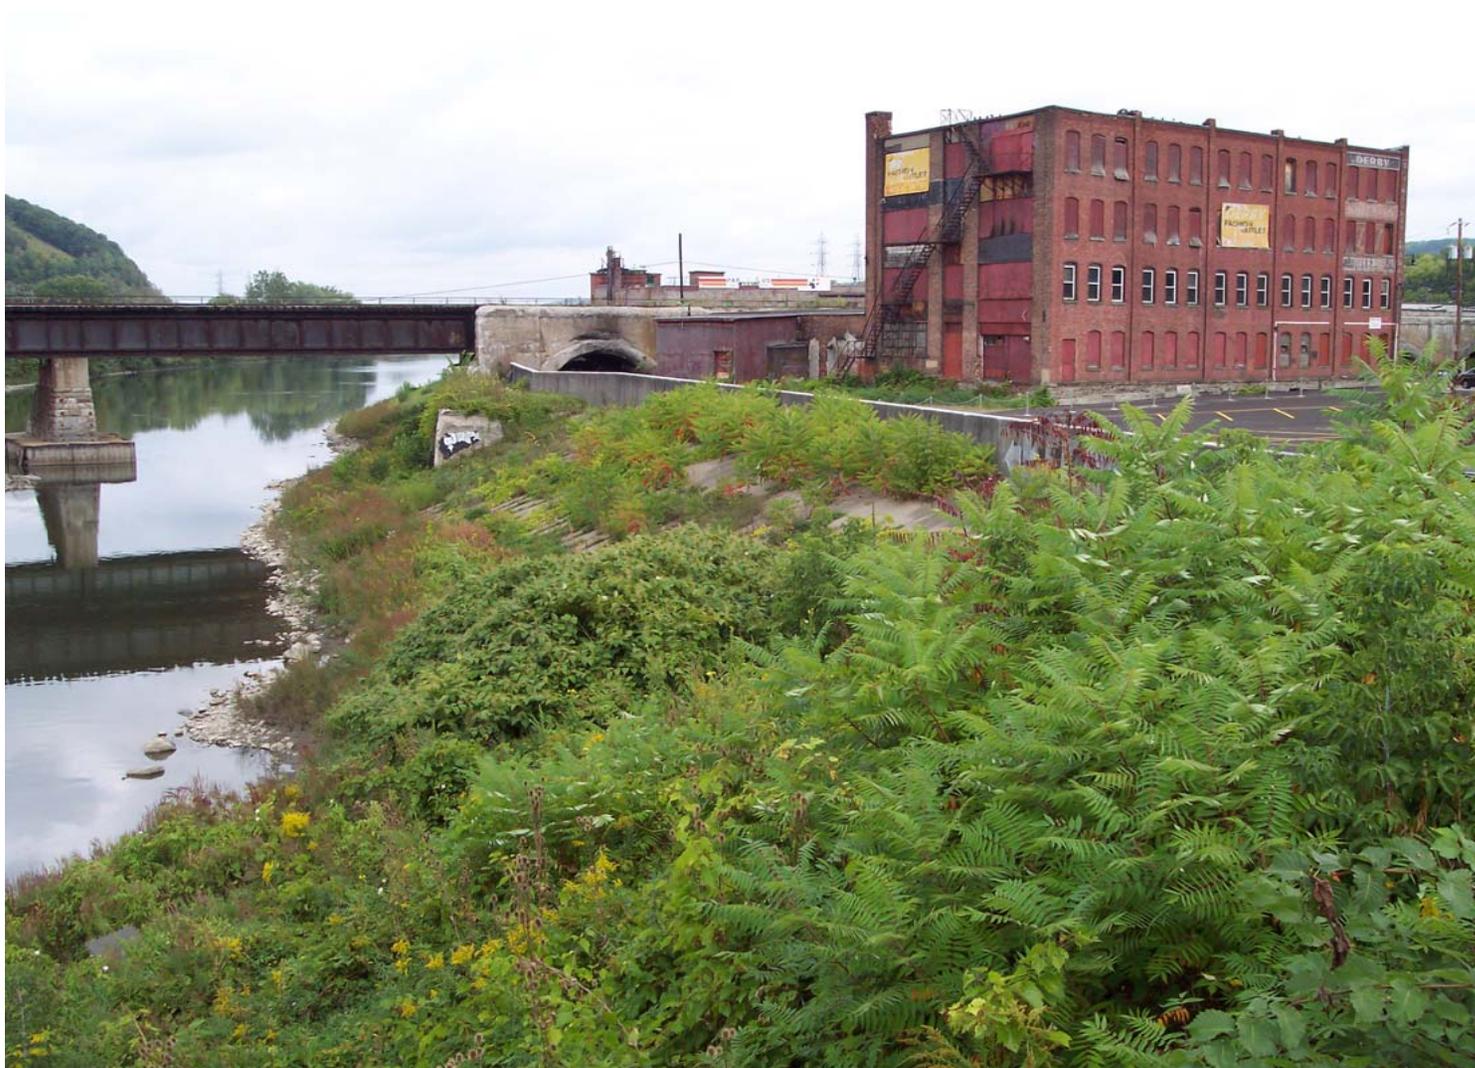
**Inspect ID:** BNGE\_2008\_a\_0014 **Name:** Floodwalls **Caption:** Unwanted Vegetation scheduled to be removed in vicinity of the East Clinton Street Bridge.

Rated Item	Rating	Rating Guidelines	Location/Remarks/Recommendations
1. Unwanted Vegetation Growth <sup>1</sup>	<b>M</b>	<b>A</b> A grass-only or paved zone is maintained on both sides of the floodwall, free of all trees, brush, and undesirable weeds. The vegetation-free zone extends 15 feet from both the land and riverside of the floodwall, at ground-level, to the centerline of the tree. Additionally, an 8-foot root-free zone is maintained around the entire structure, including the floodwall toe, heel, and any toe-drains. If the floodwall access easement doesn't extend to the described limits, then the vegetation-free zone must be maintained to the easement limits. Reference EM 1110-2-301 and/or Corps policy for regional vegetation variance.	1.) Unwanted vegetation in too close proximity to floodwall approx. 720' East of Tompkins Street Bridge or 100' West of DS#27. Additional trees adjacent to the storm drain pumping station next to the Tompkins Street Bridge are also in too close proximity to floodwall. Define property lines and remove. (See photo BNGE_2008_a_0005). 2.) Just East of Washington Street bridge, a tree in question of violating the 15' clearzone from I-wall was investigated by inspectors and found to be acceptable. (See photo BNGE_2008_a_0011). 3.) Current vegetation on R/S of floodwall in vicinity of East Clinton St. Bridge is to be removed later in year (November 2008). (See photo BNGE_2008_a_0014).

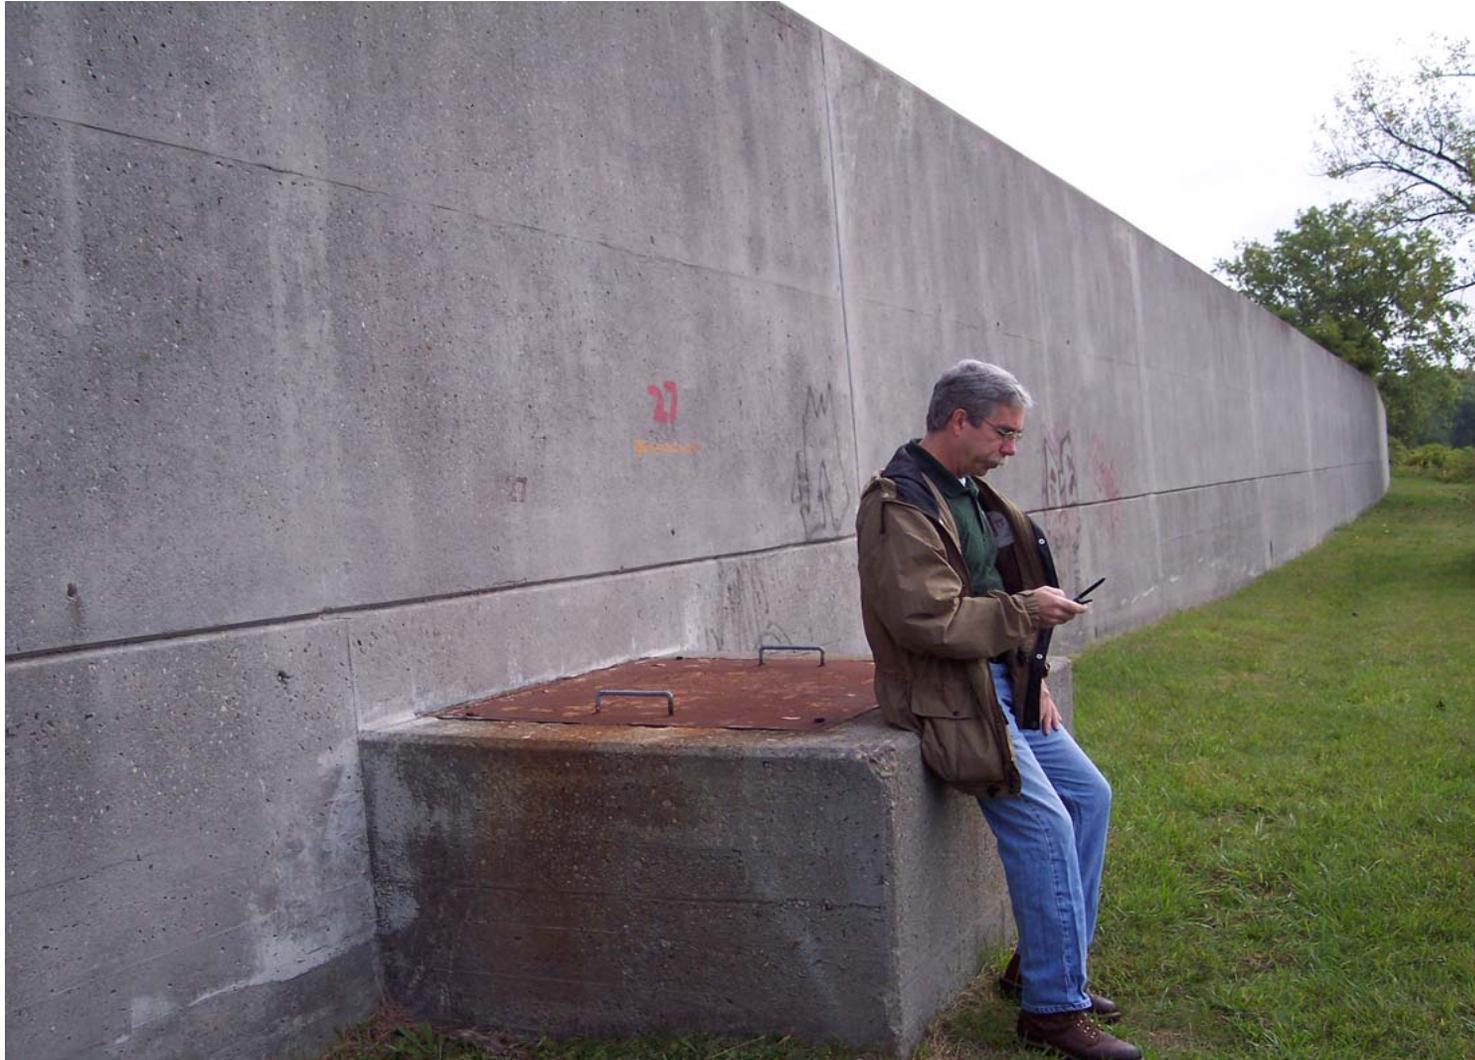
**Inspect ID:** BNGE\_2008\_a\_0004 **Name:** Interior Drainage Structure **Caption:** Approximate location of outlet of discharge pipe which was unable to be located at time of inspection.
