# Flood Damage Reduction Segment / System Inspection Report

Name of System: Northeast Binghamton System (Suquehanna & Chenango River)

Corps of Engineers Inspector: Alfred Zarnoski, P.E. ; William Wynn ; Joseph Reed ; Larry Mathena Date of Inspection: 9/16/2008

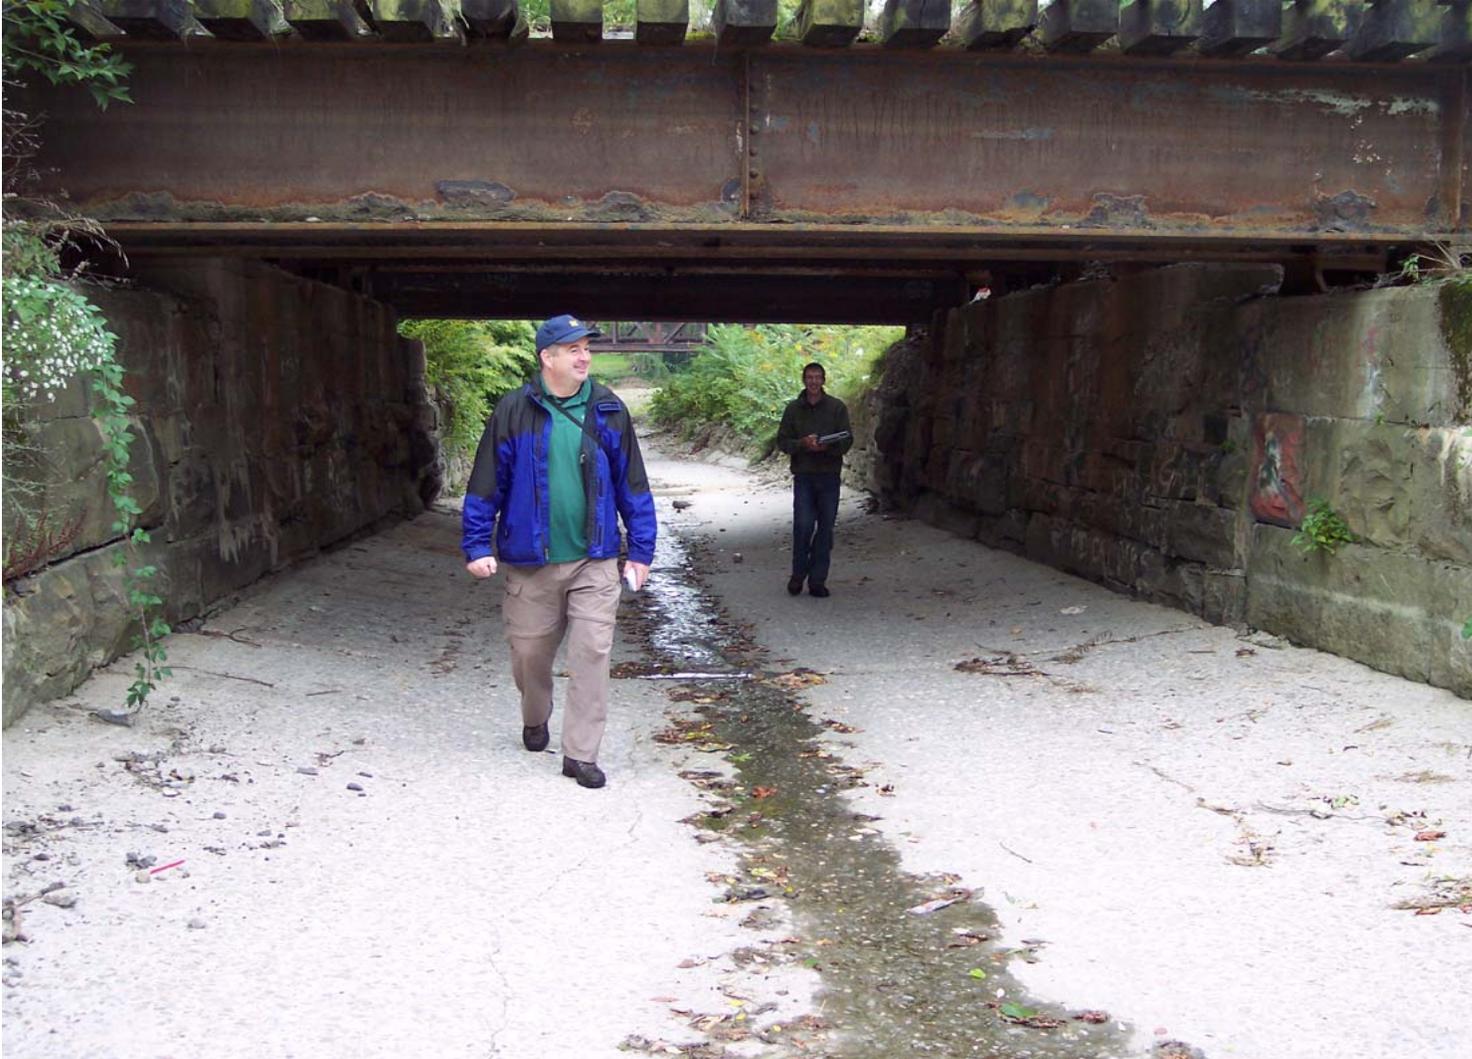
**Inspect ID:** BNGE\_2008\_a\_0001 **Name:** FDR Channel **Caption:** Chamberlain Creek at looking toward confluence with Susquehanna River.

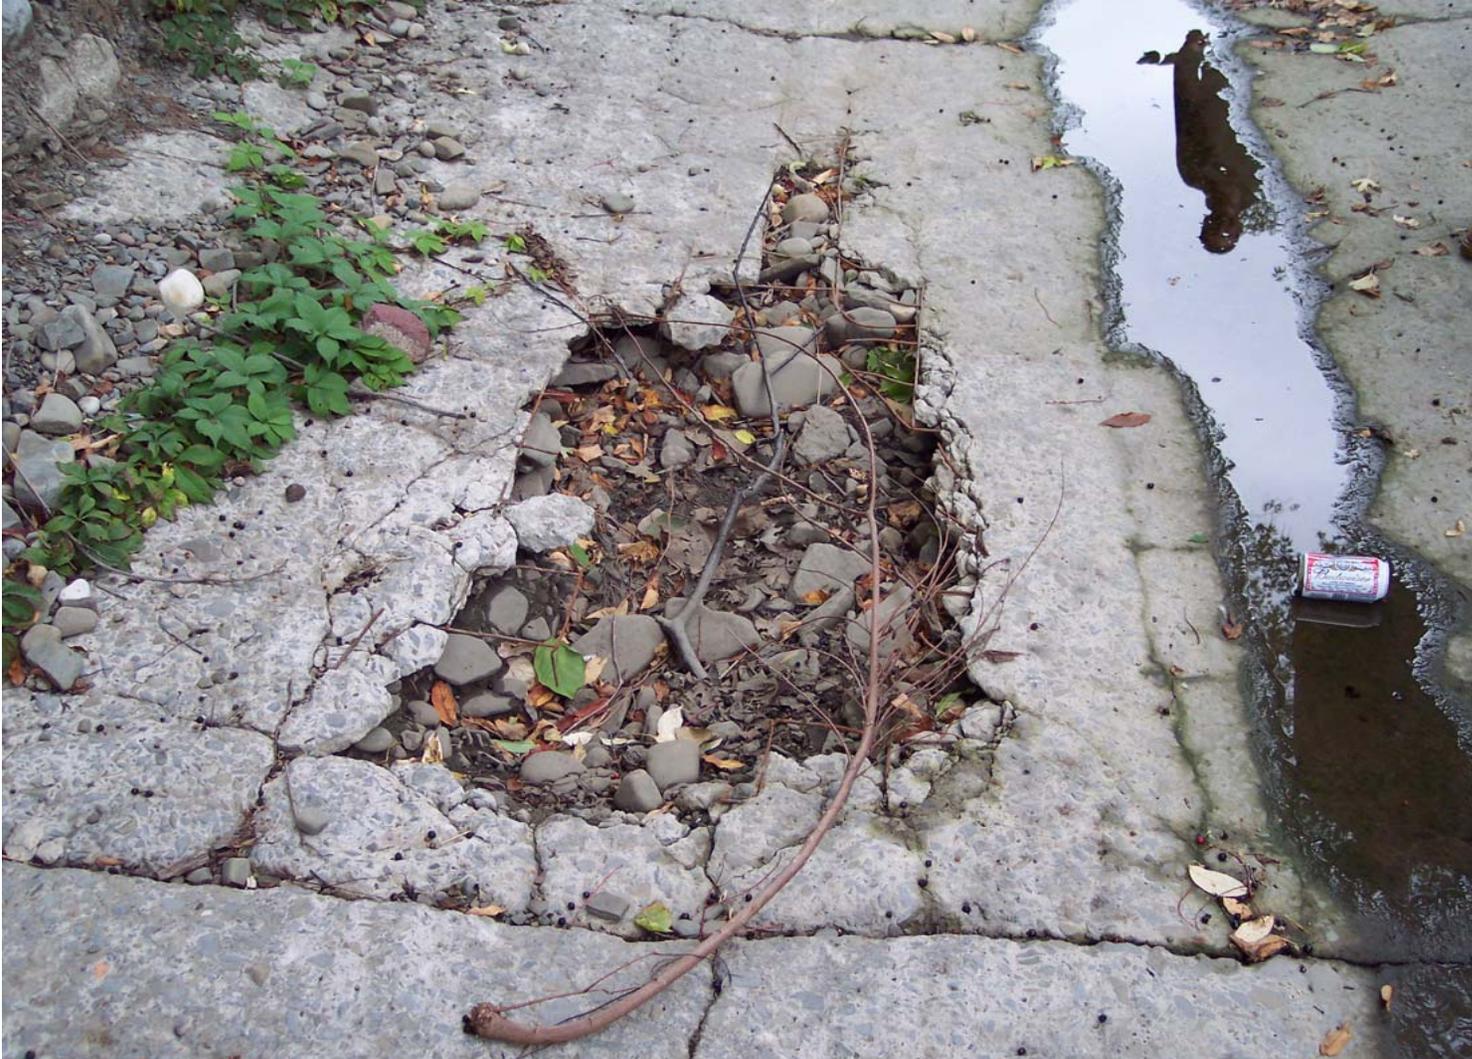
**Inspect ID:** BNGE\_2008\_a\_0002 **Name:** FDR Channel - Concrete Surface **Caption:** Typical deterioration of concrete in the bottom of Chamberlain Creek.
