PENN YAN FLOOD DAMAGE REDUCTION PROJECT

*Department of
Environmental Conservation*

Operated and Maintained by: The Village of Penn Yan

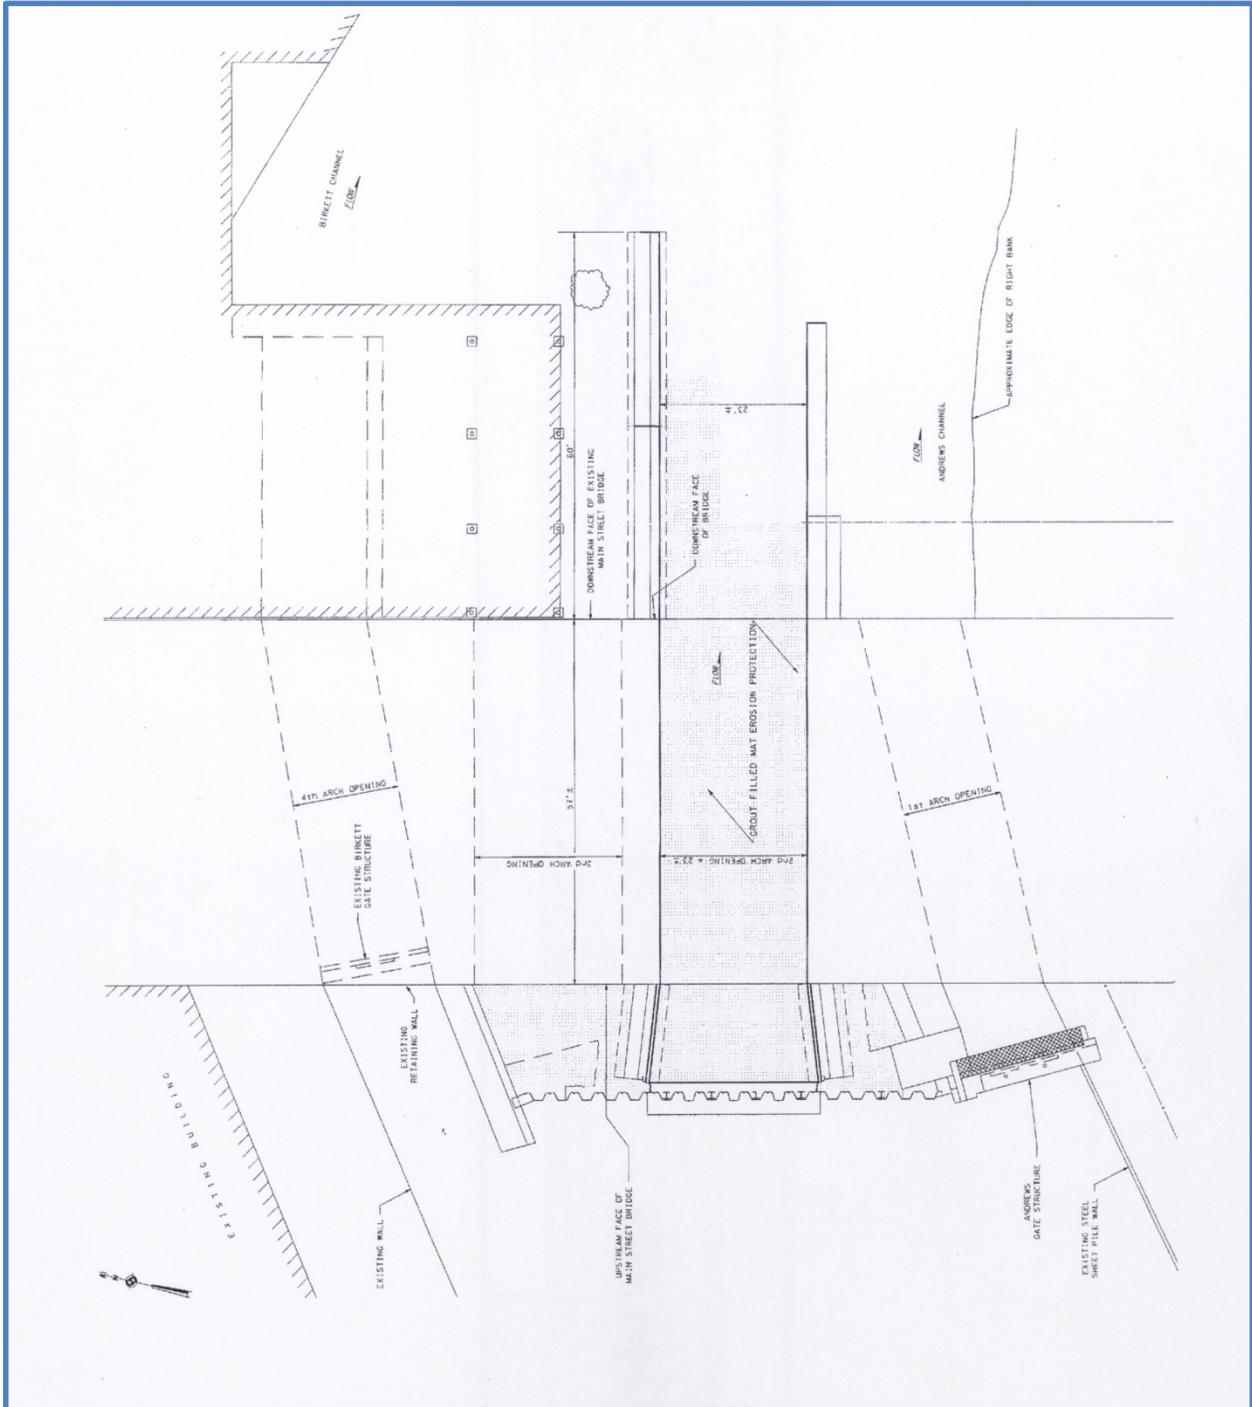
KEUKA LAKE OUTLET - CONTROL STRUCTURE GENERAL PLAN

The project, which required the removal of an earth and masonry dam, consists of three aluminum sluice gates that were added to two existing gated raceway structures. This outlet structure maintains the level of Keuka Lake and facilitates high volume discharge on the order of 1,000 cubic feet per second in order to reduce the probability of lake shoreline flooding under high lake level conditions.
