# The Chemung River Basin

# The 2004 Chemung River Basin Waterbody Inventory/Priority Waterbodies List

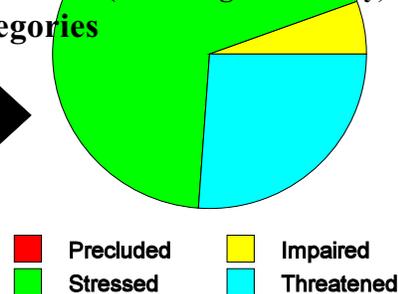
**Severity of Problems**  
(PWL Segments Only)

The second pie chart shows the severity of the most significant use impact or restriction for *Priority Waterbodies*. The levels of severity are:

- Precluded:* waters do not support appropriate uses,
- Impaired:* waters frequently do not support appropriate uses,
- Stressed:* waters support appropriate uses, but other water quality impacts are apparent, and
- Threatened:* waters support uses and have no impacts, but activities threaten future use support.

About one-third (34%) of the river miles in the Chemung River Basin (986 miles) are listed on the Priority Waterbodies List as either not supporting uses or having minor impacts or threats to water quality. The great majority (94%) of these river miles are considered *Stressed* or *Threatened* waters that fully support appropriate uses, but that have minor impacts/threats to uses. Only about six percent (6%) of basin river miles are *Impaired* and do not support appropriate uses.

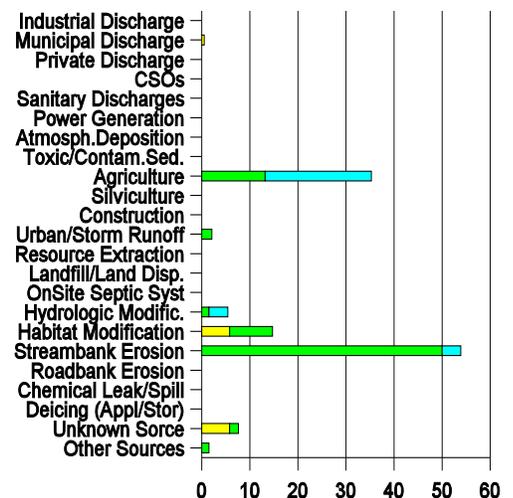
**Major Sources of Impact**  
(PWL Segments Only)

The bar charts indicate the pollutant sources that are most frequently cited as major contributors to the water quality impacts for *Priority Waterbodies* in the Chemung River Basin. The charts reflect the percentage of miles/acres of the total waterbody area on the Priority Waterbodies List where the source is listed as a major contributor to the water quality impact. For each source, the color shading of the bar indicates the severity (*Precluded, Impaired, Stressed, Threatened*) of the most significant water use impact to the waterbody.

Percent of PWL Waters Affected

Significant sources of impact and impairment to the waters of the basin include streambank erosion that increase silt/sediment loadings to the streams and lakes and agricultural nonpoint sources that increase nutrient loadings. Habitat modifications (invasive species and excessive weed growth) and hydrologic modifications (related to flood control) are also frequently cited sources of impairment/impact.

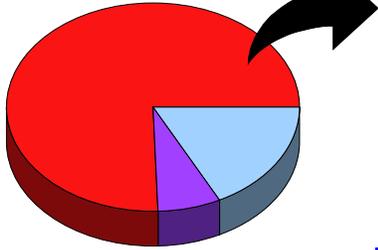
## Water Quality Assessment Categories (for ALL Waters in the Basin)

The series of charts presented on the following pages provides an overall assessment of water quality conditions in the entire Chemung River Basin. For each waterbody type (rivers/streams and lakes/reservoirs) the first chart shows the percentage of the miles/acres of waters in the basin that fall into the various *Water Quality Assessment Categories*. The red portion of the first pie indicates the percentage of waters characterized as *Impaired Segments* which do not support appropriate uses. The purple portion represents segments with *Minor Impacts* and *Threatened Waterbody Segments*. Taken together, waters in both of these categories (represented by the red and purple segments) comprise the **Priority Waterbodies** (for that waterbody type) within the basin. The percentage of miles/acres for the other Water Quality Assessment Categories – *Waterbodies Having No Known Impacts*, *UnAssessed Waterbodies*, and *Waterbodies with Impacts Needing Verification* – are shown in blue, light blue, and green respectively.

- PWL - Not Supporting Uses
- PWL - Other Minor Impacts
- No Known Impacts
- UnAssessed Waters
- Impacts Needing Verification

Eight of the 23 separate lake segments in the basin are included on the PWL as having impaired uses or minor impacts/threats to uses. However these 8 lakes impaired/impacted lakes represent 83% of the total lake acres in the basin. These water quality problems are primarily the result of excessive aquatic weed growth and/or invasive species that restrict recreational uses. However hydrologic modification in support of flood control efforts also impact recreational uses of other reservoirs.

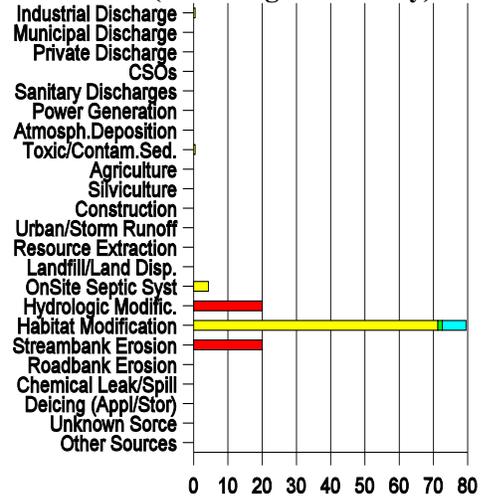
## Major Sources of Impact (PWL Segments Only)

Percent of PWL Waters Affected

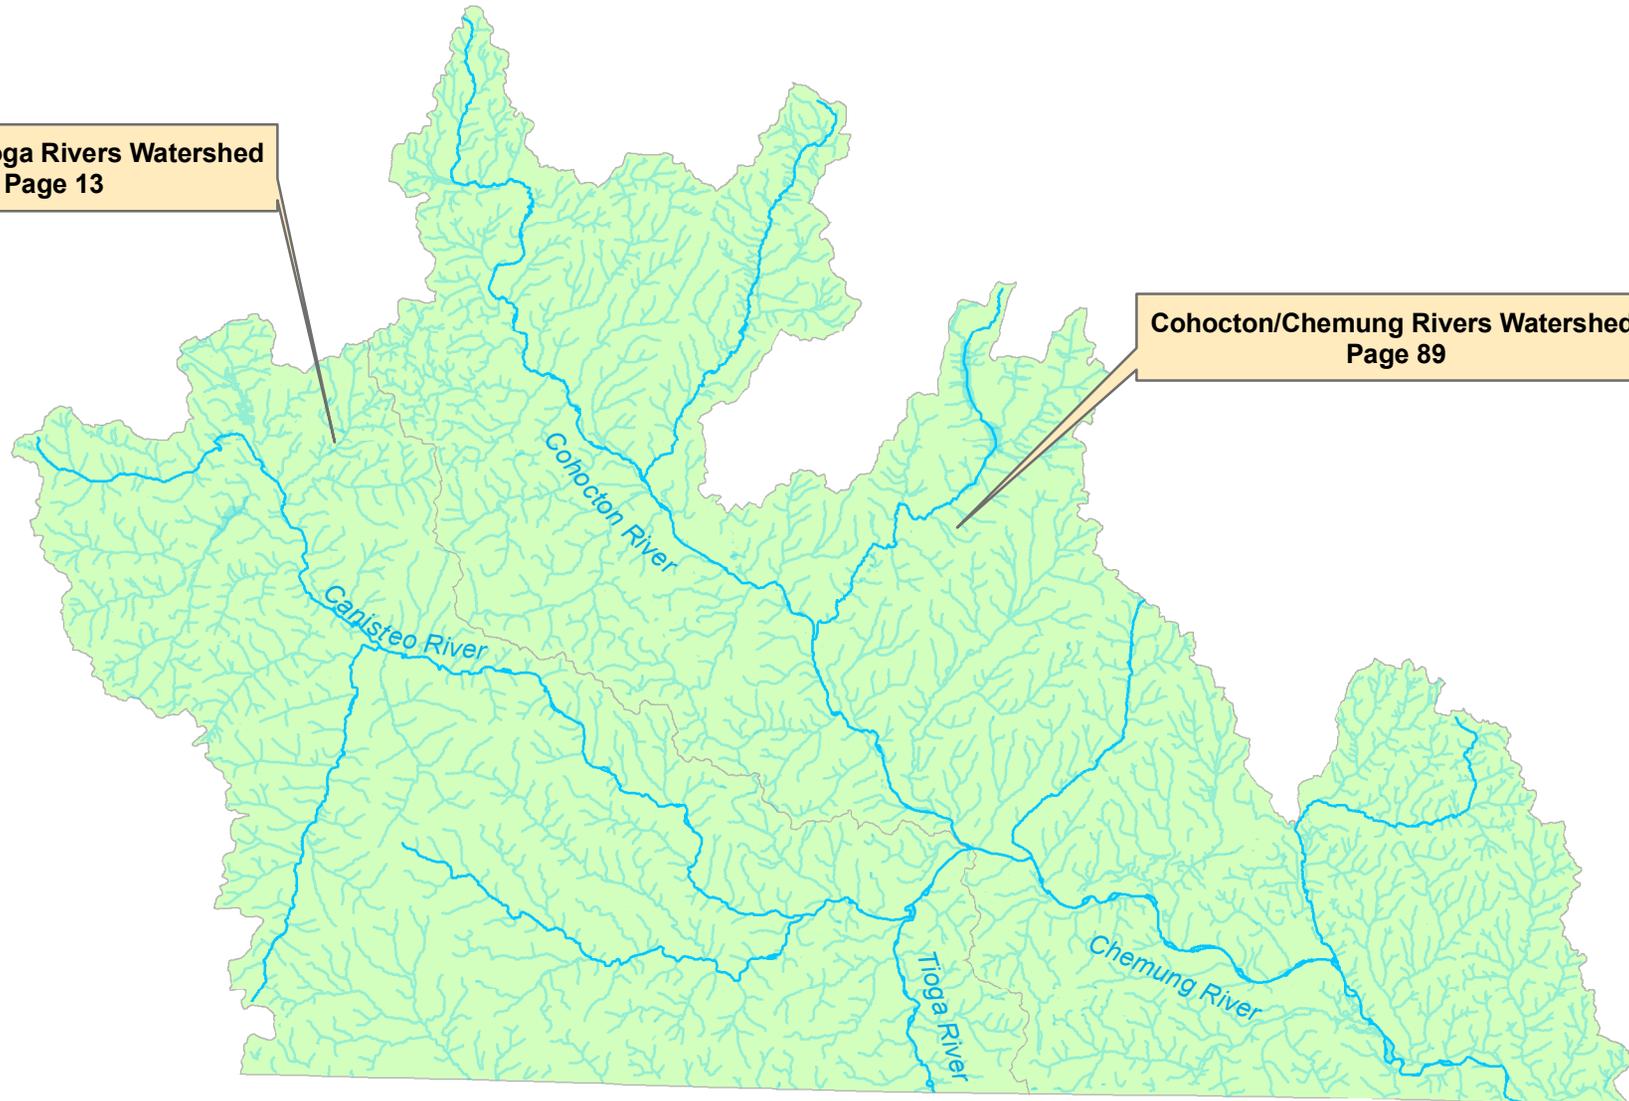
Figure 3

# Chemung River Drainage Basin Watersheds

**Canisteo/Tioga Rivers Watershed**  
Page 13

**Cohocton/Chemung Rivers Watershed**  
Page 89

The data sheets on the following pages are compiled in hydrological order and grouped by US Geological Survey Hydrologic Unit Code (HUC) basin and smaller watersheds in the Chemung River Basin (see Figure 2). An outline of the specific waterbodies in each watershed is presented at the beginning of each Watershed Section. Data sheets are included for each waterbody that has been assessed; that is, waterbodies listed as *Impaired Segments*, *Segments with Minor Impacts*, *Threatened Waters*, waters with water quality impacts *Needing Verification*, or waterbodies with *No Known Impact*. *UnAssessed* waterbodies are listed in the hydrologic outline of waterbodies at the front of each Watershed Section; however, separate data sheets for these segments are not included.
