# Monthly Report of the Operations & Maintenance Activities

Claremont Polychemical Operable Unit 5  
Groundwater Treatment System

*Old Bethpage, New York*  
December 2019

NYSDEC Standby Engineering Contract  
Work Assignment #D0076025-28

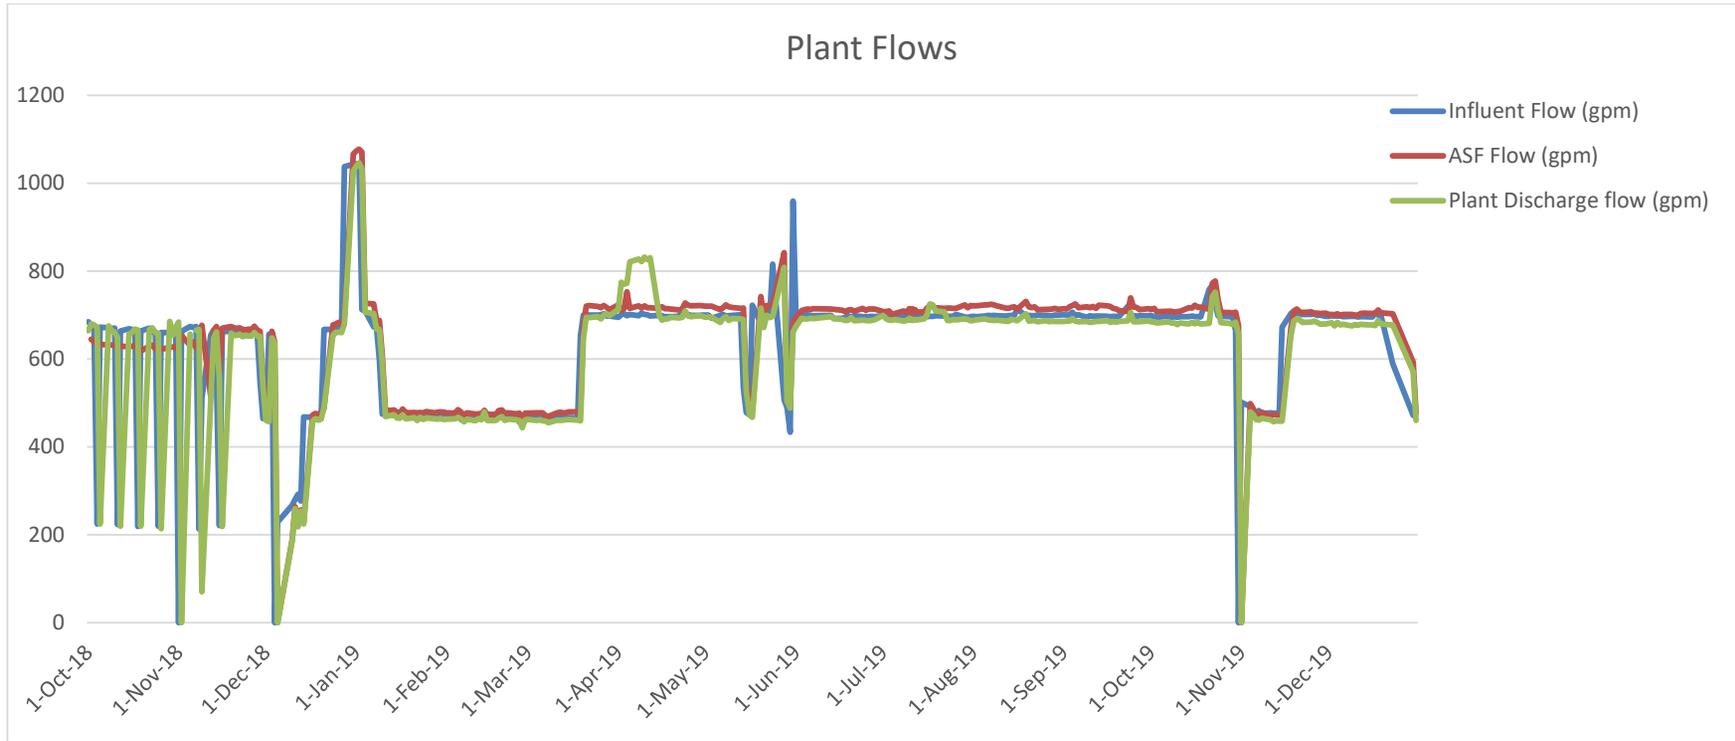
Figure 1 – Plant Discharge Daily Flow

A graphic representation of the system's daily plant discharge output is provided in Figure 1 and the daily plant totalizer readings for December are provided in Table 4, both following the text of this report.
