## SITE EVALUATION

*Pass & Seymour/Slater Property  
45 Sea Cliff Avenue  
Glen Cove, New York*

*March 1996*

**ERM-NORTHEAST  
on behalf of  
The Slater Working Group**

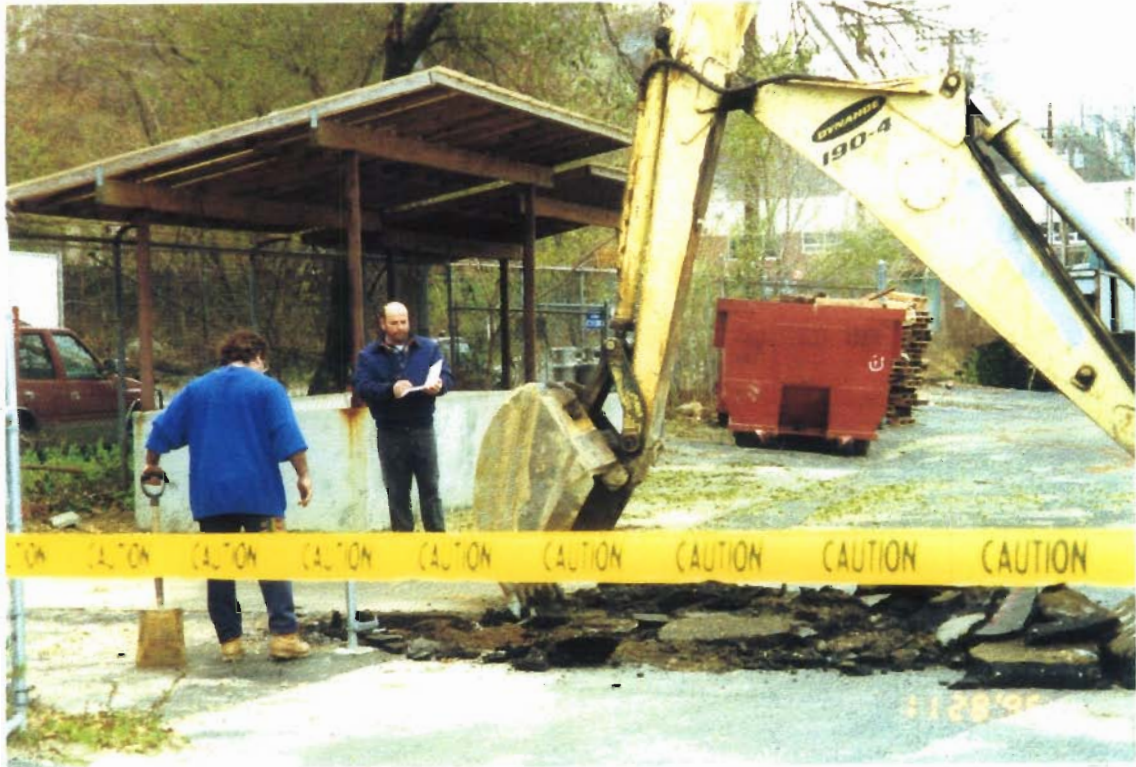
PHOTOGRAPH # 1 : Removal of Asphalt Top.  
Looking West.

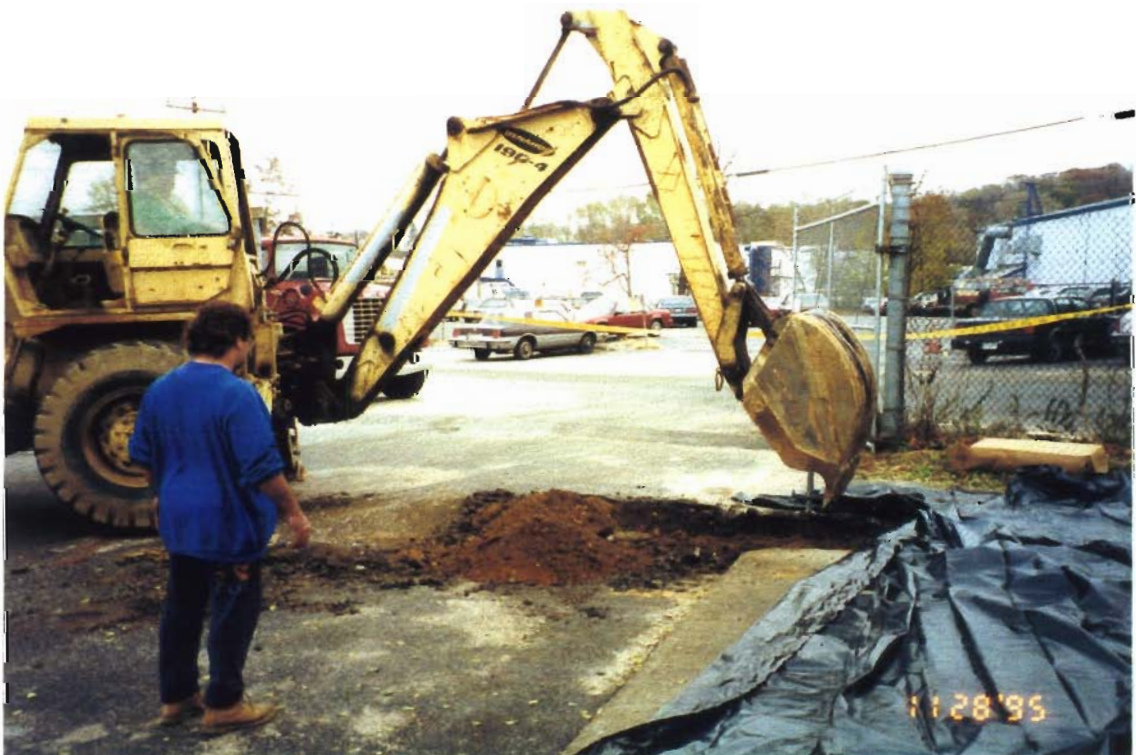
PHOTOGRAPH # 2 : Excavation Activities Begin, Note Well in  
Center of Excavation. Looking East.

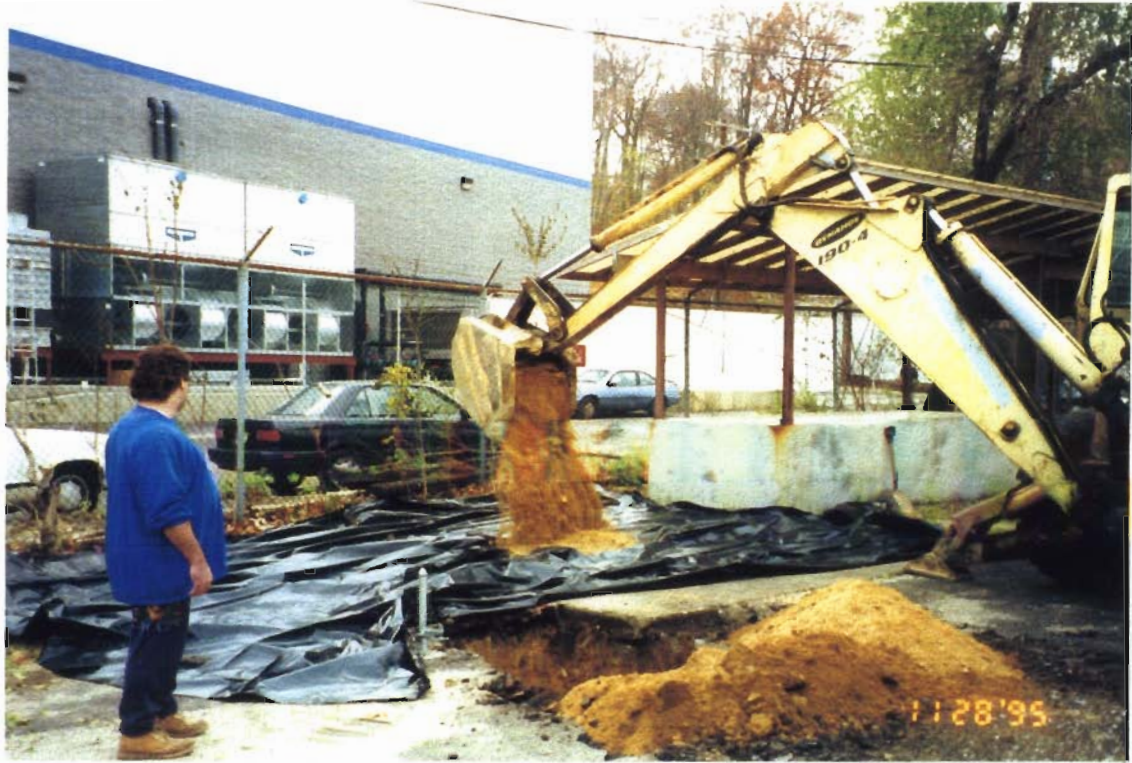
PHOTOGRAPH # 3 : Placement of Soil on Liner.  
Photocircuit Building in Background. Looking South.

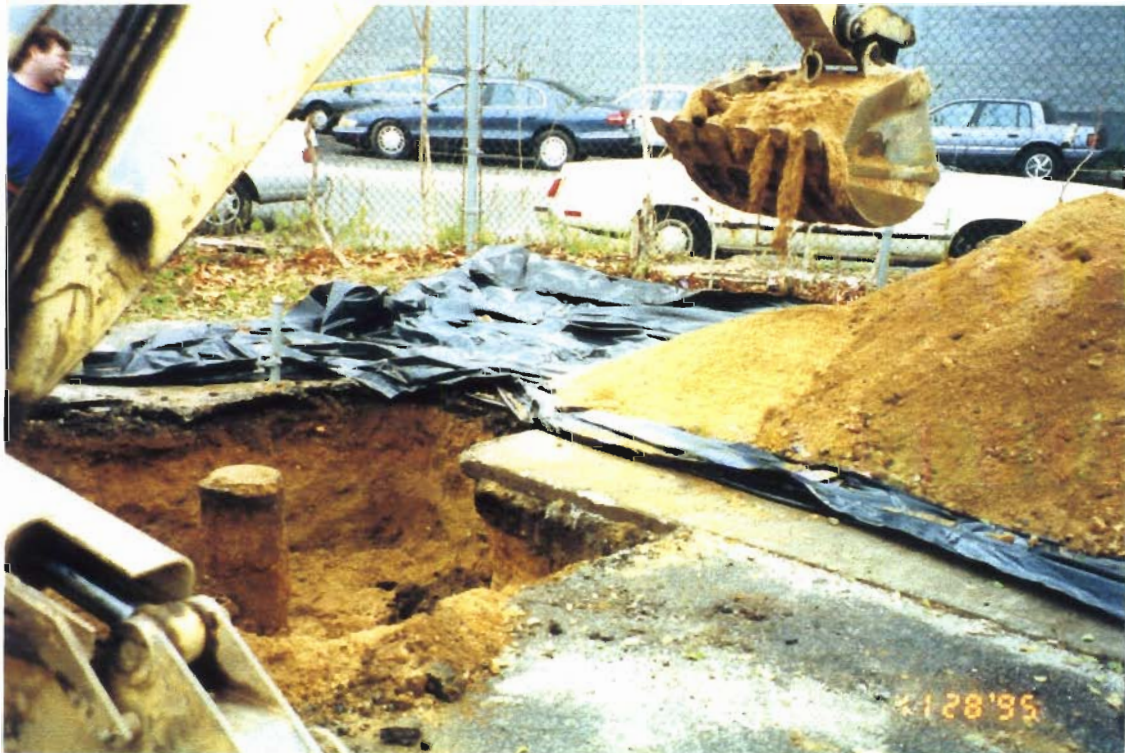
PHOTOGRAPH # 4 : Excavation Nearing Completion. Looking East.  
Note Monitoring Well in Center of Excavation.

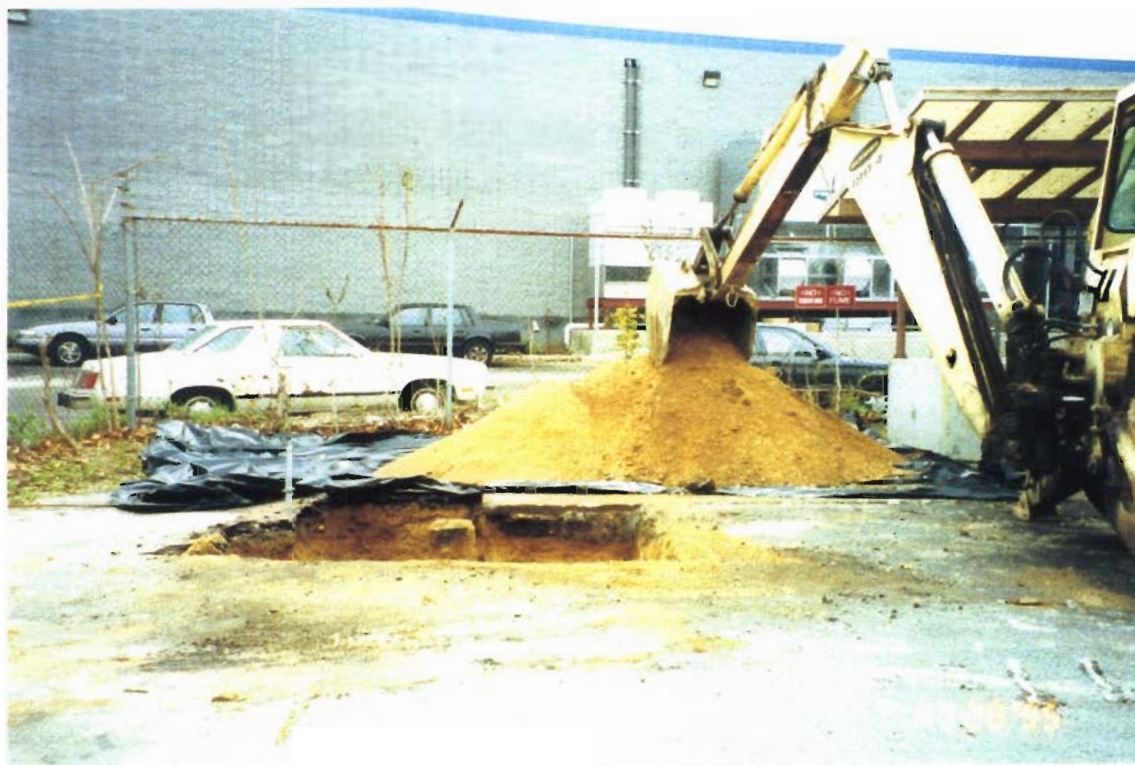
PHOTOGRAPH # 5 Excavation Completed. Looking South towards Photocircuit Building.

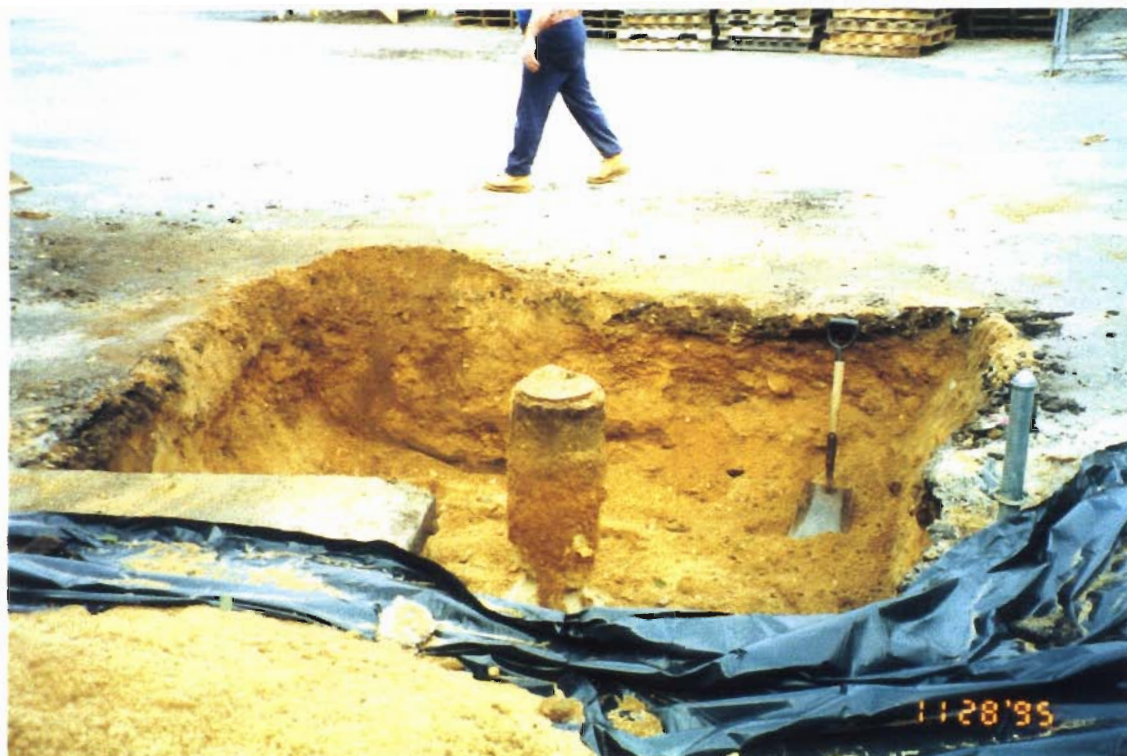
PHOTOGRAPH # 6 Three Foot Deep by Ten Foot Square Excavation Completed. Looking North.

contamination was reported to be within the first two feet from the surface. In an effort to assure that any contamination present was removed, the excavation was extended to three feet below grade. The final excavation encompassed an area of approximately ten foot square by three feet deep. The soil was stockpiled on the polyethylene liner and covered by the same material. An orange snow fence was erected around the excavation as well as a yellow caution tape. As an added level of precaution, plywood was placed over the excavation to avoid any injury from an individual falling into the hole. The disturbed area was broom-swept. Excavation work was completed by 10:58 a.m. Site photographs were taken and can be found in Appendix A.

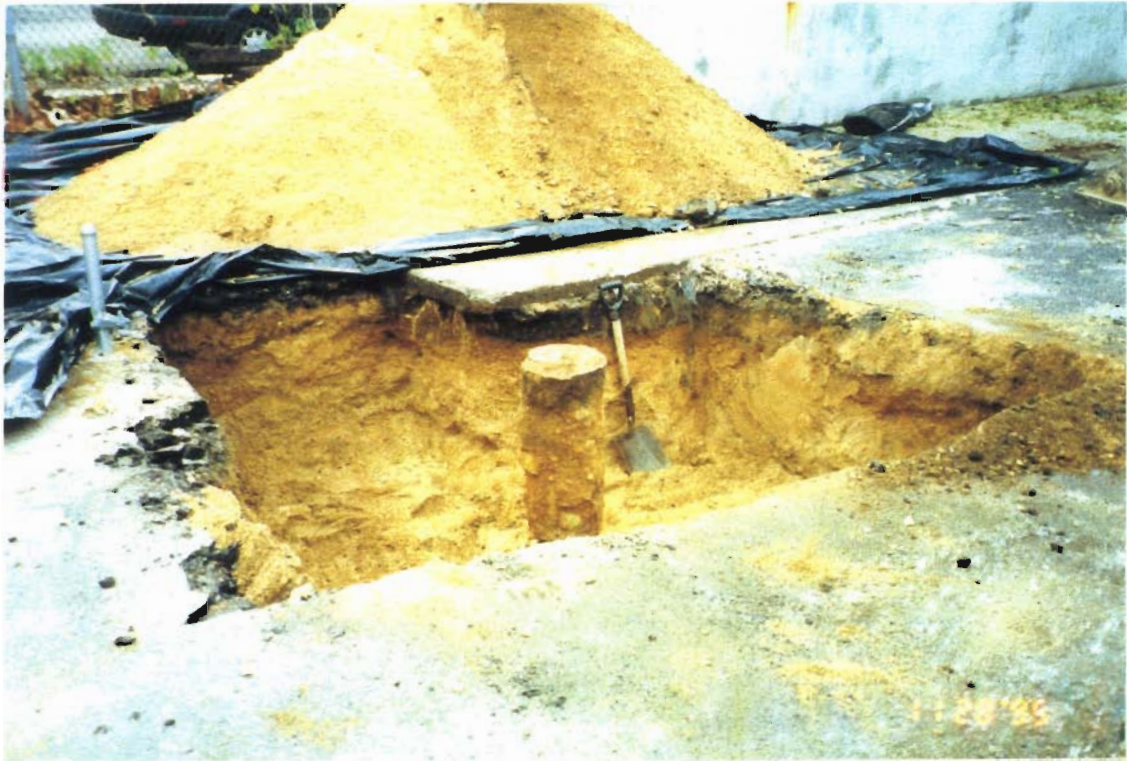
PHOTOGRAPH # 7 : Looking South at Completed Excavation.

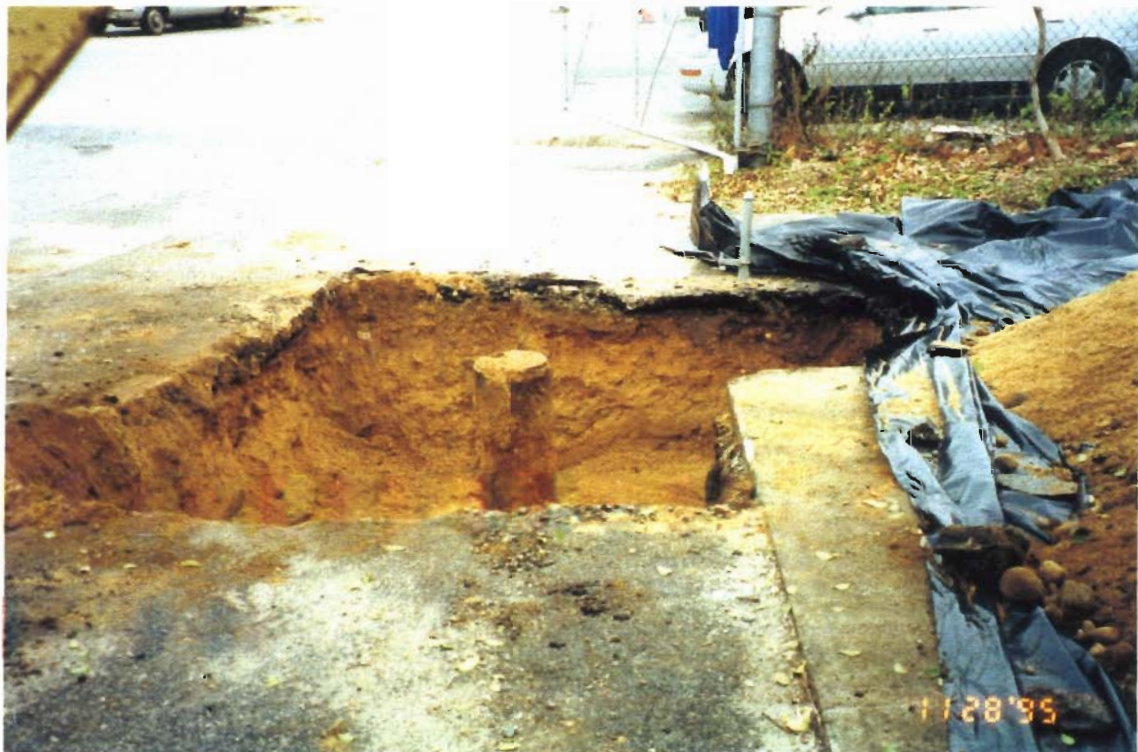
PHOTOGRAPH # 8 : Looking East at Completed Excavation.

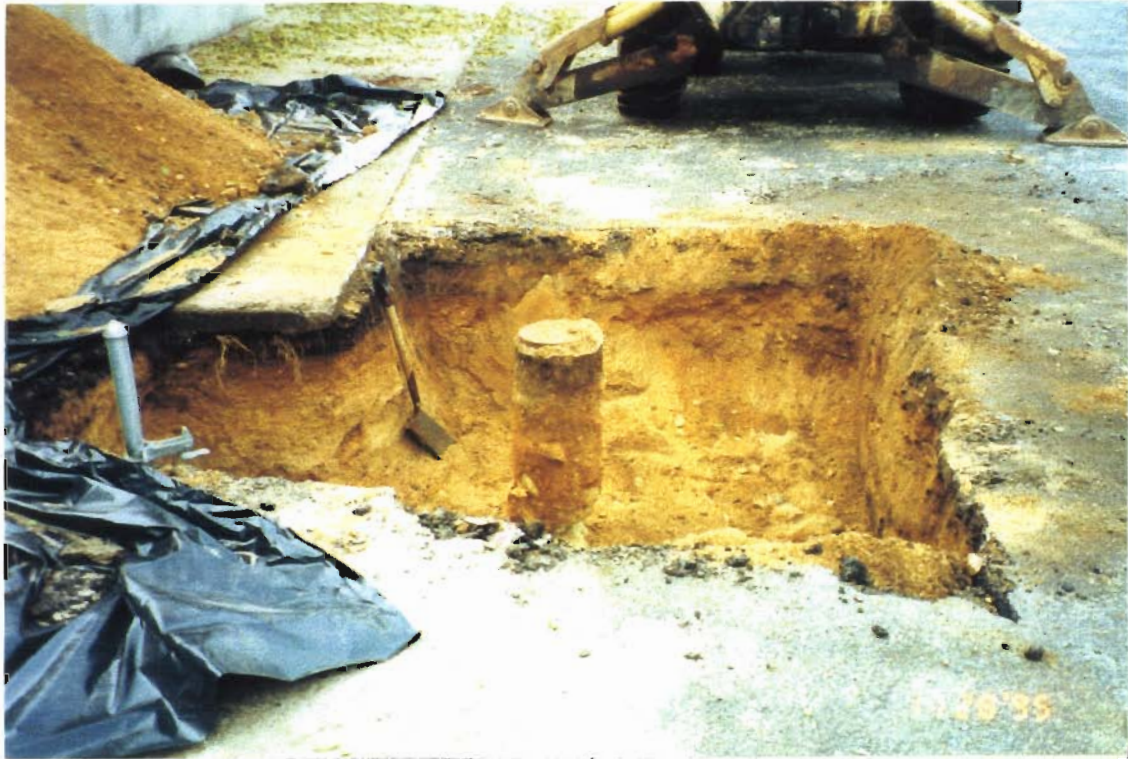
PHOTOGRAPH # 9 : Looking West at Completed Excavation.

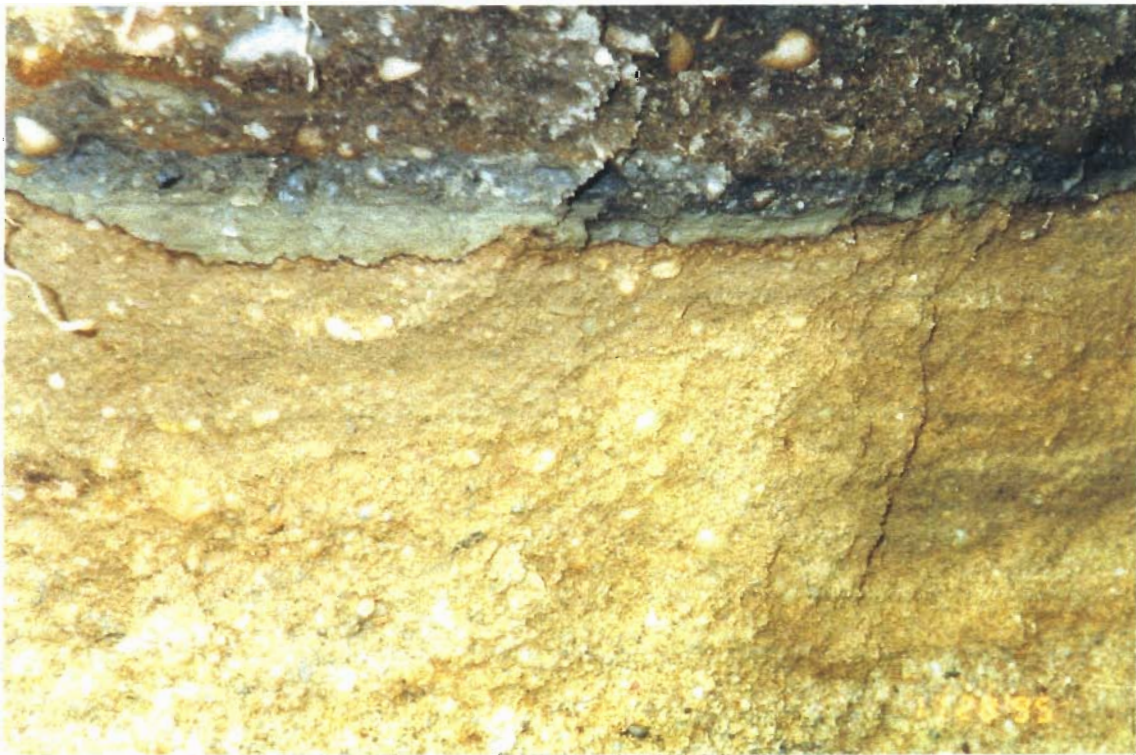
A review of soil quality data demonstrates that no contaminant source to ground water quality was located on the Pass & Seymour/Slater property. The only potential source was location S-4, however, contaminants observed were restricted to 0-2 feet below grade. The reason for this is that beneath the surface in this area of the property is a one to two inch clay layer which restricted any downward migration of contaminants (see Photograph No. 10 in Appendix A).

PHOTOGRAPH # 10: Photograph of 1 to 2 Inch Clay Layer.

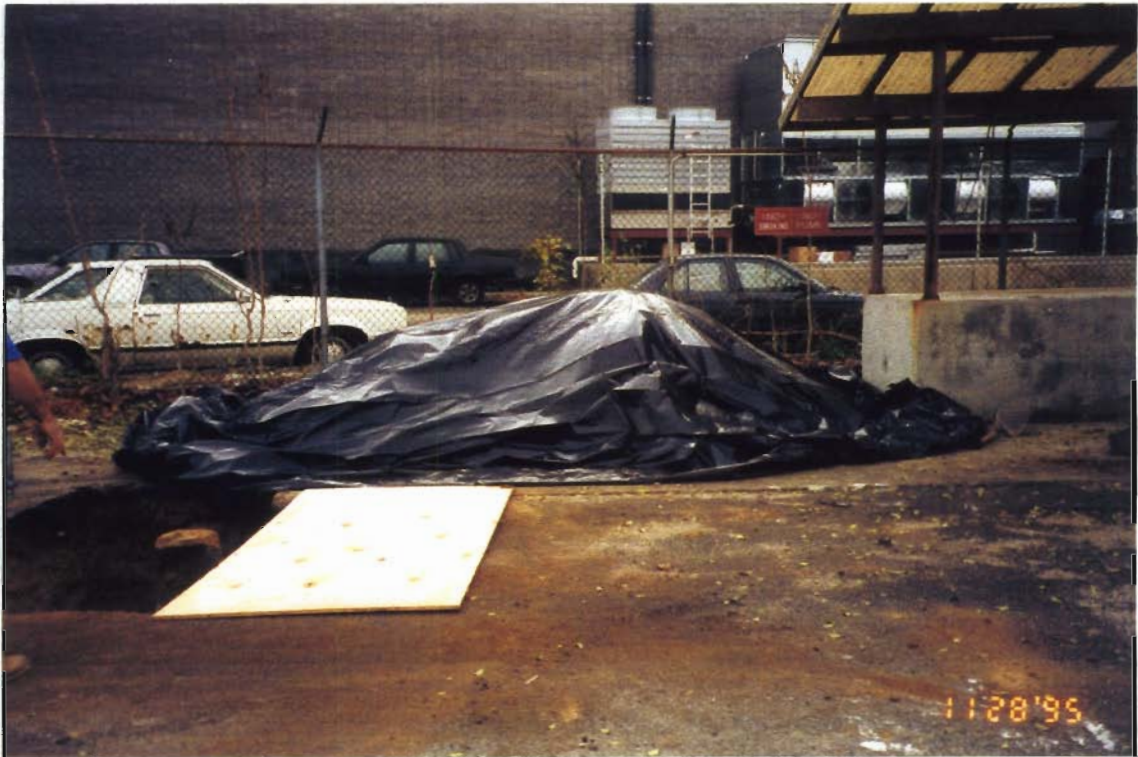
PHOTOGRAPH # 11: Waste Pile Covered with Sheeting.  
Large Rocks Used to Secure Top.

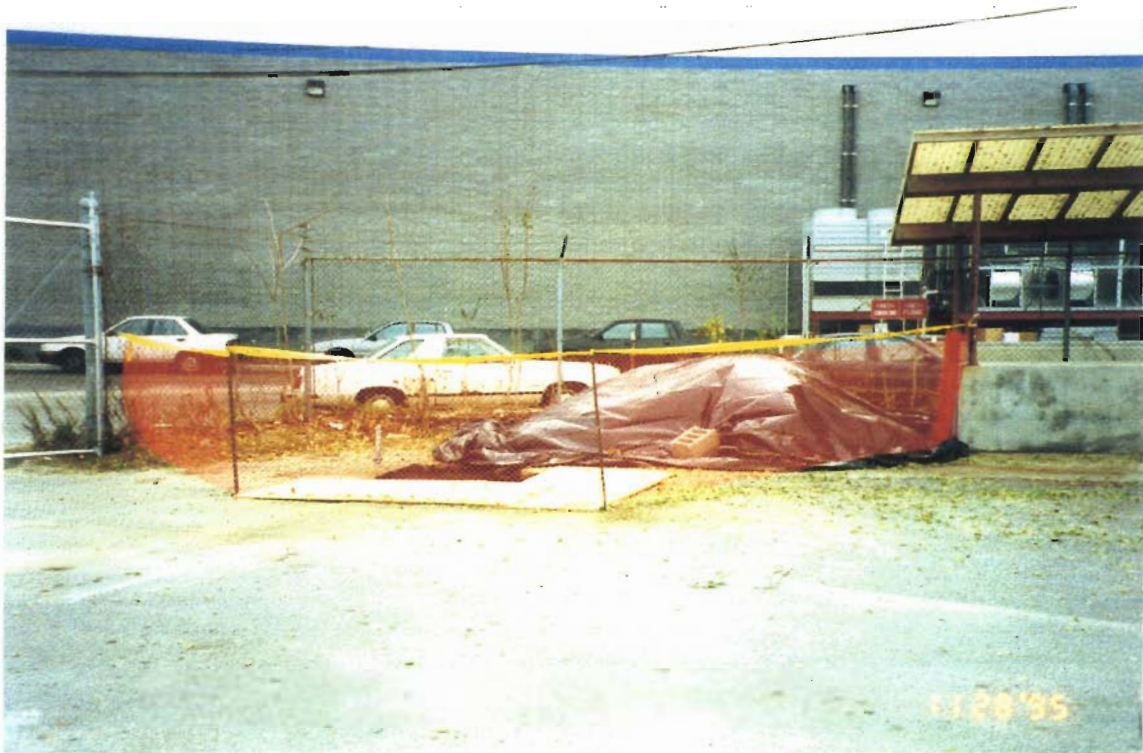
PHOTOGRAPH #12: Excavation Secured with Fencing, Plywood,  
and Yellow Caution Tape.
