**Interim Remedial Measures Report – Part A  
Operable Unit 2  
The Citizens Development Company / Flower Fashion Site  
47 Northern Blvd., Great Neck, New York**

**January 2005**

**CA RICH CONSULTANTS, INC.  
17 Dupont Street  
Plainview, New York 11803**

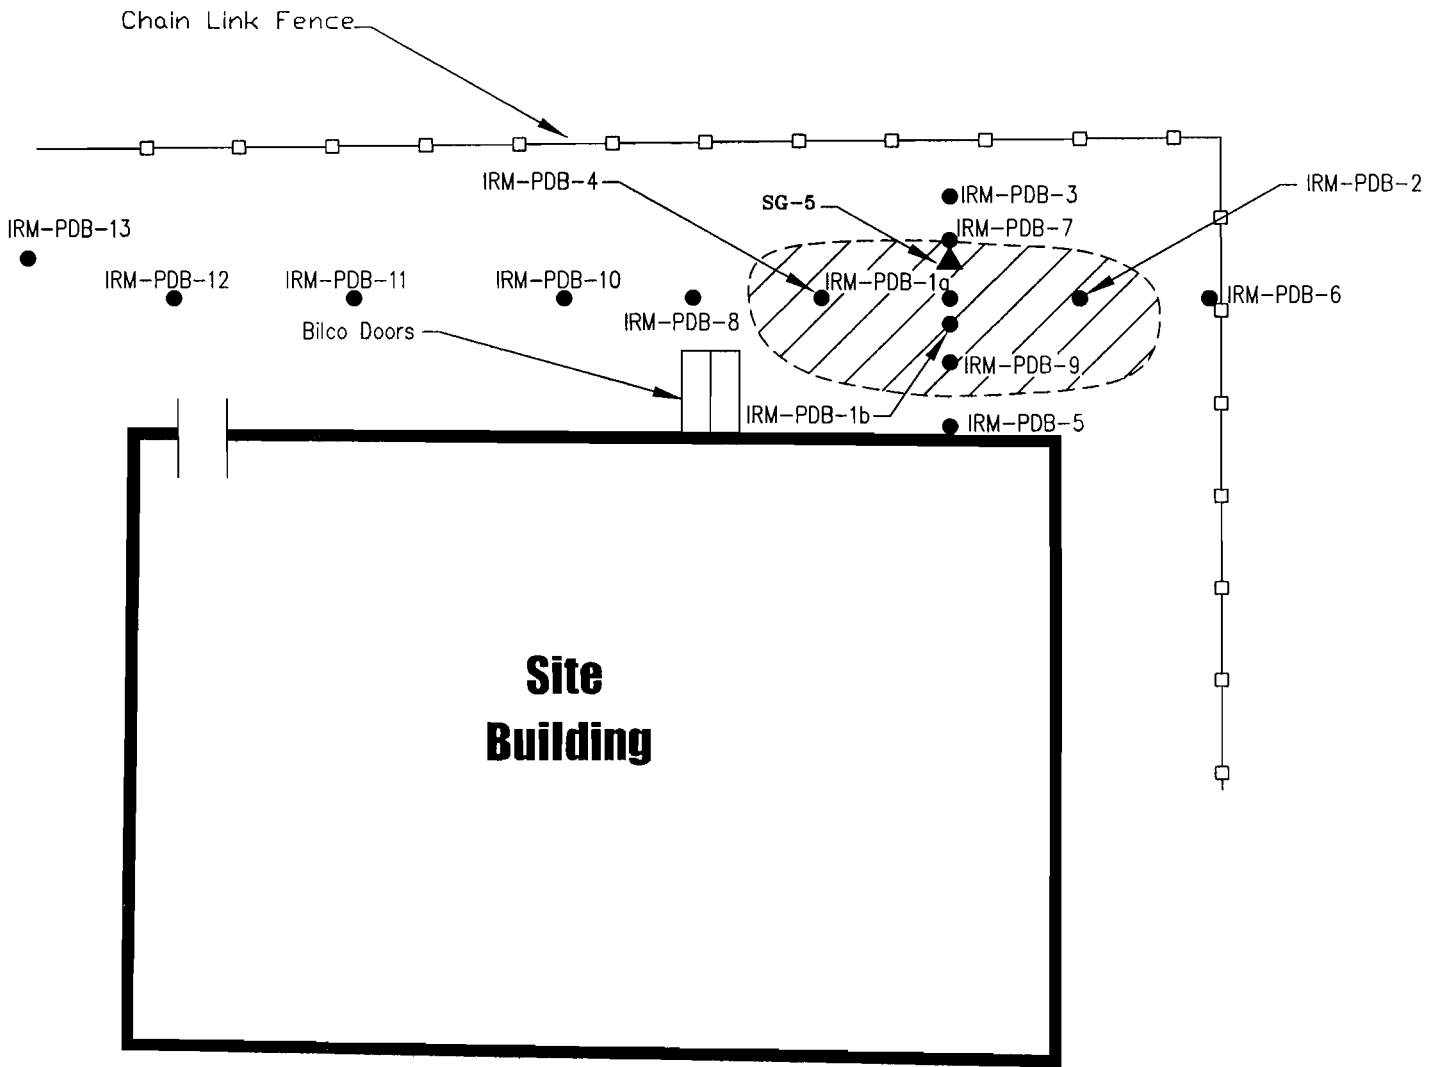
TITLE: <b>IRM BORING LOCATION MAP</b>		DATE: 1/24/05
FIGURE: 1		SCALE: 1" = 15'
DRAWING NO: 1183-1Z	CDC/FLOWER FASHION 47 NORTHERN BLVD. GREAT NECK, NY 11020	DRAWN BY: S.T.M. APPR. BY: E.A.W.

The sample collected from the 0 to 2 foot depth contained a black and odorous layer in the lower portion of the sampler. The upper and relatively clean soil from this sample was sent to Carus for NOD analysis and the lower, discolored and odorous soil was sent to American Analytical for analysis of volatile organic compounds (VOCs). The results of the VOC analysis revealed an extremely elevated reading of 860,000 ug/kg of PCE. A copy of the laboratory results are included as Appendix B. Apparently, the previous consultants that worked on this Site missed a zone of soil in the eastern portion of the rear yard that was grossly contaminated with PCE. A second boring "IRM-PDB-1b" was also installed on that date to confirm the information observed in the initial boring.

On July 29, 2004, CA RICH installed a series of shallow soil borings, designated IRM-PDB-2 through 10, in the rear of the Site to delineate the area containing the discolored and odorous soil. This area, which is illustrated in Figure 1, was used to define the area for a targeted soil excavation and disposal effort discussed below.

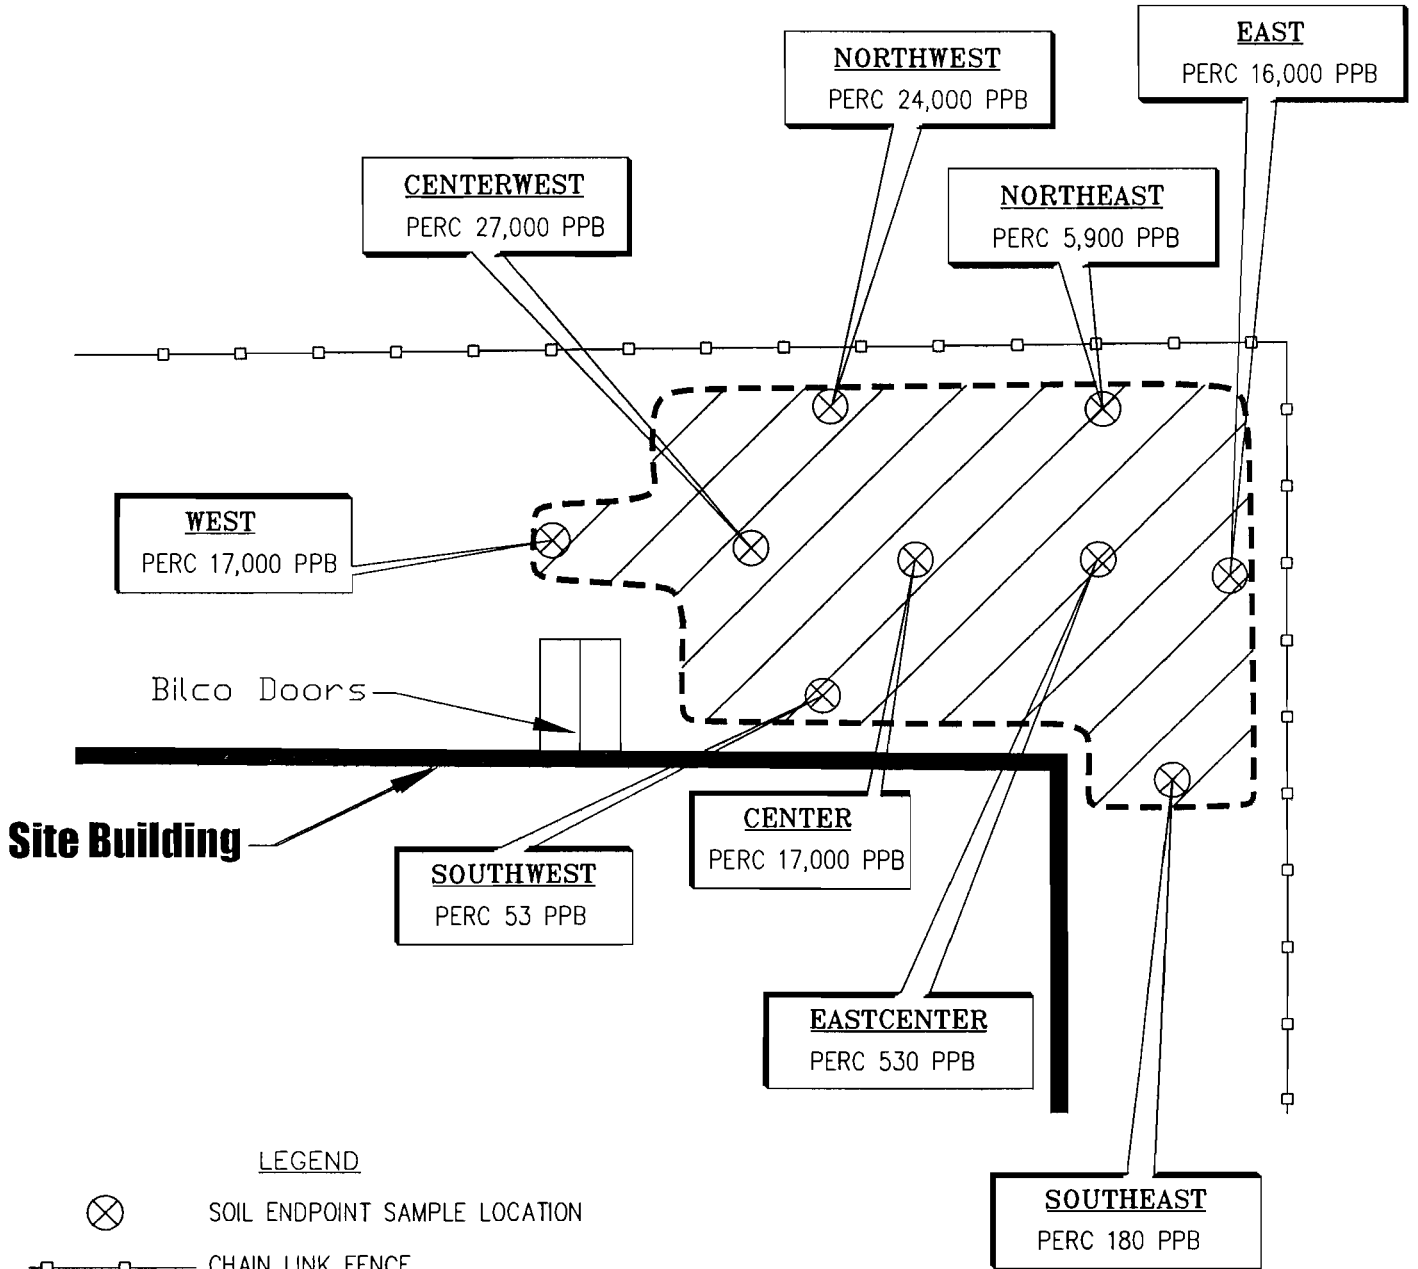
<b>CA RICH CONSULTANTS, INC.</b>	
Certified Groundwater and Environmental Specialists 17 Dupont Street, Plainview, New York 11803	
TITLE:	DATE:
PCE In Soil Endpoint Samples August 26, 2004	1/24/05
FIGURE:	SCALE:
2	As Shown
DRAWING NO:	DRAWN BY:
1183-1AZ.1	S.T.M.
	APPR. BY:
	E.A.W.

A series of nine excavation end-point soil samples were collected from the bottom of the excavation and sidewalls. The sidewall samples were collected as a composite of the soil along the bottom of the excavation wall and below the first asphalt layer discussed above. The samples were analyzed by Accredited Laboratories for total VOCs using EPA Method 8260. These results, which are summarized on Table 1 and Figure 2, ranged in concentration from 53 ug/kg to 27,000 ug/kg. A "DUSR" for this data is included as Appendix D.

On August 17 and 18, 2004, the pavement covering the eastern half of the rear yard was removed. On August 23<sup>rd</sup> approximately 77 tons of PCE contaminated soil was excavated from the rear of the building. The soil was temporarily staged on plastic sheeting in the parking lot behind the Site and then transported as a hazardous waste to Stablex in Quebec, Canada. Copies of the waste disposal manifests are included as Appendix C.

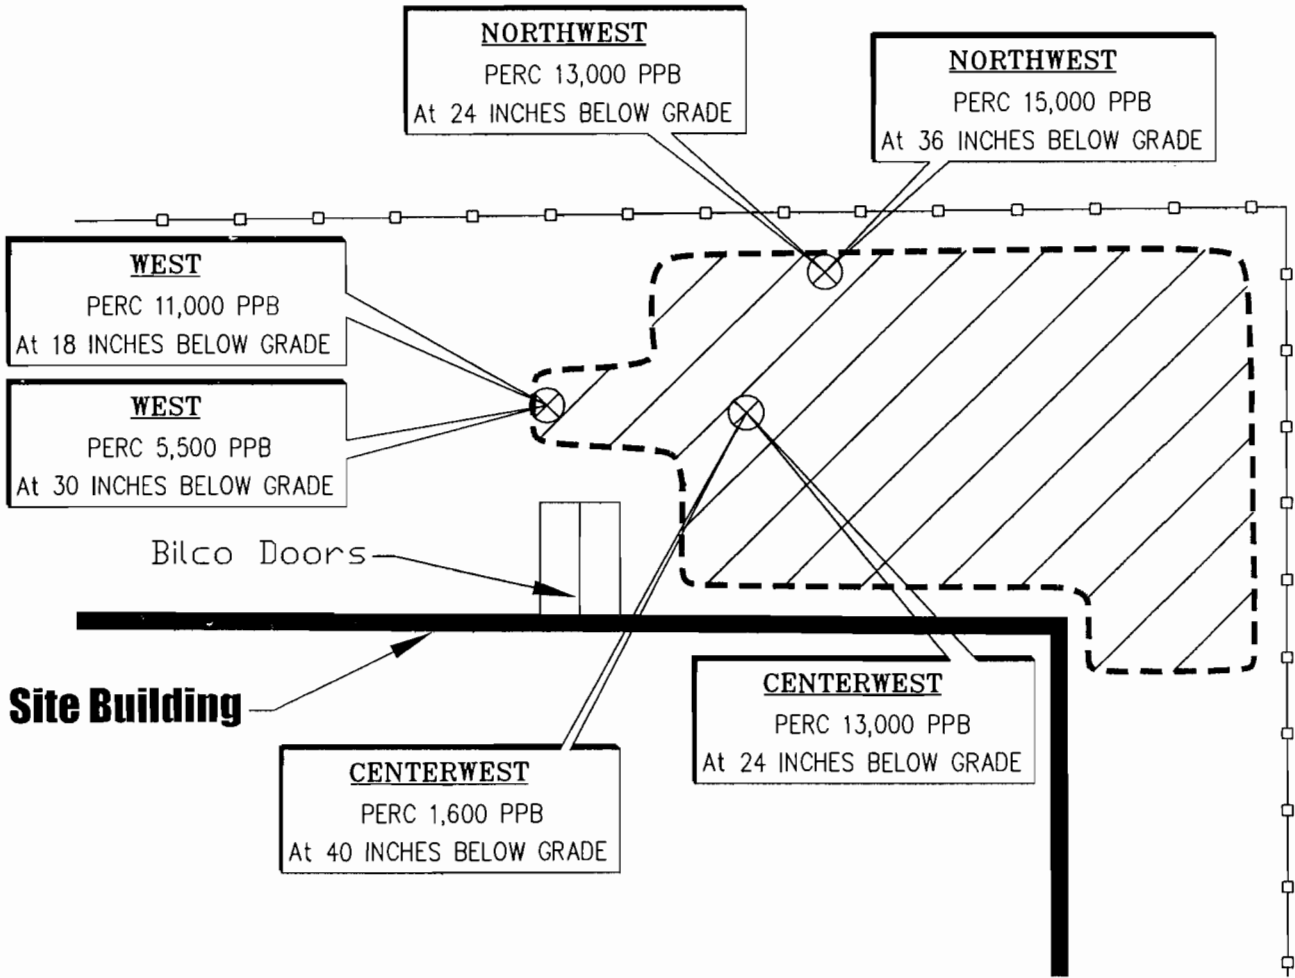
In order to confirm the results from August 26<sup>th</sup> sampling data, the excavation remained opened; and on September 9, 2004 three of the excavation end-point soil sample locations were resampled. The samples were delivered to EcoTest Laboratories and analyzed for the same parameters performed earlier. An additional sample was collected at approximately one foot below each of the three locations. As shown on Table 2 and Figure 3, the samples collected at the bottom and sidewalls of the excavation again contained elevated concentrations of PCE, confirming the earlier data reported by Accredited Laboratories. A "DUSR" for this data is included as Appendix D.

The reported concentrations were, however, lower than those collected August 26<sup>th</sup> indicating that the PCE in the soil is amenable to evaporation and that soil vapor extraction would be an effective alternative for remediation of the shallower soils at the Site. The deeper soil samples contained PCE at concentrations above the NYSDEC-TAGM #4046 Cleanup Objective. Based on these results, in-situ treatment using permanganate injection was selected for the remediation of the deeper soil containing PCE, as well as, the underlying groundwater.

The excavation was the backfilled with clean fill material and covered with new concrete pavement. A layer of orange plastic barrier fence was placed at the bottom of the excavation as a marker. The clean backfill was tested and confirmed to be free of VOCs before placement at the Site. These test results are included as Appendix E.

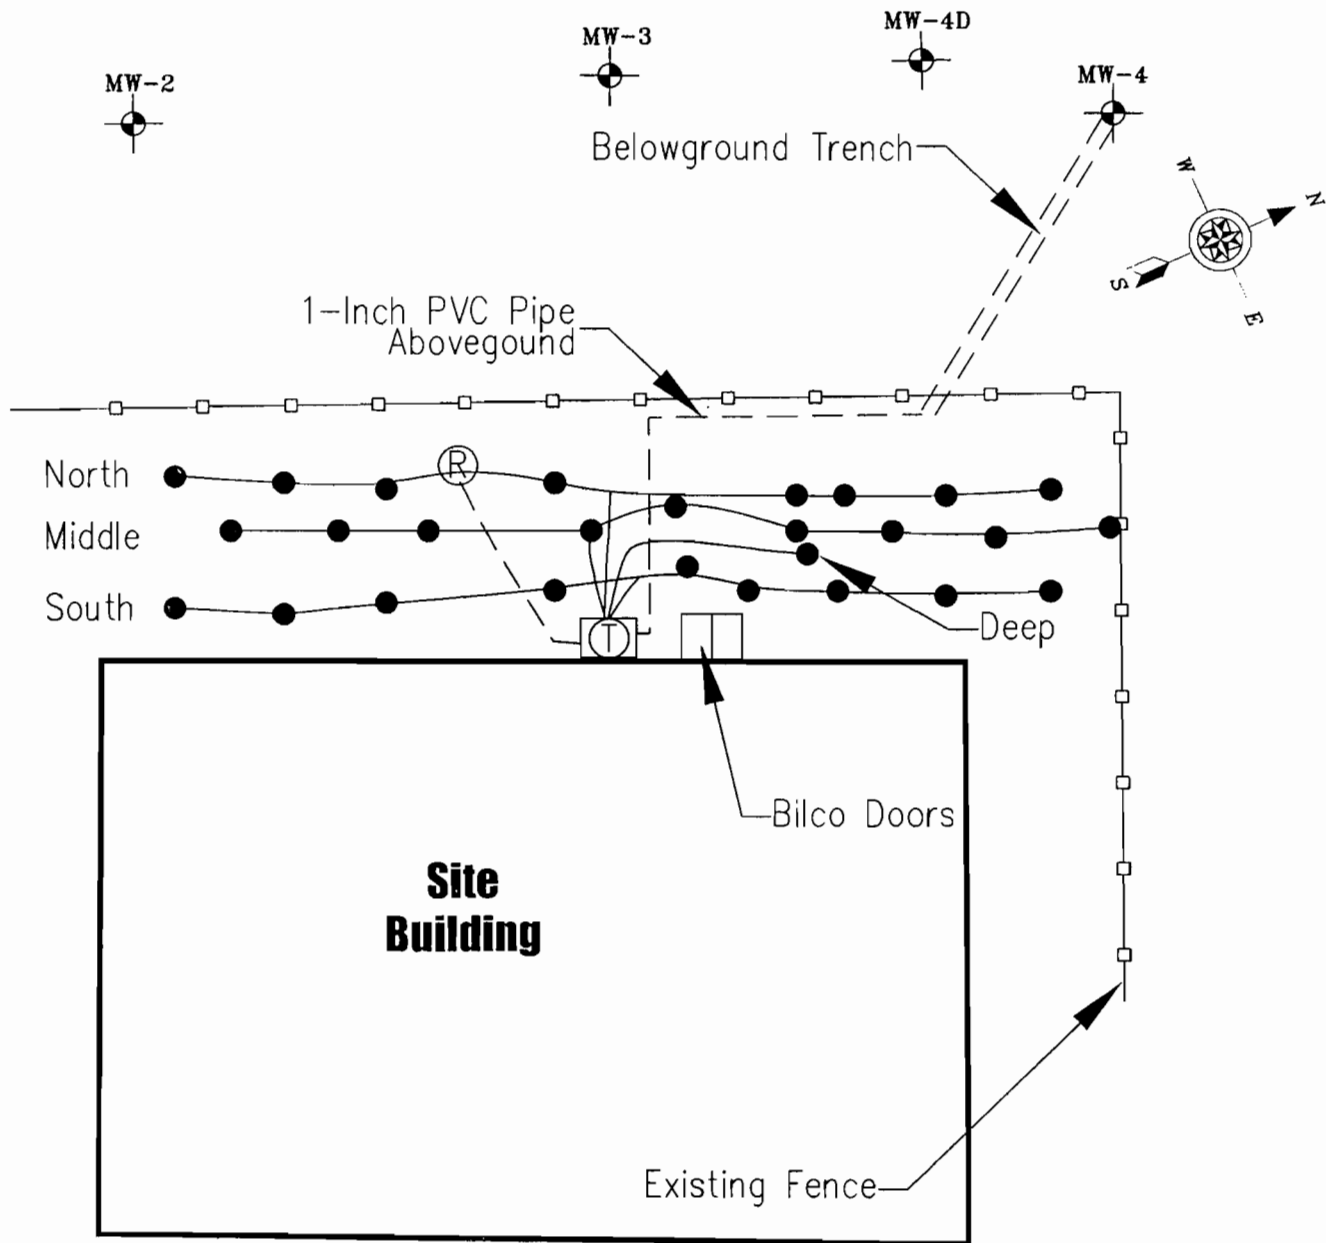
On October 13 and 14, a total of 27 permanganate injection points were installed at the locations shown on Figure 4 using the Geoprobe™ probing system. Each of the injection points consists of a 1-inch diameter, flush-threaded, schedule 40 PVC pipe with 0.030-inch slots (30 slot) screens. The two outer rows of injection points were installed with the slotted section set from two to five feet below grade. The middle row of injection points was installed with the slotted section set from 7 to 12 feet below grade. One deep injection point, screened from 35 to 45 feet, was also installed. An existing on-site remediation well was also used in the permanganate injection system.

Monitoring well MW-4 was equipped with a 2-3/4 inch diameter submersible pump capable of achieving a pumping rate of approximately 15 gallons per minute (gpm). During the injection program, a pumping rate of only 4 gpm could be maintained without dewatering the well. A utility trench for electric power and a discharge line was installed from the well head of MW-4 to the rear yard of the Site where a permanganate mixing tank was located. The discharge line from the submersible pump was connected to the top of a mixing tank. The 27 injection points were connected to header lines in four groups of points as shown in Figure 4. Each of the header lines were connected to a discharge port at the bottom of the tank such that the water pumped from well MW-4 was used to fill the tank, prepare a permanganate solution and then discharge the solution to the groups of points.

Bulk sodium permanganate was purchased in 55-gallon drums and at a concentration of 40% from the Carus Chemical Company. Using the mixing tank, 50-gallon doses of 5% sodium permanganate were prepared by mixing 5 gallons of 40% sodium permanganate with 45 gallons of well water from MW-4. The solution was applied from the mixing tank to the groups of injection points and allowed to saturate the subsurface soils. This process was performed from October 21 to November 5, 2004. All 27 points were treated as described below.

After the permanganate solution was applied to the injection points, valves on the mixing tank were adjusted to allow the water pumped from well MW-4 to flow directly to the header lines of the injection points. Once the permanganate solution percolated downward and reached the water table, it flowed with the underlying groundwater toward well MW-4. Well MW-4 was used to pump the underlying groundwater, capture the injected solution and discharge it to the mixing tank for re-circulation through the injection points.

The discharge from well MW-4 was checked for residual permanganate on a daily basis using a colorimeter. The goal of the injection program was to sustain a pinkish coloration in the discharge of well MW-4. Neither a pink coloration, nor a colorimeter reading, was observed in the well water from MW-4 during the injection program.

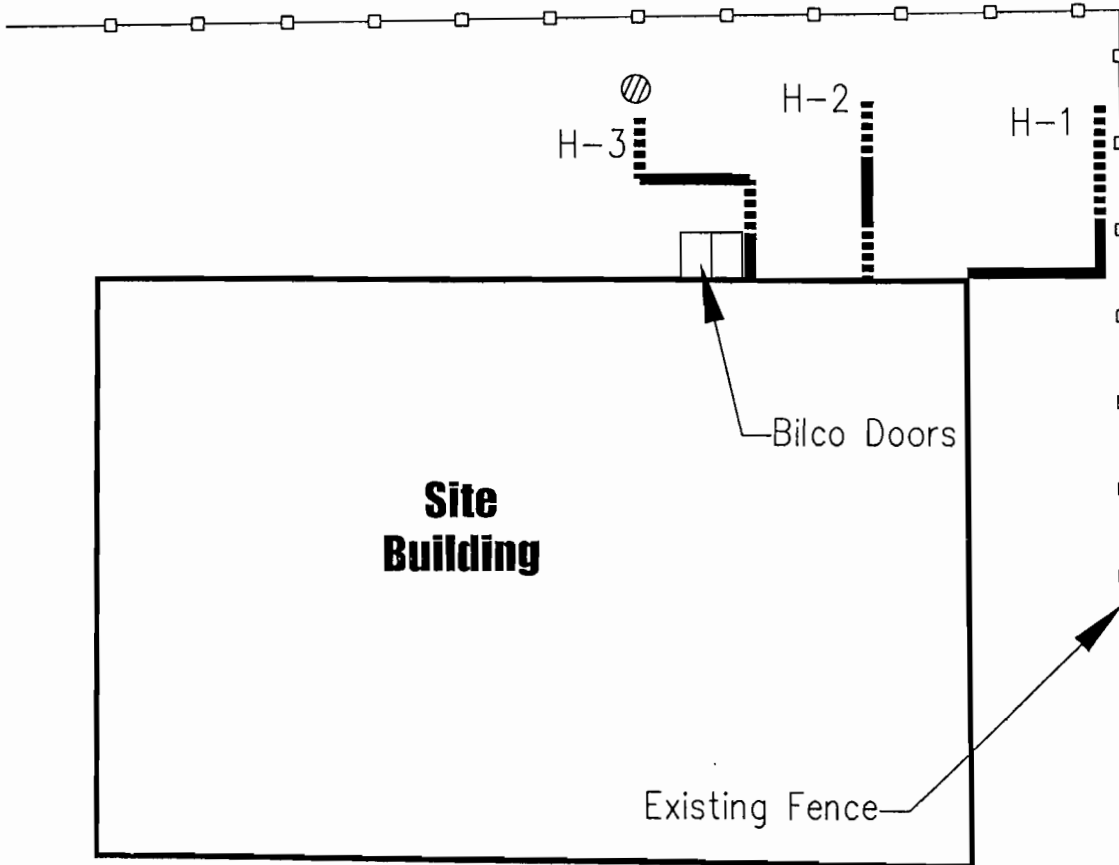
SUBSURFACE PIPING LAYOUT FOR  
SOIL VAPOR EXTRACTION SYSTEM

During the backfilling of the August 2004 excavation, three horizontally-oriented SVE lines were installed. The lines were constructed of 2-inch diameter schedule 40 PVC pipe and 0.020-inch slotted (20 slot) SVE screens. These lines were buried approximately one foot below grade and are illustrated in Figure 5. A more detailed discussion of the SVE system pilot test, installation and operation will be presented in the IRM Report "Part B" expected to be submitted in early Spring 2005.
