**Annual Groundwater, Soil Vapor and Indoor Air Monitoring Report for
December 2011**

**Citizen Development Company / Flower Fashion Site
47 Northern Boulevard
Great Neck, New York**

NYSDEC Site # 1-30-070

January 2012

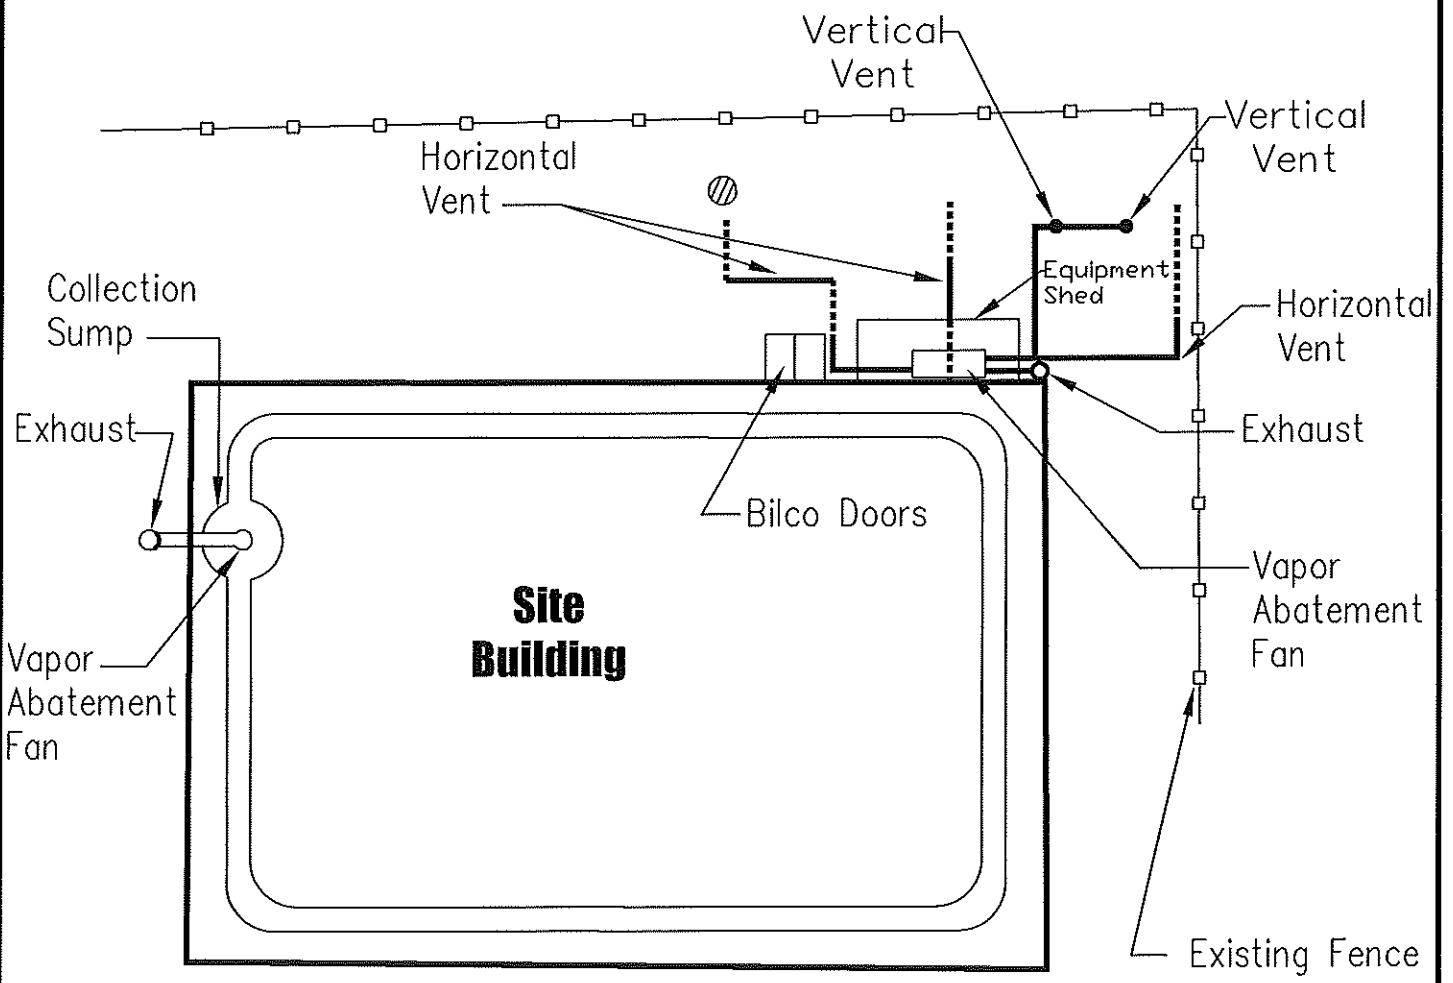
Operation of the SVE System in the Rear of the Property – The SVE system has remained in operation from January 2005 to the July 2011. A final post remediation soil boring was performed in December 2010 and the results included in the Annual Monitoring Report for that year.. Based on those results, the NYSDEC concurred that the SVE system could be turned off and converted to an SSD system by replacing the blower with an energy efficient vapor abatement fan (Ref. 17). This conversion was performed in July 2011. The layout of the SSD systems are illustrated on Figure 2.

Currently, there is a Sub-Slab Depressurization (SSD) system operating in the basement of the existing building. The system consists of a perforated pipe buried beneath the basement floor that is connected to a Fantech® low pressure SSD blower that exhausts extracted soil vapor at a rate of approximately 150 cfm. A second SSD system is connected to the horizontal and shallow vertical vents that were installed for the SVE system. Indoor air quality tests currently indicate that this system is effectively controlling sub-slab PCE vapors.
