Re: Preliminary Site Characterization –  
Gem Cleaners  
84 North Village Avenue  
Rockville Centre, New York  
Site No. 1-30-082

This letter report serves to summarize the Preliminary Site Characterization (PSC) activities conducted at the Gem Cleaners site located at 84 North Village Avenue, Rockville Centre, New York. Refer to Figure 1 for the site location.

**SITE ASSESSMENT & REMEDIATION REPORT  
FOR THE PROPERTY LOCATED AT  
84 NORTH VILLAGE AVENUE  
ROCKVILLE CENTRE, NEW YORK**

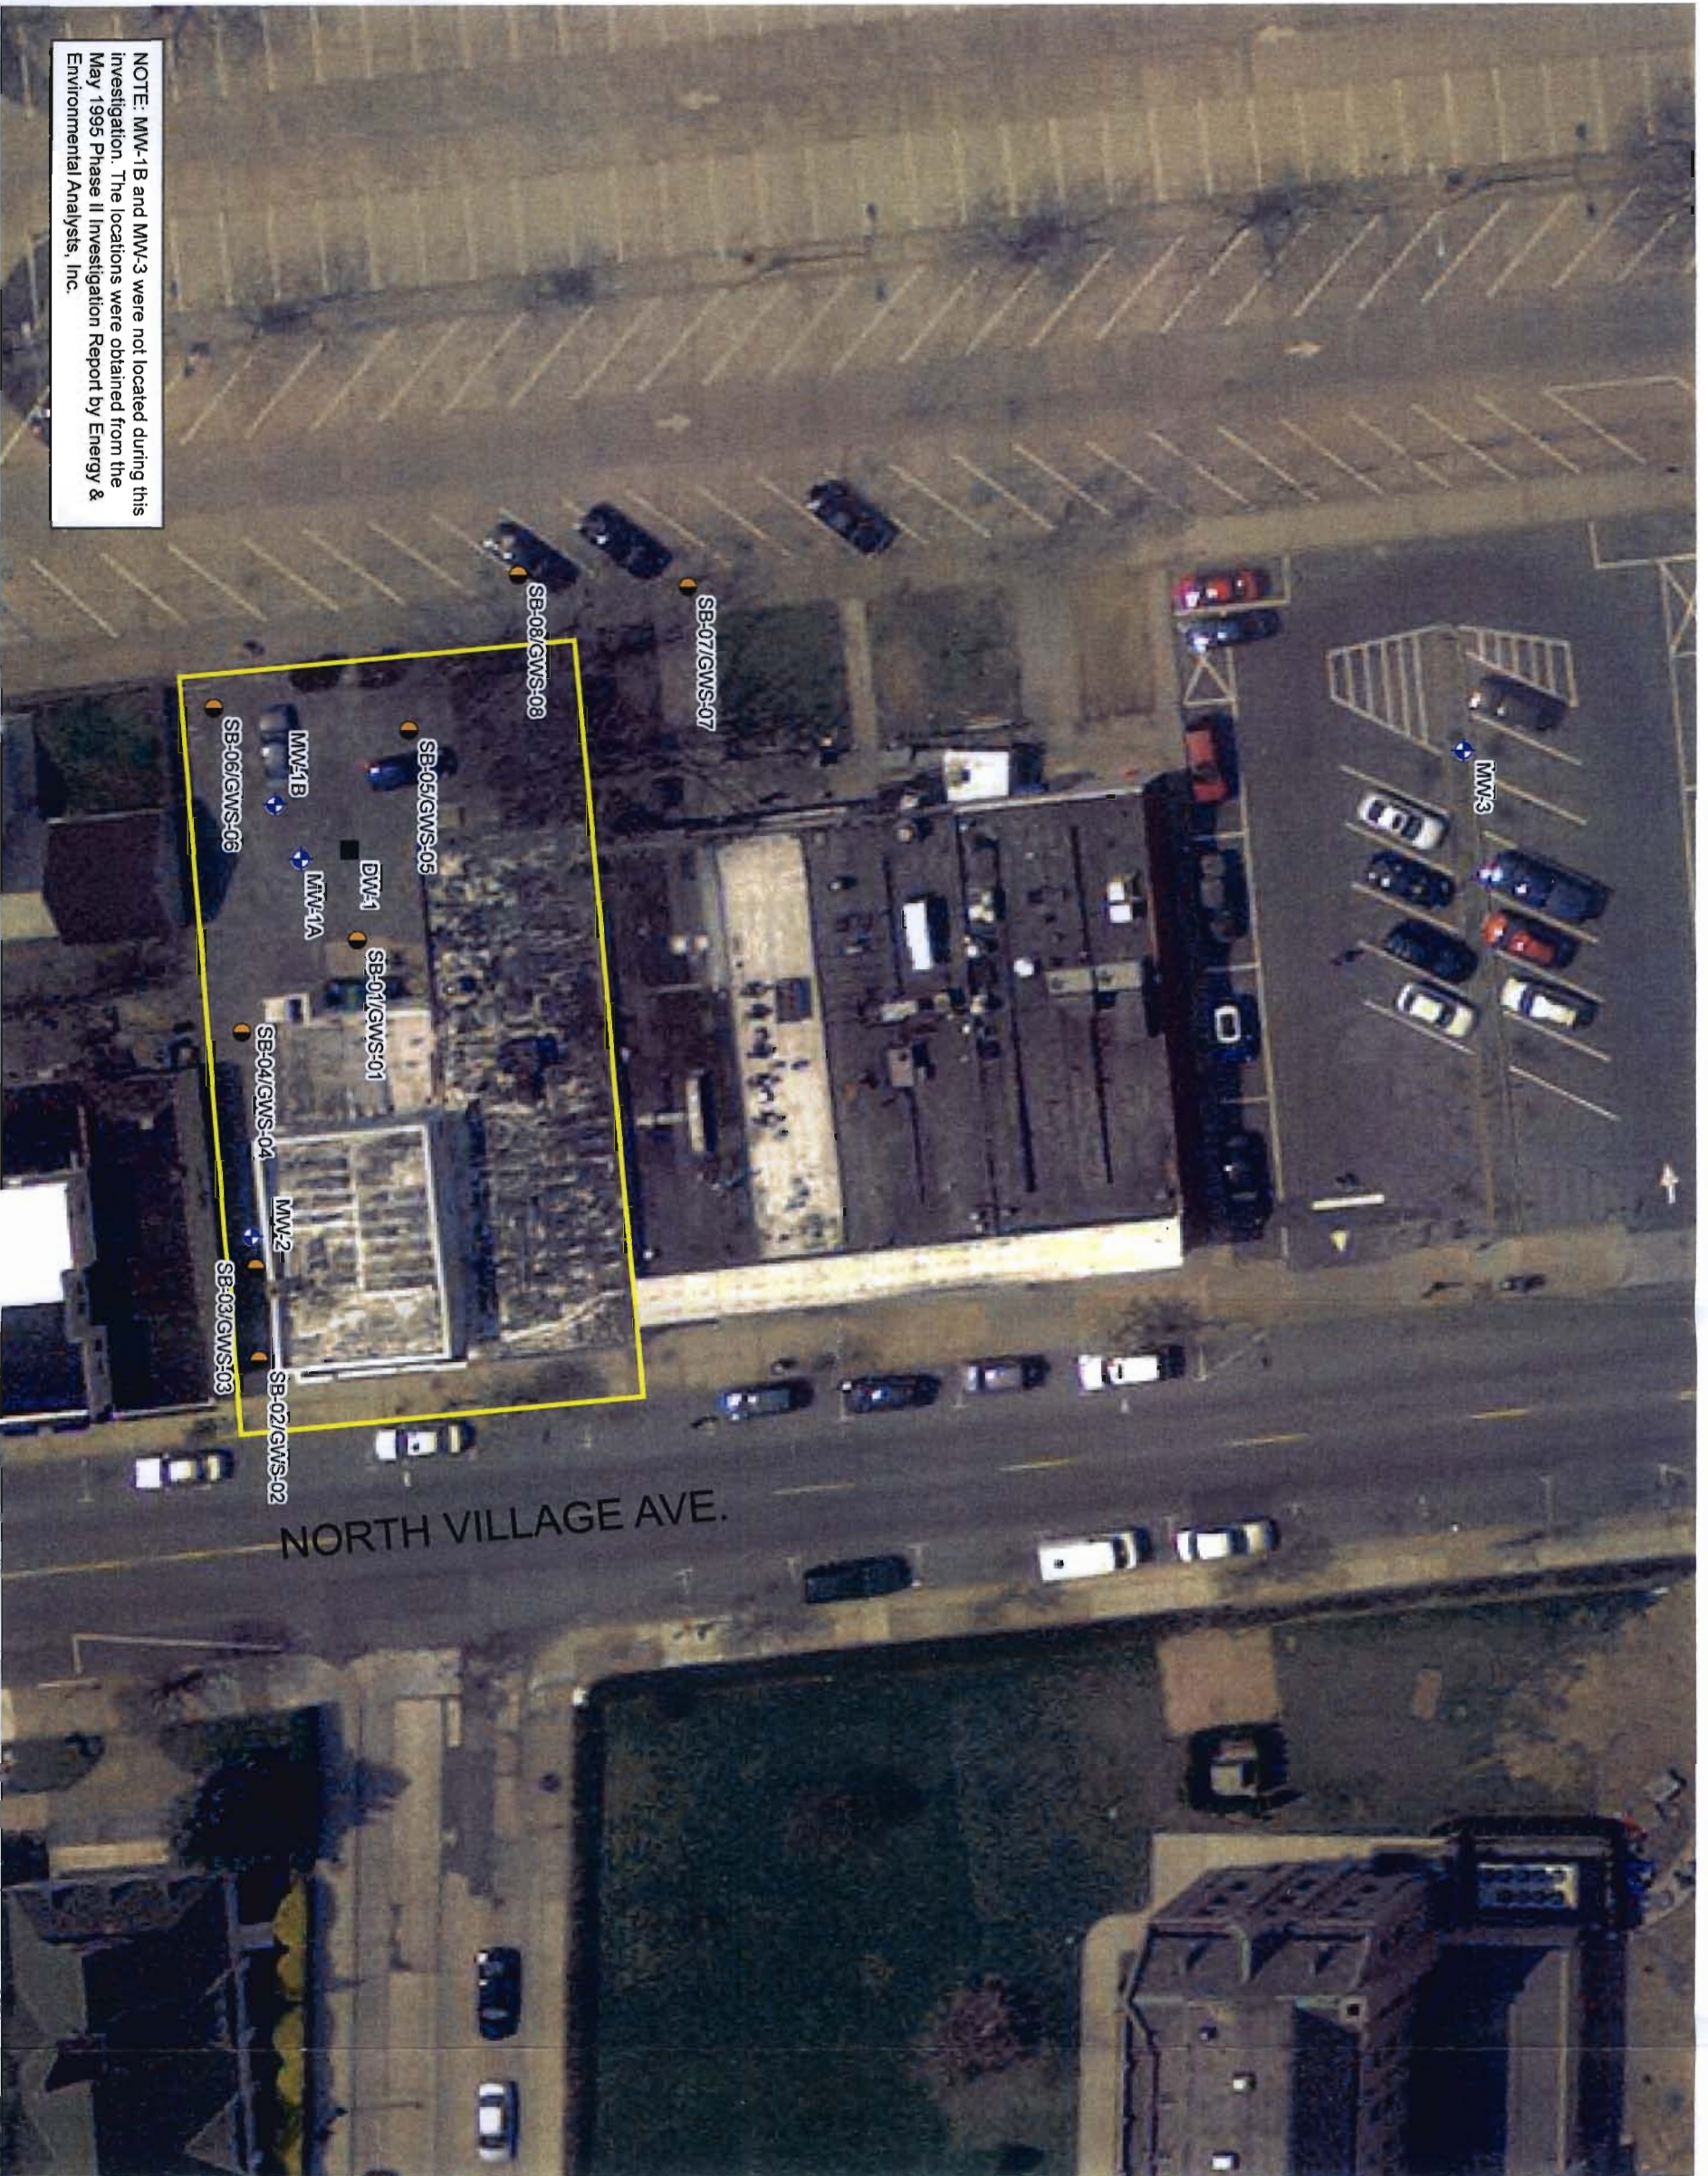
The site has one dry well (DW-1) and two existing monitoring wells (MW-1A and MW-2), located in the paved lot and driveway south of the building. Two additional monitoring wells, MW-1B (located in the proximity of MW-1A and DW-1) and MW-3 (located approximately 300 ft north of the site) were shown on site plans from previous site assessment reports provided by NYSDEC. MW-1B and MW-3 could not be located during the PSC activities, but are presented in Figures 2 and 3.

NOTE: MW-1B and MW-3 were not located during this investigation. The locations were obtained from the May 1995 Phase II Investigation Report by Energy & Environmental Analysts, Inc.

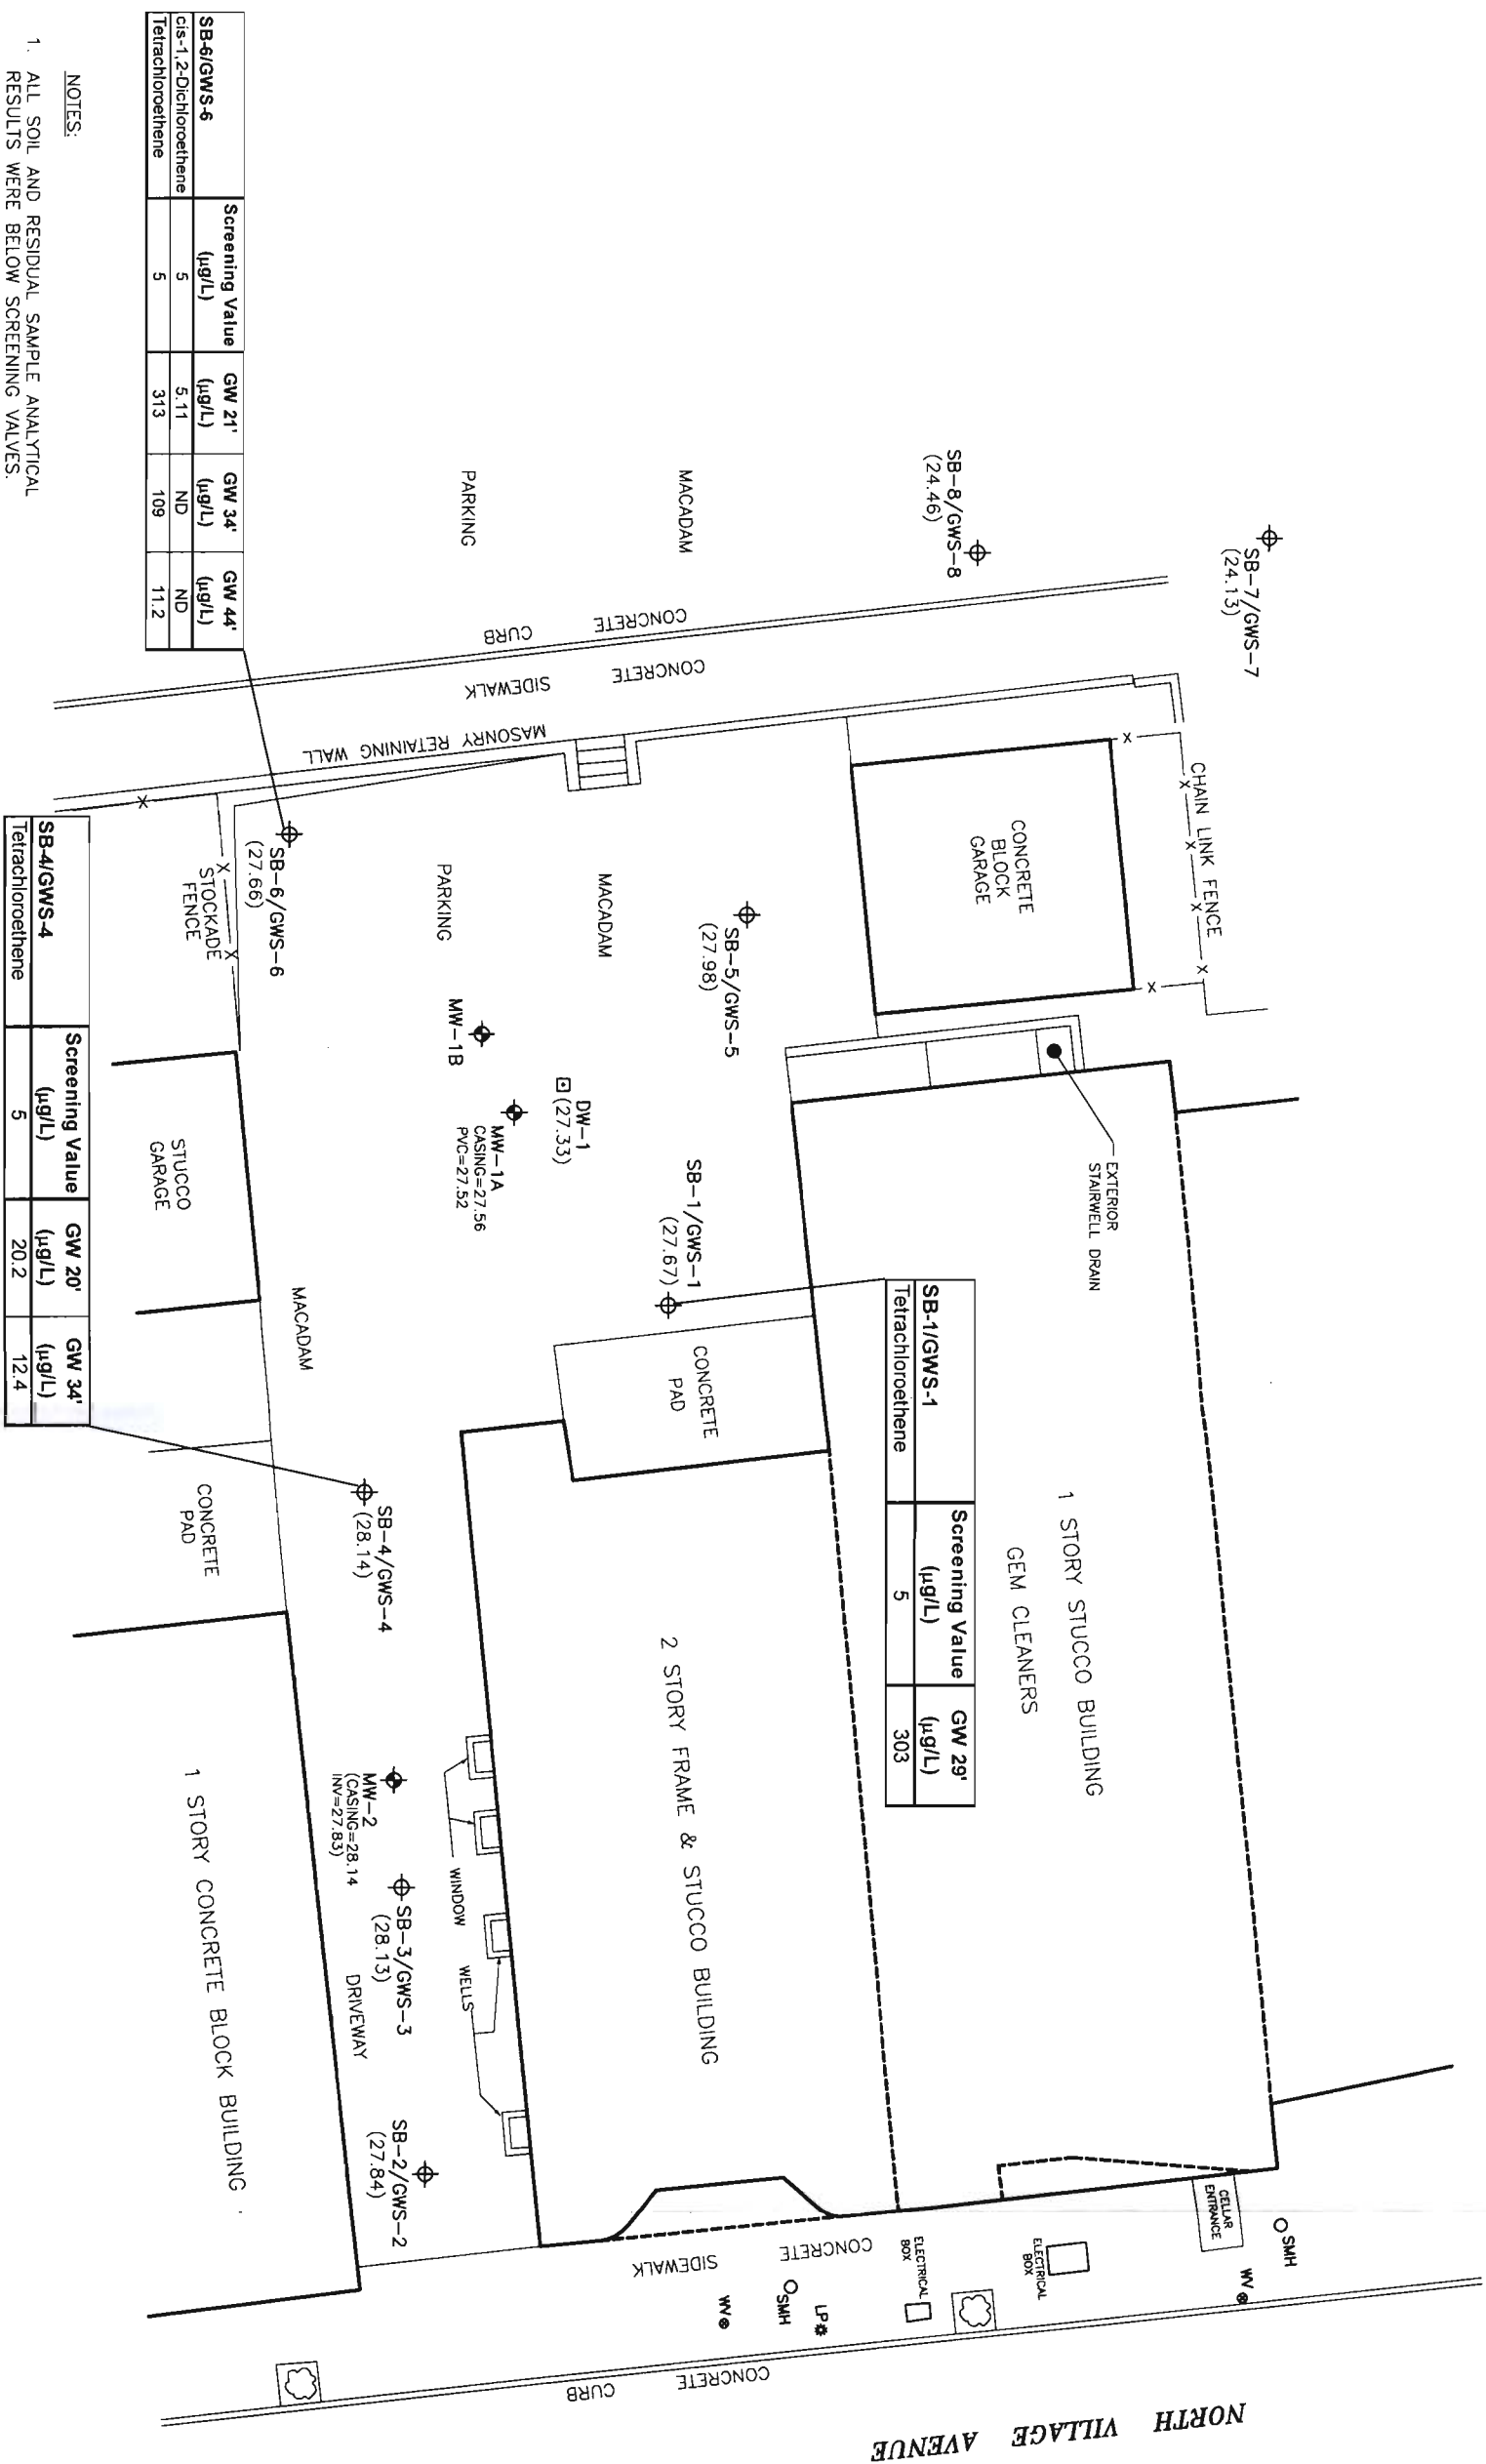
FIGURE 3

- NOTES:**
1. ALL SOIL AND RESIDUAL SAMPLE ANALYTICAL RESULTS WERE BELOW SCREENING VALUES.
  2. DATE OF FIELD SURVEY: MARCH 3, 2006, BY YEC, INC., VALLEY COTTAGE, NEW YORK
  3. HORIZONTAL DATUM: NAD 83 FROM GPS OBSERVATIONS
  4. VERTICAL DATUM: NGVD 1929 FROM GPS OBSERVATIONS (TO CONVERT TO NAVD 1988 SUBTRACT 0.60)
  5. MW-1B WAS NOT LOCATED DURING THIS INVESTIGATION. THE LOCATION WAS OBTAINED FROM THE MAY 1995 PHASE II INVESTIGATION REPORT BY ENERGY & ENVIRONMENTAL ANALYSTS, INC.
- ND = NOT DETECTED IN SAMPLE  
FD = FIELD DUPLICATE

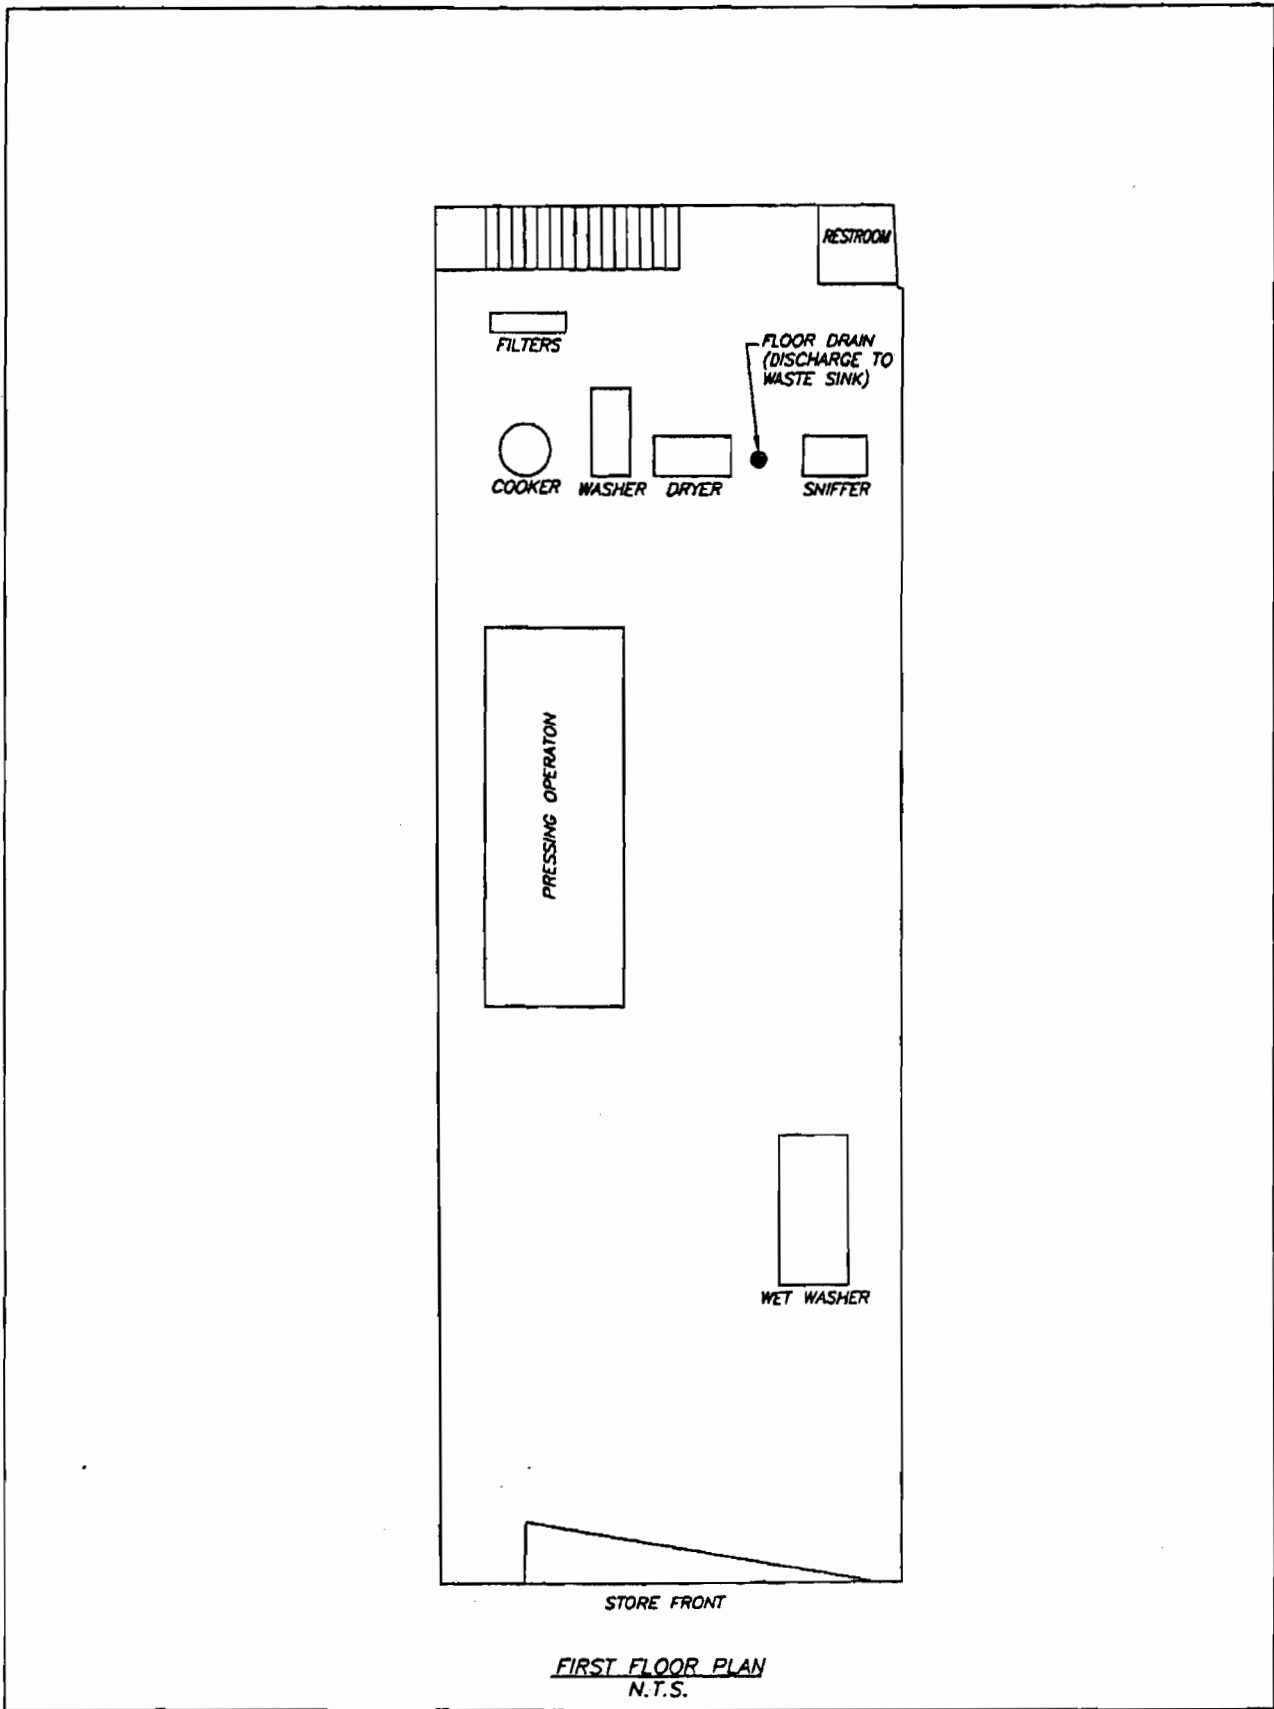
FIRST FLOOR PLAN  
N.T.S.

The initial site inspection was conducted on January 22, 1997 and focused on the current operations of the facility and the generation of liquid waste. During the site inspection, it was noted that early generation (transfer machine) equipment is still being utilized and the facility consumes approximately 200 gallons of PCE per year. Early generation machines do not employ many of the waste reduction and recovery technologies that are inherent in the later generation equipment, such as refrigerator condensers. Therefore, these operations tend to use more PCE throughout the year and generate greater volumes of liquid waste. Equipment used during the process includes the following; a Washex washing machine, Solve Miser dryer, Sniff-O-Miser sniffer, Filter King filters, Per Corporation cooker, and Remi-Dri vacuum system. With the exception of the vacuum system, the dry cleaning equipment is utilized on the first floor of the subject building. Figure 2 shows a general layout of the first floor.

As part of the process, PCE is stored at the base of the washer. Prior to washing, the PCE is pumped through the filters, which are designed to remove fatty acids, water and migrant dyes from the PCE. To further remove impurities from the PCE, the PCE is routed to the cooker every other day. The employee at the site indicated that both the muck generated by the cooking process and the spent filters are placed in 30 gallon drums and disposed of by Saftey Kleen. Saftey Kleen drums were observed at the site.

Once the washing operation is complete and the PCE drained, the clothes are transferred to the dryer. The sniffer is connected to both the washer and dryer and is designed to capture vapors from these

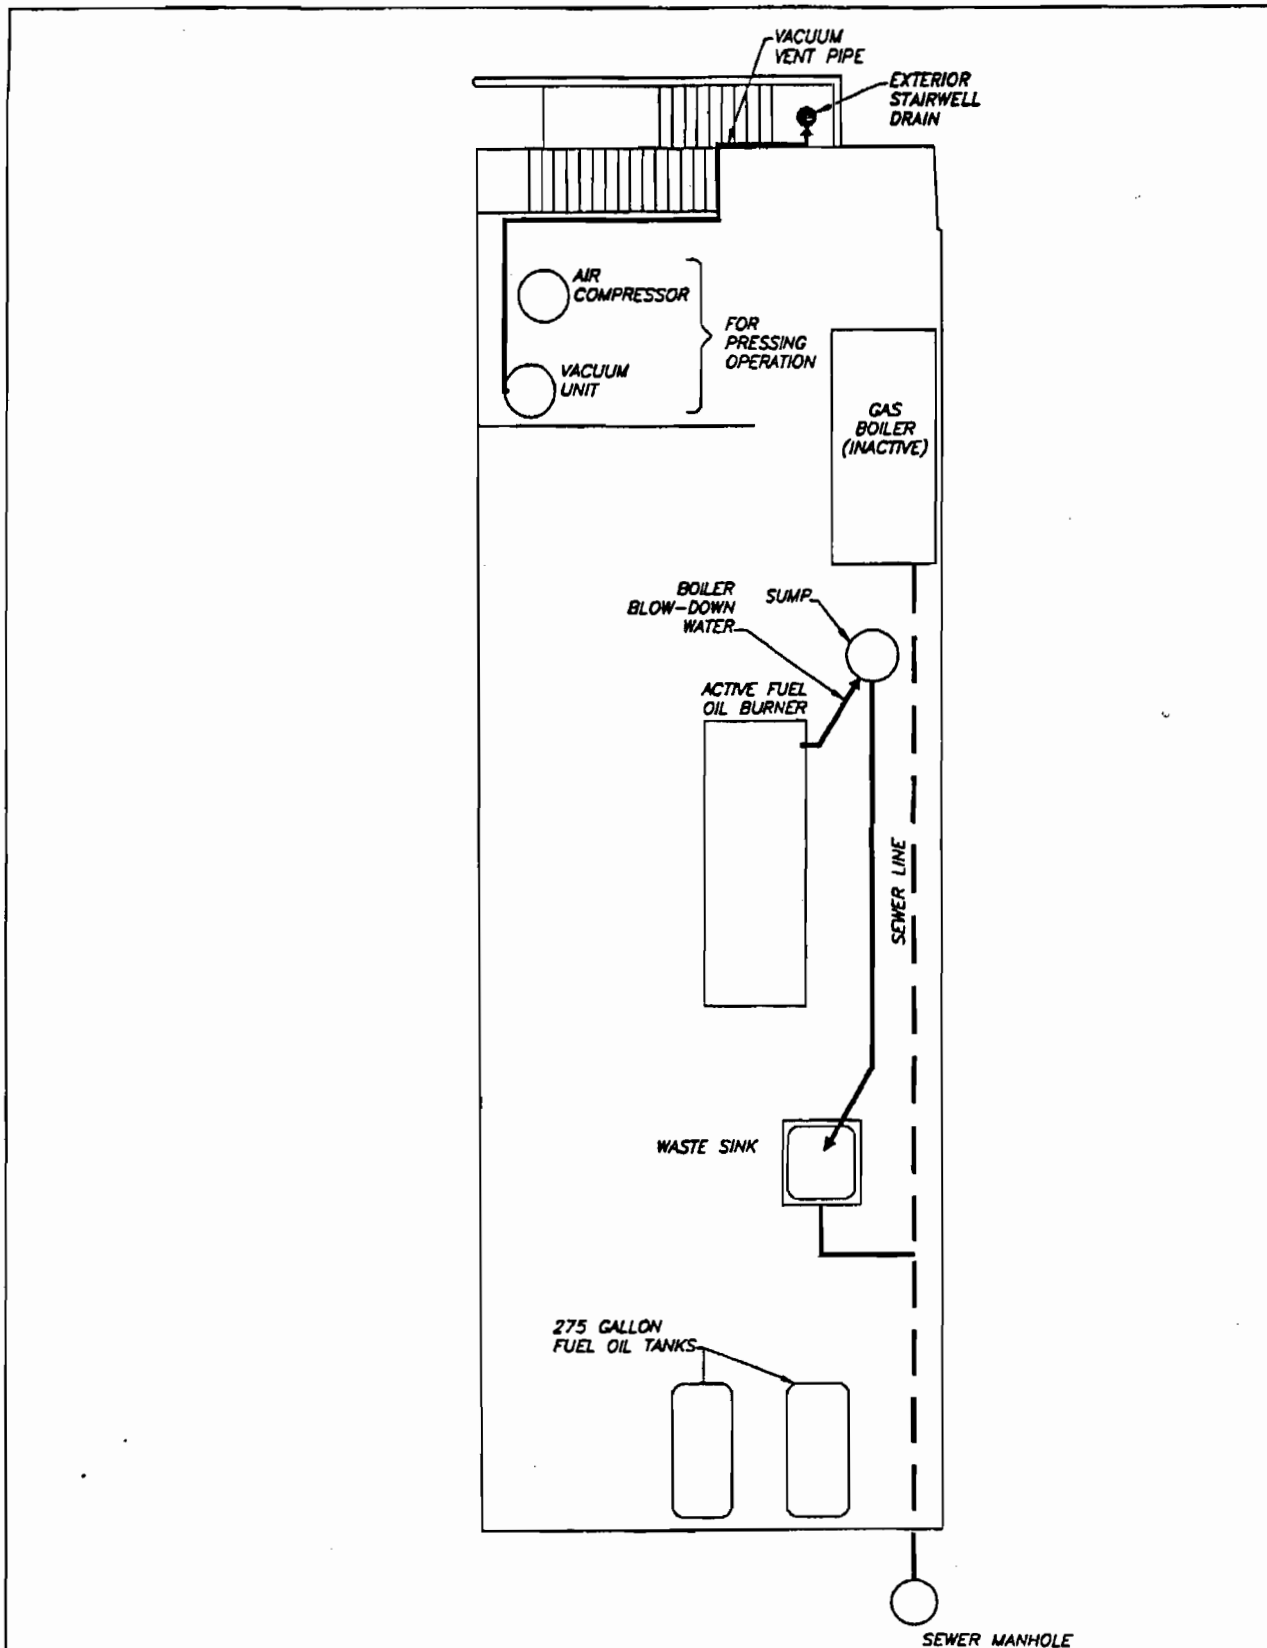
BASEMENT FLOOR PLAN  
N.T.S.

Figure 3 shows the general layout of the basement. As described in EEA's Phase I report, a sump pit is located off the northwest corner of the active fuel oil fired boiler. The sump pit consists of a pre-fabricated metal receptacle fitted into the basement floor which is currently receiving boiler condensate. No piping was noted in the sump pit and probing with a steel bar revealed it contained a solid bottom. The sump did contain a float activated sump pump, which turns on the pump when liquids reach a designated level. The sump pump discharged, via flex hose, to the waste sink also located in the basement. Numerous other pipes were also routed to the waste sink. One appeared to be from the floor drain located on the first floor, while another appeared to be an abandoned washing machine used for typical wet cleaning also located on the first floor.

The vacuum unit and associated equipment are located in the southwest corner of the basement. The system is designed to pull vapor and residual water from the press and spotting board operations located on the first floor. This vapor and water contains PCE released from the clothes. Water collected during the process is drained through the bottom of the unit when the system is shut down, while the vapor is typically released through a vent routed to the outside of the building. The vacuum vent at Gem Cleaners, constructed of PVC, was routed along the basement's west wall and horizontally out through a hole cut in the wooden basement door. Since the vent pipe was not routed vertically up, small quantities of water drawn into the system are released. The majority of liquid appeared to drain on the inside of the basement door, where a six inch concrete curb exists preventing water from entering or leaving the basement. Some liquid did appear to drain on the outside of the

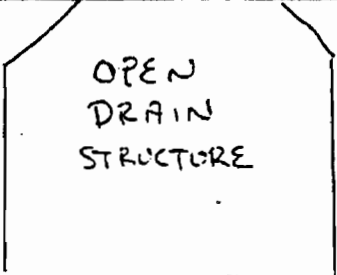
<p>OPEN DRAIN STRUCTURE</p>
10	0	S-1	6-8	DRY	<p>FINE TAN/YW SAND + gravel</p> <p style="text-align: center;">↓</p> <p>EOB @ 20ft</p>
	0	S-2	8-10	DRY	
	0	S-3	10-12	DRY	
15	0	S-4	12-13	DRY	
	0	S-5	13-15	MOIST	
20	0	S-6	18-20	WET	19 D WT
