# Long-Term Monitoring Plan

Dzus Fastener Site (OU 1 & OU 2)

NYSDEC Site No. 1-52-033

Work Assignment No. D003821-2.1

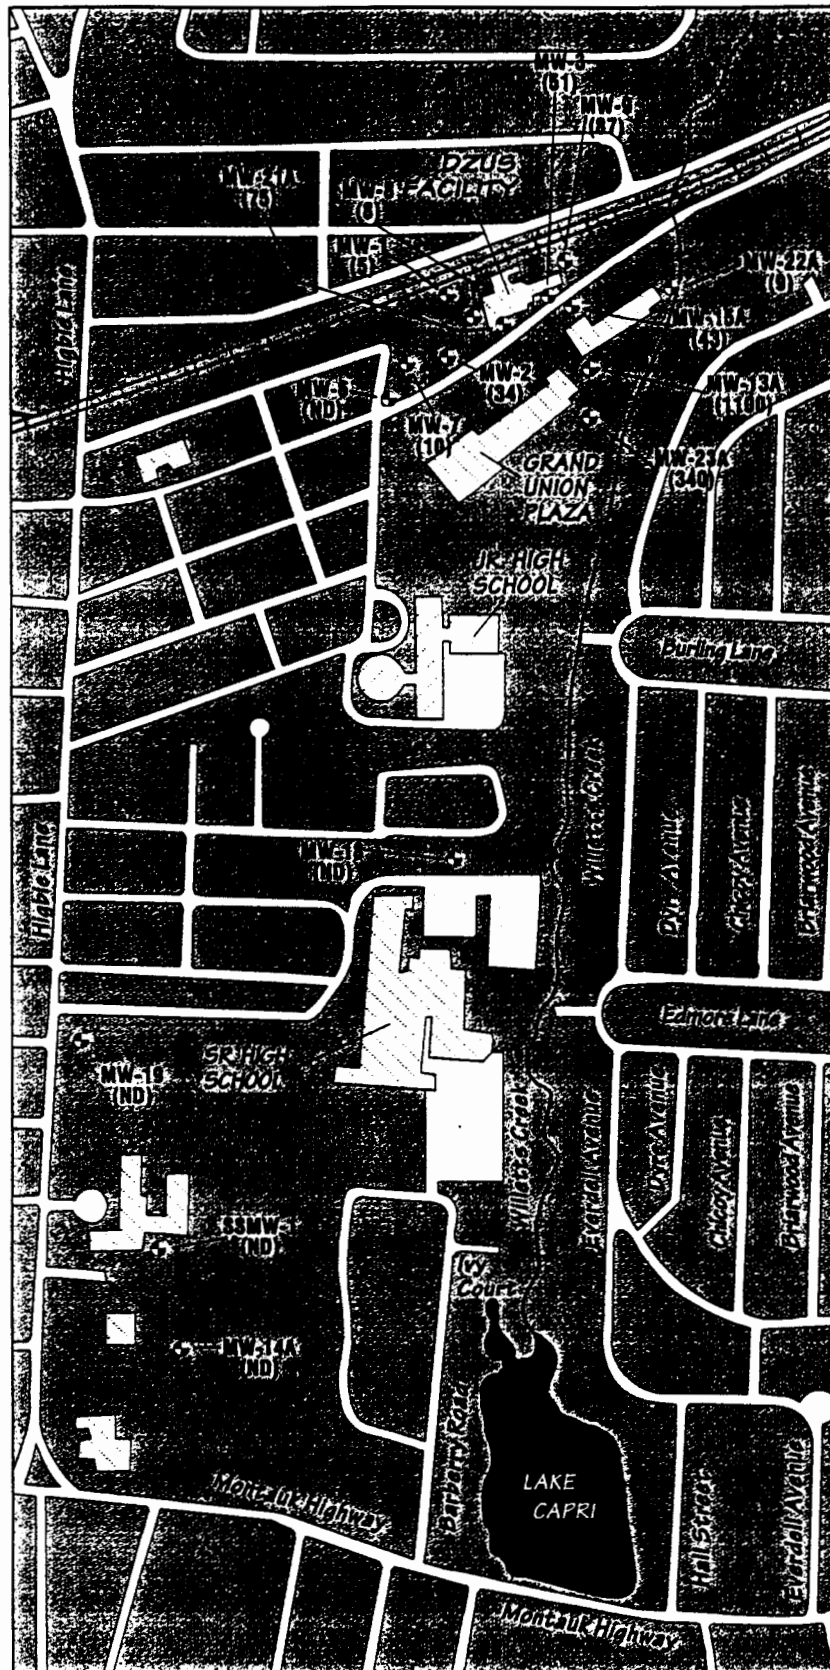
**Cadmium  
Concentrations, ug/l, (ppm)  
JUNE 8 & 9, 1998**

**(ND-Not Detected)**
