PHASE 1 INVESTIGATION

Bull Path Landfill

Site No. 152059

Town of East Hampton, Suffolk County

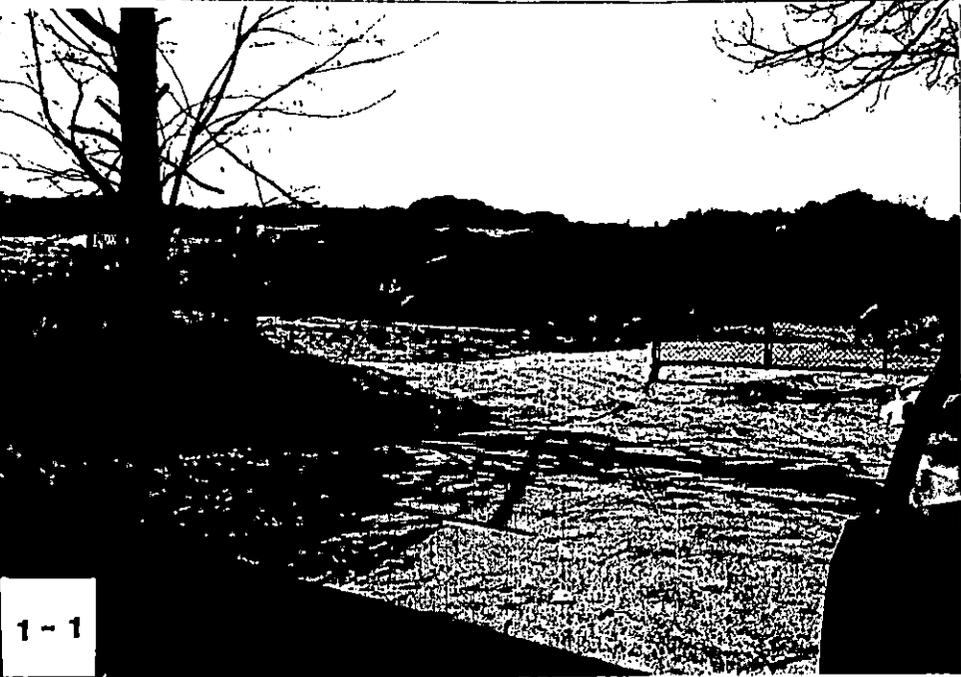
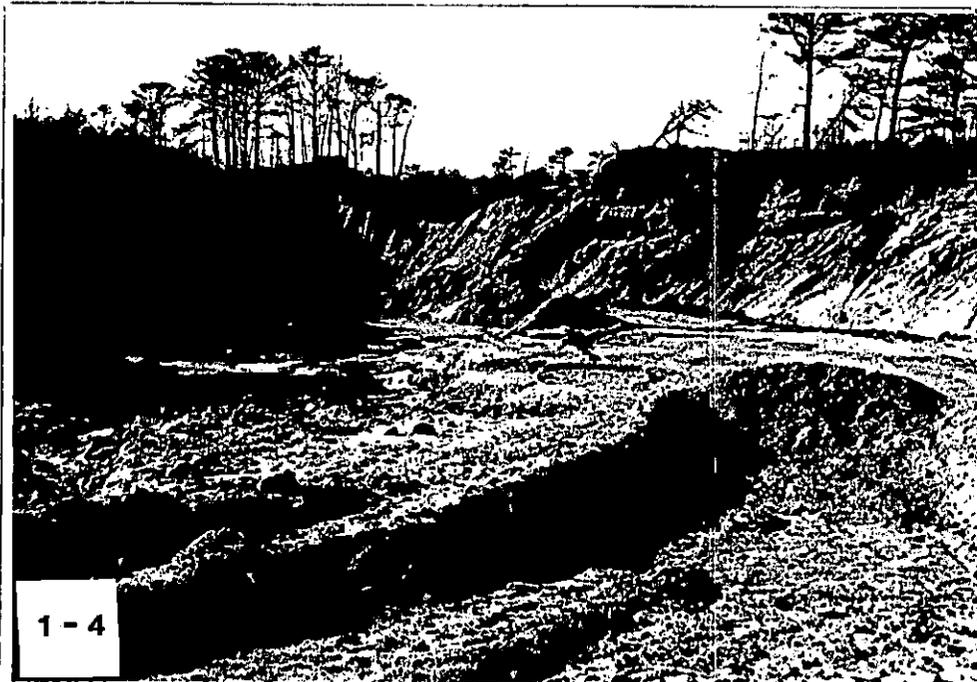
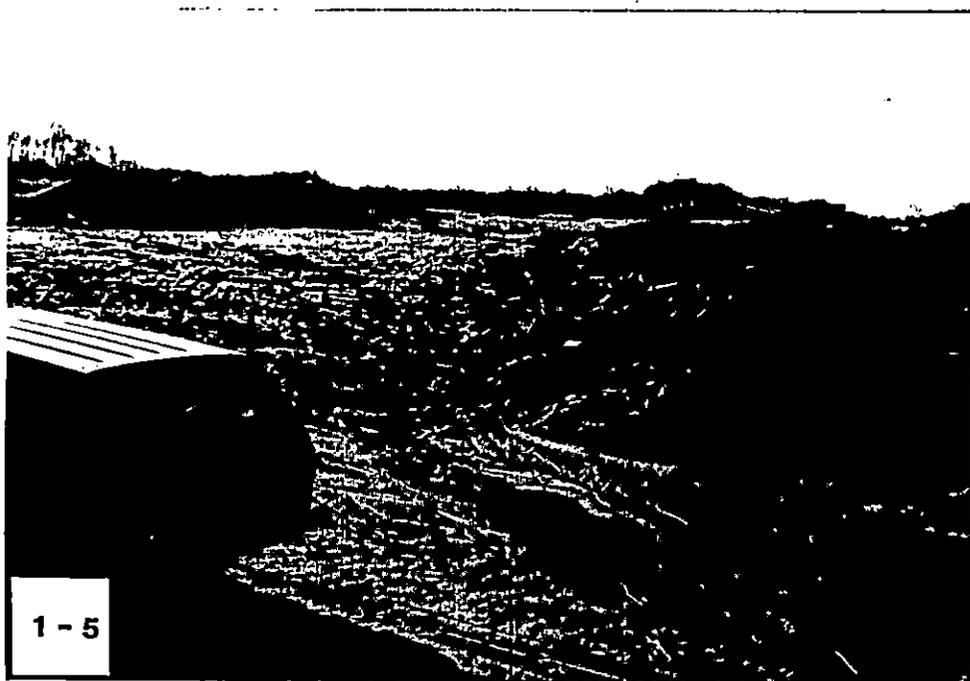
PHOTO LOG - BULL PATH LANDFILL

<u>Photo</u>	<u>Description</u>
1-1	Facing west, this is the view of the landfill from the entrance off Old Northwest Road. The entrance to the property is locked at all times, but the site is not entirely fenced in. There were substantial brush piles seen on top of the landfill due to the excessive tree damage during Hurricane Gloria of September 1985.
1-2	Facing southwest, this is the southwestern edge of the landfill. In the center of the photo is the beginning of the berm surrounding much of the landfill.
1-3	Facing northwest, this is another close-up of the berm on the western edge of the landfill. The individuals in the photo are standing on top of the berm while the photographer is standing on the landfill proper. It is evident in the photo that the landfill is heavily vegetated by tall grass and trees.
1-4	This is a sand pit on the northern edge of the landfill. There is ponding at the base of the pit, seen in the back of the photo. The photo shows a good soil profile.

1-5	Facing west, leachate is seen bubbling through the sandy driveway near the entrance gate. The water was only slightly discolored, and there had been extensive rains the day before. The water eventually flowed down to the base of the sand pit in Photo 1-4. There was no other evidence of leachate on site.
1-6 thru 1-8	From a vantage point along the northern perimeter of the landfill looking towards the southwest, these next photos depict the extent of the landfill. The landfill has been covered with a sandy material and seeded. The brush piles are a result of storm damage from a recent hurricane.

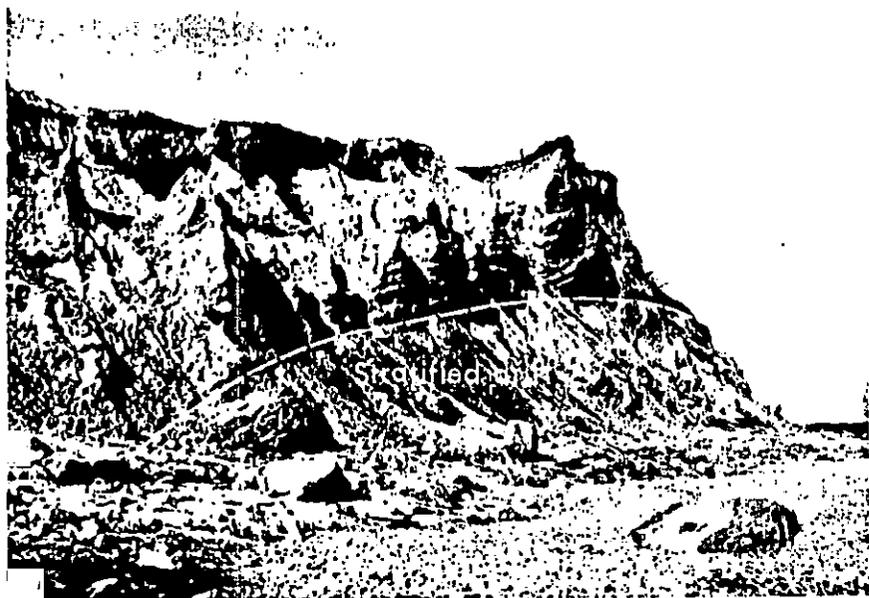
FIGURE 2.—Outcrop showing till above stratified drift composed chiefly of interbedded silt and clay, south side of Montauk Air Force Station. (Photograph by U.S. Geological Survey.)

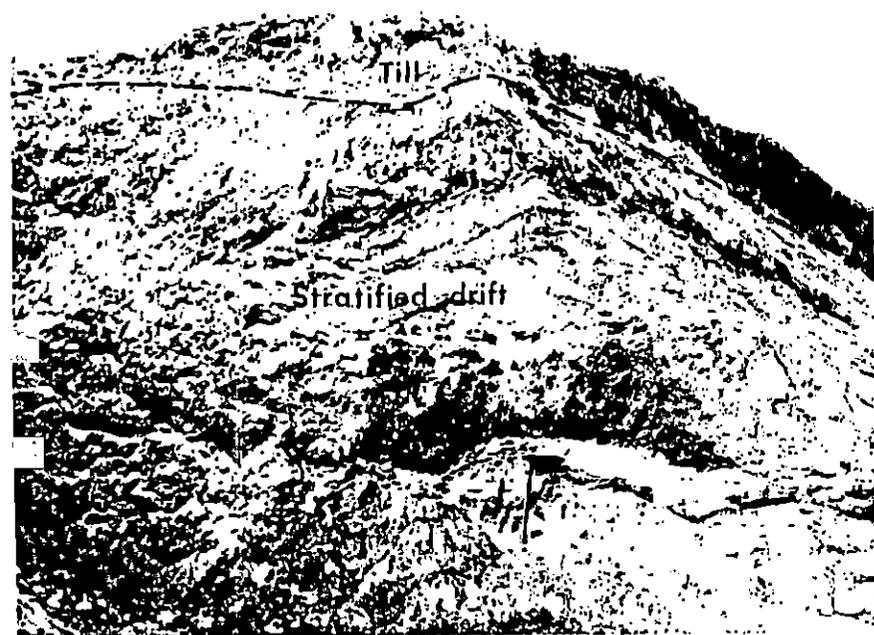
FIGURE 3.—Close-up view of till and underlying stratified drift composed chiefly of silt and clay, south side of Montauk Air Force Station. The trencher is lying against a lens

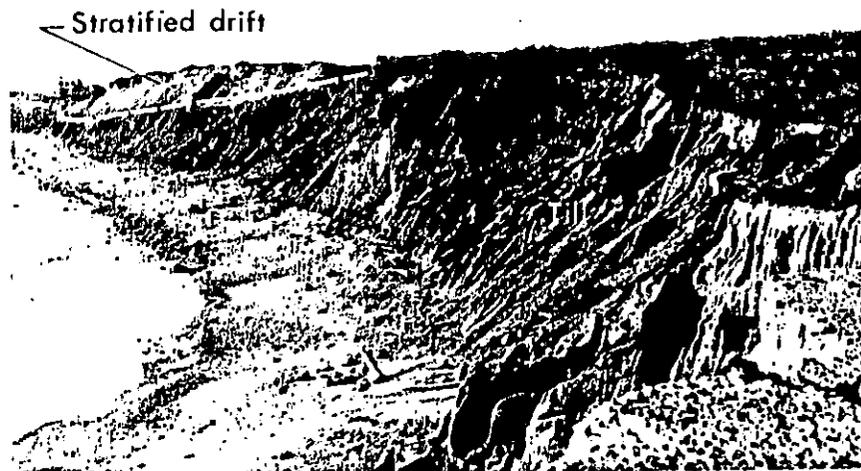
FIGURE 4.—Outcrop showing stratified drift above till, south side of Montauk Air Force Station. (Photograph by U.S. Geological Survey.)

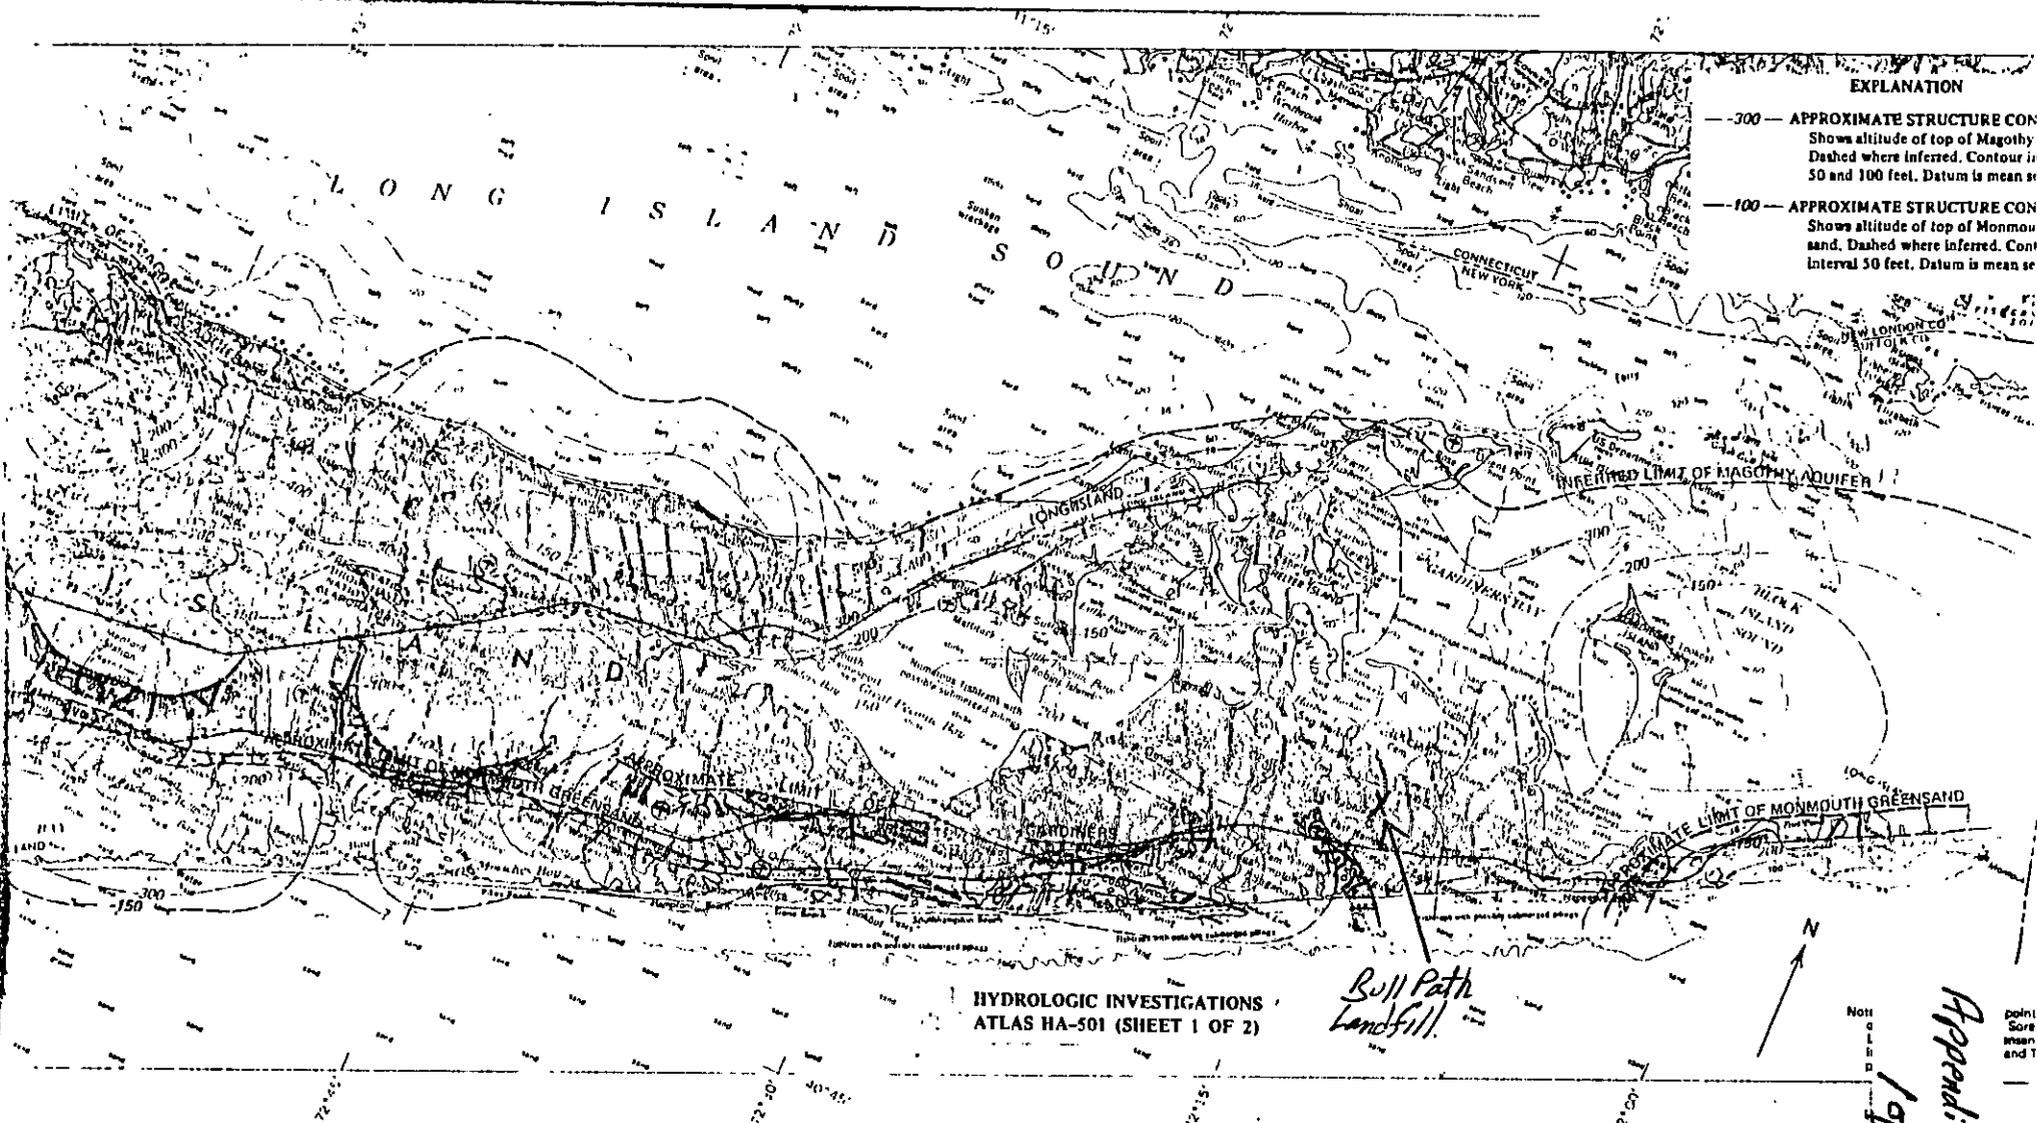
- 300- APPROXIMATE STRUCTURE CONTOUR
Shows altitude of top of Magothy sand. Dashed where inferred. Contour interval 50 and 100 feet. Datum is mean sea level.
- 100- APPROXIMATE STRUCTURE CONTOUR
Shows altitude of top of Monmouth sand. Dashed where inferred. Contour interval 50 feet. Datum is mean sea level.

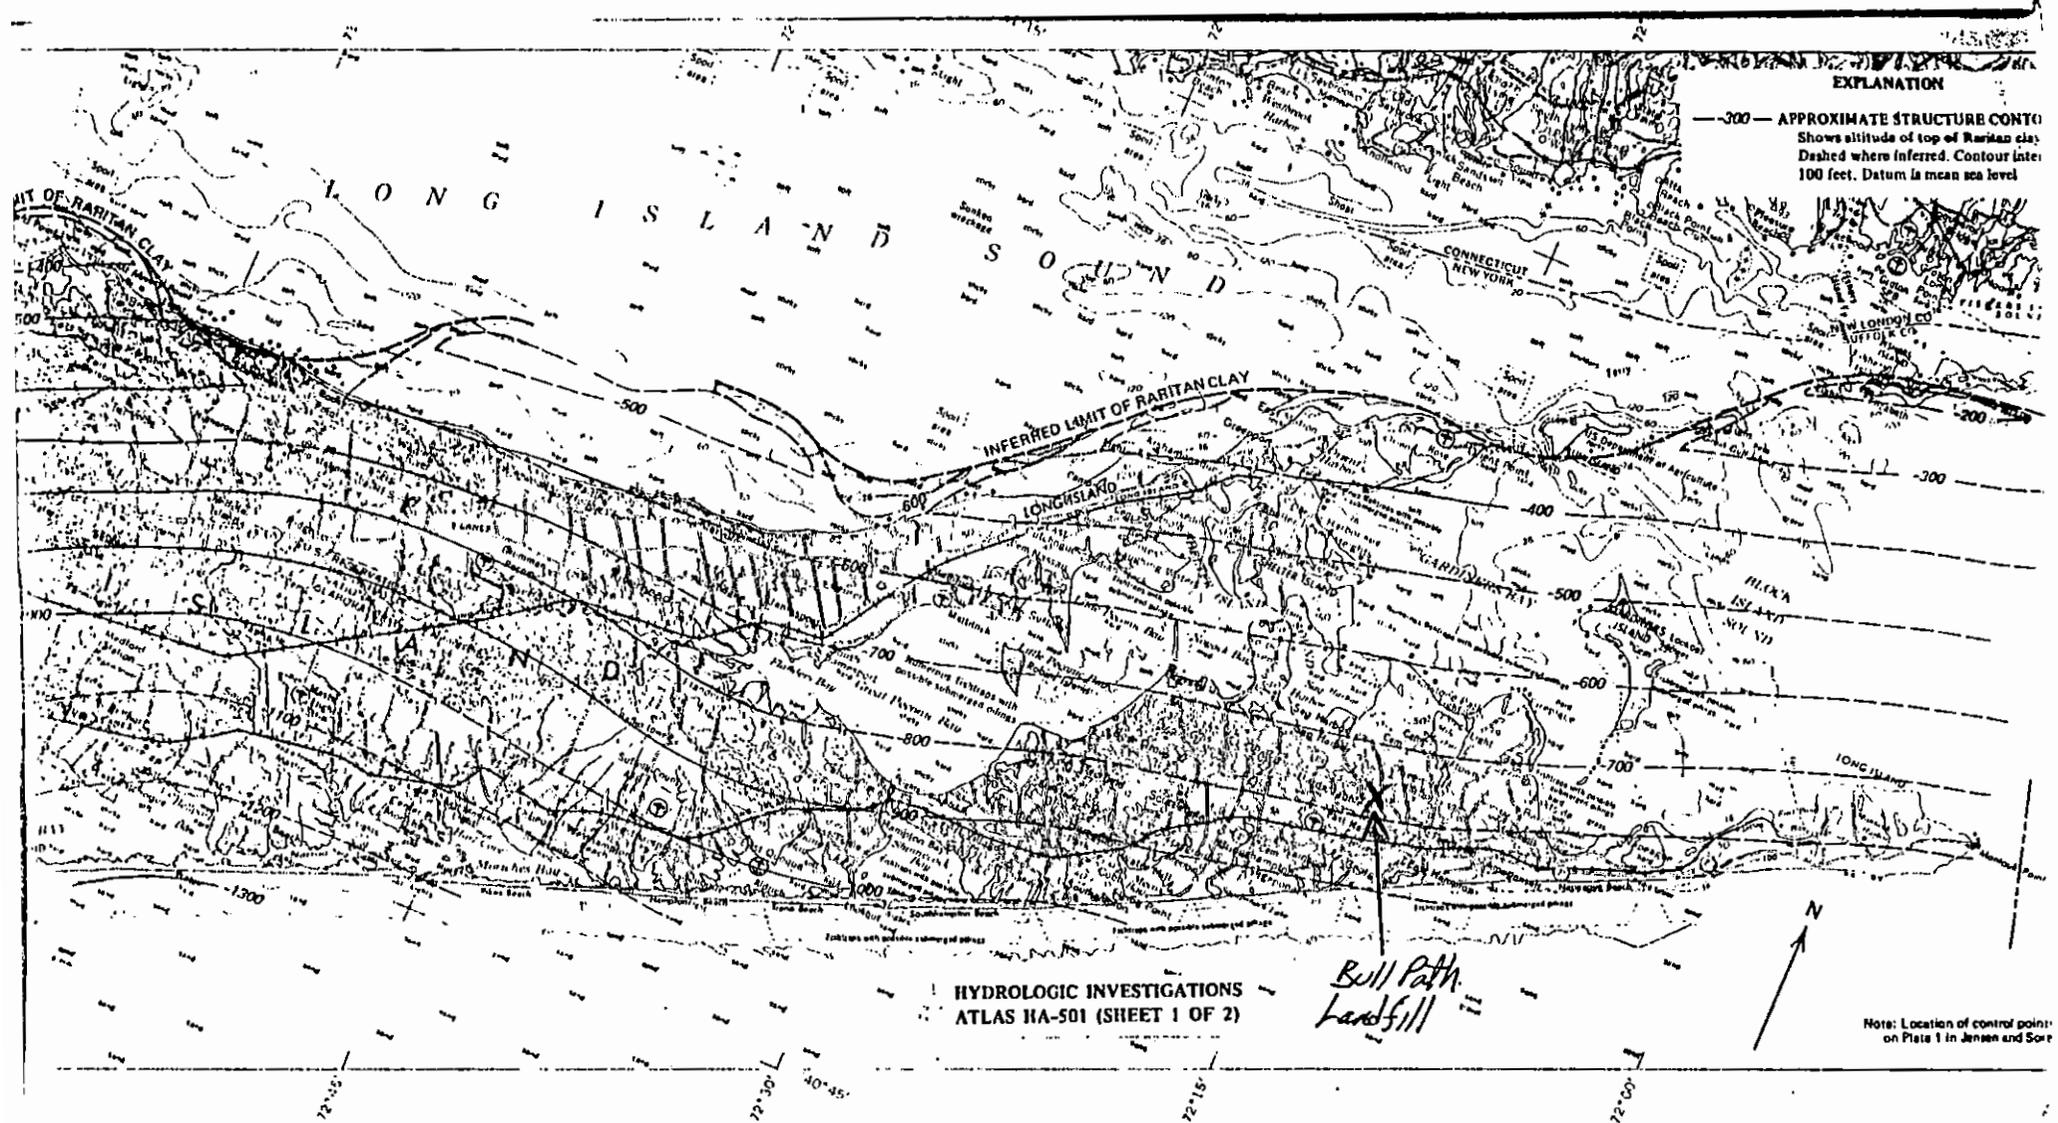
EXPLANATION
 — 100 — APPROXIMATE STRUCTURE CONTOUR
 Shows altitude of top of Raritan clay
 Dashed where inferred. Contour interval
 100 feet. Datum is mean sea level

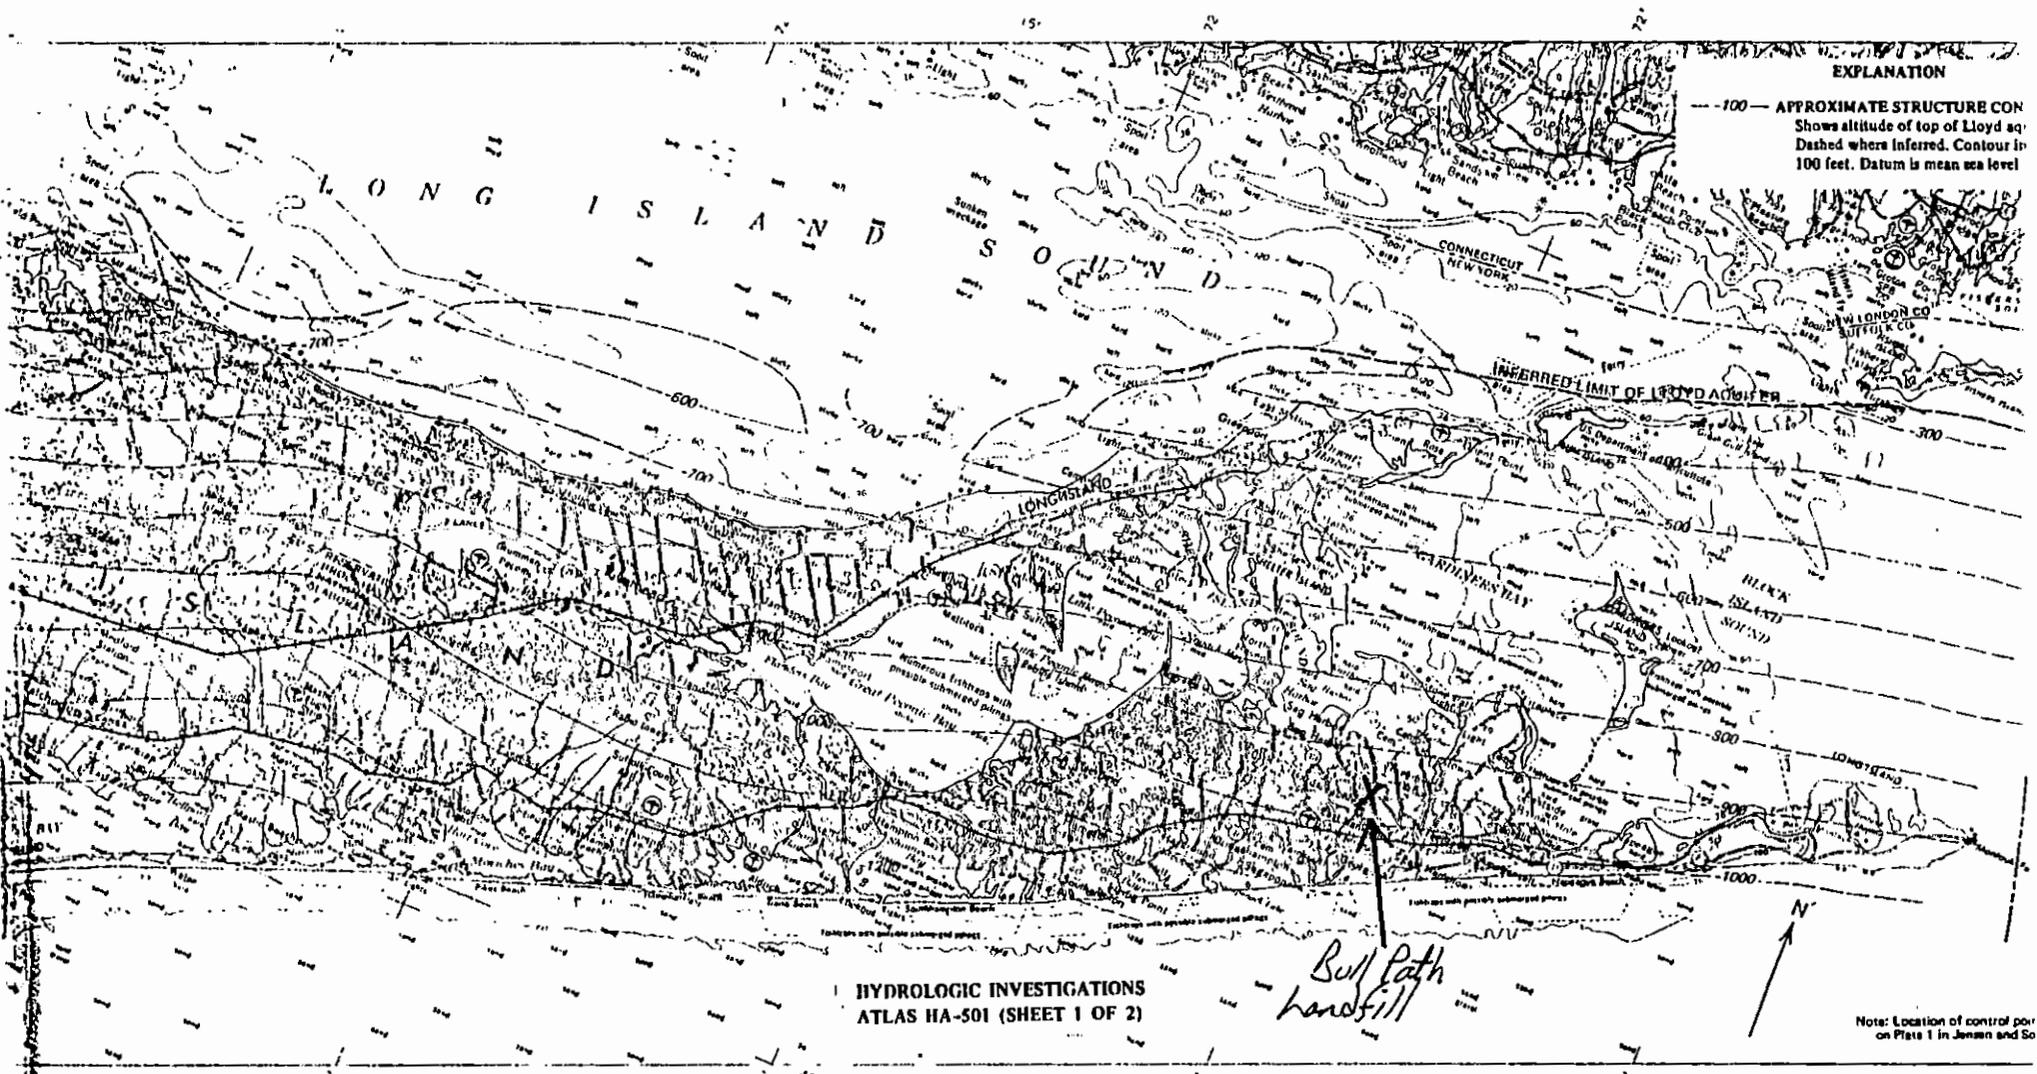
--- 100 --- APPROXIMATE STRUCTURE CONTOUR
Shows altitude of top of Lloyd aquifer
Dashed where inferred. Contour interval 100 feet. Datum is mean sea level.

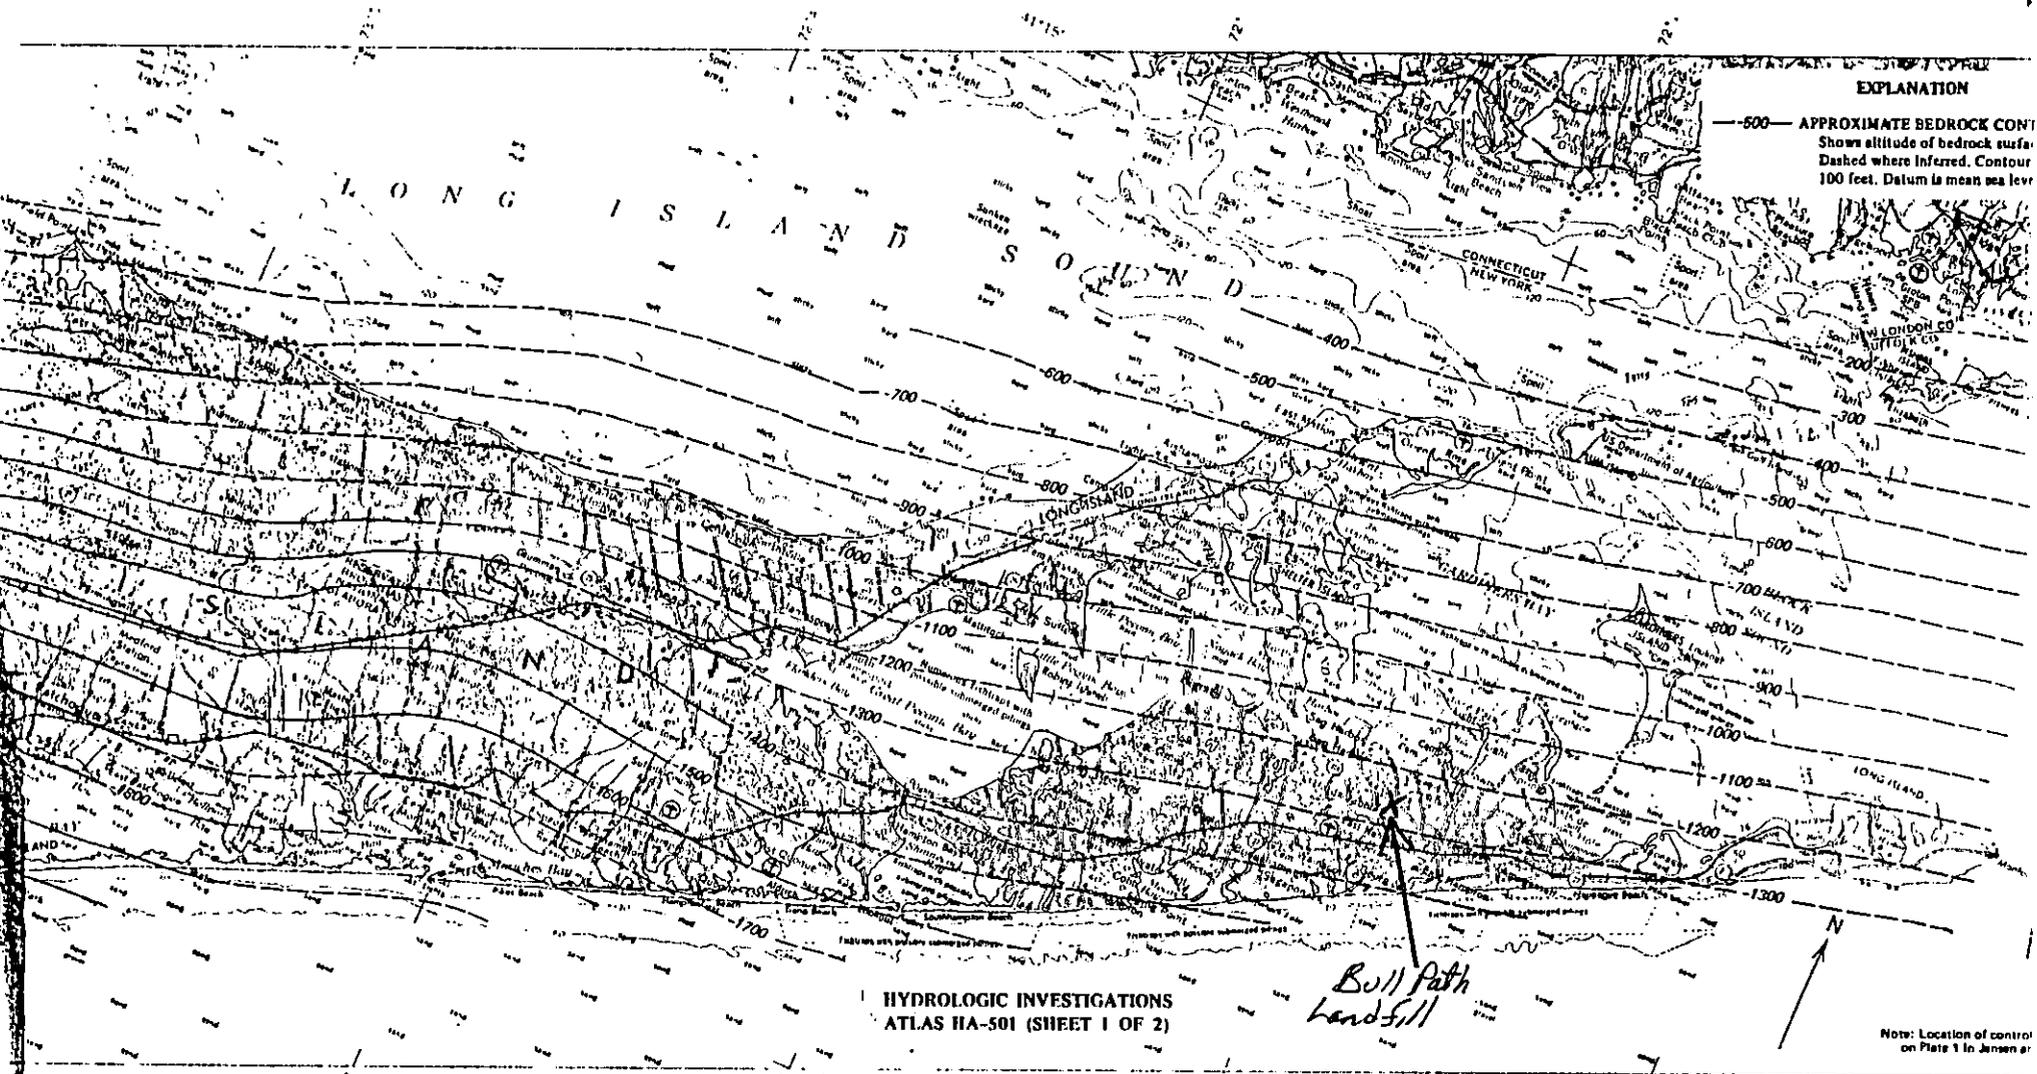
—500— APPROXIMATE BEDROCK CONTOUR
 Shows altitude of bedrock surface.
 Dashed where Inferred. Contour
 100 feet. Datum is mean sea level
