Project: National Heatsheet Printing Site - Off-Site - Site Management
 Contractors: AECOM and Preferred Environmental Services
 AECOM Job No: _____
 Site No: _____
 AECOM Project Manager: Walt Howard

DAILY REPORT

O&M DATA SHEET - NATIONAL HEATSET - OFF-SITE SYSTEM

PHOTOGRAPHIC LOG

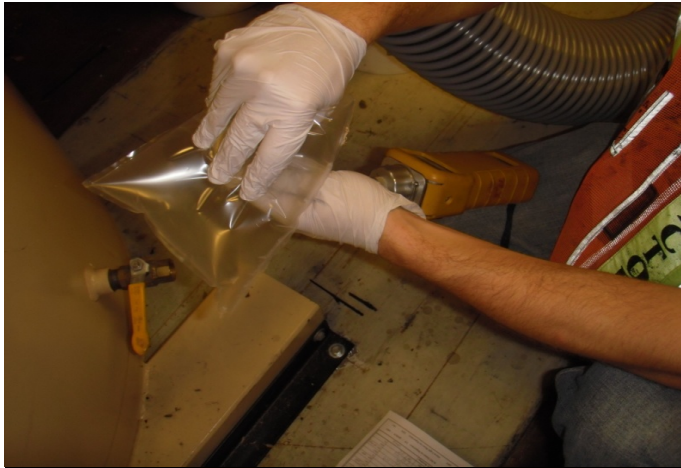
PHOTO	DATE	TIME	DESCRIPTION	COMMENTS
Picture 303	9/6/2012	12:00	The vapor points within the GAC shed were screened in a Tedlar bag.	
Picture 309	9/6/2012	13:40	Bubbling was noted beneath the eductor head for DDC-5

Picture 303- The vapor points within the GAC shed were screened in a Tedlar bag.
