**Periodic Review Report No. 3  
January 1, 2016 – December 31, 2016  
National Heatset Printing Co. Site (152140)**

**Town of Babylon  
Suffolk County, New York**

March 2017  
Version: DRAFT  
EA Project No. 14907.16

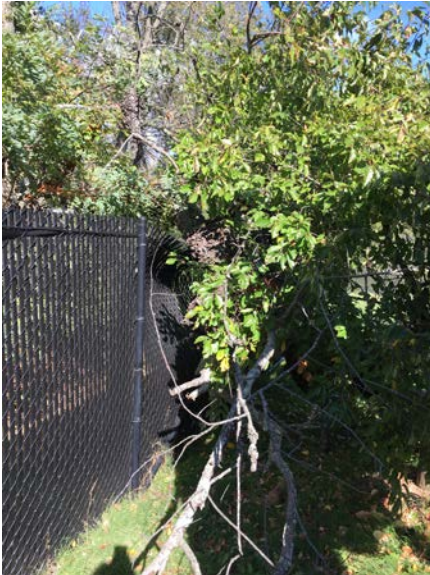
Minor damage was observed at the off-site DDC system enclosure during the October 2016 quarterly event. Upon arrival, it was observed that a tree branch from the SCWA – Albany Avenue Well Field property had fallen onto the west fence line of the equipment trailer compound. The branch was removed and placed back on SCWA property. A portion of the west fence line is bent slightly as a result, but still retains its functionality.

Tree from SCWA property on off-site system fence line (1 of 2)

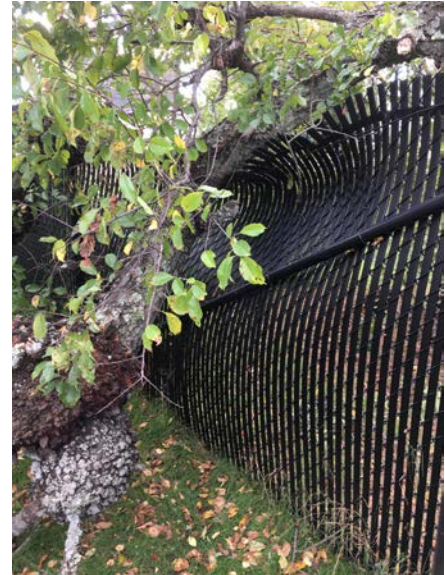
Tree from SCWA property on off-site system fence line (2 of 2)

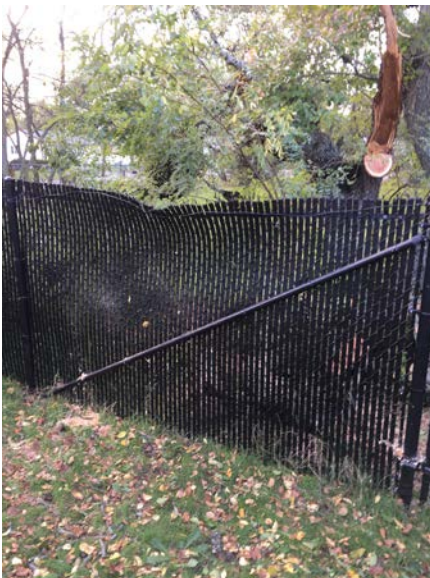
Damage to fence from tree

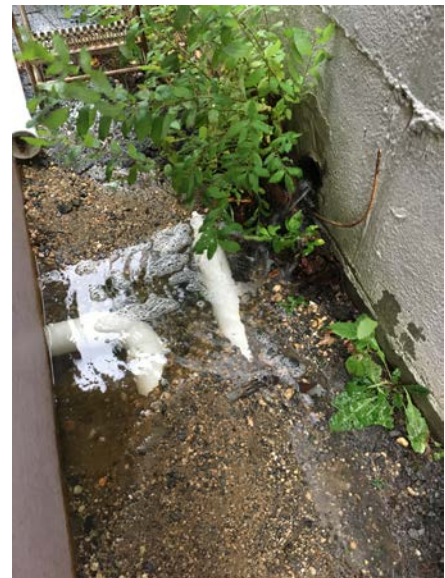
The SVE system and surrounding areas were generally observed to be in good condition during the annual inspection (**Appendix B**). There was no evidence of vandalism to the SVE treatment system and new outdoor manifold. Additionally, a roof drain from the 1 Adams Boulevard building (located near the horizontal well manifold) was observed to be eroding the soil cover for the well lines and entering the system during heavy rain events. Modifications will be made in early 2017 to divert flow away from the SVE treatment trailer. Inside the building, vapor-monitoring points sustain continual wear and tear due to the daily operations of the tenant. At the time of inspection, it was noted that one of the well covers for MW-G was broken. The cap will be replaced in early 2017.

Water from roof drain ponding over horizontal well manifold

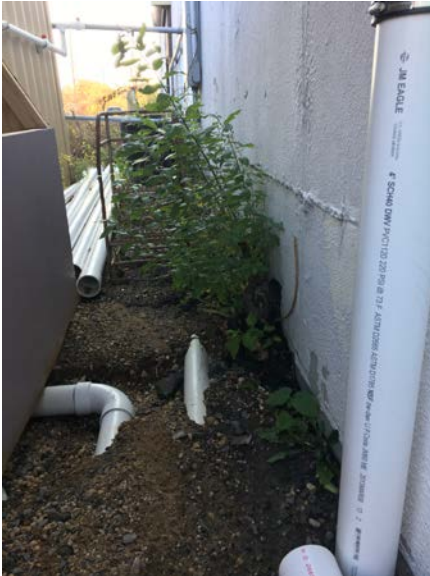
Erosion near SVE manifold

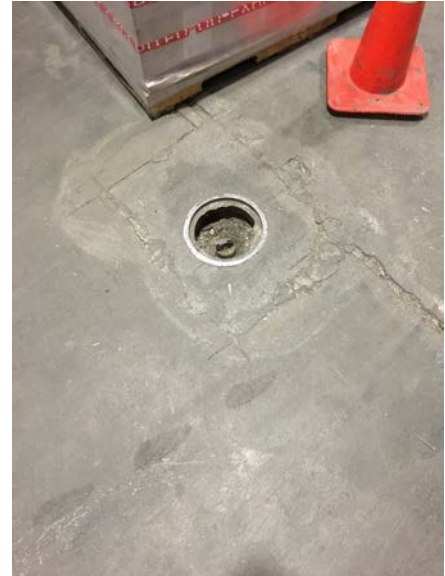
Missing well cap inside 1 Adams Blvd.

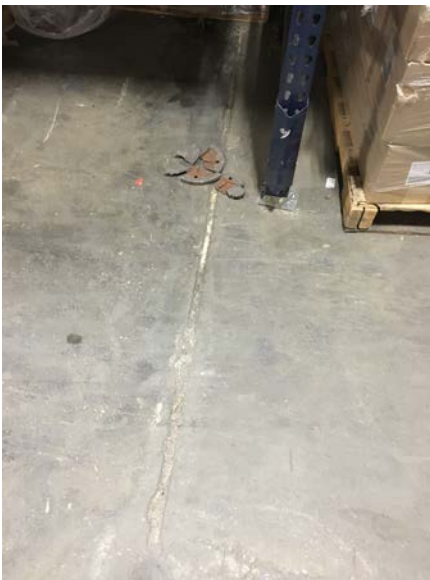
Well cap for MW-G

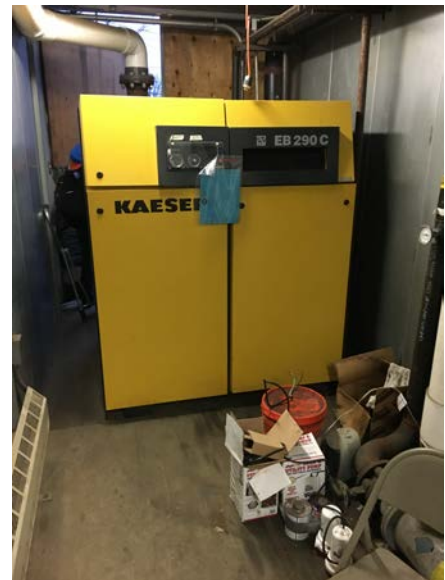
On December 22, 2016, it was noted that the BP-01 pressure gauge on the blower in on-site DDC system #2 might be faulty. A replacement was ordered though D&D and repairs are scheduled for early 2017; in the interim, the system will remain operational.

Blower in System #2 with faulty pressure gauge.
