SUB-SLAB VENTILATION SYSTEM INSTALLATION REPORT 72 East Main Street, Babylon, NY

EUGENE'S DRY CLEANERS SITE – SITE # 152157 WORK ASSIGNMENT NO. D004434-27

INSTALLATION CONTRACTOR'S FINAL REPORT FOR SUB-SLAB VENTILATION SYSTEM INSTALLATION

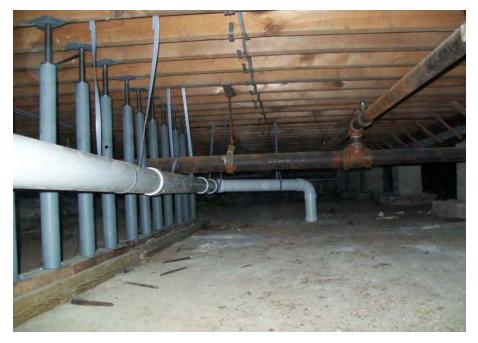
1. Suction point SP-1, looking north from MP-4

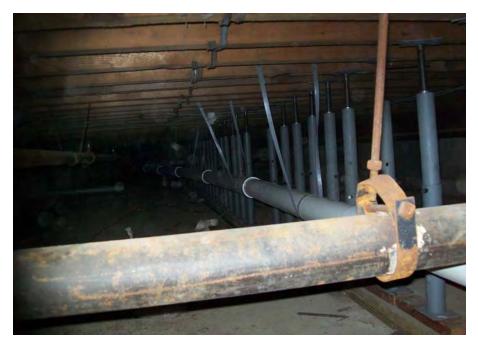
2. Suction piping, looking south from SP-1 toward SP-2

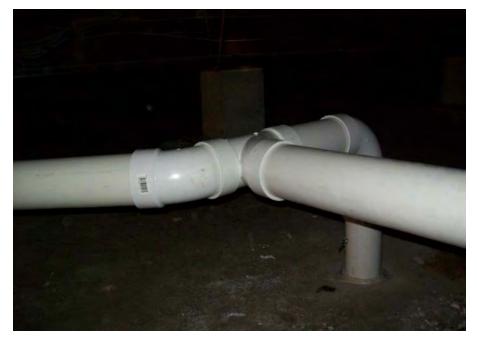
3. Suction point SP-2 and manifold: piping from SP-1 at left, piping to system discharge (toward crawlspace entrance) at right

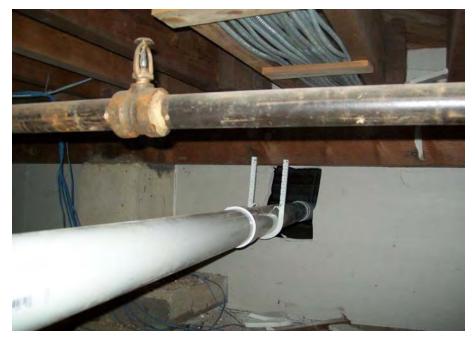
4. Suction piping routed through drywall partition, looking southwest toward crawlspace entrance from eastern side of partition near SP-2

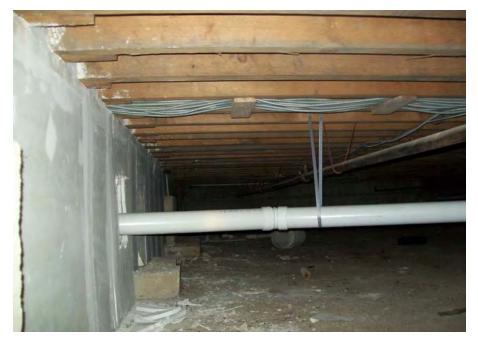
5. Suction piping at western side of drywall partition, looking south

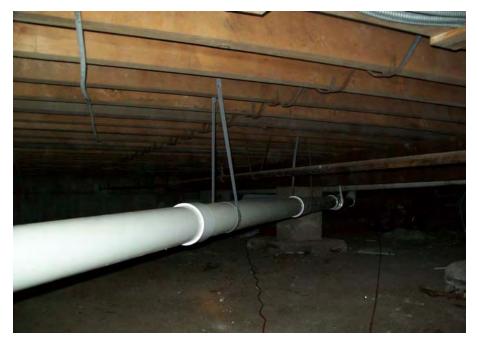
6. suction piping, looking southwest from drywall partition toward crawlspace entrance

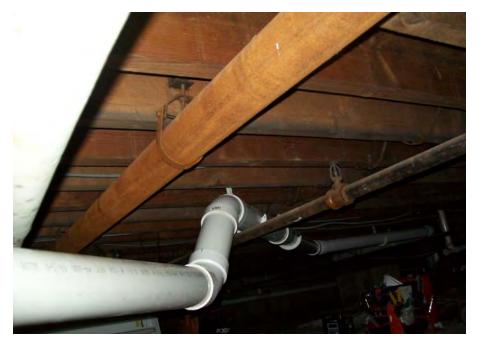
7. Suction piping, looking southwest from near MP-1 toward crawlspace entrance

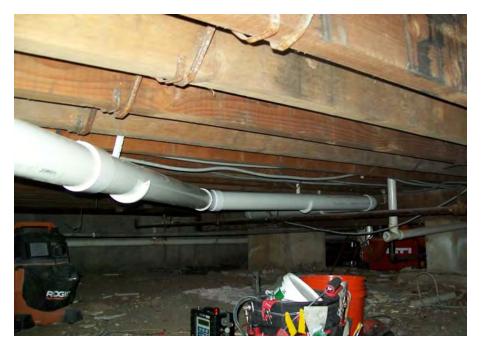
8. Suction piping, looking southwest toward crawlspace entrance from just northeast of entrance

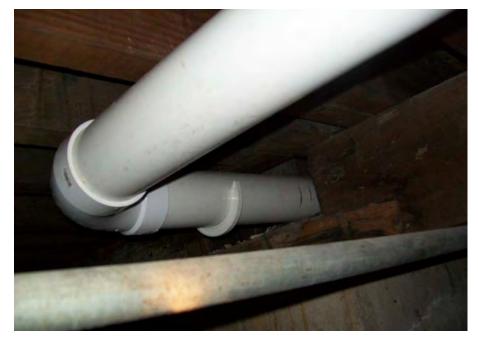
9. Suction piping routed through pre-existing support beam cut-out just east of crawlspace entrance, looking southwest

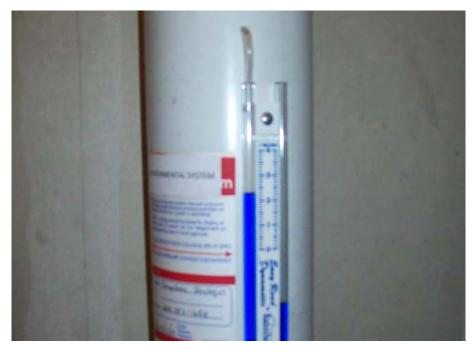
10. U-tube manometer on vertical suction piping located in first floor utility closet at southern end of building

A u-tube manometer, which serves as the system fail-safe device, was installed on the vertical suction piping in the first floor utility closet. The u-tube manometer was securely attached to the piping with a fastening screw and associated pressure tubing was inserted directly into the system suction pipe. The u-tube manometer measures internal system pressure (in units of W.C.) and is an indicator that the system fan is operating.

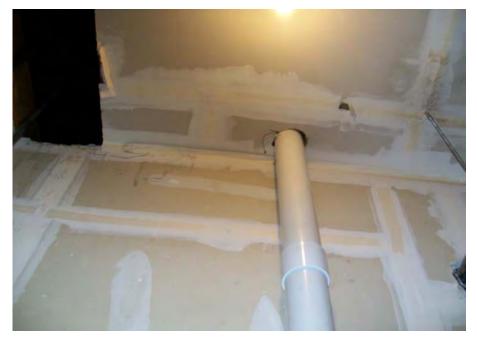
11. Suction piping continuing vertically to rooftop fan and system discharge point above first-floor utility closet and crawlspace entrance

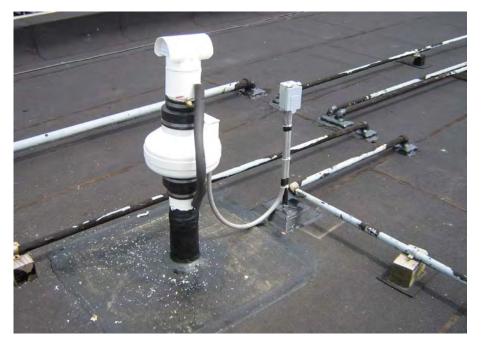
12. Exterior system features on south-central portion of building rooftop, immediately above the first-floor utility closet and crawlspace entrance

At the request of the property owner, the system fan was installed on the building rooftop in order to maintain building aesthetics. The fan was installed on the suction pipe terminus above the utility closet and crawlspace entrance, approximately two feet above the roof surface. The fan was mounted directly to the suction piping using 6-inch by 4-inch flexible couplers with steel draw bands. A Fan Guard drain system was installed on the system piping immediately above the fan and a PVC rain cap was installed above the drain to prevent excessive internal moisture and entrance of foreign materials (e.g., leaves or small animals).

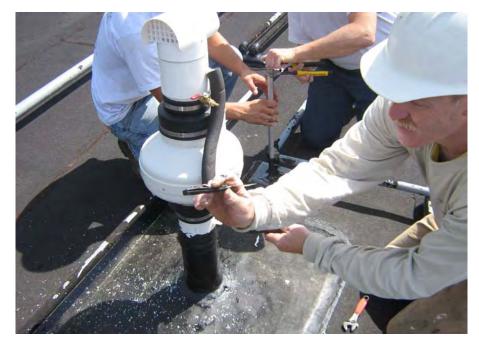
13. System fan with view of sample port and drain line

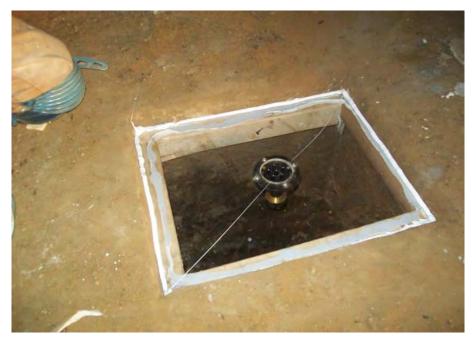
14. Sealed sump cover (recessed) with on-way Dranjer valve

In order to seal off an area of potential system vacuum loss and likely vapor intrusion, a ¼" thick, clear Lexan cover was installed on a sump pit located near the central portion of the crawlspace. The cover was recessed below the edge of the pit to allow collection of water, and a one-way Dranjer valve was installed that allows water to drain from above while maintaining an air-tight seal. A pliable elastomeric sealant was used to create an air-tight seal around the cover. The pliable sealant allows the cover to easily be removed and replaced as needed, providing access to the sump pit.
