FOCUSED REMEDIAL INVESTIGATION REPORT

**PRECISION CONCEPTS
26 PRECISION DRIVE
SHIRLEY, NEW YORK 11967**

NYS DEC IHWDS I.D. No. 1-52-158

JULY 1999

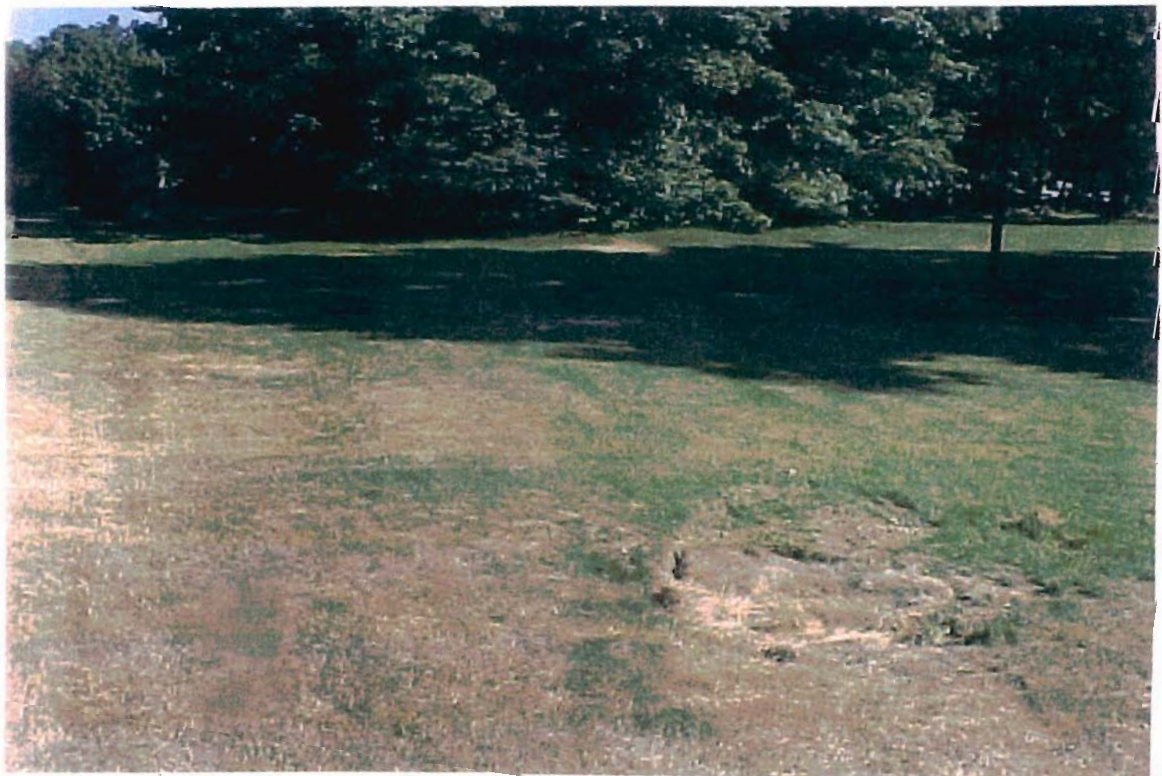
8. View showing location of on-site septic system.

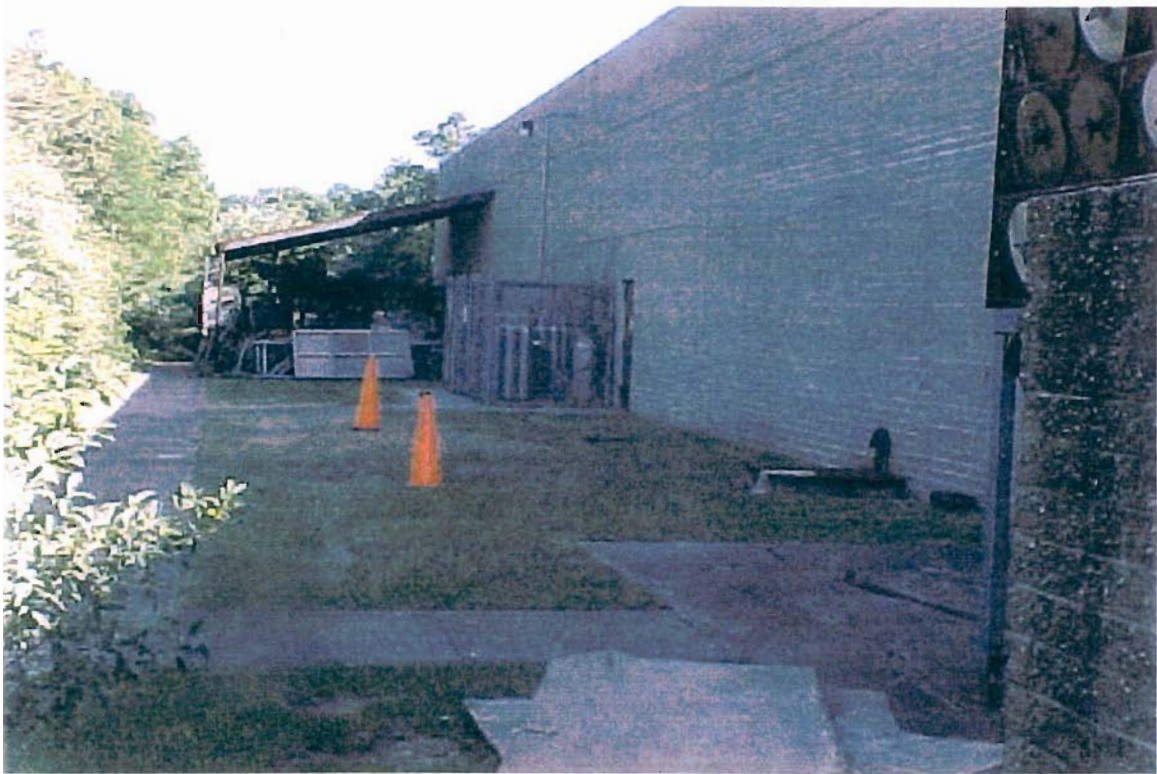
9. View showing location of east side leaching pool system.

Representative samples were collected from the bottom invert levels of the two (2) leaching pools. In addition, one (1) soil boring was completed immediately down-gradient (south) of the leaching pools. Soil samples were collected from each of the borings at depths of twenty-five (25) feet bls, thirty (30) feet bls, and thirty-six (36) feet bls. Groundwater was encountered at a depth of thirty-seven (37) feet below grade throughout the Site. There was no apparent visual evidence of suspected contamination noted in any of the samples collected from the east side leaching pool system. The PID field screening results for soil boring LP-1 varied from 1.1 ppm in the sample obtained from thirty-six (36) to thirty-eight (38) feet bls to 2.2 ppm in the sample obtained from thirty (30) to thirty-two (32) feet bls. The PID field screening results for soil boring LP-2 varied from 1.2 ppm in the sample obtained from thirty (30) to thirty-two (32) feet bls to 1.9 ppm in the sample obtained from twenty-five (25) to twenty-seven (27) feet bls. Although, please note that the weather conditions were extremely humid during the site investigation activities.

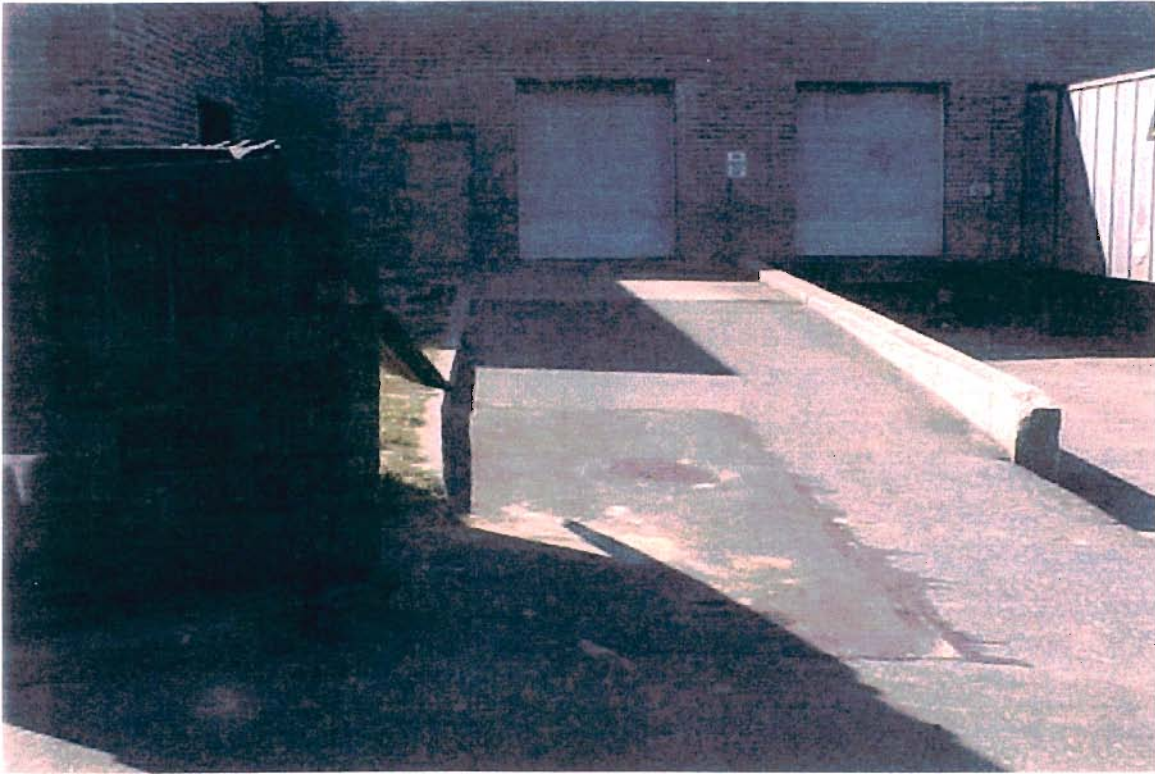
11. View showing location of roof drain pools on south side of site.

Representative samples were collected from the bottom invert levels of the two (2) roof drain pools. In addition, one (1) soil boring was completed immediately down-gradient (south) of roof drain pools RDP-1 and RDP-2. Soil samples were collected from each of the borings at depths of twenty-five (25) feet bls, thirty (30) feet bls, and thirty-six (36) feet bls. Groundwater was encountered at a depth of thirty-seven (37) feet below grade throughout the Site. There was no apparent visual evidence of suspected contamination noted in any of the samples collected from the south side roof drainage system.. The PID field screening results for soil boring RDP-1 varied from 0.4 ppm in the sample obtained from the invert level to 0.6 ppm in the sample obtained from thirty-six (36) to thirty-eight (38) feet bls. The PID field screening results for soil boring RDP-2 varied from 0.4 ppm in the sample obtained from thirty (30) to thirty-two (32) feet bls to 1.2 ppm in the sample obtained from twenty-five (25) to twenty-seven (27) feet bls. Although, please note that the weather conditions were extremely humid during the site investigation activities.

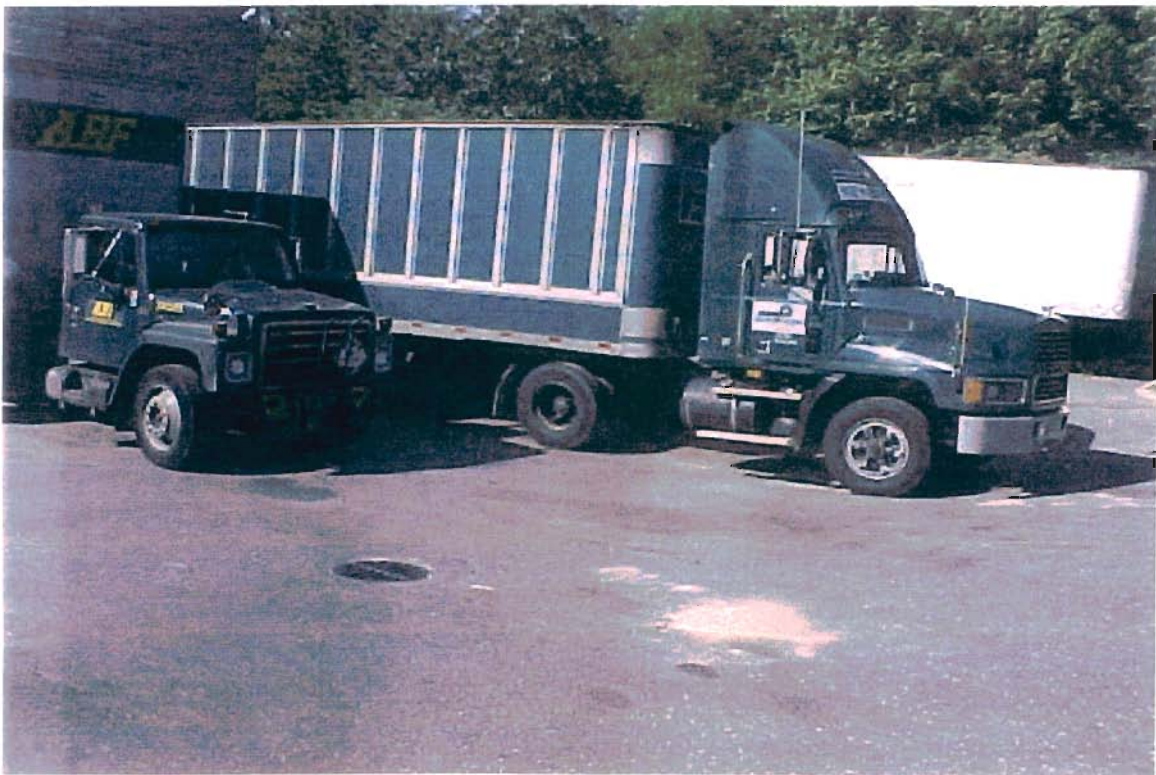
12. View showing location of storm water drywells on south side of site.

Representative samples were collected from the bottom invert levels of the two (2) storm drains. In addition, one (1) soil boring was completed immediately down-gradient (south) of the storm water drains. Soil samples were collected from each of the borings at depths of twenty-five (25) feet bls, thirty (30) feet bls, and thirty-six (36) feet bls. Groundwater was encountered at a depth of thirty-seven (37) feet below grade throughout the Site. There was no apparent visual evidence of suspected contamination noted in any of the samples, with the exception of both of the invert level samples which were noted to be slightly discolored. The PID field screening results for soil boring DW-1 varied from 11.6 ppm in the sample obtained from thirty-five (35) to thirty-seven (37) feet bls to 21.2 ppm in the sample obtained from thirty (30) to thirty-two (32) feet bls. The PID screening results for soil boring DW-2 varied from 0.6 ppm in the sample obtained from twenty-five (25) to twenty-seven (27) feet bls to 1.0 ppm in the sample obtained from thirty-six (36) to thirty-eight (38) feet bls. Although, please note that the weather conditions were extremely humid during the site investigation activities.
