Weekly Report No.: 029

Period: 02/27/23 through 03/05/23

This Weekly Air Monitoring Report summarizes perimeter air monitoring data collected during the referenced period in accordance with the Community Air Monitoring Plan (CAMP) which was included as part of the NYSDEC approved Remedial Action Work Plan for the Former Fulton Manufactured Gas Plant (MGP) Site – Parcel III and Portion of Parcel IV.

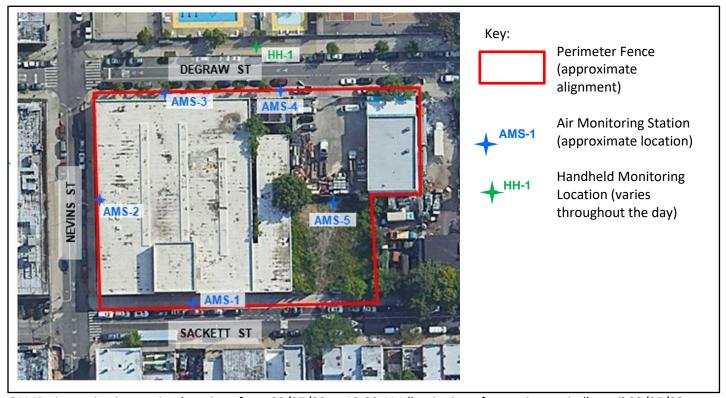
Figure 1 – CAMP Station Locations

Air monitoring was performed during the reporting period in accordance with the CAMP. Air Monitoring location for the reporting period is shown on **Figure 1.** The air monitoring program consists of:

CAMP air monitoring station locations from 02/27/23 at 12:00 AM (beginning of reporting period), until 03/05/23 at 11:59 PM (end of reporting period).

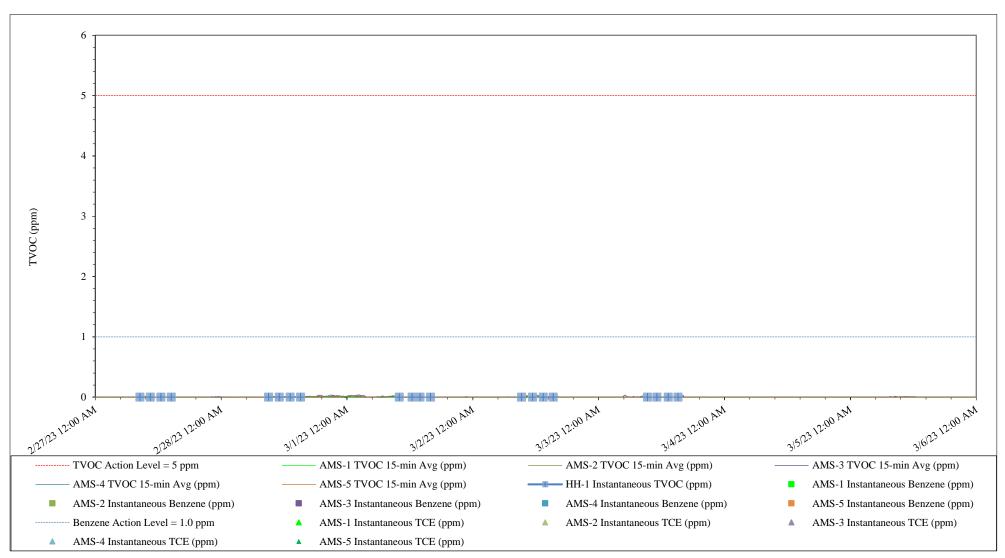
Figure 2 – Summary of TVOC, Benzene, and Tri-chloroethylene Concentrations 02/27/23 through 03/05/23

There were no TVOCs or PM_{10} concentrations above the CAMP-established action levels during the reporting period. Figures 2 and 3 summarize the TVOC and PM_{10} concentrations, respectively, recorded during the reporting period.
