HRS DOCUMENTATION RECORD COVER SHEET

Name of Site: Meeker Avenue Plume

Name of Site: Meeker Avenue Plume Date Prepared: September 2021

City, County, State, Zip Code: Brooklyn (Kings County), NY 11222

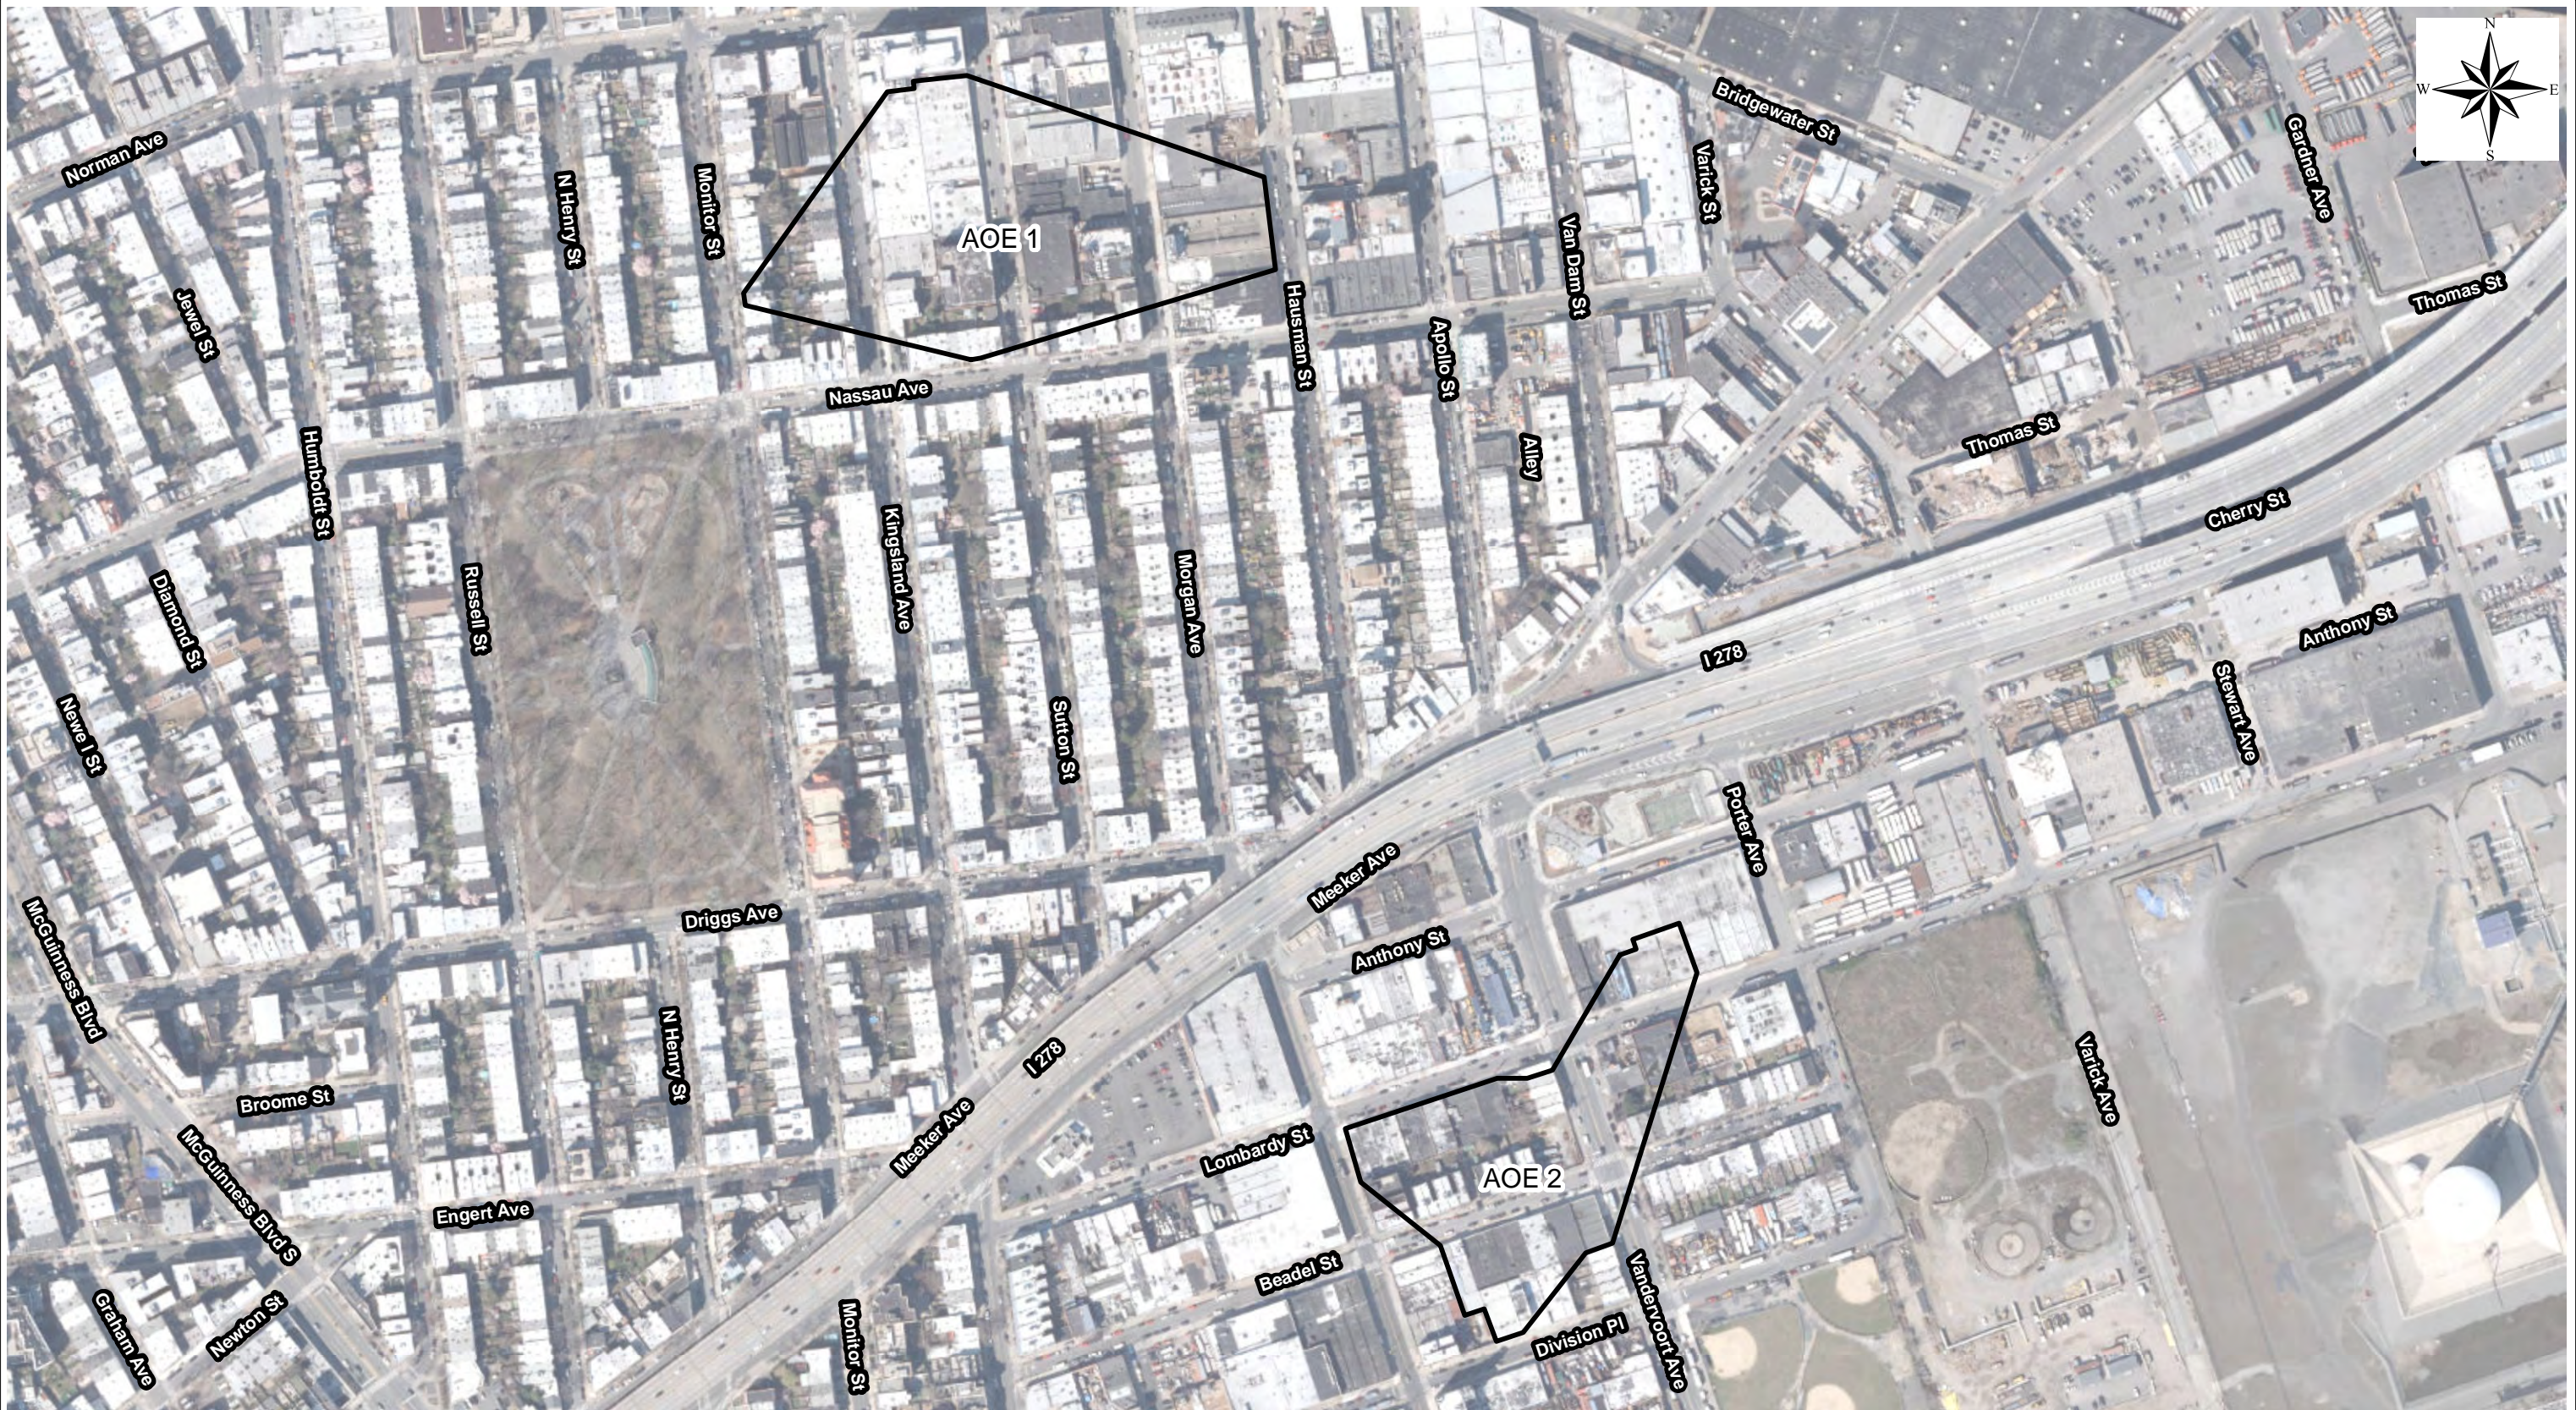
FIGURE #: 2

TITLE:
AREAS OF OBSERVED EXPOSURE
MEEKER AVENUE PLUME
BROOKLYN, KINGS COUNTY NY

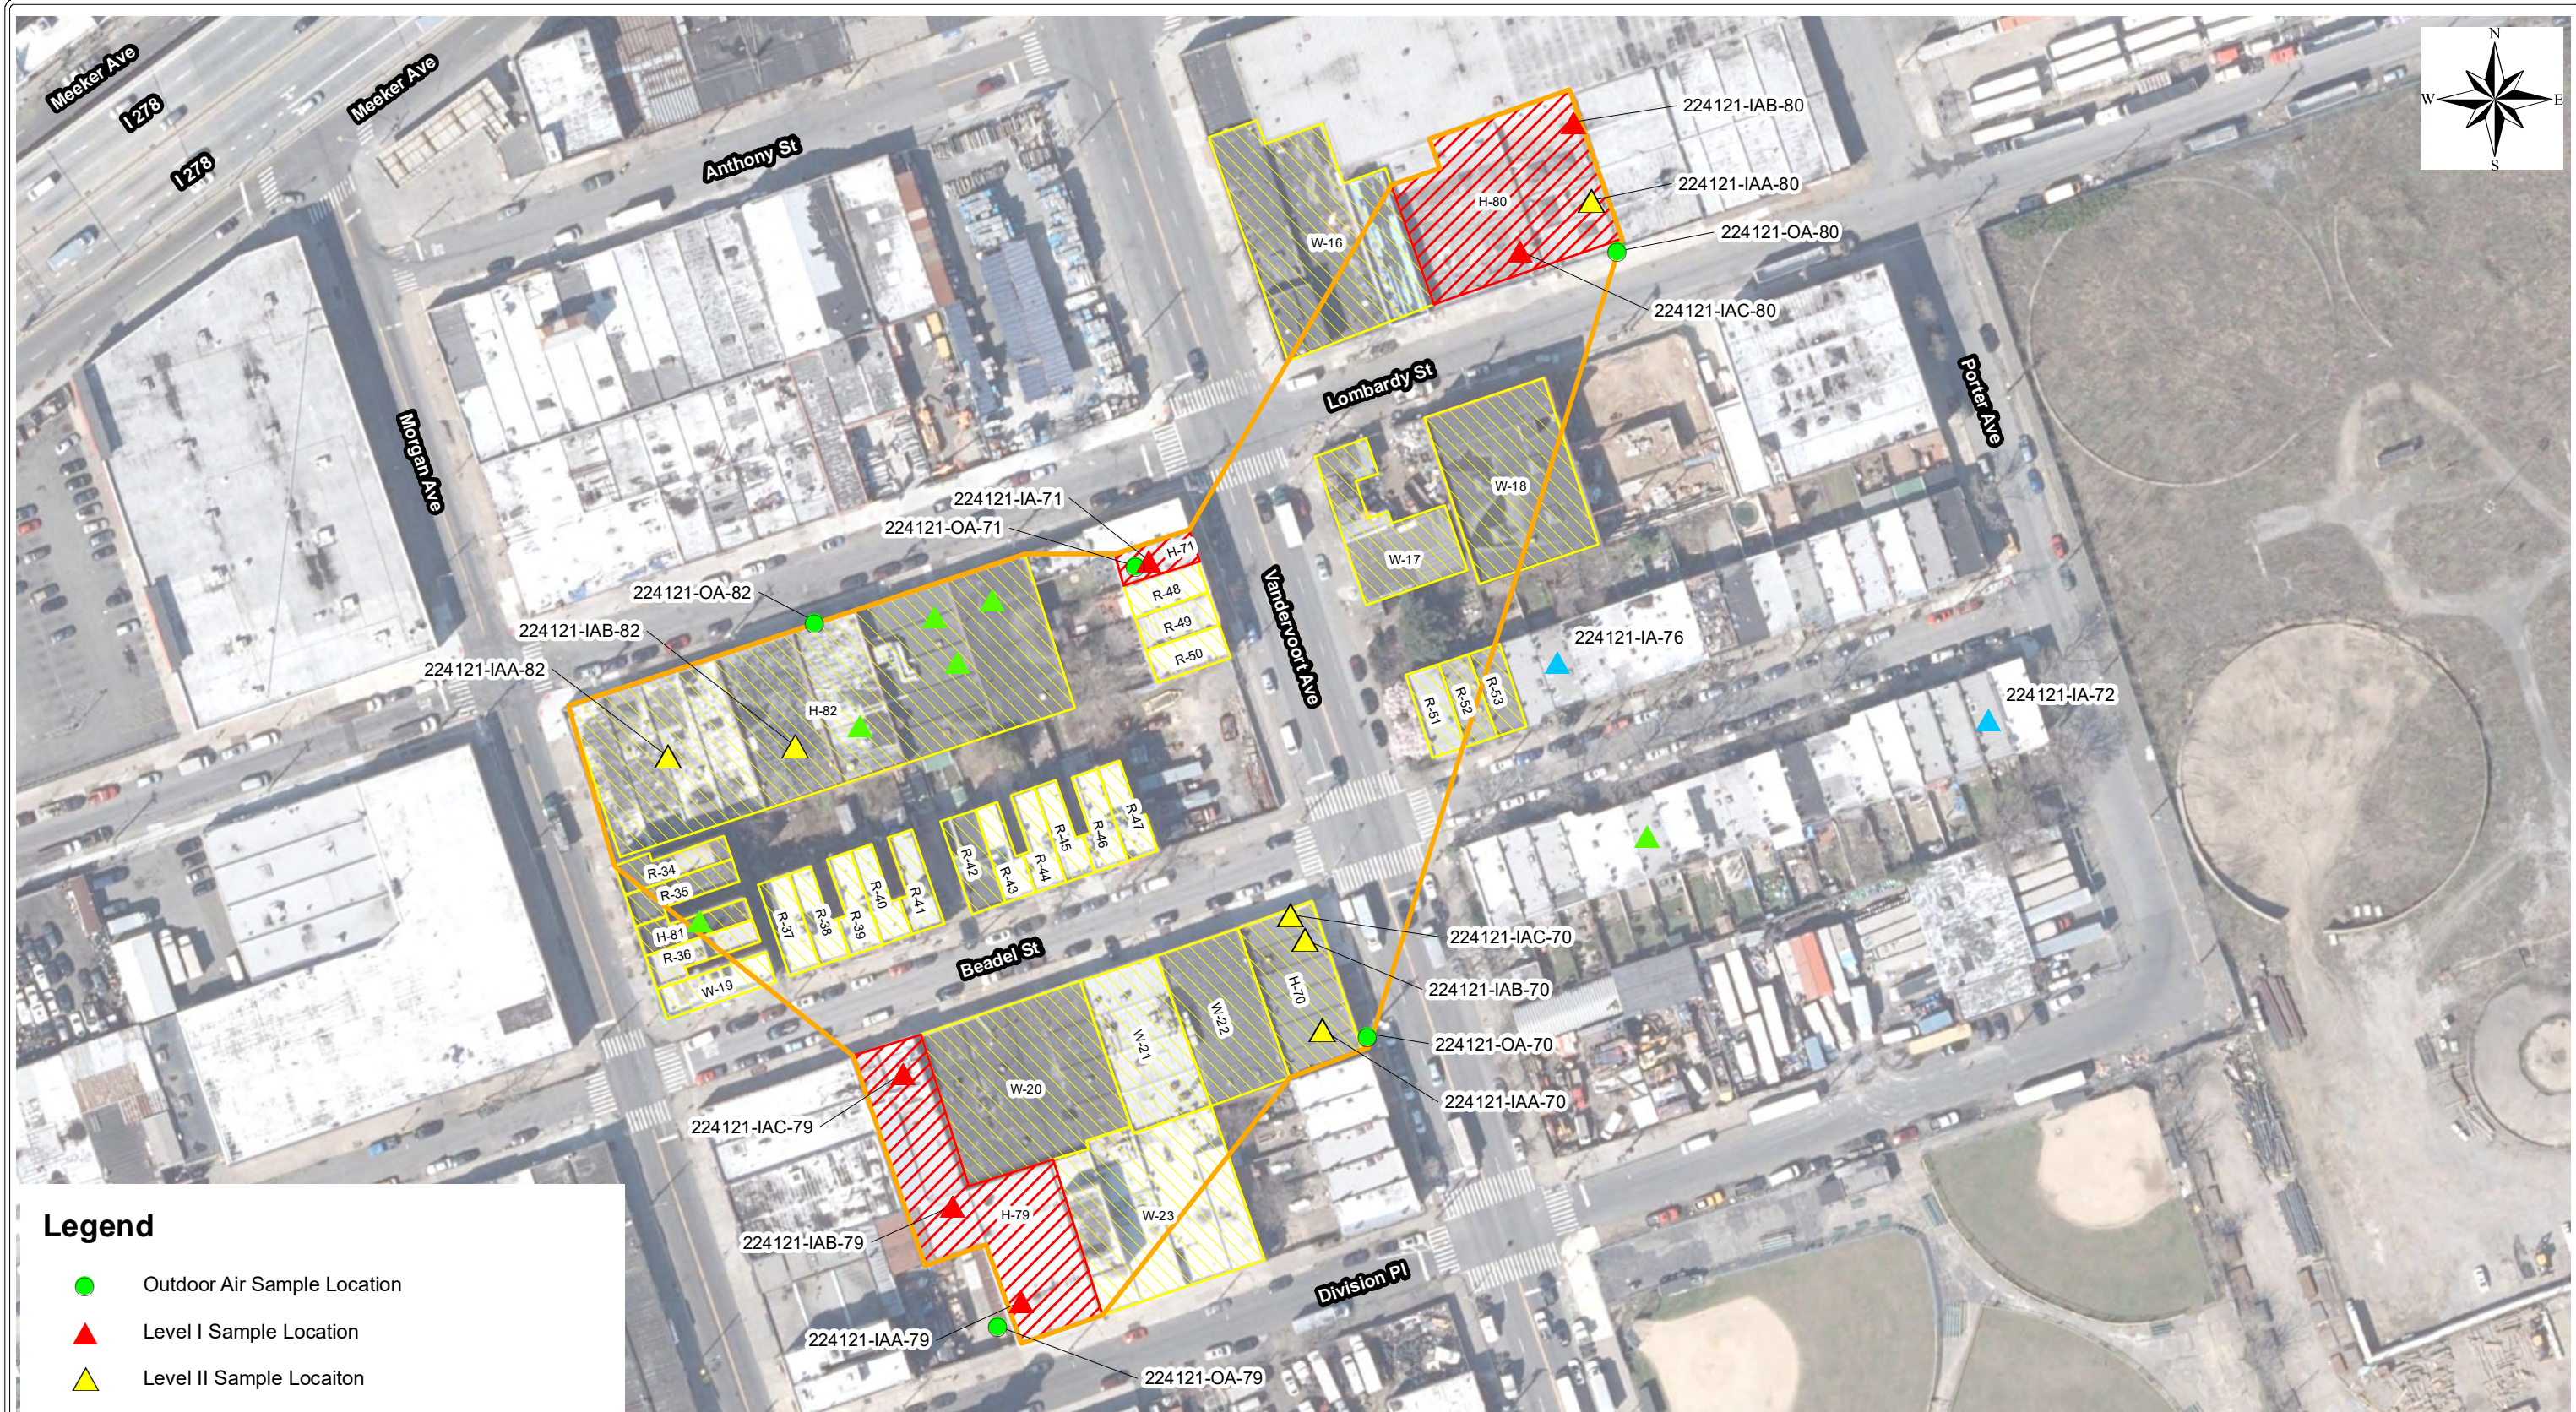
FIGURE #: 4

AREA OF OBSERVED EXPOSURE 2
MEEKER AVENUE PLUME
BROOKLYN, KINGS COUNTY NY

There are 22 regularly occupied residential structures and 12 regularly occupied workplaces within AOE 2. The AOE is delineated based on one residential structure and four workplace structures that had observed exposure concentrations of site-attributable hazardous substances, as documented through indoor air sampling (see **Observed Exposure by Chemical Analysis** below). Twenty-one additional residential structures and 8 additional workplaces are inferred to be within AOE 2 based on their location between the structures that meet the observed exposure criteria through chemical analysis (see **Figure 4**) [Ref. 1, Section 5.2.0].

| TABLE 10. AOE 1 / AOE 2 – STRUCTURE CONTAINMENT | | | |
|--|--|--|---|
| H-70-1 H-70-2 H-71 H-79 H-80-1 H-80-2 H-82-1 | 10 | Evidence of subsurface intrusion with documented observed exposure | See AOE description above; Figure 4 |
