Prepared for:
NYSDEC
Albany, NY

Prepared by:
AECOM
Chestnut Ridge, NY
60237880
July 2014

Remedial Investigation Report Jung Sun Laundry Site (No. 241102)

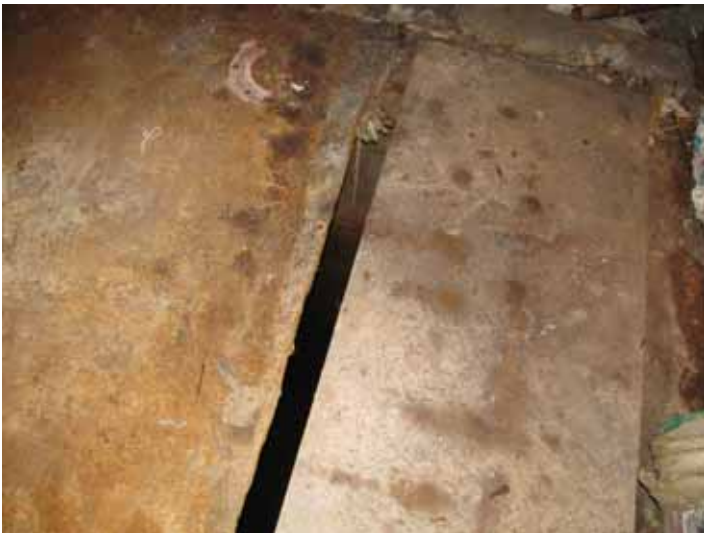
Stained trenches and road plates in the southern portion of the building.

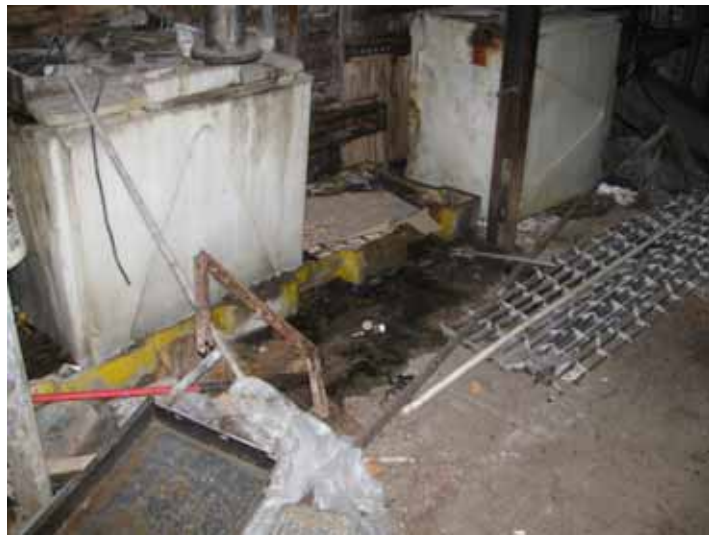
Garbage filled trenches and drains inside of the building.

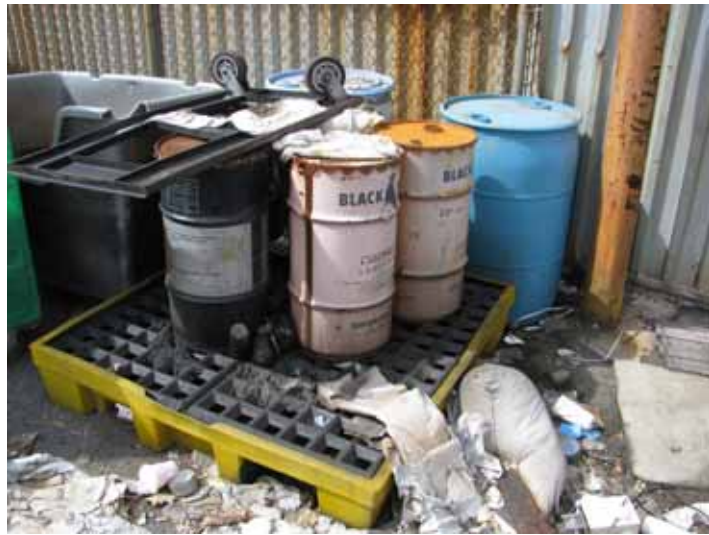
Overflowing chemical storage tanks on an overflowing spill containment pallet. Note the staining in front of the pallet.
