Project: Clarkstown Landfill

Subject: 2022 Annual Landfill Gas Report

PROJECT: **Clarkstown Sanitary Landfill; Landfill Gas Management**
 Town of Clarkstown, Department of Engineering & Facilities Management
 West Nyack, New York
 NYSDEC Inactive Hazardous Waste Site No. 344001

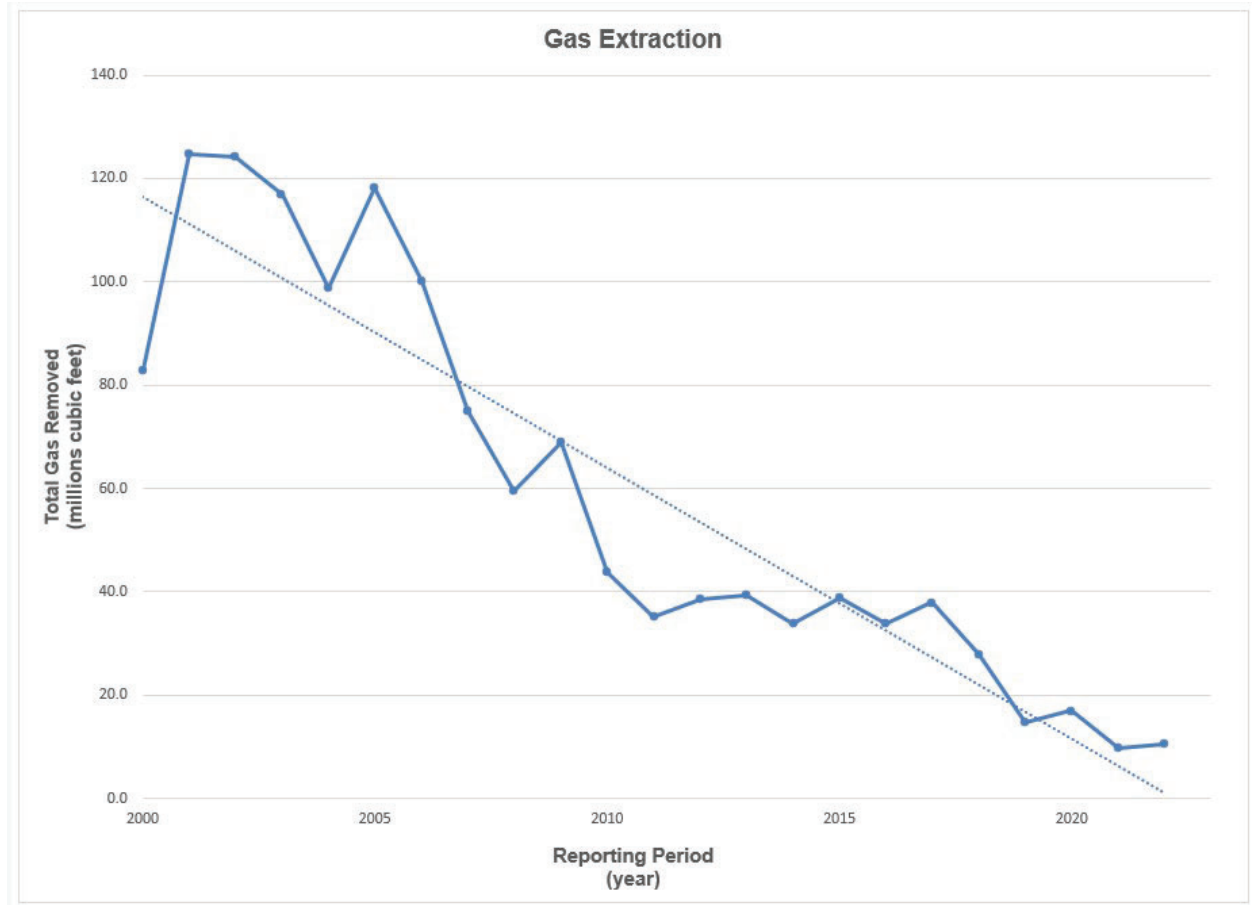
Graph 4-1: Gas Volume Extraction Trends

Graph 4-1 illustrates the volume of landfill gas removed on an annual basis. A decreasing trend in the volume of gas removed from the Landfill over the past 21 years is observed. This is the expected result of continued landfill gas removal.

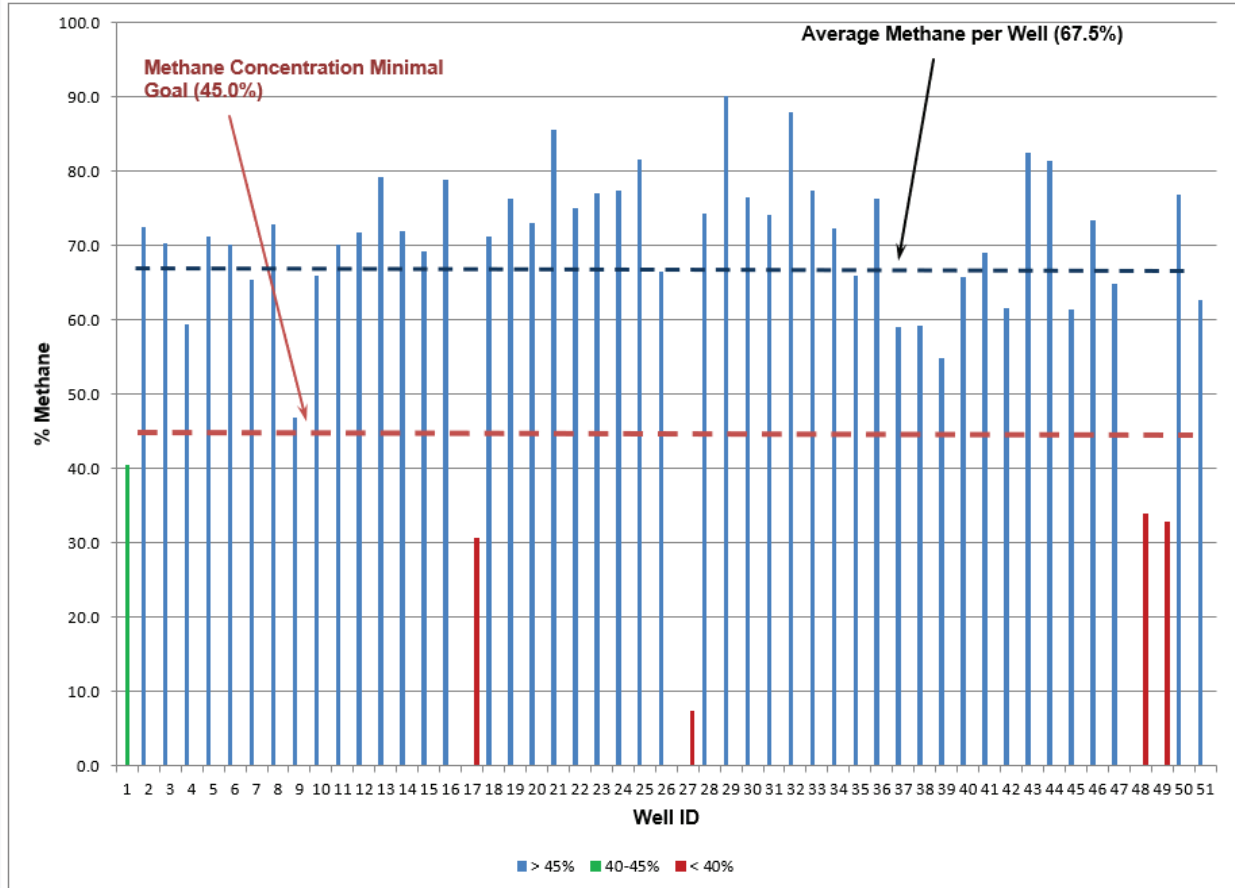
Graph 4-2 Average Methane Concentrations per Extraction Well

The average methane composition during this period was 67.5% (up from 62.6% the previous year). Forty-Seven wells had an average methane concentration above the 45% methane goal. One of the fifty-two wells were below the goal (>45%) but within 5% of it. The remaining four wells had average methane concentrations less than 40%, three of these four wells are located along the perimeter of the Landfill or in low lying areas. Diminishing methane levels are expected in these areas and data from the last 20 years, which show a reduction in methane production along the perimeter, confirms this. Methane production and accumulation along the Landfill perimeter remains low despite limiting the flow using valve settings.

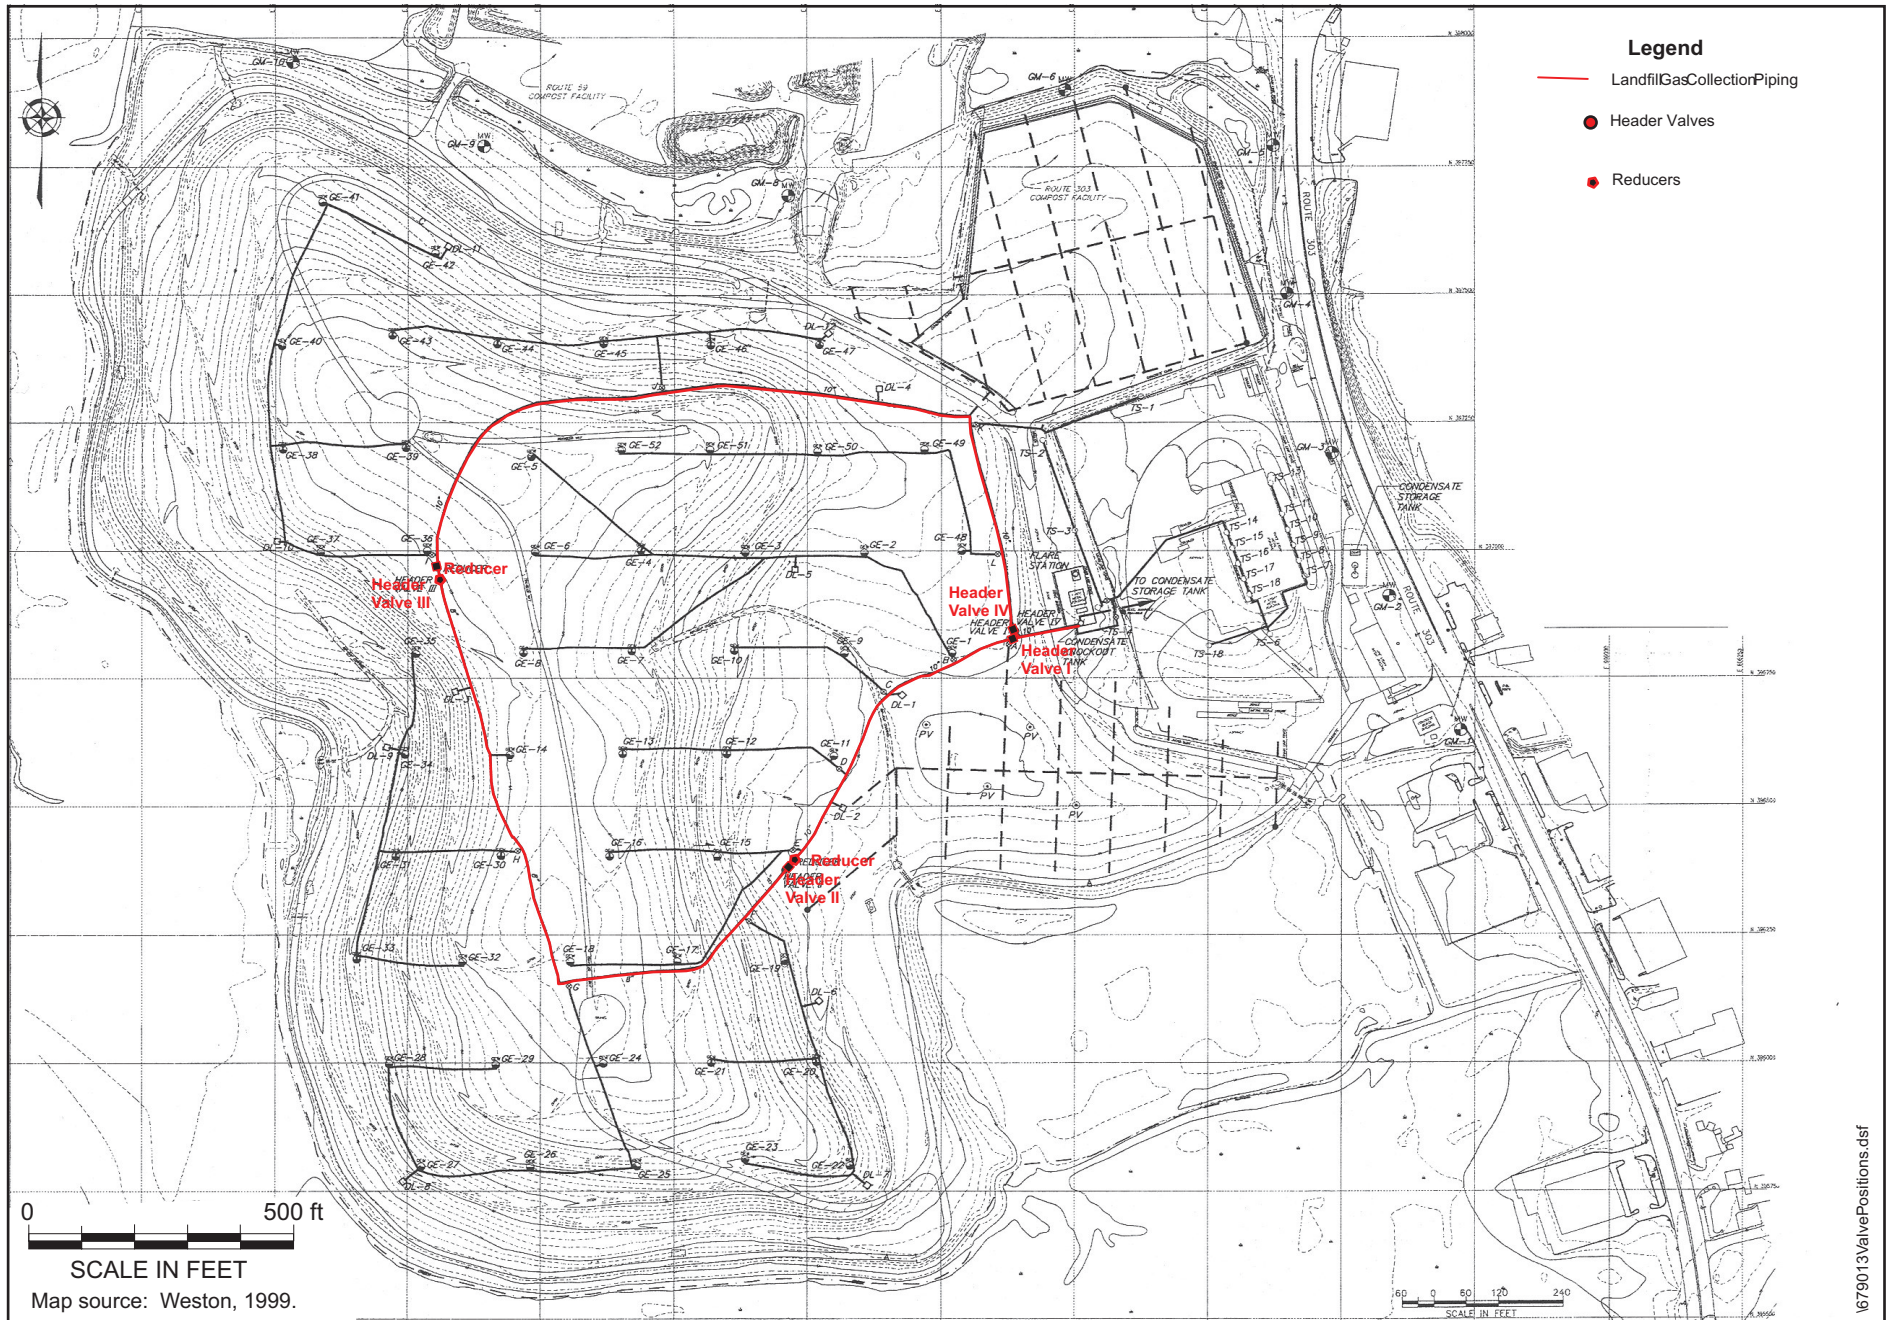
Figure 2

The landfill gas (LFG) system (Figure 2) was designed to collect, transport, and incinerate gas generated at the capped Landfill. The system is constructed of a main header pipe, horizontal surface collection areas, and 10 extraction legs with 52 extraction wells. The entire system is comprised of approximately 18,000 linear feet of high-density polyethylene (HDPE) pipe of varying diameters. This section provides a description of the monitoring and maintenance of the LFG system, which includes the following:

Landfill Gas Collection Network
Clarkstown Landfill
West Nyack, NY 10994

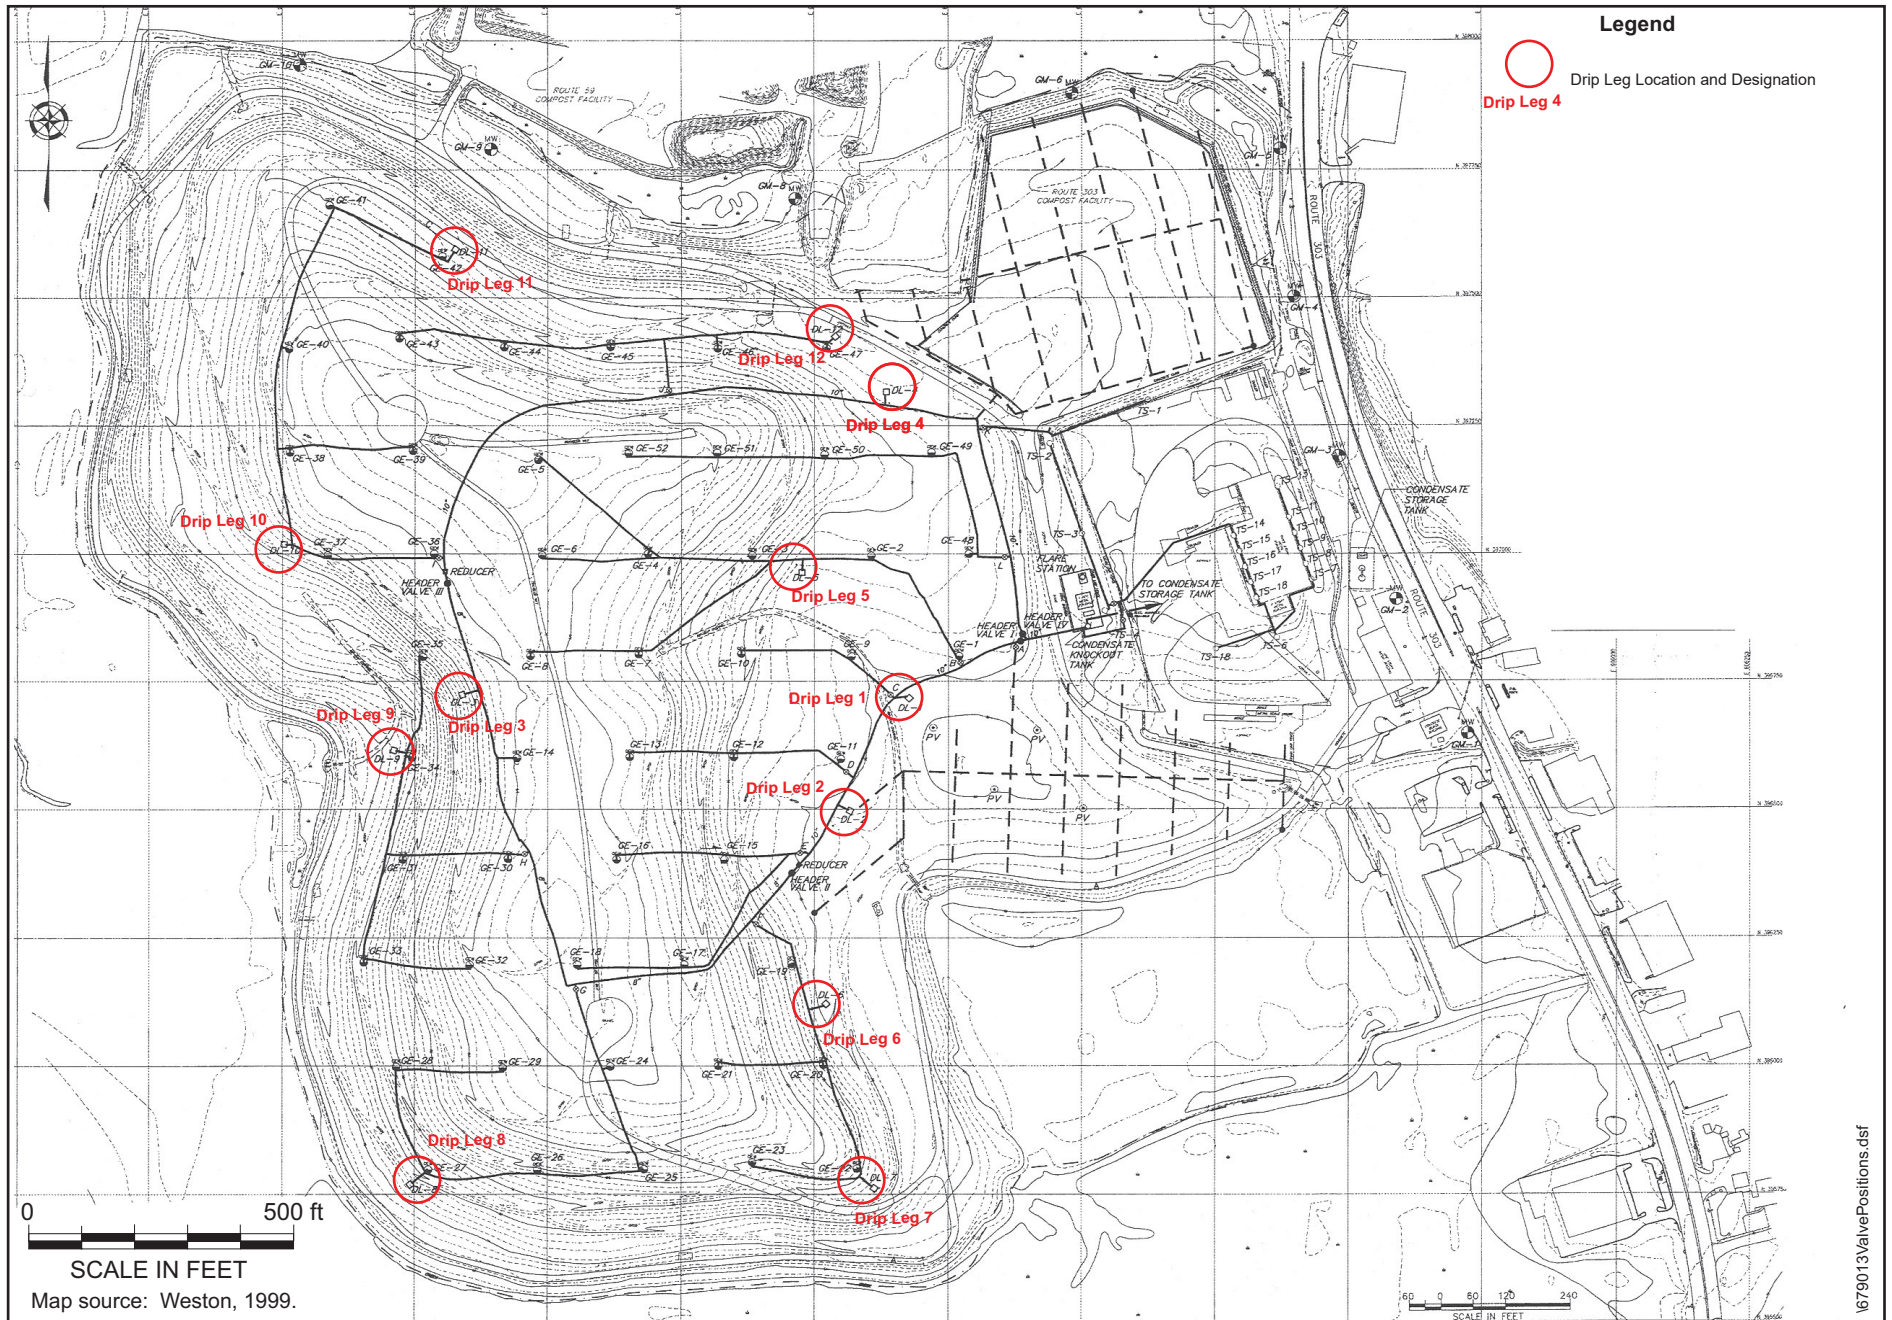
Figure 5

There are 12 drip leg assemblies (Figure 5) located at the Landfill. Some areas along the gas collection piping experience restrictions in air flow caused by the accumulation of condensate in low lying areas of the gas collecting piping. These locations are near Drip Leg (DL) 1, DL-5, a 2" PVC drip leg located adjacent to GE-09 (referred to as "GE-09"), and to a lesser extent DL-10. These areas are inspected/monitored, and condensate is removed during monthly site visits. It should be noted that it is common for condensate to accumulate in landfill gas lines and these issues are not unique to this landfill.

Drip Leg Assembly Locations
Clarkstown Landfill
West Nyack, NY 10994

At each restricted location, the collection leg was tapped and fitted with a pipe-sleeve and tee. A PVC riser pipe and valve were connected to this sleeve/tee. The modification to the Landfill collection pipe is used exclusively to remove condensate. During each monthly site visit, each location was inspected for the presence of condensate (positive vs. negative pressure). If positive pressure or minimal negative pressure is noted, condensate is removed by utilizing a submersible or peristaltic pump. This method has been effective in removing the blockages caused by condensate in the collection pipe.

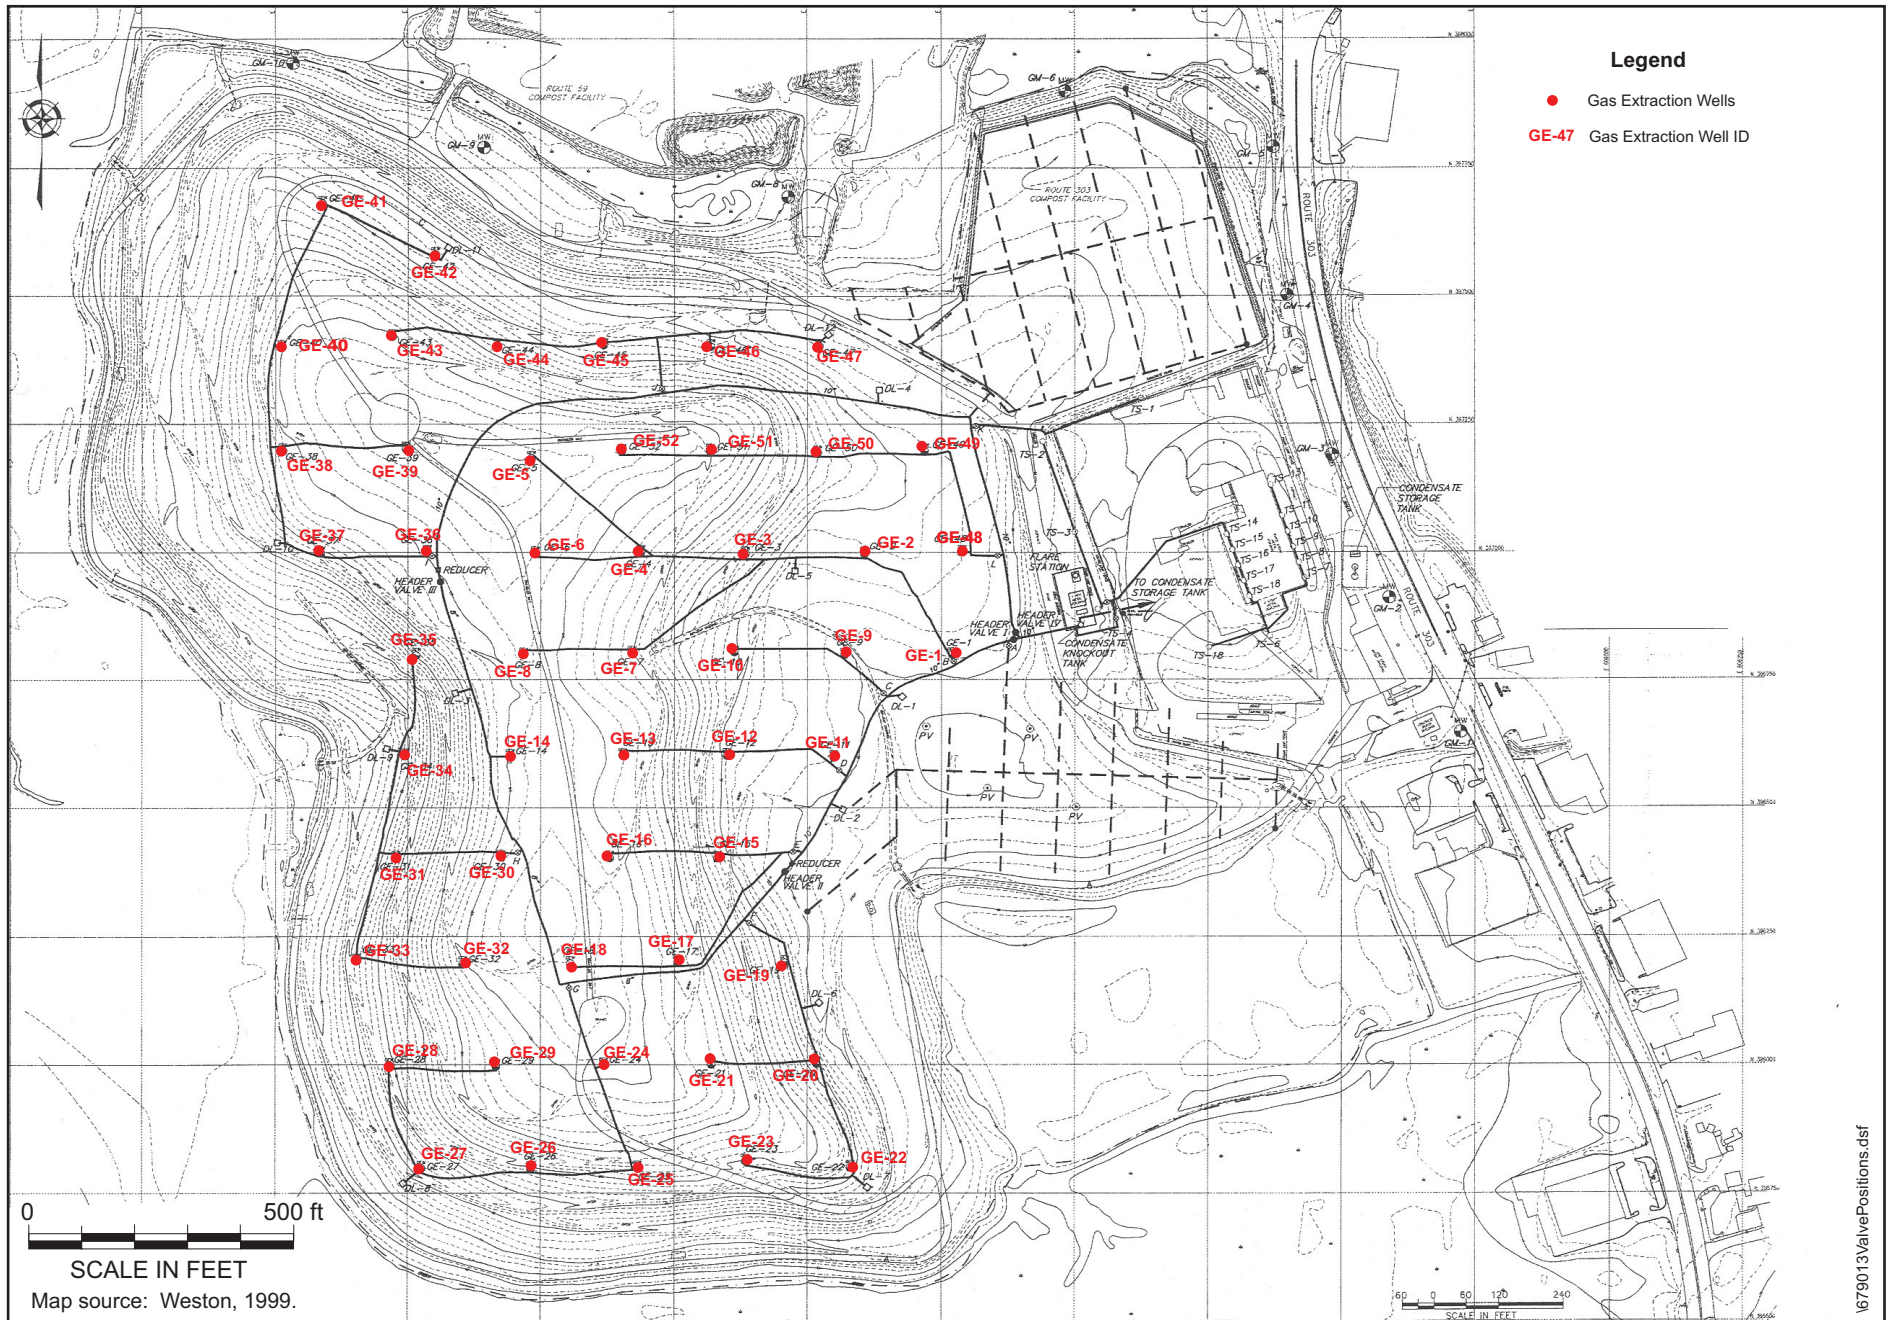
Figure 6

The 52 LFG extraction wells (Figure 6) were inspected during monthly site visits. Gas extraction well monitoring, and inspections of each well were conducted to identify potential leakage, liquid pooling, and hazardous methane conditions in the surrounding area. Observations noted during the monthly inspections were reported on Form DP-1, which is included as Appendix B.

Settlement of the well head vaults is an ongoing issue at the Landfill. The Town, in conjunction with HDR, has evaluated the well head construction and design and has retrofitted LFG extraction wells and vaults at 38 locations with new QED® Accu-Flo well heads, located above grade. Three of these were replaced in December of 2022 (GE-10, GE-15, and GE-26). This new design eliminates the slip/trip/fall hazard which was associated with settlement of the old vault system. Additionally, the new well heads are clearly visible and easily accessible. The new well head design also allows differential pressures to be measured. These measurements allow HDR to calculate the flow rate for the wells that have been retrofitted.

Fourteen LFG extraction wells and associated valves have not yet been retrofitted. These vaults are constructed out of heavy-duty fiberglass. Over the years, some of the vaults have exhibited minimal to moderate amounts of damage around the lip of the vault and/or the vault covers. This damage is cosmetic and does not affect the performance or operation of the LFG collection piping or wells.

Gas Extraction Wells
Clarkstown Landfill
West Nyack, NY 10994
