Taconic Plastics Remedial Investigation – Progress Update

Site Number: 442047

Site Location: 136 Coonbrook Road, Petersburg, NY

November, 2020

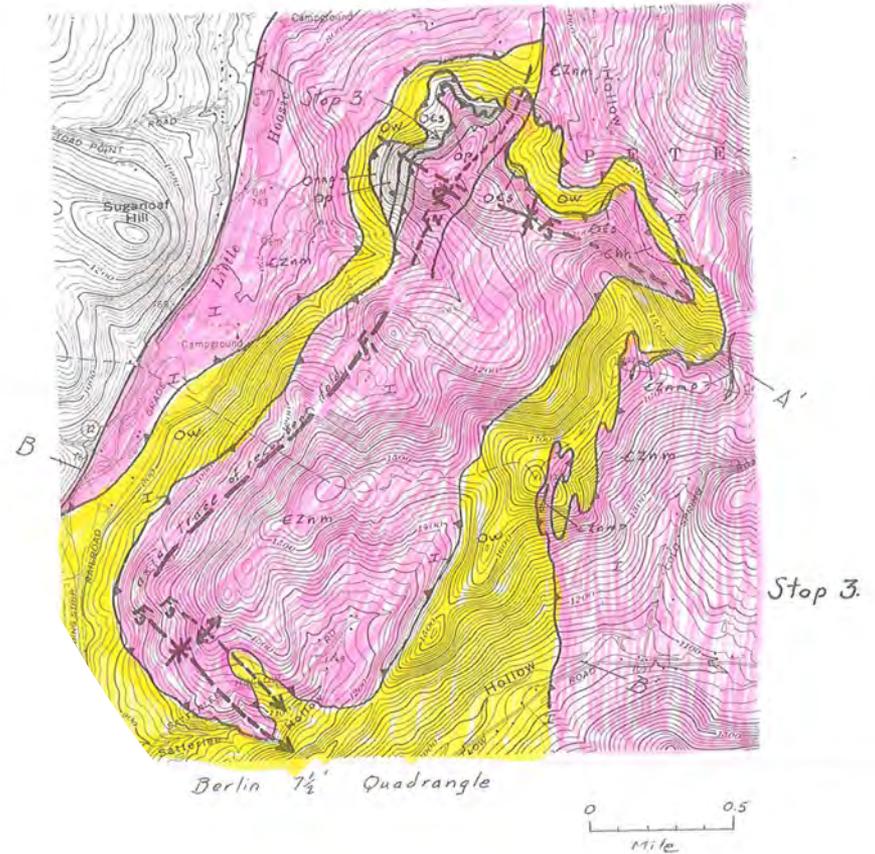
- Bedrock is phyllite. The phyllite in the region is highly deformed from the Taconic Orogeny (mountain building event).
- Bedrock is overlain by unconsolidated soils and sediment – this overburden can be thick in the valley
- depth to bedrock at the site, in the valley, is between 20 and 110 feet below ground surface.
- Bedrock outcrops on both sides of the valley.
- The hillsides have very thin soil cover.

Potter, 1972, 1978

Figure 3 for stratigraphy.
Wings Brook thrust fault and
.

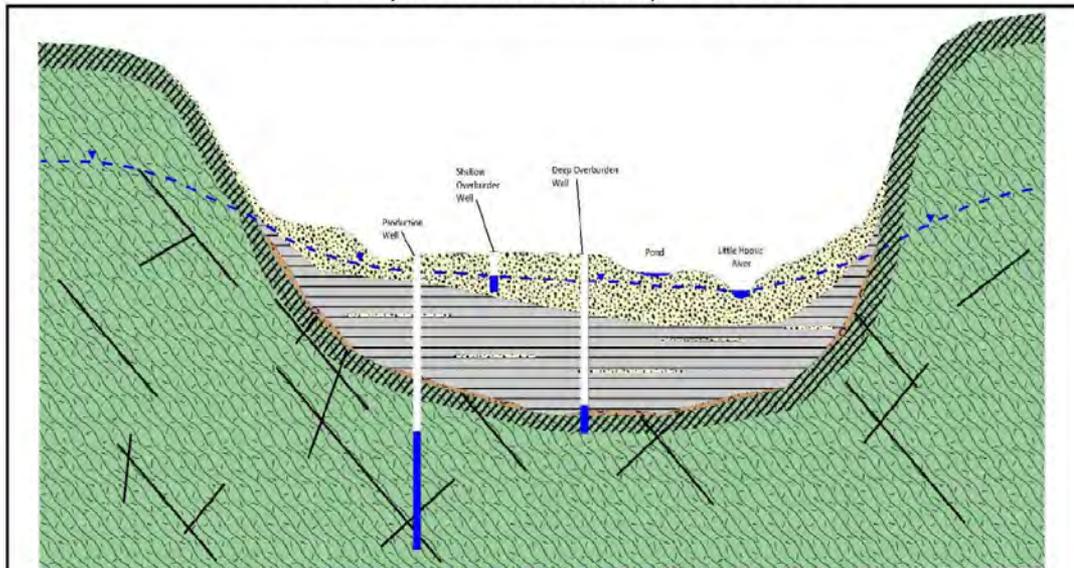
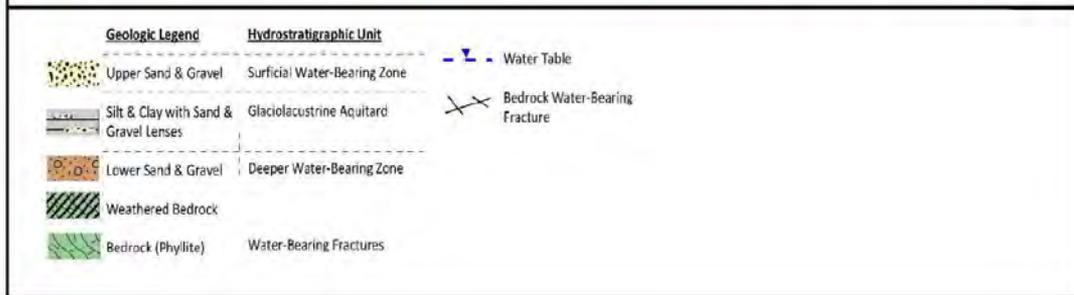
Preliminary Cross-Sectional Conceptual Site Model

- Overburden consists of three units:
 - Shallow overburden – Sand and Gravel (~5-25 feet thick)
 - Silts and clay (~5 to 60 feet thick)
 - Sand and gravel – (thin or non-existent)

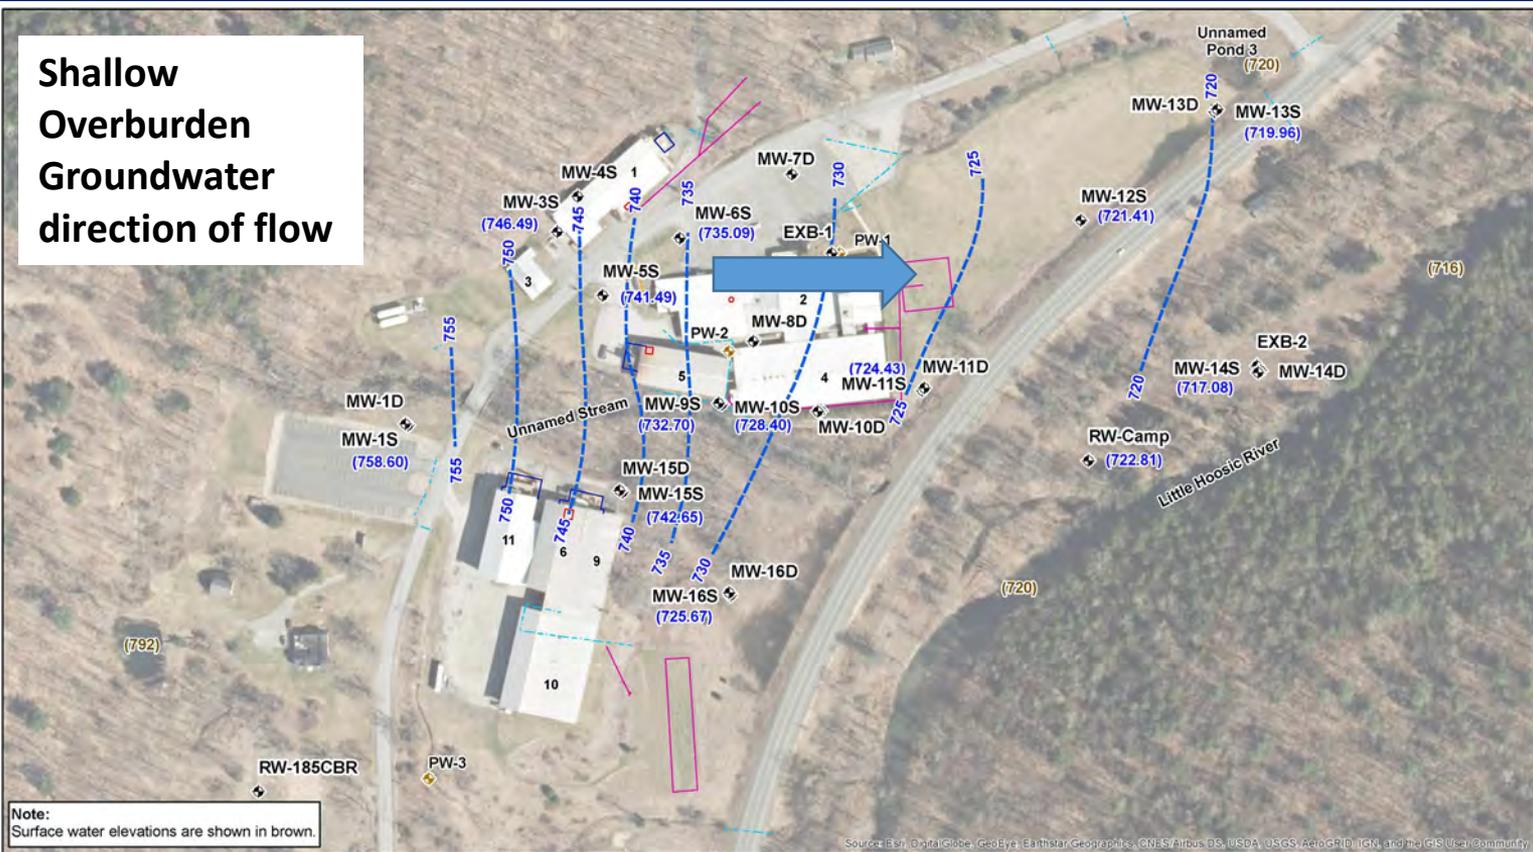
**Shallow
Overburden
Groundwater
direction of flow**

Note:
Surface water elevations are shown in brown.

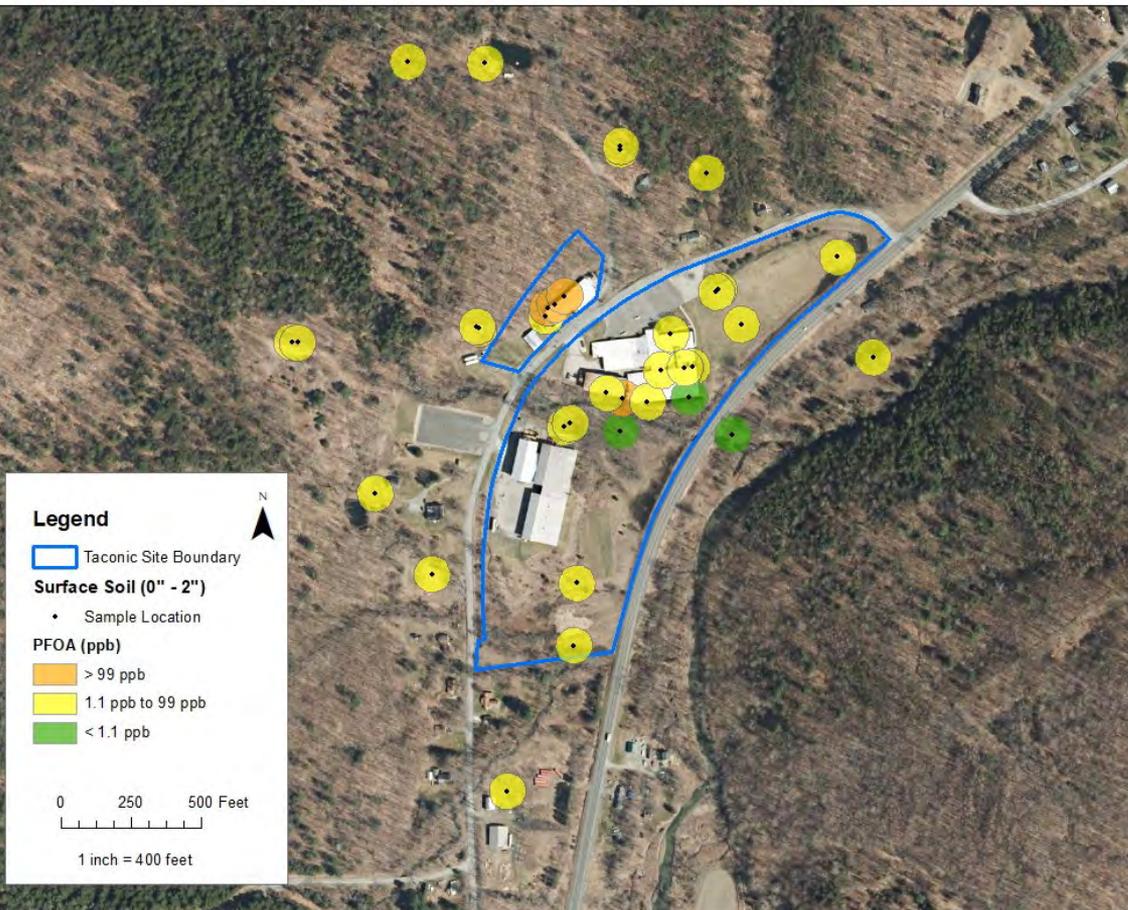
Soil Sampling

- Maximum detection 310 ng/g
- Minimum detection 0.24 ng/g

- "A" interval 0"-2"

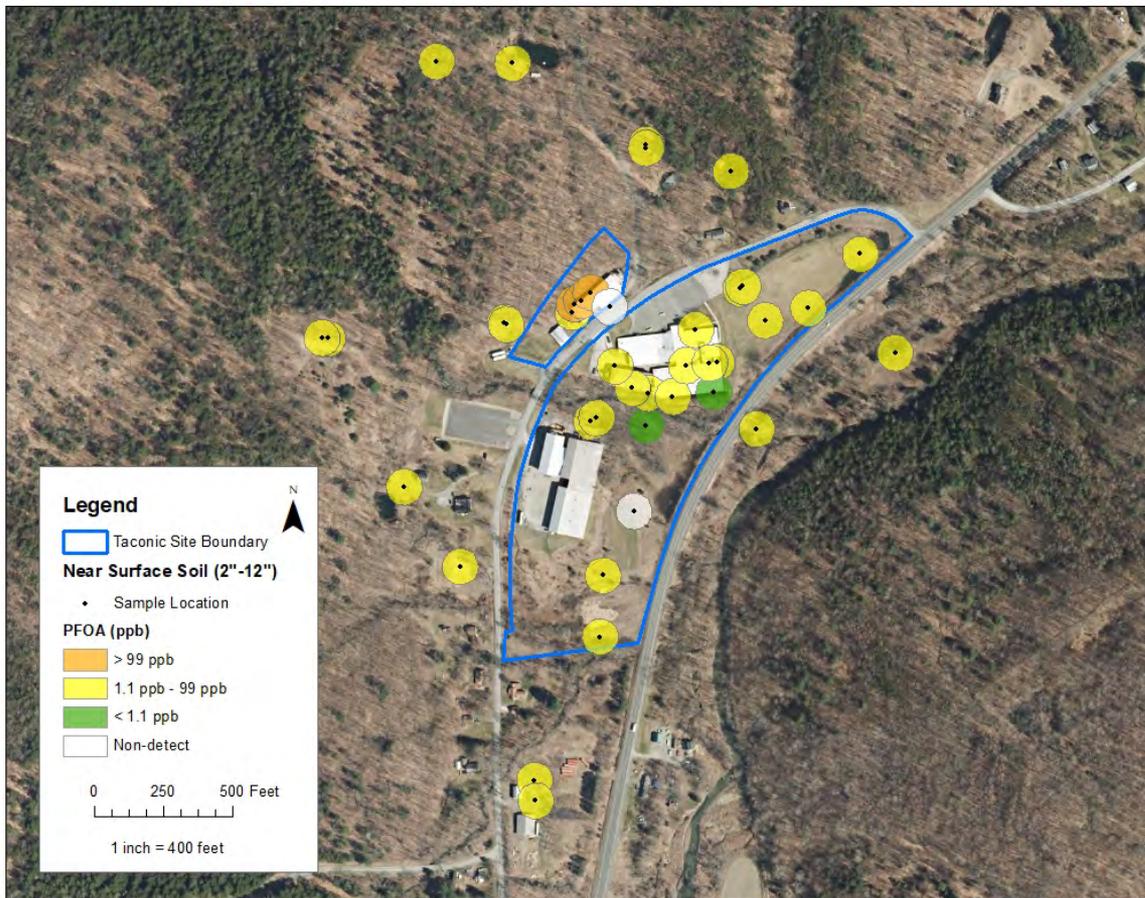
Soil Sampling

- Maximum detection 1100 ng/g
- Minimum detection 0.87 ng/g

- "B" interval 2"-12"

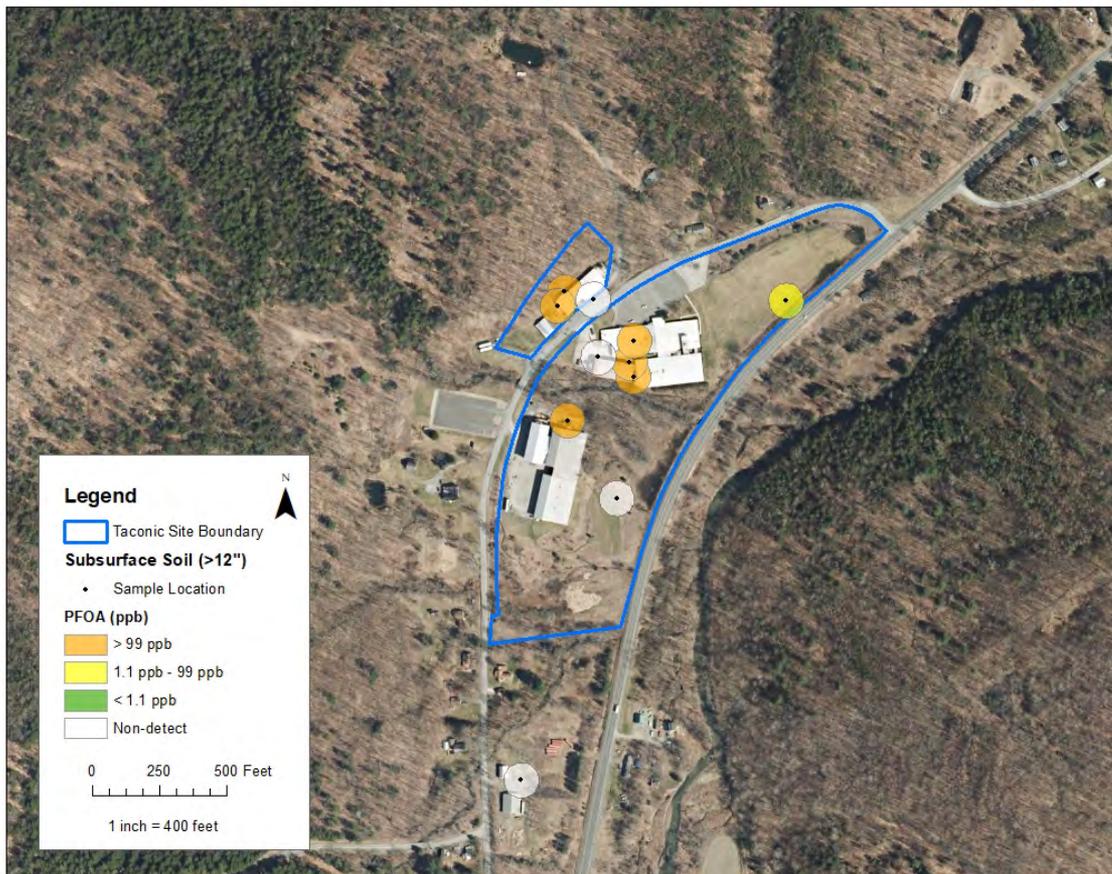
Soil Sampling

- Maximum detection 43000 ng/g
- Minimum detection 0.068 ng/g
- PFOS only present in “source location” soil samples, and not in every interval

- > 12” below ground surface

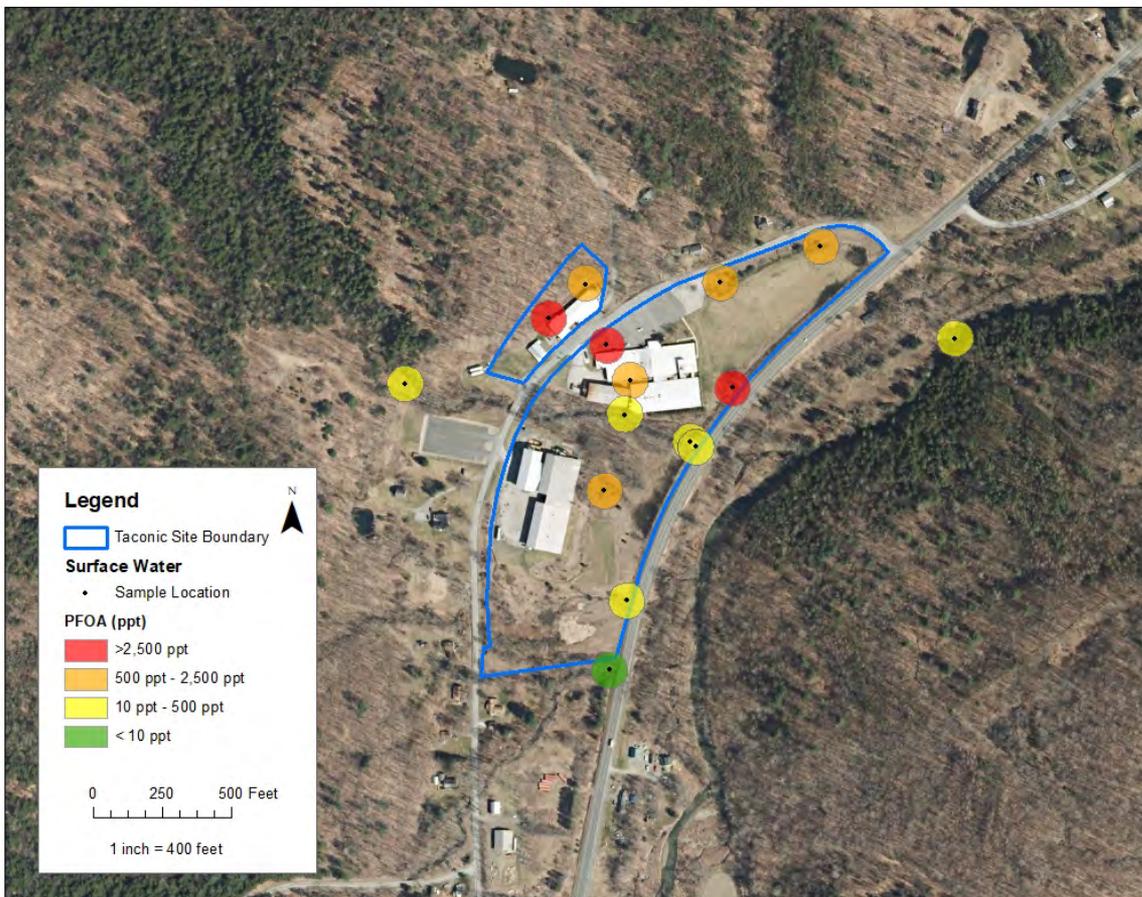
Surface Water Sampling

- Maximum detection 14 ug/L
- Minimum detection 0.015 ug/L
- PFOA detected in every sample
- PFOS inconsistently detected, detections range from 0.00039-0.0026 ug/L in surface water samples collected

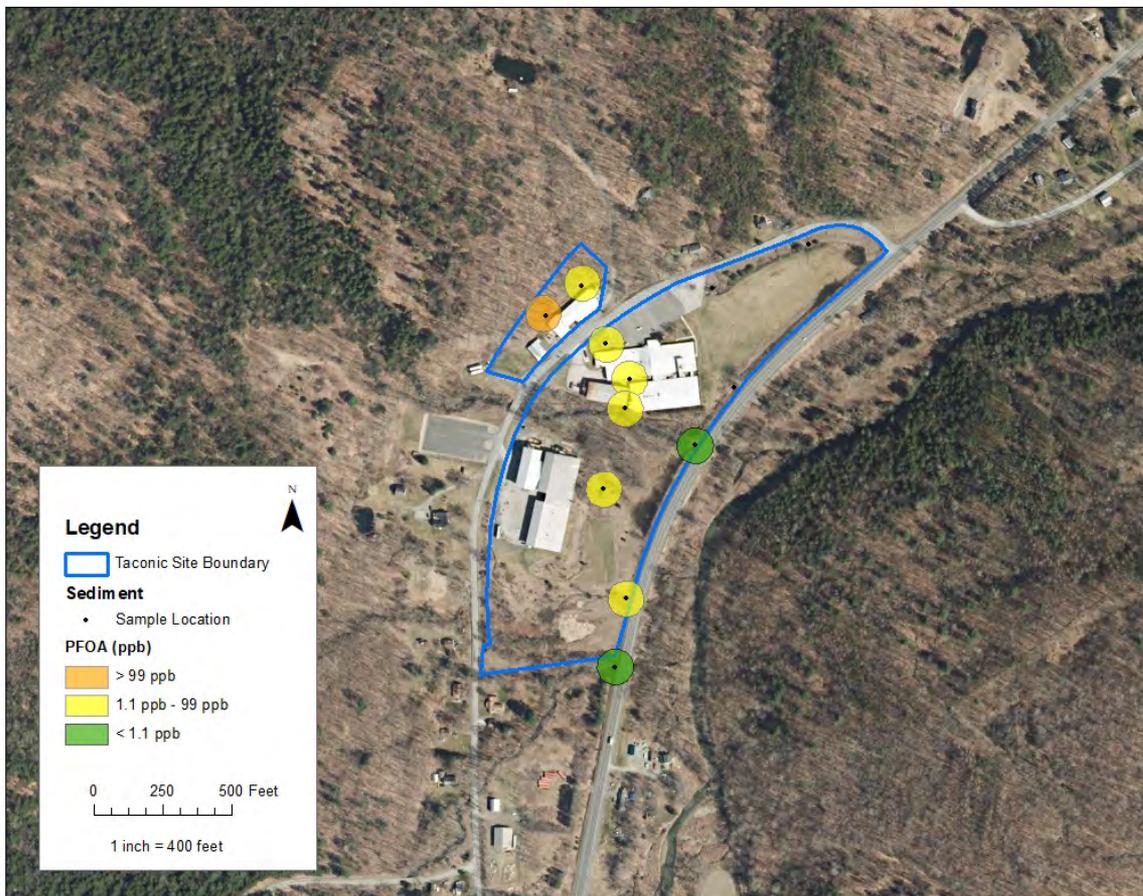
Sediment Sampling

- Maximum detection 610 ng/g
- Minimum detection 0.54 ng/g
- PFOA detected in every sample
- PFOS ND in sediment, except behind Building 1

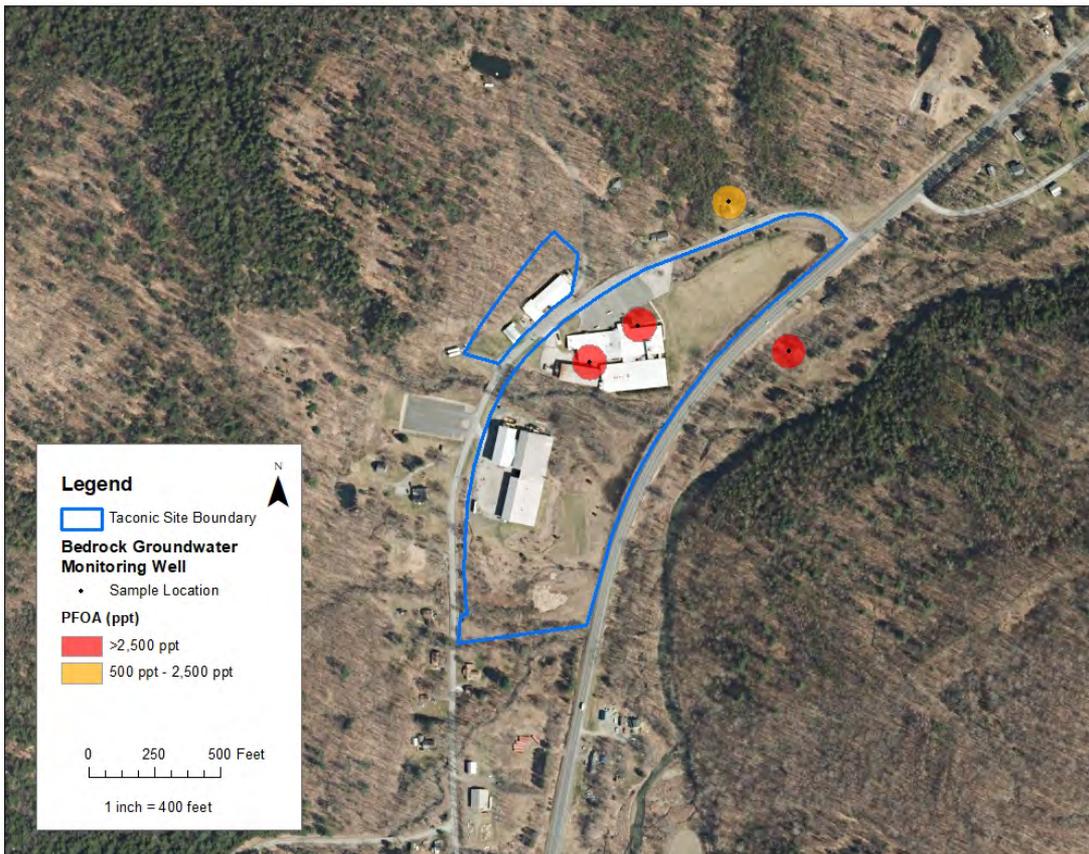
Bedrock Groundwater

Detections range from:
2.1 to 8.1 ug/L

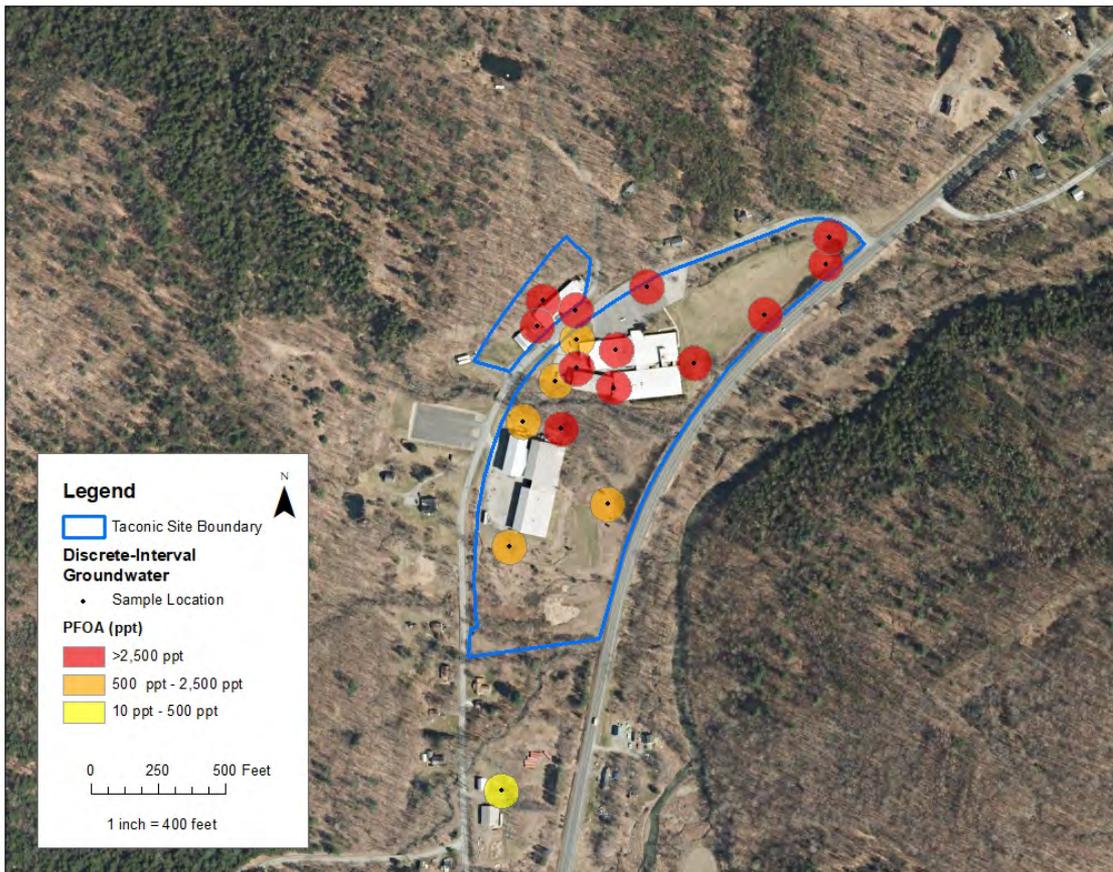
Overburden Groundwater Sampling

- PFOA detected in every sample
 - Range from 0.068 to 5600 ug/L
- PFOS detected inconsistently at lower concentration
 - Maximum detection 0.014 ug/L

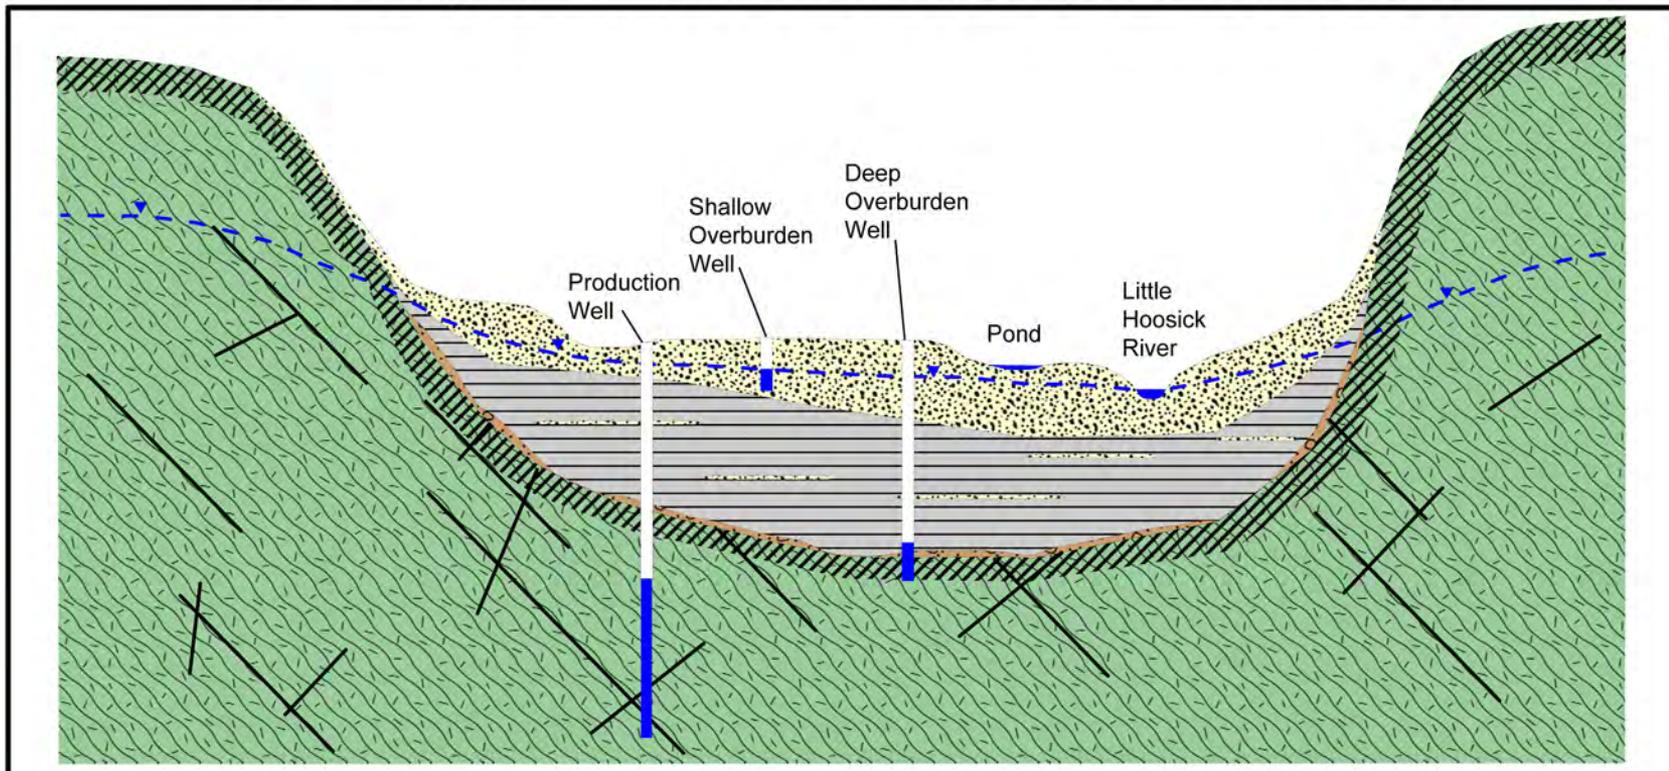
Preliminary Cross-Sectional Conceptual Site Model

Contaminants of Concern:

- PFAS

Source:

- Historical disposal of industrial waste via on-site drywells and outfalls
- Historical Aerial deposition

Migration and Pathways:

- Overburden groundwater aquifer (shallow and deep) on- and off-site
- Bedrock Aquifer
- Migration toward the Little Hoosic River
