Preliminary Site Assessment
&
Interim Remedial Measures Study
for the
Schenectady (Seneca St.) Site
Schenectady, New York

Prepared for
Niagara Mohawk Power Corporation
November 1998

WHEELER
FOSTER WHEELER ENVIRONMENTAL CORPORATION

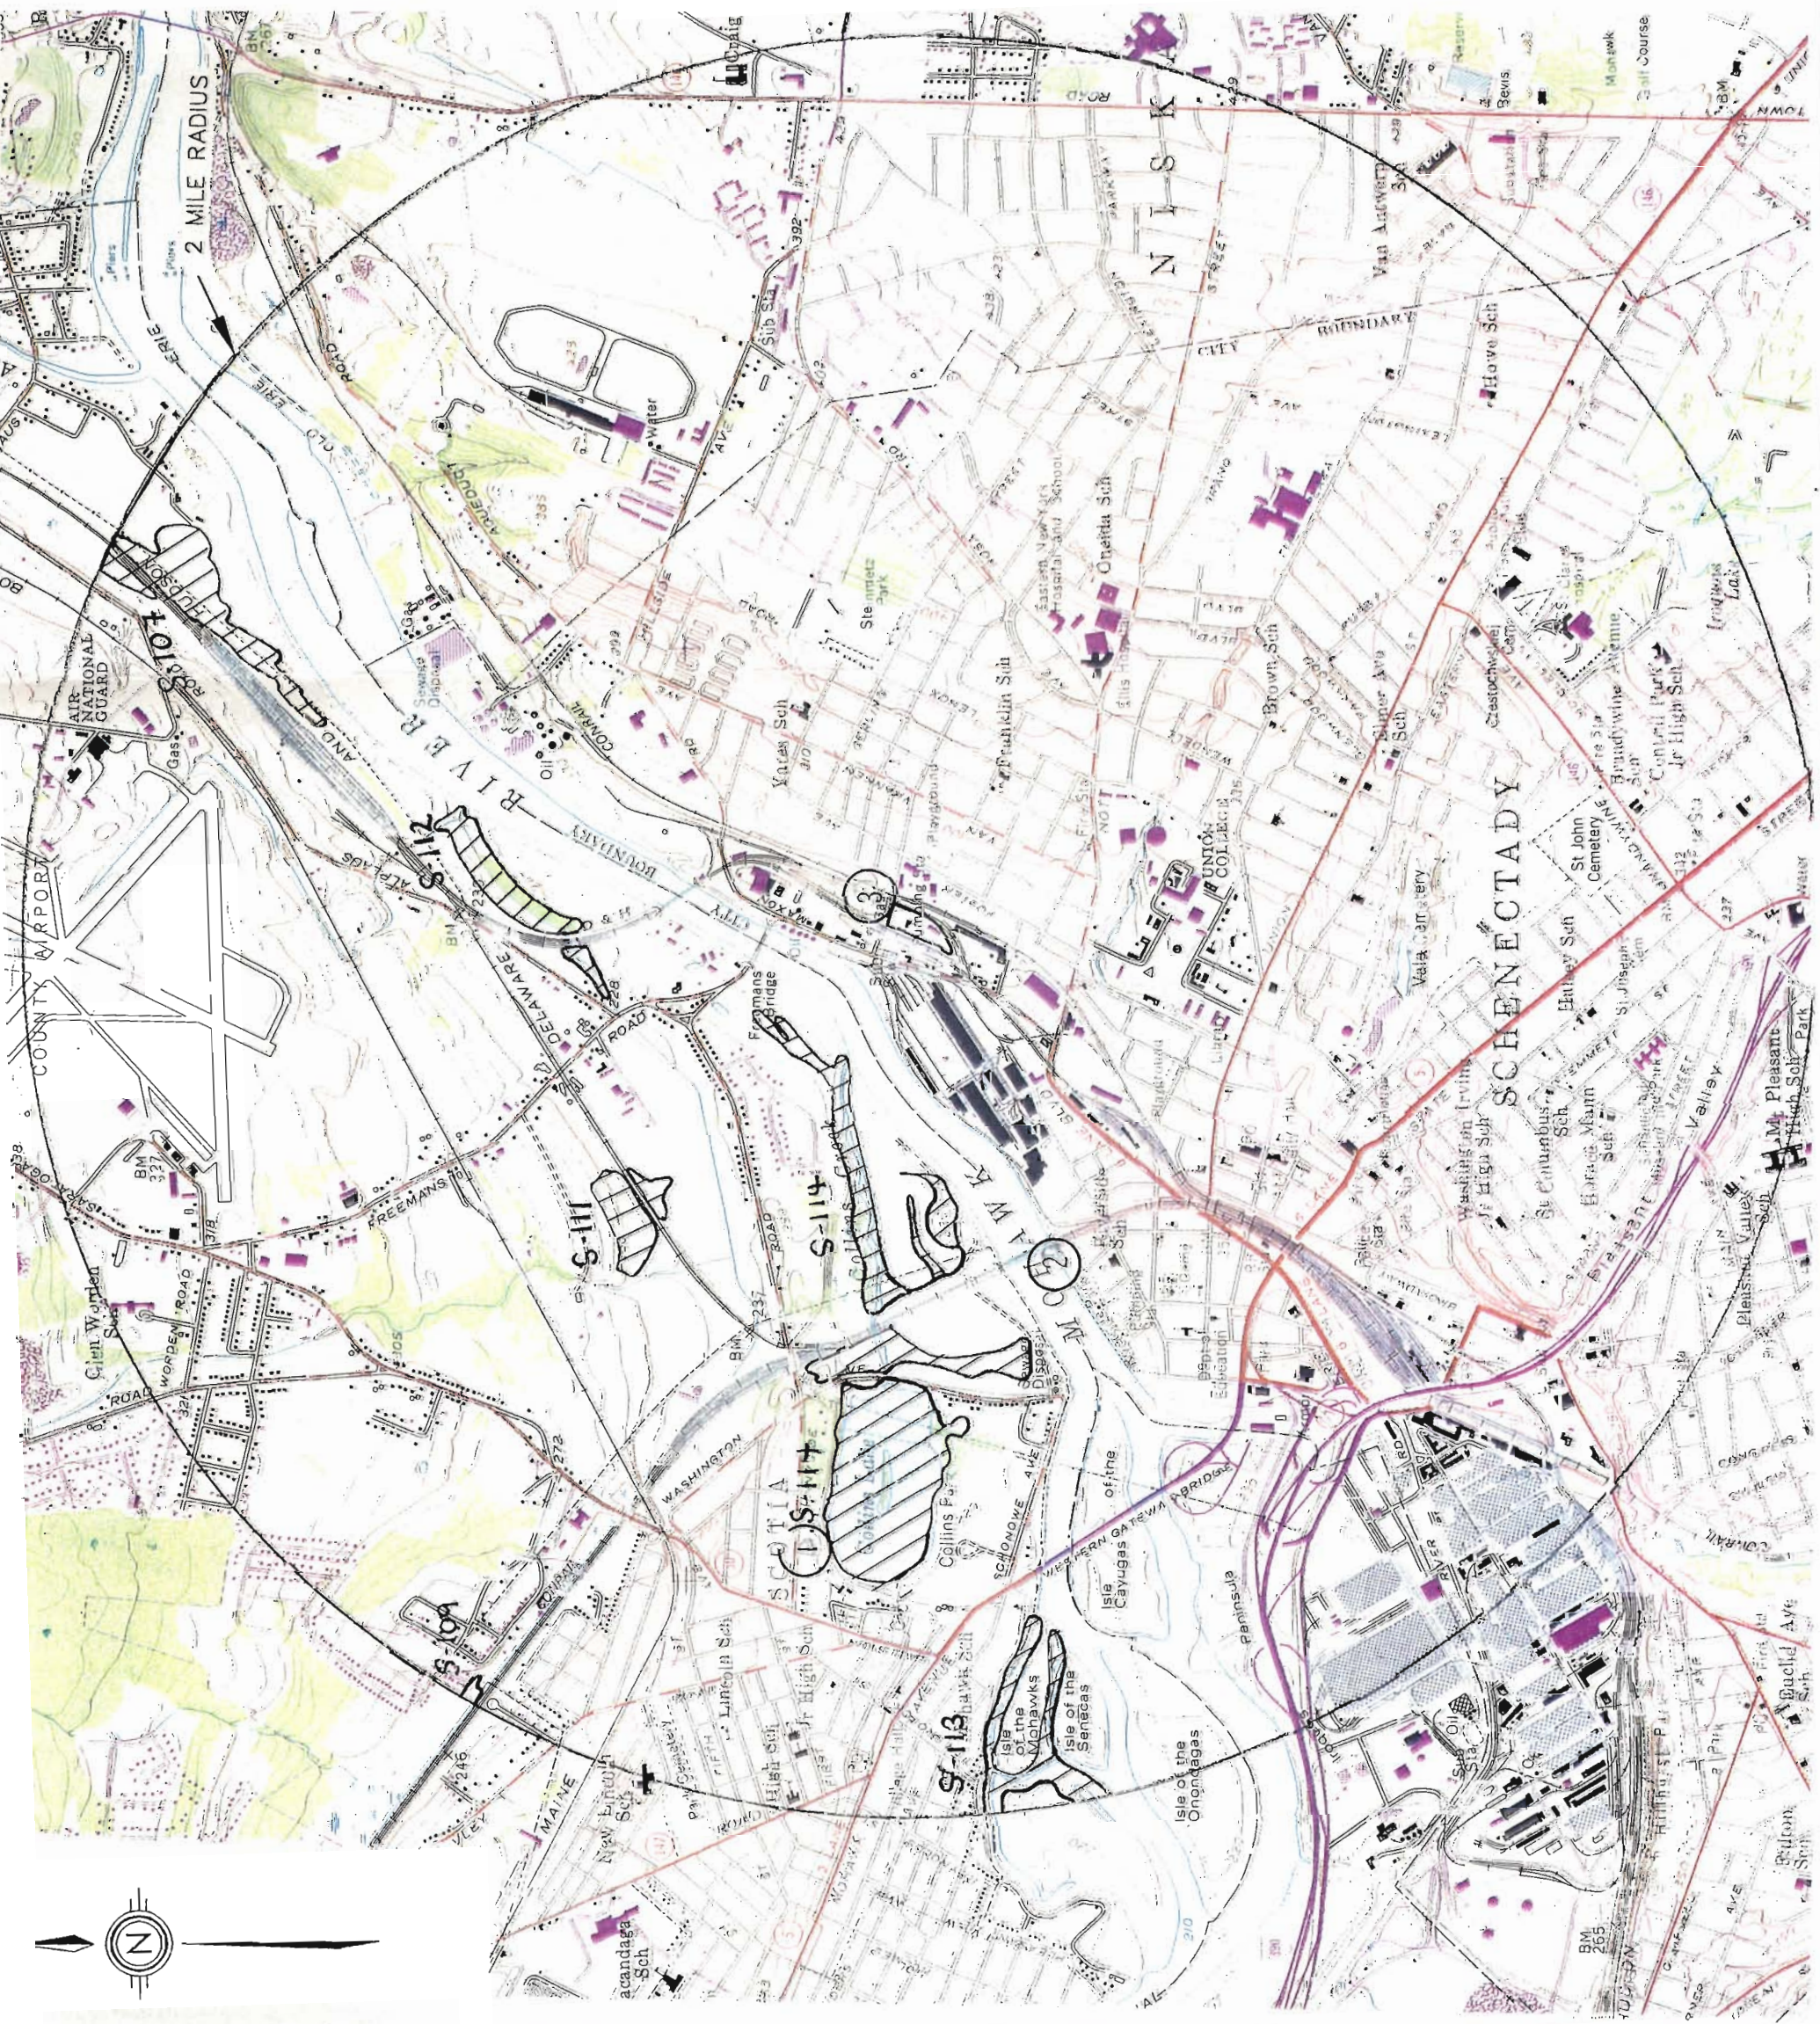
The locations of documented fish and wildlife resources within a two-mile radius of the Site are shown on Figure 5-1. The New York Natural Heritage Program lists the occurrence of three rare plant species within a two-mile radius of the Site. The State listed endangered side-oats grama (*Bouteloua curtipendula*) was observed in the vicinity of Collins Lake in 1884 (approximately 1.5 miles east northeast of the Site). The State listed category SH (historically known from New York) erect knotweed (*Polygonum erectum*) was recorded on the bank of the Mohawk River near the New York Central Railroad bridge (approximately 0.75 mile southwest of the Site) in 1946. Additionally, the State listed category S1 (extremely rare) narrow-leaf paleseed (*Leucospora multifida*) was observed just north of the intersection of Seneca Street and the bike path
